# Tree Survey and Report

BS 5837

Acorn Lodge, Pinder Oaks  
Upper Sheffield Road, Barnsley

SEPTEMBER 2017

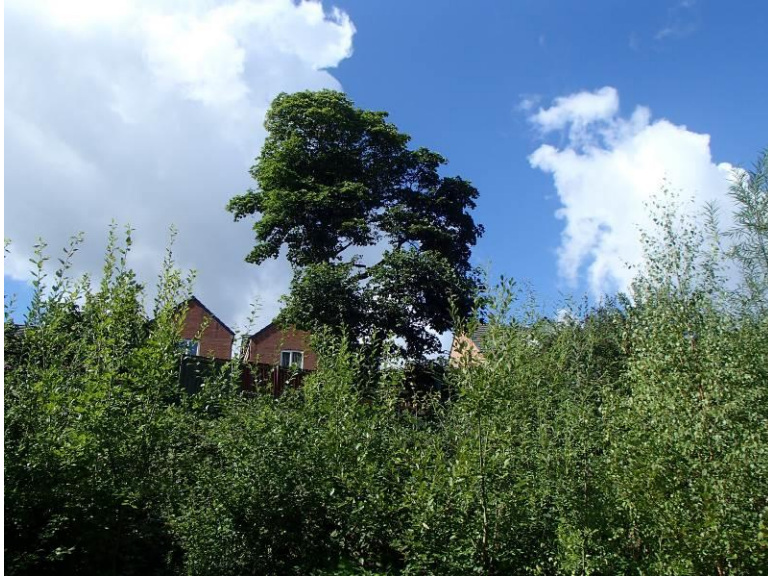
| Tree No. | Species | Hgt (m) | Diam (mm) | Spread N, S, E, W (m) | Hgt 1 <sup>st</sup> brch | Hgt to crown | Age Class | Physiological and Structural Condition. Preliminary Management Recommendations | Est RC years | Grade BS5837 | RPA (rad) (m2) | Photo |
|---|---|---|---|---|---|---|---|---|---|---|---|---|
| T1 | Sycamore<br><i>Acer pseudo-platanus</i> | 15 | 400?<br>~ | 7, 5, 3, - | 1 | 1 | M | Good foliage health, low canopy, low limb overextended to north-east at ~2m AGL.<br><i>Suggest remove limb to NE. Other work TBC.</i> | 10-20 | C | 4.5<br>64 | 1, 2, 3 |

**Photo 1:** T1 Sycamore, western boundary

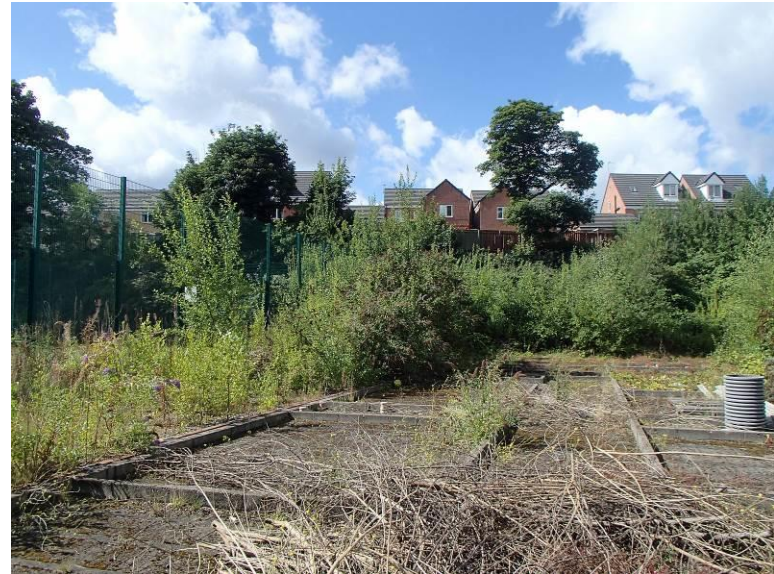
| Tree No. | Species | Hgt (m) | Diam (mm) | Spread N, S, E, W (m) | Hgt 1 <sup>st</sup> brch | Hgt to crown | Age Class | Physiological and Structural Condition. Preliminary Management Recommendations | Est RC years | Grade BS5837 | RPA (rad) (m2) | Photo |
|---|---|---|---|---|---|---|---|---|---|---|---|---|
| T2 | Sycamore<br><i>Acer ps.</i> | 5 | 300<br>~ | 3, 3, 3, 3<br>? | 1 | 1 | M | Has been topped (presumably by neighbours to west) so form potentially very compromised.<br><i>No immediate works required - TBC.</i> | 10-20 | C | 3<br>28 | 2, 3 |
| T3 | Sycamore<br><i>Acer ps.</i> | 8 | ? | 2, 2, 2, 2<br>? | - | - | M | Good foliage health, low canopy.<br><i>No immediate works required - TBC.</i> | 10-20 | C | 3<br>28 | 2, 3 |
| T4 | Sycamore<br><i>Acer ps.</i> | 10<br>~ | ? | 4, 4, 4, 4<br>? | - | - | M | Good health, low canopy, possibly multi-stem. Larger than neighbours.<br><i>No immediate works required - TBC.</i> | 20-30 | B | 4.5<br>64 | 2, 3 |

**Photo 2:** T1 RHS, T2 (topped), T3 & T4 to LHS; all Sycamores

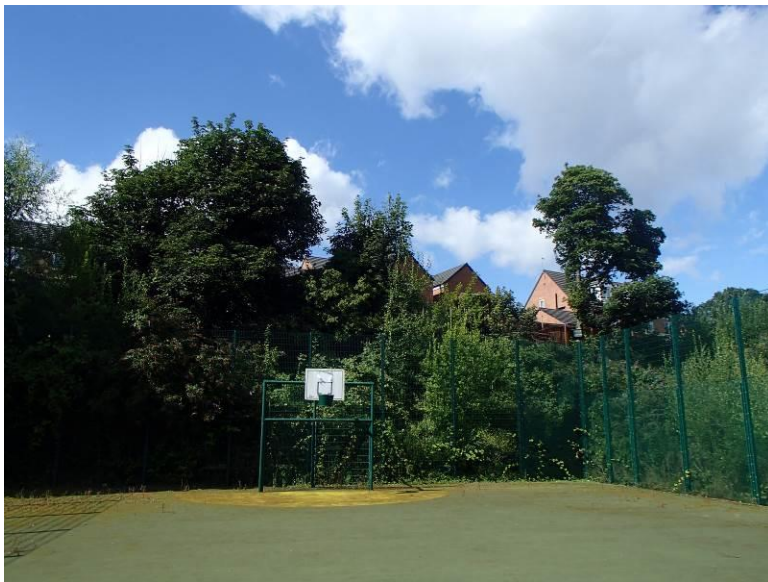
| Tree No. | Species | Hgt (m) | Diam (mm) | Spread N, S, E, W (m) | Hgt 1 <sup>st</sup> brch | Hgt to crown | Age Class | Physiological and Structural Condition. Preliminary Management Recommendations | Est RC years | Grade BS5837 | RPA (rad) (m2) | Photo |
|---|---|---|---|---|---|---|---|---|---|---|---|---|
| T5 | Sycamore<br><i>Acer ps.</i> | 10<br>~ | ? | 2, 2, 3, 3 | - | - | M | Good foliage health, low canopy. Squirrel damage at top of canopy.<br><i>No immediate works required - TBC.</i> | 10-20 | C | 3<br>28 | 2, 3 |

**Photo 3:** T1 RHS, T2 (topped); T3, T4 & T5 LHS

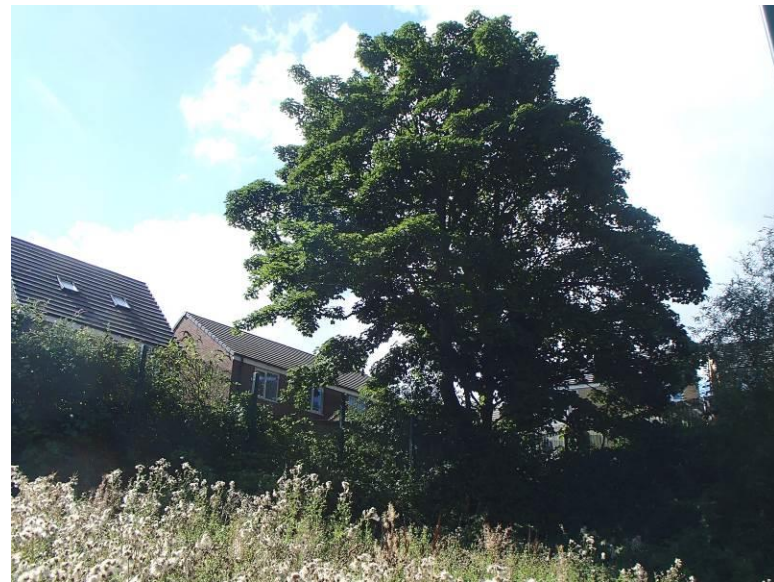
| Tree No. | Species | Hgt (m) | Diam (mm) | Spread N, S, E, W (m) | Hgt 1 <sup>st</sup> brch | Hgt to crown | Age Class | Physiological and Structural Condition. Preliminary Management Recommendations | Est RC years | Grade BS5837 | RPA (rad) (m2) | Photo |
|---|---|---|---|---|---|---|---|---|---|---|---|---|
| T6 | Sycamore<br><i>Acer ps.</i> | 12<br>~ | 400<br>~ | 4, 3, -, - | 1 | 1 | M | Assumed to be in site ownership - TBC. Good foliage health; appears to be compromised by T7. Ivy up stem to 8m+.<br><i>To be felled for development purposes - for retaining wall construction.</i> | 10-20 | C | 4.5<br>64 | 4 |
| T7 | Sycamore<br><i>Acer ps.</i> | 18 | 550+<br>~ | 6, 7, 7, 4 | 2 | 2 | M | Assumed to be in site ownership - TBC. Good foliage health, dominant tree on this boundary. Twin stemmed at 2m, junction appears sound, but not checked. Minor deadwood. Very close to houses to south.<br><i>To be felled for development purposes - for retaining wall construction.</i> | 20-30 | B | 6.6<br>135 | 4 |

**Photo 4:** T7 LHS, T6 hidden, south-west boundary

The plan of proposals indicates that the TPO Sycamores T6 and T7 cannot be retained, as they are immediately adjacent to the necessary retaining wall which will be a significant structure. The ownership status of these trees must be established before full construction details are agreed. Replacements for T6 & T7 and for previously lost or fallen TPO trees are included in the scheme and are fully detailed on the landscape plan which accompanies the application.

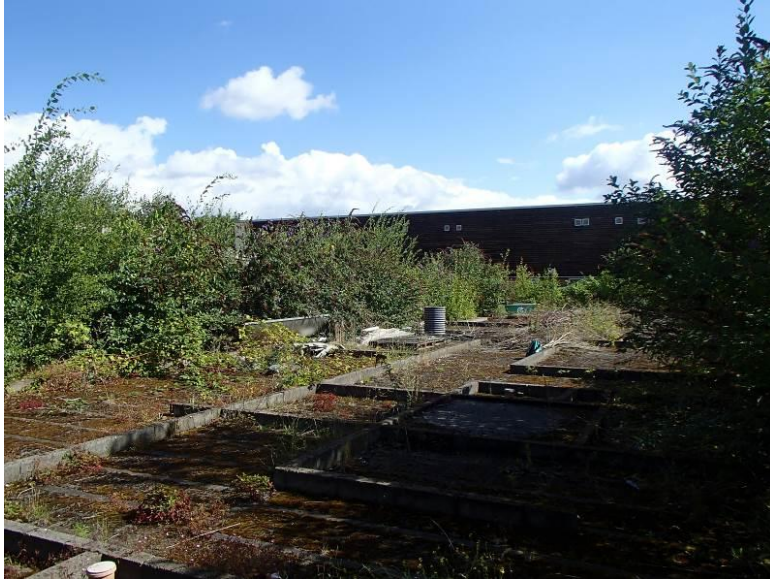
| Tree No. | Species | Hgt (m) | Diam (mm) | Spread N, S, E, W (m) | Hgt 1 <sup>st</sup> brch | Hgt to crown | Age Class | Physiological and Structural Condition. Preliminary Management Recommendations | Est RC years | Grade BS5837 | RPA (rad) (m2) | Photo |
|---|---|---|---|---|---|---|---|---|---|---|---|---|
| G1 | Birch, Osier, Willow Poplar | 1 to 5 | Up to 60 | Plan | - | - | Y SM | Pioneer vegetation on all open sections of site. Unmaintained. Has wildlife value, but limited external amenity value and no long term viability.<br><i>To be removed for development.</i> | - | - | - | 2, 5 |

**Photo 5:** Group 1, scrub and self-seeded within site

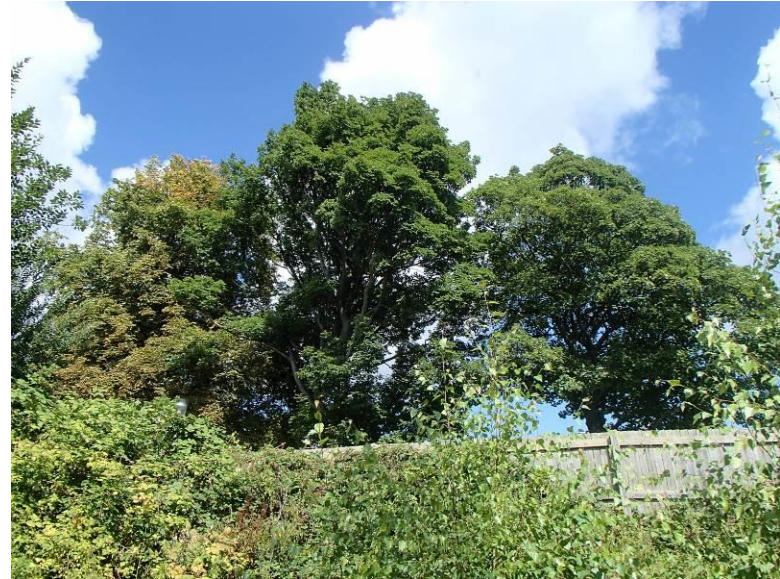
| Tree No. | Species | Hgt (m) | Diam (mm) | Spread (m) | Hgt 1 <sup>st</sup> brch | Hgt to crown | Age Class | Physiological and Structural Condition. Preliminary Management Recommendations | Est RC years | Grade BS5837 | RPA (rad) (m2) | Photo |
|---|---|---|---|---|---|---|---|---|---|---|---|---|
| G2 | <b>Comprises all Mature Trees, as below.</b><br>Not on original development site so visually checked only.<br>Notes for specific individuals; as described.<br>Heights, 20 to 25m; DBHs 600- 900mm; Spreads 12 to 20m | | | | | | | <b>Full Safety Inspections Recommended.</b><br>Some possibly hollowing detected by sounding, crown deterioration in some trees. Possibly fungal brackets present – verbal indication from site staff. Ivy up some stems, recommend cutting. | 30+ | A<br>As Group | Plan | 6 to 11 |

**Photo 6:** Mature trees in Group 2, along access road, from site

Notwithstanding any development works or approvals, it is recommended that all trees in G2 are more fully safety inspected because various issues and potential safety problems were identified in this BS5837 survey. In addition Ivy should be cut and, if possible, removed from the crowns.

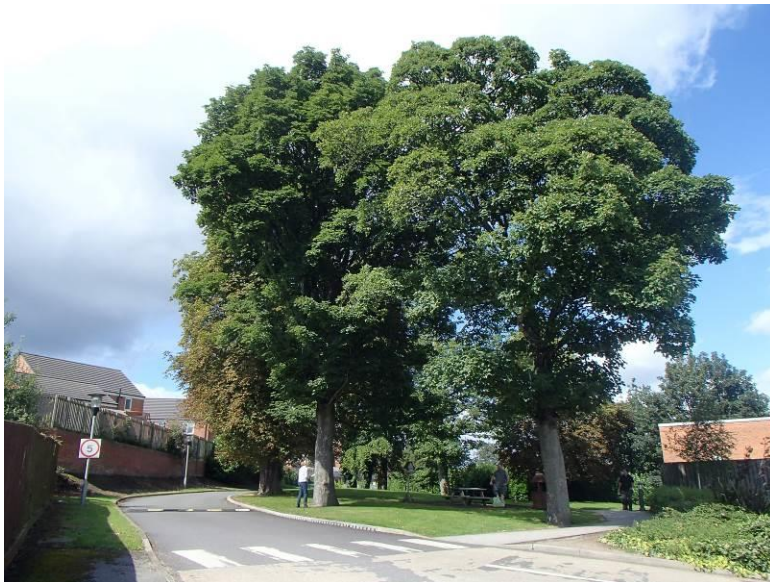
| Tree No. | Species | Hgt (m) | Diam (mm) | Spread (m) | Hgt 1 <sup>st</sup> brch | Hgt to crown | Age Class | Physiological and Structural Condition. Preliminary Management Recommendations | Est RC years | Grade BS5837 | RPA (rad) (m2) | Photo |
|---|---|---|---|---|---|---|---|---|---|---|---|---|
| T8 | Sycamore<br><i>Acer ps.</i> | | | | | | M | Alongside access road, foliage in fair health.<br>No obvious structural issues. | | B | Plan | 6, 7 |
| T9 | Sycamore<br><i>Acer ps.</i> | | | | | | M | Alongside access road, foliage in fair health.<br>No obvious structural issues. | | B | Plan | 6, 7 |

**Photo 7:** Group 2, along access road; T8 and T9 Sycamores

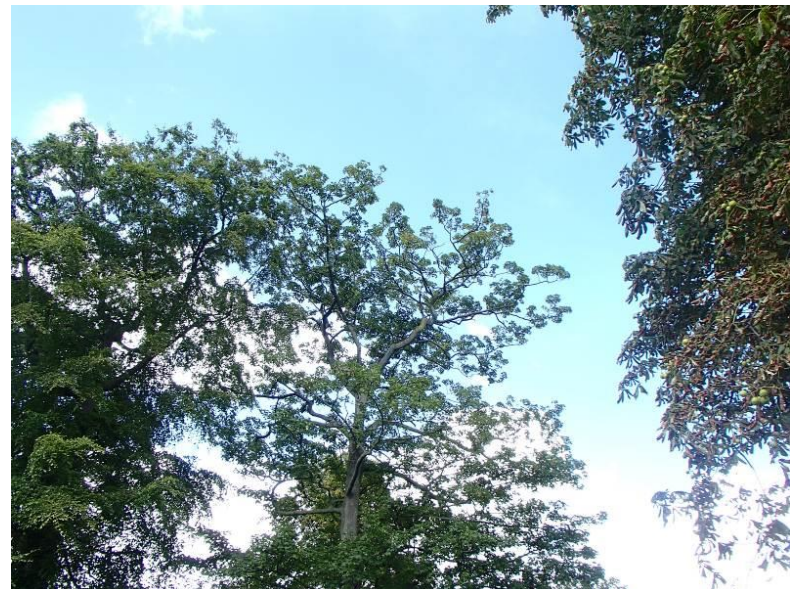
| Tree No. | Species | Hgt (m) | Diam (mm) | Spread (m) | Hgt 1 <sup>st</sup> brch | Hgt to crown | Age Class | Physiological and Structural Condition. Preliminary Management Recommendations | Est RC years | Grade BS5837 | RPA (rad) (m2) | Photo |
|---|---|---|---|---|---|---|---|---|---|---|---|---|
| T10 | Sycamore<br><i>Acer ps.</i> | | | | | | M | Crown showing serious decline, possible stem hollowing from soundings. Close to footpath.<br><i>To be felled for development purposes - for roadway and parking construction</i> | | C | - | 8 |

**Photo 8:** T10 Sycamore decline, in Group 2

Within Group G2 a space is proposed for overspill car and minibus parking. This is located on a more open area within G2, relatively free of trees, and adjacent to Sycamore T10 that shows significant decline. Removal & replacement of T10 is therefore proposed to establish a suitable and efficient parking space. A temporary set-back of the CEZ is proposed and a predominantly no-dig construction method will be used to create the parking and roadway. This will be a stabilised gravel 'Geogrid' system, over a geotextile membrane and free-draining hardcore, with a small section of full depth construction to allow a level approach from the existing road.

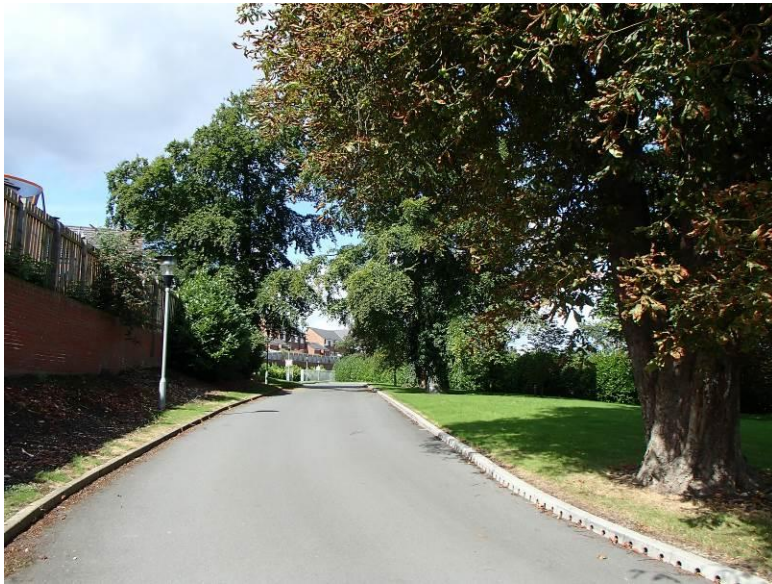
| Tree No. | Species | Hgt (m) | Diam (mm) | Spread (m) | Hgt 1 <sup>st</sup> brch | Hgt to crown | Age Class | Physiological and Structural Condition. Preliminary Management Recommendations | Est RC years | Grade BS5837 | RPA (rad) (m2) | Photo |
|---|---|---|---|---|---|---|---|---|---|---|---|---|
| T11 | Horse Chestnut<br><i>Aesculus h.</i> | | | | | | M | Alongside access road, foliage showing leaf miner/virus. Twin stem at 1.5m appears sound. Low growth, compromising bigger vehicles.<br><b>Recommend crown lifting.</b> | | B | Plan | 9 |

**Photo 9:** Chestnut T11 in Group 2, Beech T13 far left

The remaining trees in G2 are outside the principal red-line site area but may be impacted by site compounds, traffic, storage, parking etc. The whole area should therefore be fenced as shown on the TPP, with a temporary set-back only for construction of the overspill parking as described. Those trees in G2 alongside the access road (including T9, T11, and T13, T14, T15 & T16) should be crown lifted to a nominal 4 to 5m above the road, with appropriate re-balancing on the opposite verge side as required.

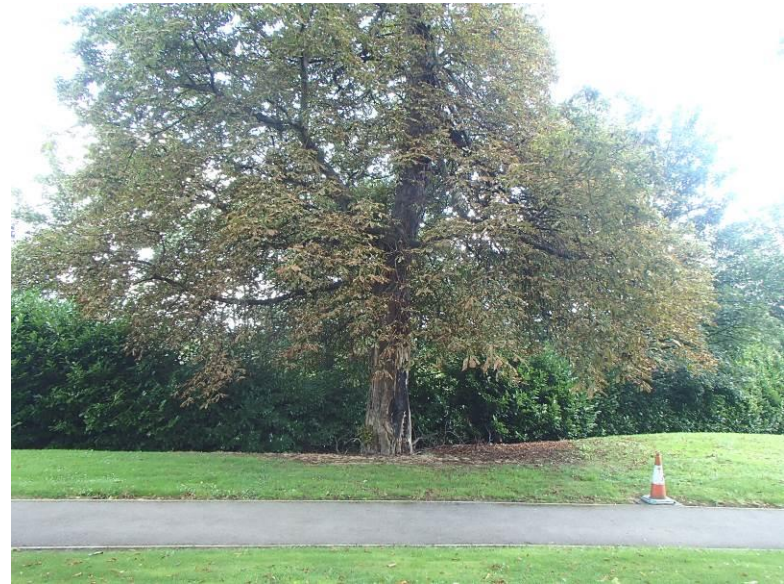
| Tree No. | Species | Hgt (m) | Diam (mm) | Spread (m) | Hgt 1 <sup>st</sup> brch | Hgt to crown | Age Class | Physiological and Structural Condition. Preliminary Management Recommendations | Est RC years | Grade BS5837 | RPA (rad) (m2) | Photo |
|---|---|---|---|---|---|---|---|---|---|---|---|---|
| T12 | Horse Chestnut<br><i>Aesculus hippo-castanum</i> | | | | | | M | Serious stem base decay, probably initiated by fire damage. Full inspection and diagnosis required. Foliage has serious decline, from leaf miner and probable virus infection.<br><b>Suggest crown reduction as minimum solution, possibly fell and replace.</b> | | C or U<br>TBC | - | 10 |

**Photo 10:** Chestnut T12, serious stem decline (off-site)

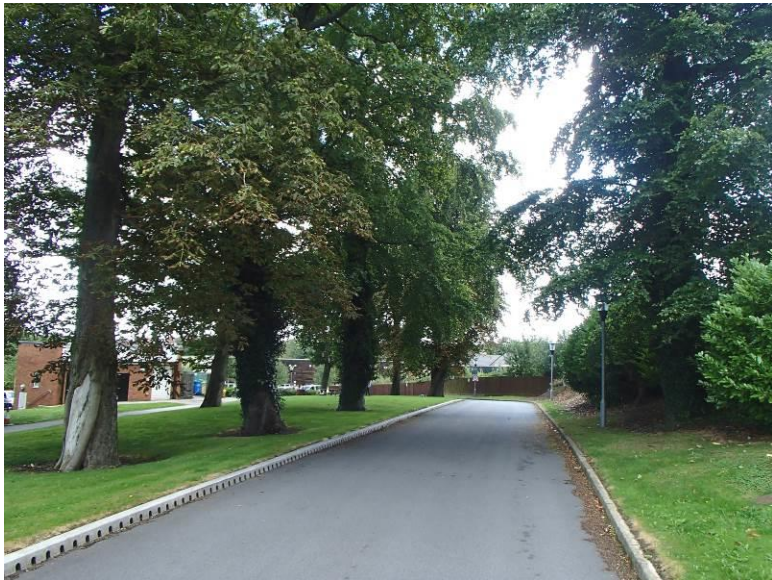
| Tree No. | Species | Hgt (m) | Diam (mm) | Spread (m) | Hgt 1 <sup>st</sup> brch | Hgt to crown | Age Class | Physiological and Structural Condition. Preliminary Management Recommendations | Est RC years | Grade BS5837 | RPA (rad) (m2) | Photo |
|---|---|---|---|---|---|---|---|---|---|---|---|---|
| T13 | Beech<br><i>Fagus sylvatica</i> | | | | | | M | Crown showing minor decline, possibly stem hollowing. Close to access road, <b>recommend crown lifting to clear vehicles. Cut Ivy</b> | | B | Plan | 9, 11 |
| T14 | Beech<br><i>Fagus sylvatica</i> | | | | | | M | Crown showing minor decline, possibly stem hollowing. Close to access road, <b>recommend crown lifting to clear vehicles. Cut Ivy.</b> | | B | Plan | 11 |
| T15 | Sycamore<br><i>Acer ps.</i> | | | | | | M | Close to access road, <b>recommend crown lifting to clear vehicles. Cut Ivy</b> | | B | Plan | 11 |
| T16 | Horse Chestnut<br><i>Aesculus h.</i> | | | | | | M | Alongside access road, foliage in fair health. Stem scarring, but no obvious structural issues.<br><b>Recommend crown lifting to clear vehicles.</b> | | B | Plan | 11 |

**Photo 11:** Group 2, access road, T13 RHS; T14, T15, T16 LHS

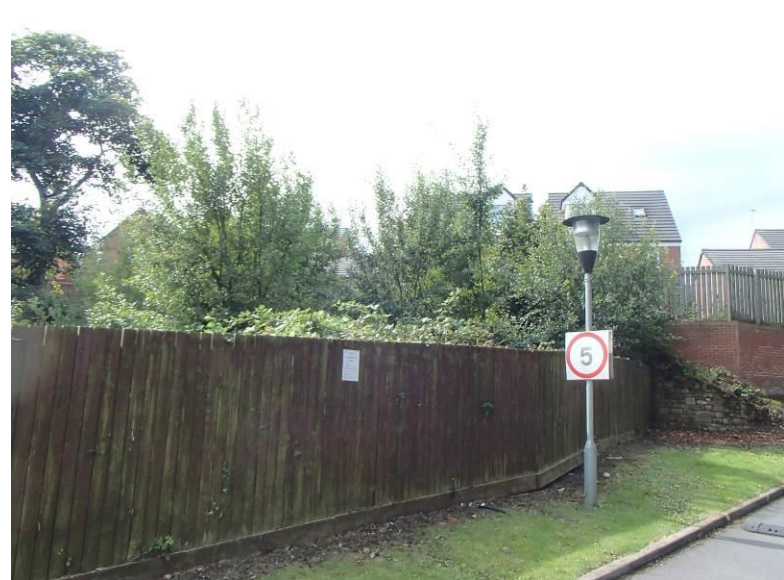
**Photo 12:** Northern site boundary, T1 to far left.
