ARBORICULTURAL REPORT & Impact Assessment to BS5837:2012 at:

***Park Hollow,
Wombwell,
Barnsley,
South Yorkshire
S73 0HN***

Date: *December 2018*

Reference: *AWA2438*

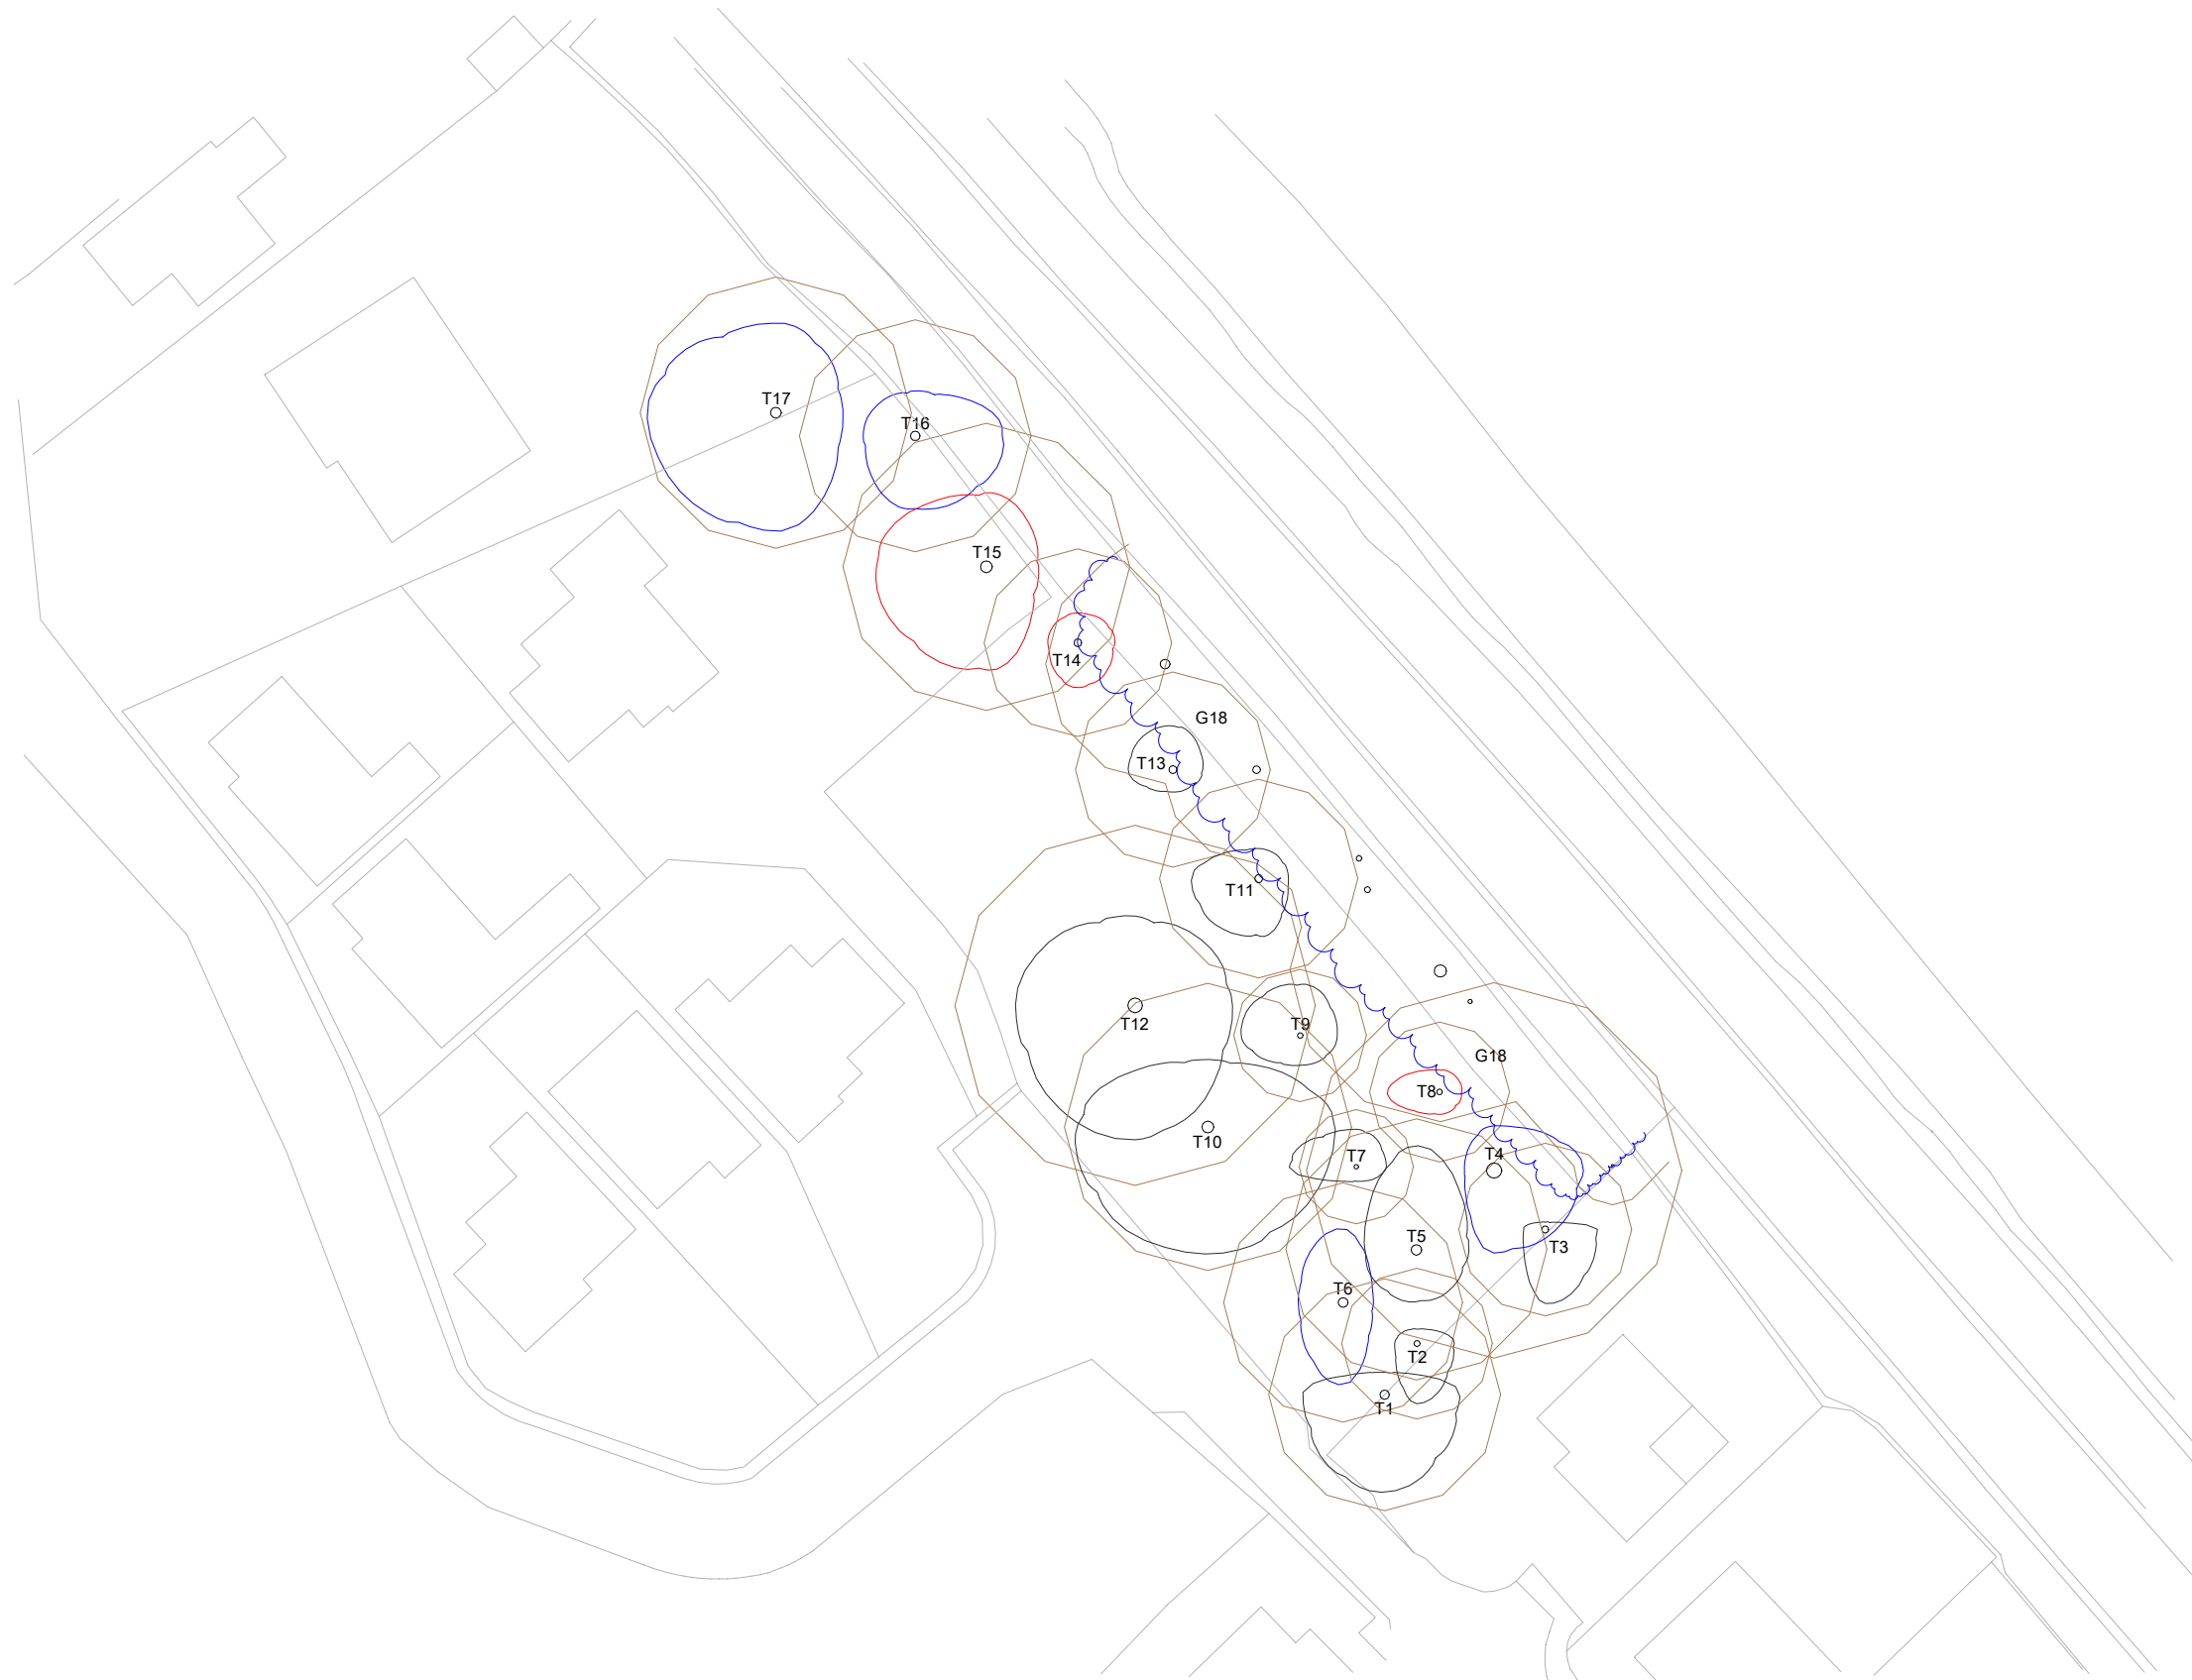
Appendix 5: Tree Constraints Plan

- 3.2.12 The tree Root Protection Area (RPA) detailed on the Tree Constraints Plan at Appendix 5, has been used as a layout design tool, to inform on the area around a tree where the protection of the roots and soil structure is treated as a priority.

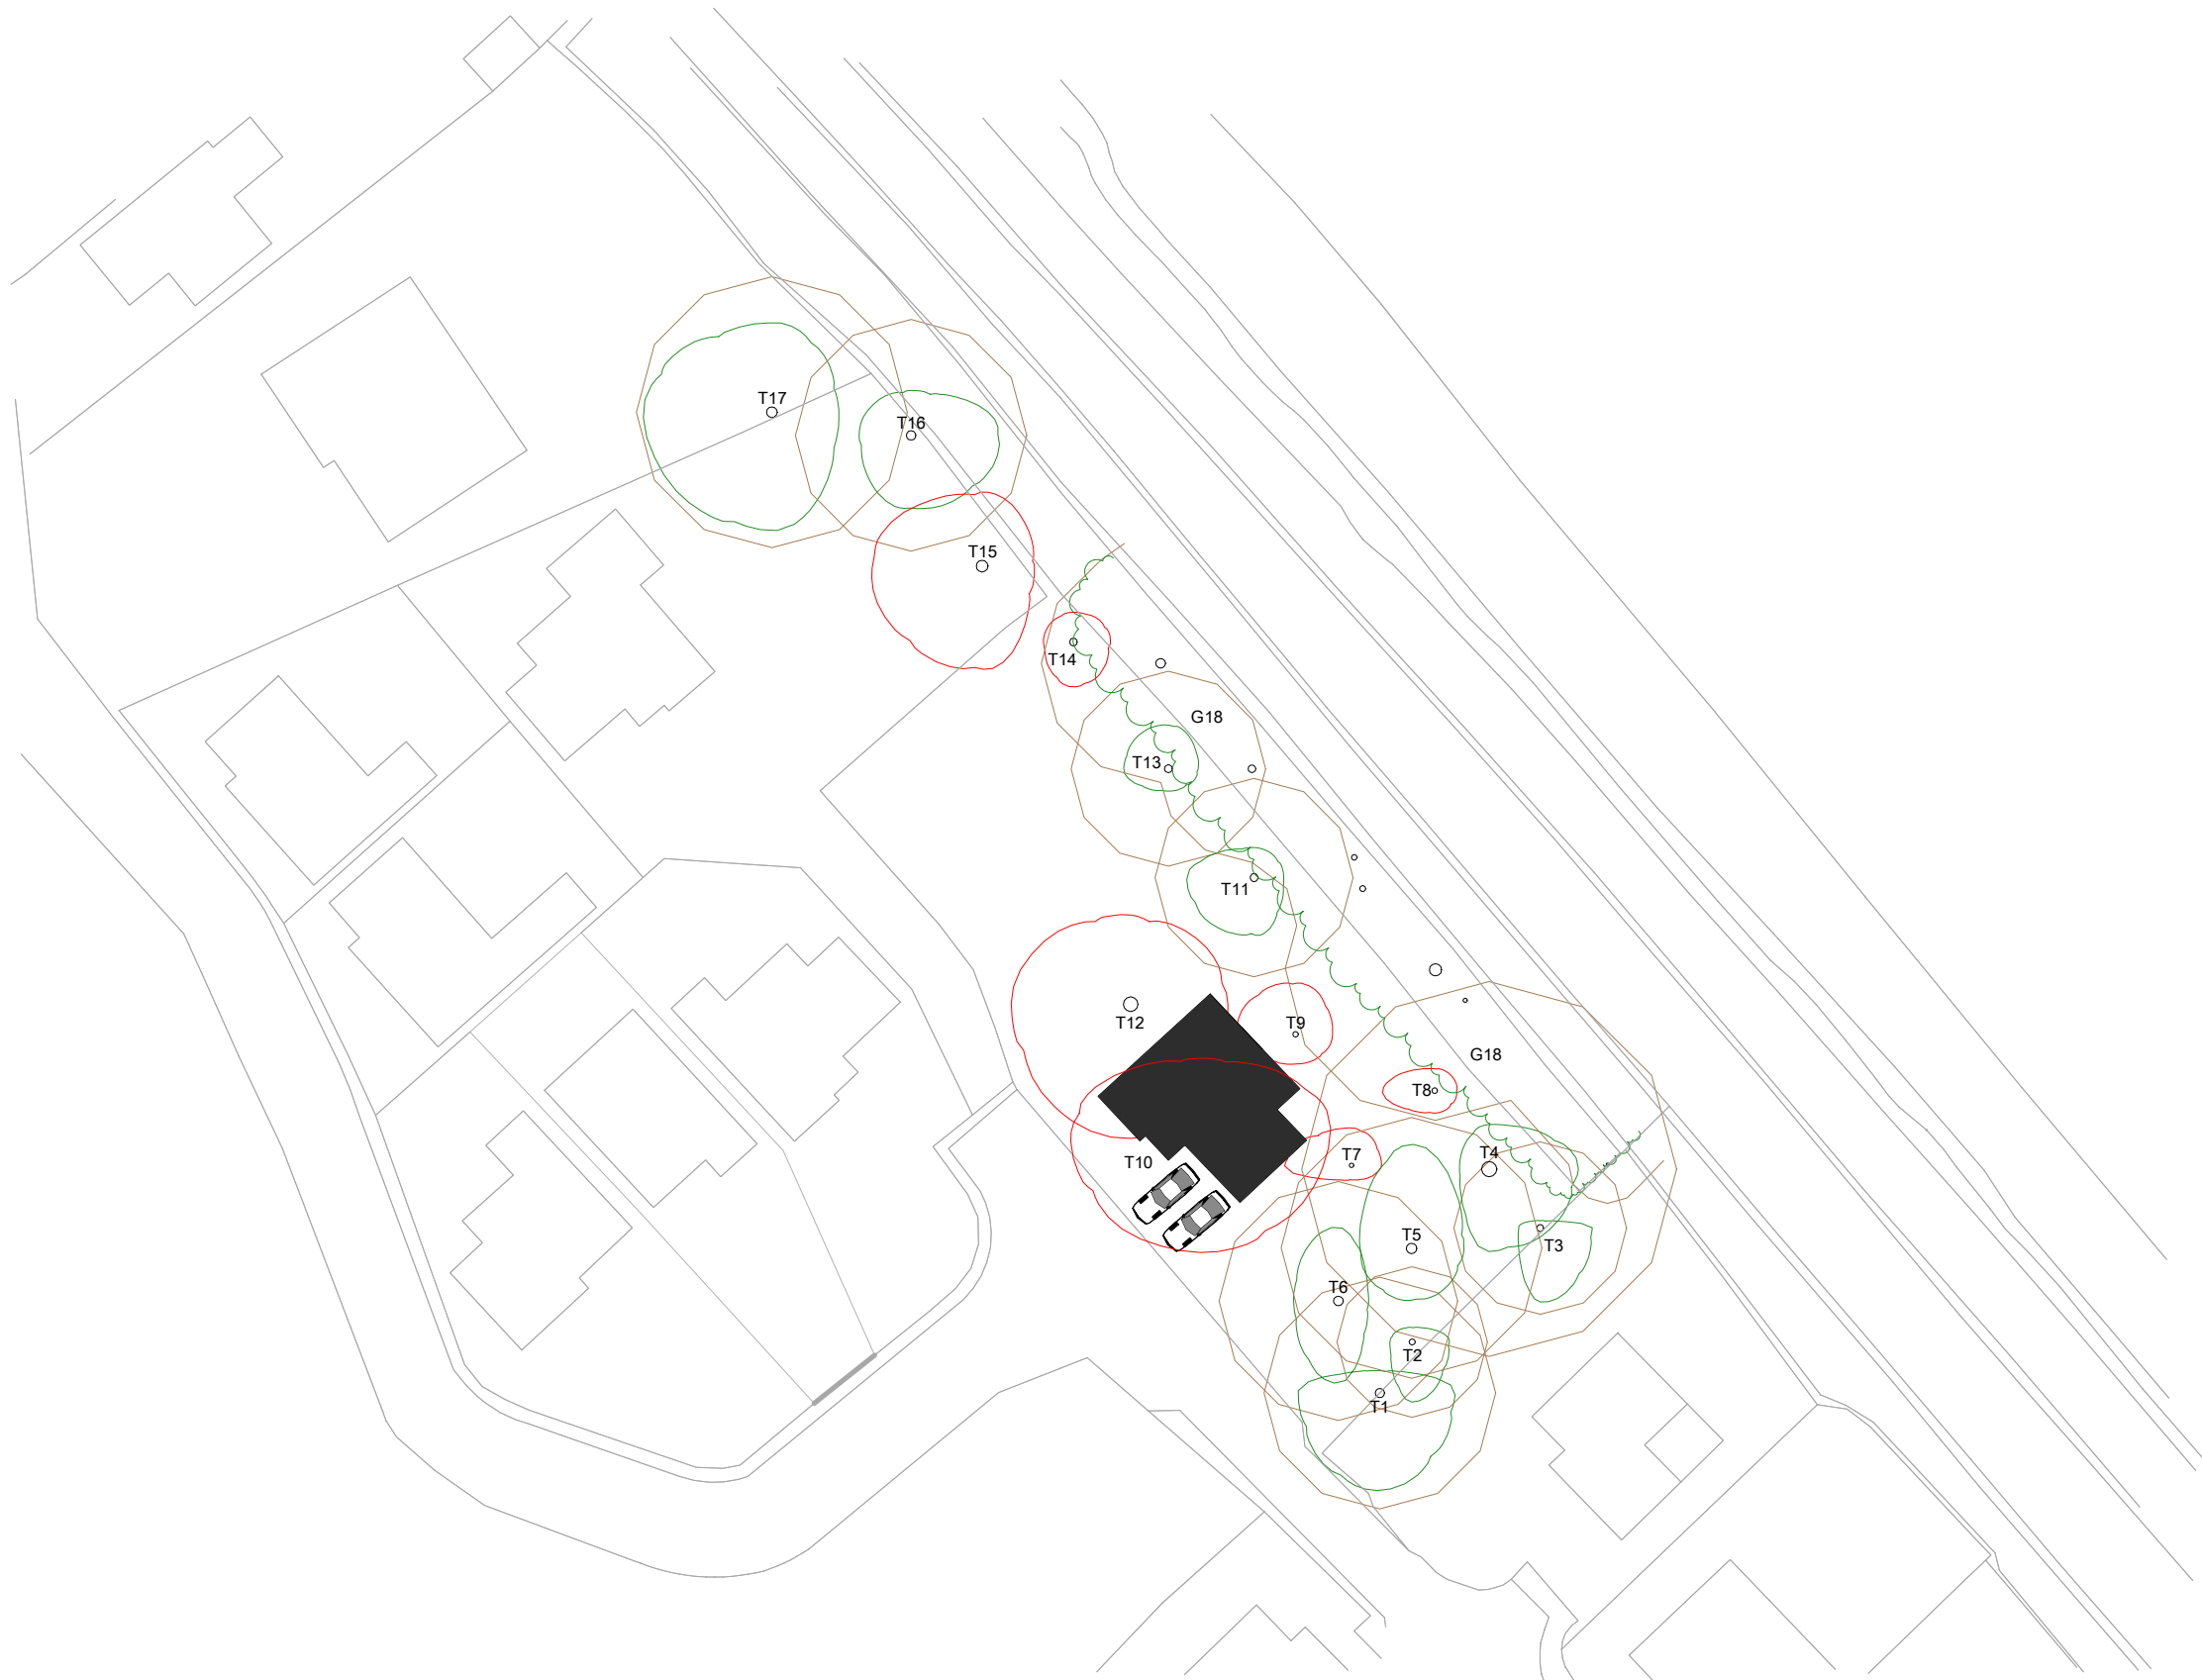
**Appendix 6:
Tree Impacts Plan**
14 & 15 Park Hollow, Barnsley, S73 0HN
Ref: AWA2438

- 4.2.1 From assessing the new development proposals, 4 trees will require removal as they are situated in the footprint of the structure or their retention and protection throughout the development is not suitable.

- 4.2.2 The trees that require removal are T7, T9, T10 and T12. The trees that require removal are all lower value, retention category 'C'.
- 4.2.3 The semi to early mature Sycamore tree, T7 and T9 both have damage to their buttress roots and stem. The removal of these slightly suppressed trees will be to the benefit of the larger trees both within the site and along the embankment to the north east.

- 4.2.4 The trees T10 and T12 are both large; however, both have defects likely to limit their prospects and their suitability for retention close to residential properties and a public road. The resultant loss of amenity from their removal can largely be mitigated through a considered and appropriate planting scheme to compliment the new development.

- 4.2.5 In addition, the trees T8, T14 and T15 are retention category 'U' and require removal regardless of any development at the site (as detailed in Appendix 4).
