ARBORICULTURAL REPORT

& Impact Assessment

***Birkwood Primary School,
Darfield Road,
Cudworth,
Barnsley
S72 8HG***

Reference: *AWA5374*

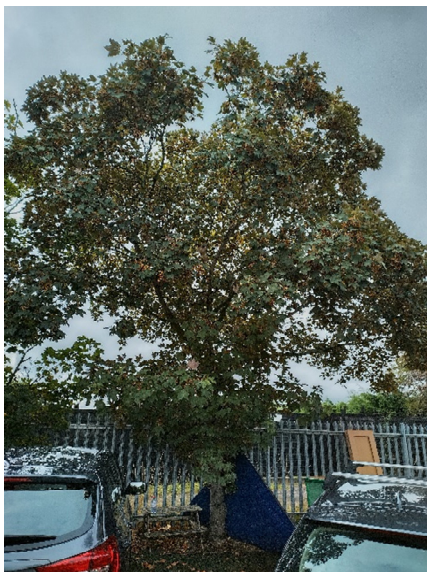
Photo 3: Stem of T3 facing west

T3	Sycamore	<i>Acer pseudoplatanus</i>	Semi-mature	7	1	240	No	1	4	3.5	3	3.5	No visual defects. Limited access	Single stemmed. Vertical. Old pruning wounds	Normal. Minor tar spot. Old pruning wounds. Minor deadwood	Material on stem at base of tree. Provides screening. Overhanging adjacent land	Good	Fair	>40 yrs	Moderate	B	No works required to facilitate development
T4	Sycamore	<i>Acer pseudoplatanus</i>	Semi-mature	7	1	210	No	2	2	2	2	2	No visual defects	Single stemmed. Old pruning wounds. Minor decay	Minor dieback. Minor deadwood	Provides screening. Overhanging adjacent land	Fair	Fair	10 to 20 yrs	Low	C	No works required to facilitate development
T5	Sycamore	<i>Acer pseudoplatanus</i>	Early-mature	11	1	390	No	2	2.5	5	5	5	No visual defects	Single stemmed. Vertical. Old pruning wounds	Normal. Well developed crown . Minor deadwood. Old pruning wounds. Slightly unbalanced	Provides screening. Overhanging adjacent land	Good	Good	>40 yrs	Moderate	B	No works required to facilitate development

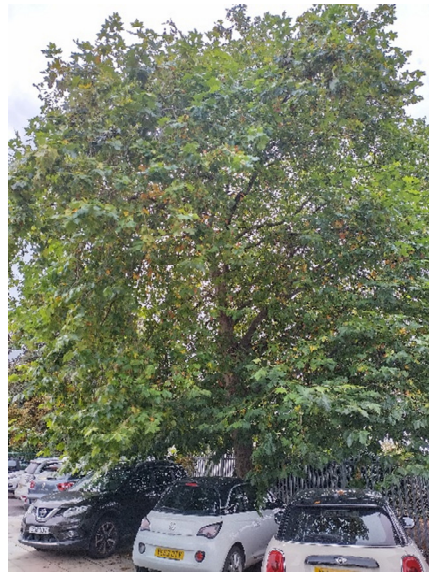
Photo 6: T7 facing southwest

- 3.2.6 The better individual trees are T7 London Plane, T8 Sycamore, Sycamore T30 and T33 Sycamore. These have good arboricultural value with well-developed crowns and a more mature age class.

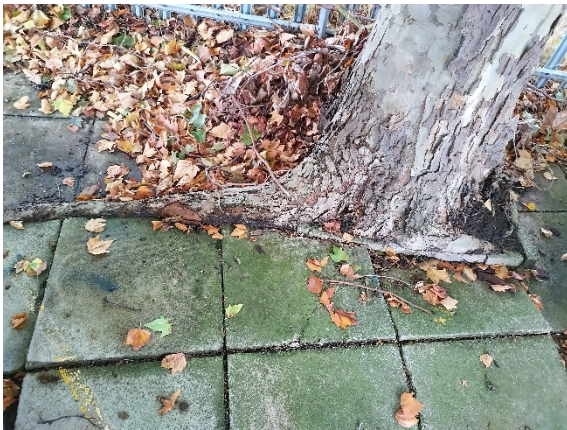
- 3.2.10 T7 is causing some pavement movement. While not a significant issue at present this may get worse in the future and should be monitored.
- 3.2.11 The tree Root Protection Area (RPA) for each tree has been plotted as a polygon centred on the base of the stem. Due to the presence of roads, structures, topography (and past tree management) the RPA is likely to be a simplified representation of the tree roots actual morphology and disposition. However, detailed modifications to the shape of the RPA would largely be based on conjecture and so have been avoided.

Photo 7: T7 pavement damage

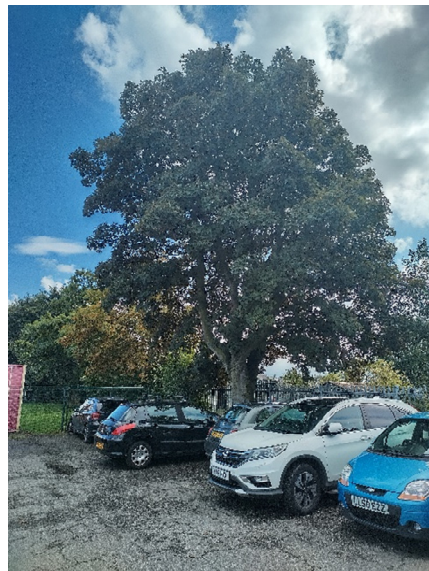
Photo 8: T8 facing south

4.2.4 The proposed new extension is situated close to the crown of retained Sycamore T8. The eastern and south eastern crown of T8 is high, likely due to historic formative pruning, and as the proposed new extension is single storey, the crown of T8 will likely be clear of the proposed new extension, however, the eastern and south eastern crown of may require some minor lifting and reduction works to provide adequate clearance during construction. Any required pruning works to T8 would be minor and the tree would readily tolerate the works. Additionally, T8 is a mature Sycamore whose crown is likely at, or close to, its maximum meaning future nuisance issues are unlikely.

4.3.2 Potentially damaging activities are proposed in the vicinity of a retained tree. The proposed new extension encroaches into the edge of the RPA of retained Sycamore T8. The encroachment into the RPA is minor and there is already hardstanding within the RPA of T8 at the location of the proposed new extension, with a likely significantly compacted sub-base beneath which has likely limited roots extension into the location of the proposed new extension. As such, provided the excavations within the RPA are strictly

limited to the footprint of the proposed new extension, T8 should remain largely unaffected by the works, provided care is taken during construction.

T8	Sycamore	<i>Acer pseudoplatanus</i>	Mature	15	1	730	No	2.5	6.5	5	5.5	5	Exposed roots. No visual defects	Single stemmed. Bark damage. Cup Union . Vertical. Multiple stemmed at 2.5m.	Normal. Minor deadwood. Well developed crown . Old pruning wounds	Provides screening. Overhanging adjacent land	Good	Good	>40 yrs	Moderate	B	Minor crown lift and/or reduce if required to provide clearance from development, pruning to suitable pruning points
T9	Common Holly	<i>Ilex aquifolium</i>	Semi-mature	5	1	290	No	1.5	3	3	3	3	Limited access. No visual defects. Epicormic growth	Single stemmed. Old pruning wounds	Small / sparse. Minor deadwood	Spineless variety situated in raised plant bed.	Fair	Good	>40 yrs	Moderate	C	Removal required to facilitate development
T10	Common Horse Chestnut	<i>Aesculus hippocastanum</i>	Early-mature	10	1	360	No	2.5	4.5	4.5	4	4	No visual defects	Multiple stemmed. at 2m. Vertical. Old pruning wounds. Stubs	Minor deadwood	Moderate leaf miner. Provides screening. Overhanging adjacent land	Good	Good	>40 yrs	Moderate	B	No works required to facilitate development

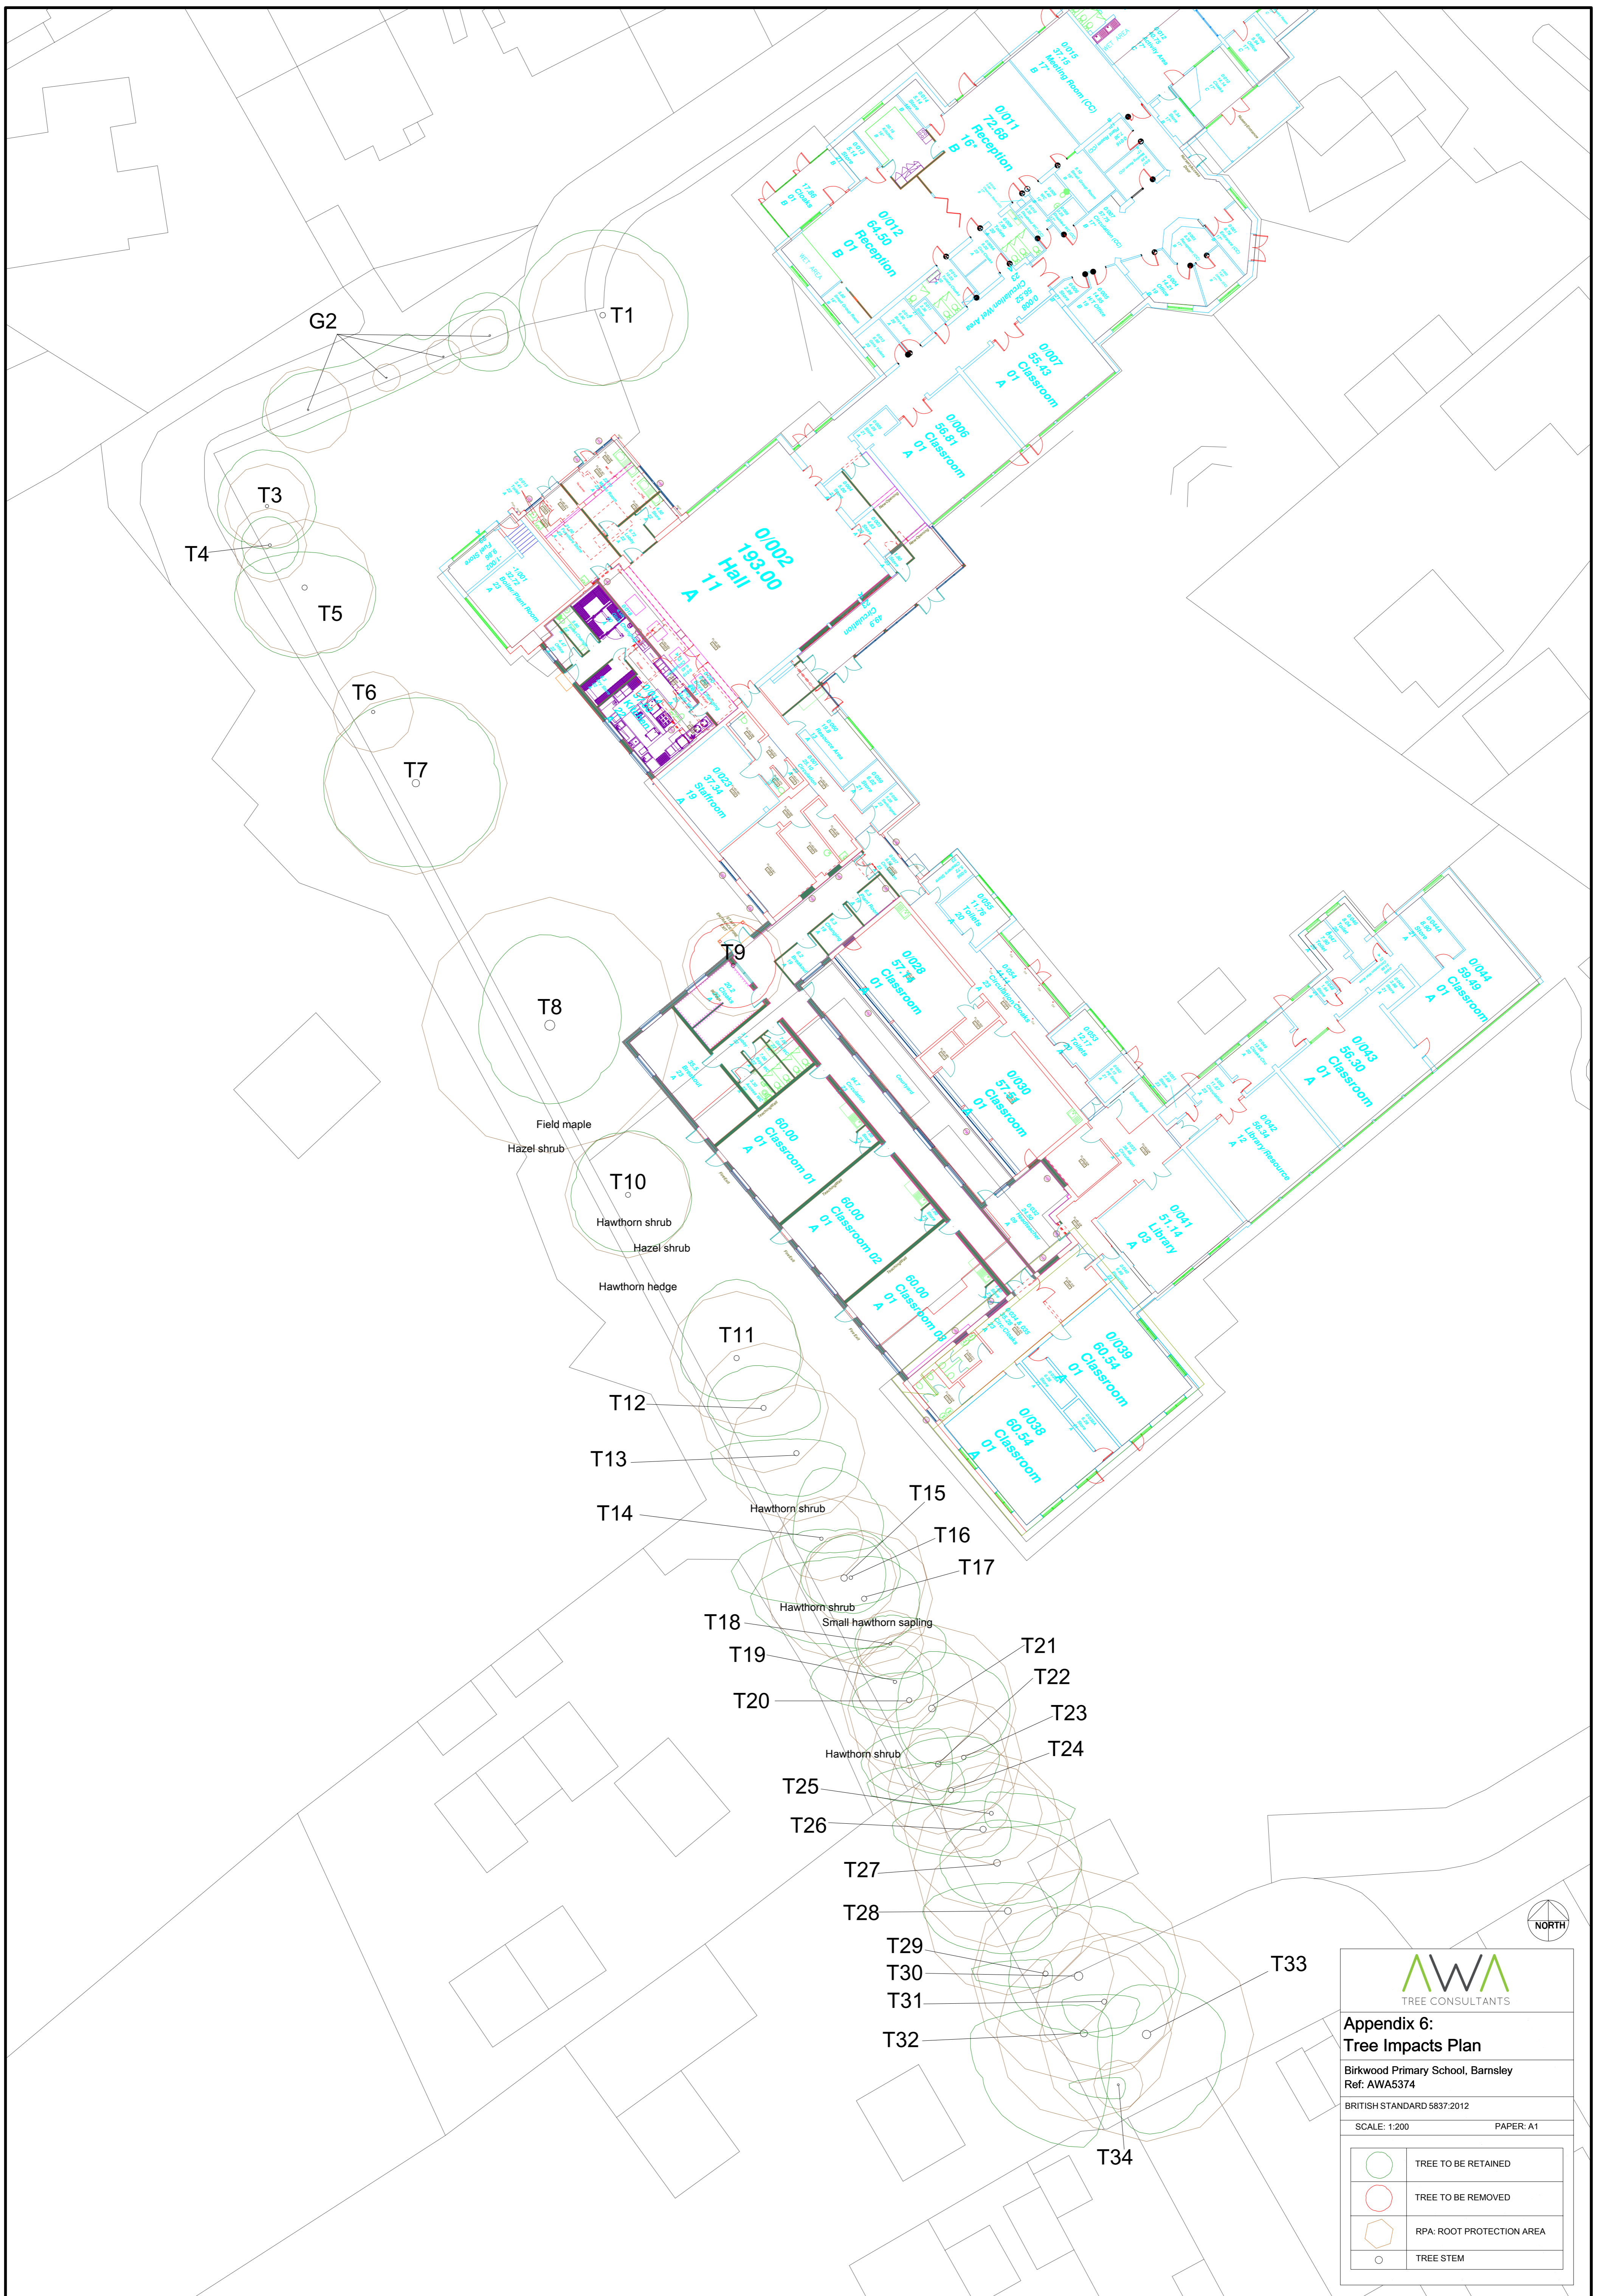
Appendix 6:
Tree Impacts Plan
 Birkwood Primary School, Barnsley
 Ref: AWA5374
 BRITISH STANDARD 5837:2012

4.2.1 From assessing the new development proposals, 1 tree will require removal to facilitate the development as it is situated in the footprint of the development or its retention and protection throughout the development is not suitable.

4.2.2 The tree that requires removal to facilitate the development is T9.

4.2.3 T9 is a semi-mature Holly of little arboricultural significance. Due to the low value of the tree to be removed the removal will have only a negligible negative arboricultural impact.

- 4.4.1 The retained trees will require protection by fencing in accordance with BS 5837: 2012, during the development phase.
- 4.4.2 If required by the Local Planning Authority, an associated Arboricultural Method Statement, detailing protective fencing specifications and construction methods close to the retained trees can be provided.
