ARBORICULTURAL REPORT

to BS5837:2012 at:

Land at
Fieldside Road,
Goldthorpe,
Barnsley,
South Yorkshire
S63 9LX

Reference: *AWA2273*

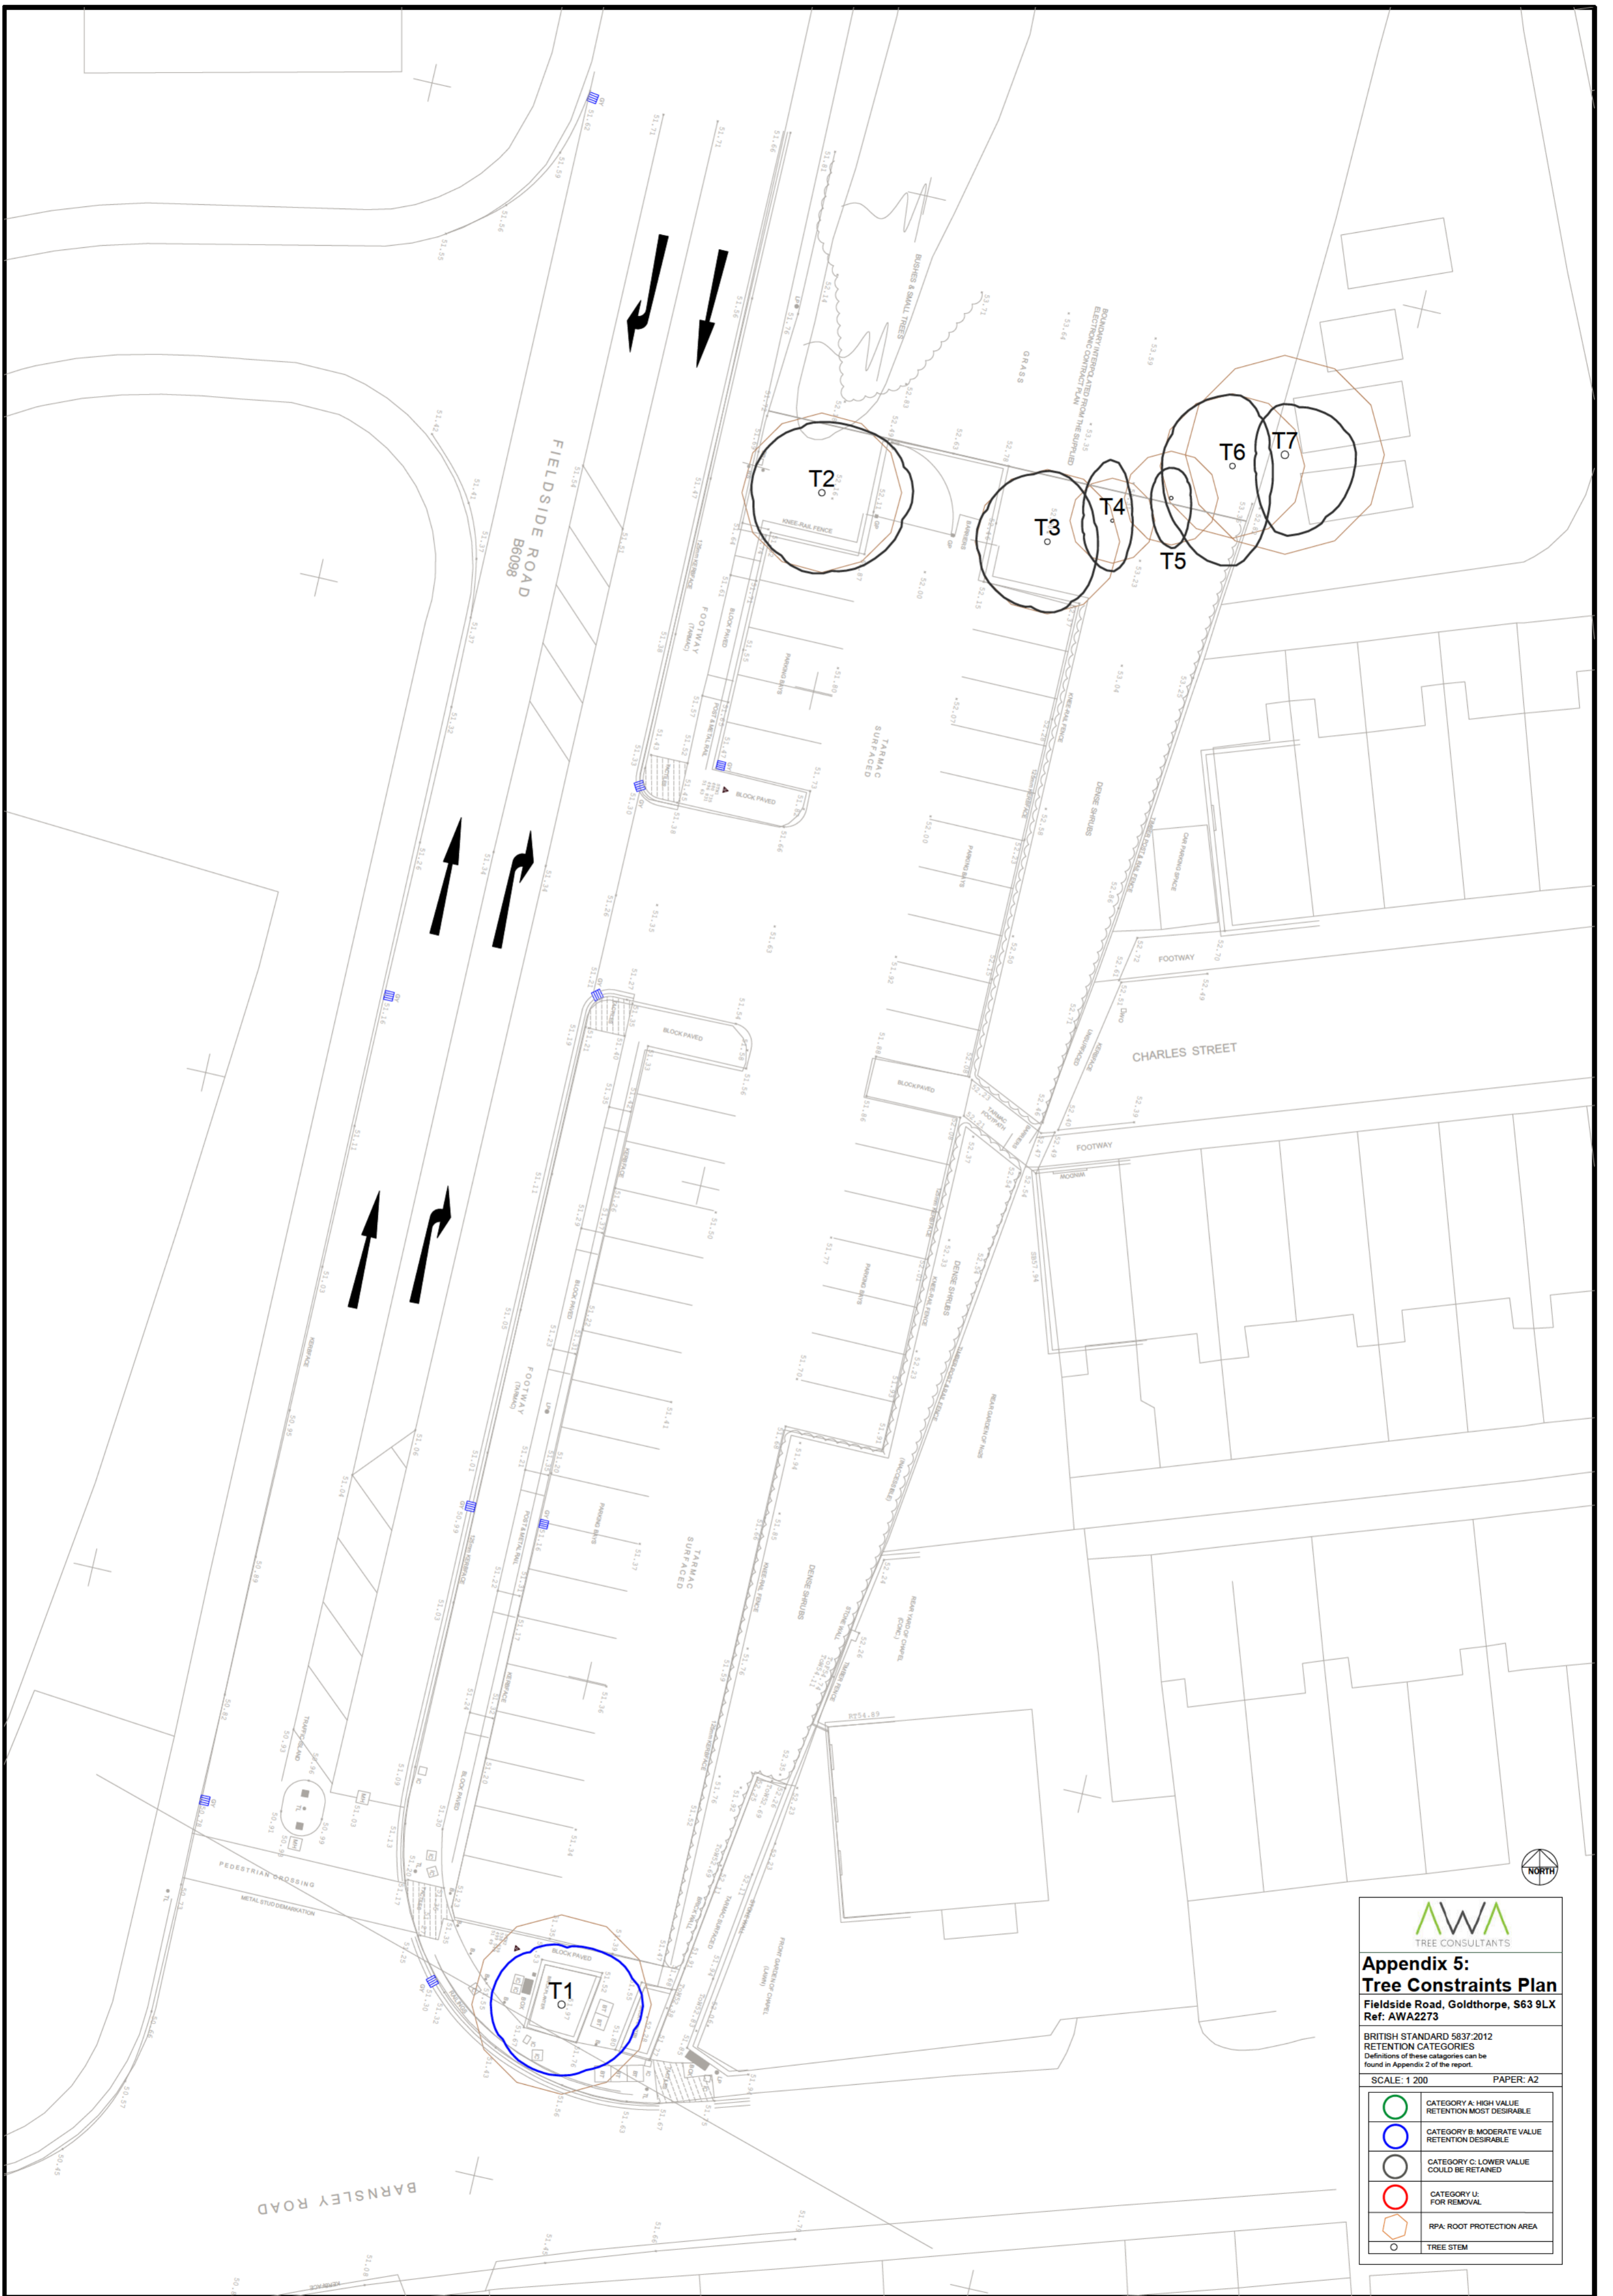
Appendix 5:
Tree Constraints Plan
 Fieldside Road, Goldthorpe, S63 9LX
 Ref: AWA2273

- 3.2.6 Close to the southern site boundary is a Swedish Whitebeam tree planted in a 2m x 2m planting bed (T1). This tree is visually prominent from both within the site and the surrounding areas, being close to a wide road junction. It provides some moderate amenity value and is suitable for retention within any future development.

- 3.2.7 At the northern end of the site is a row of Norway Maple trees (T2 – T6). These are generally in a fair or poor condition, several of them having suffered from damage caused by a fire at the edge of the car park. The two trees, T4 and T5 have particularly sparse crowns and a high proportion of deadwood. These two trees may be unsuitable for retention in the longer term regardless of any future development.

- 3.2.8 Beyond the north east corner of the site is a mature Sycamore tree that has been preciously topped at 2m (T7). This tree has some significant defects; however, it provides some visual amenity and screening between the site and the residential properties beyond.

- 3.2.10 The tree Root Protection Area (RPA) is detailed on the Tree Constraints Plan at Appendix 5. The RPA for each tree has been plotted as a polygon centred on the base of the stem. Due to the presence of roads, structures, topography (and past tree management) the RPA is likely to be a simplified representation of the tree roots actual morphology and disposition.

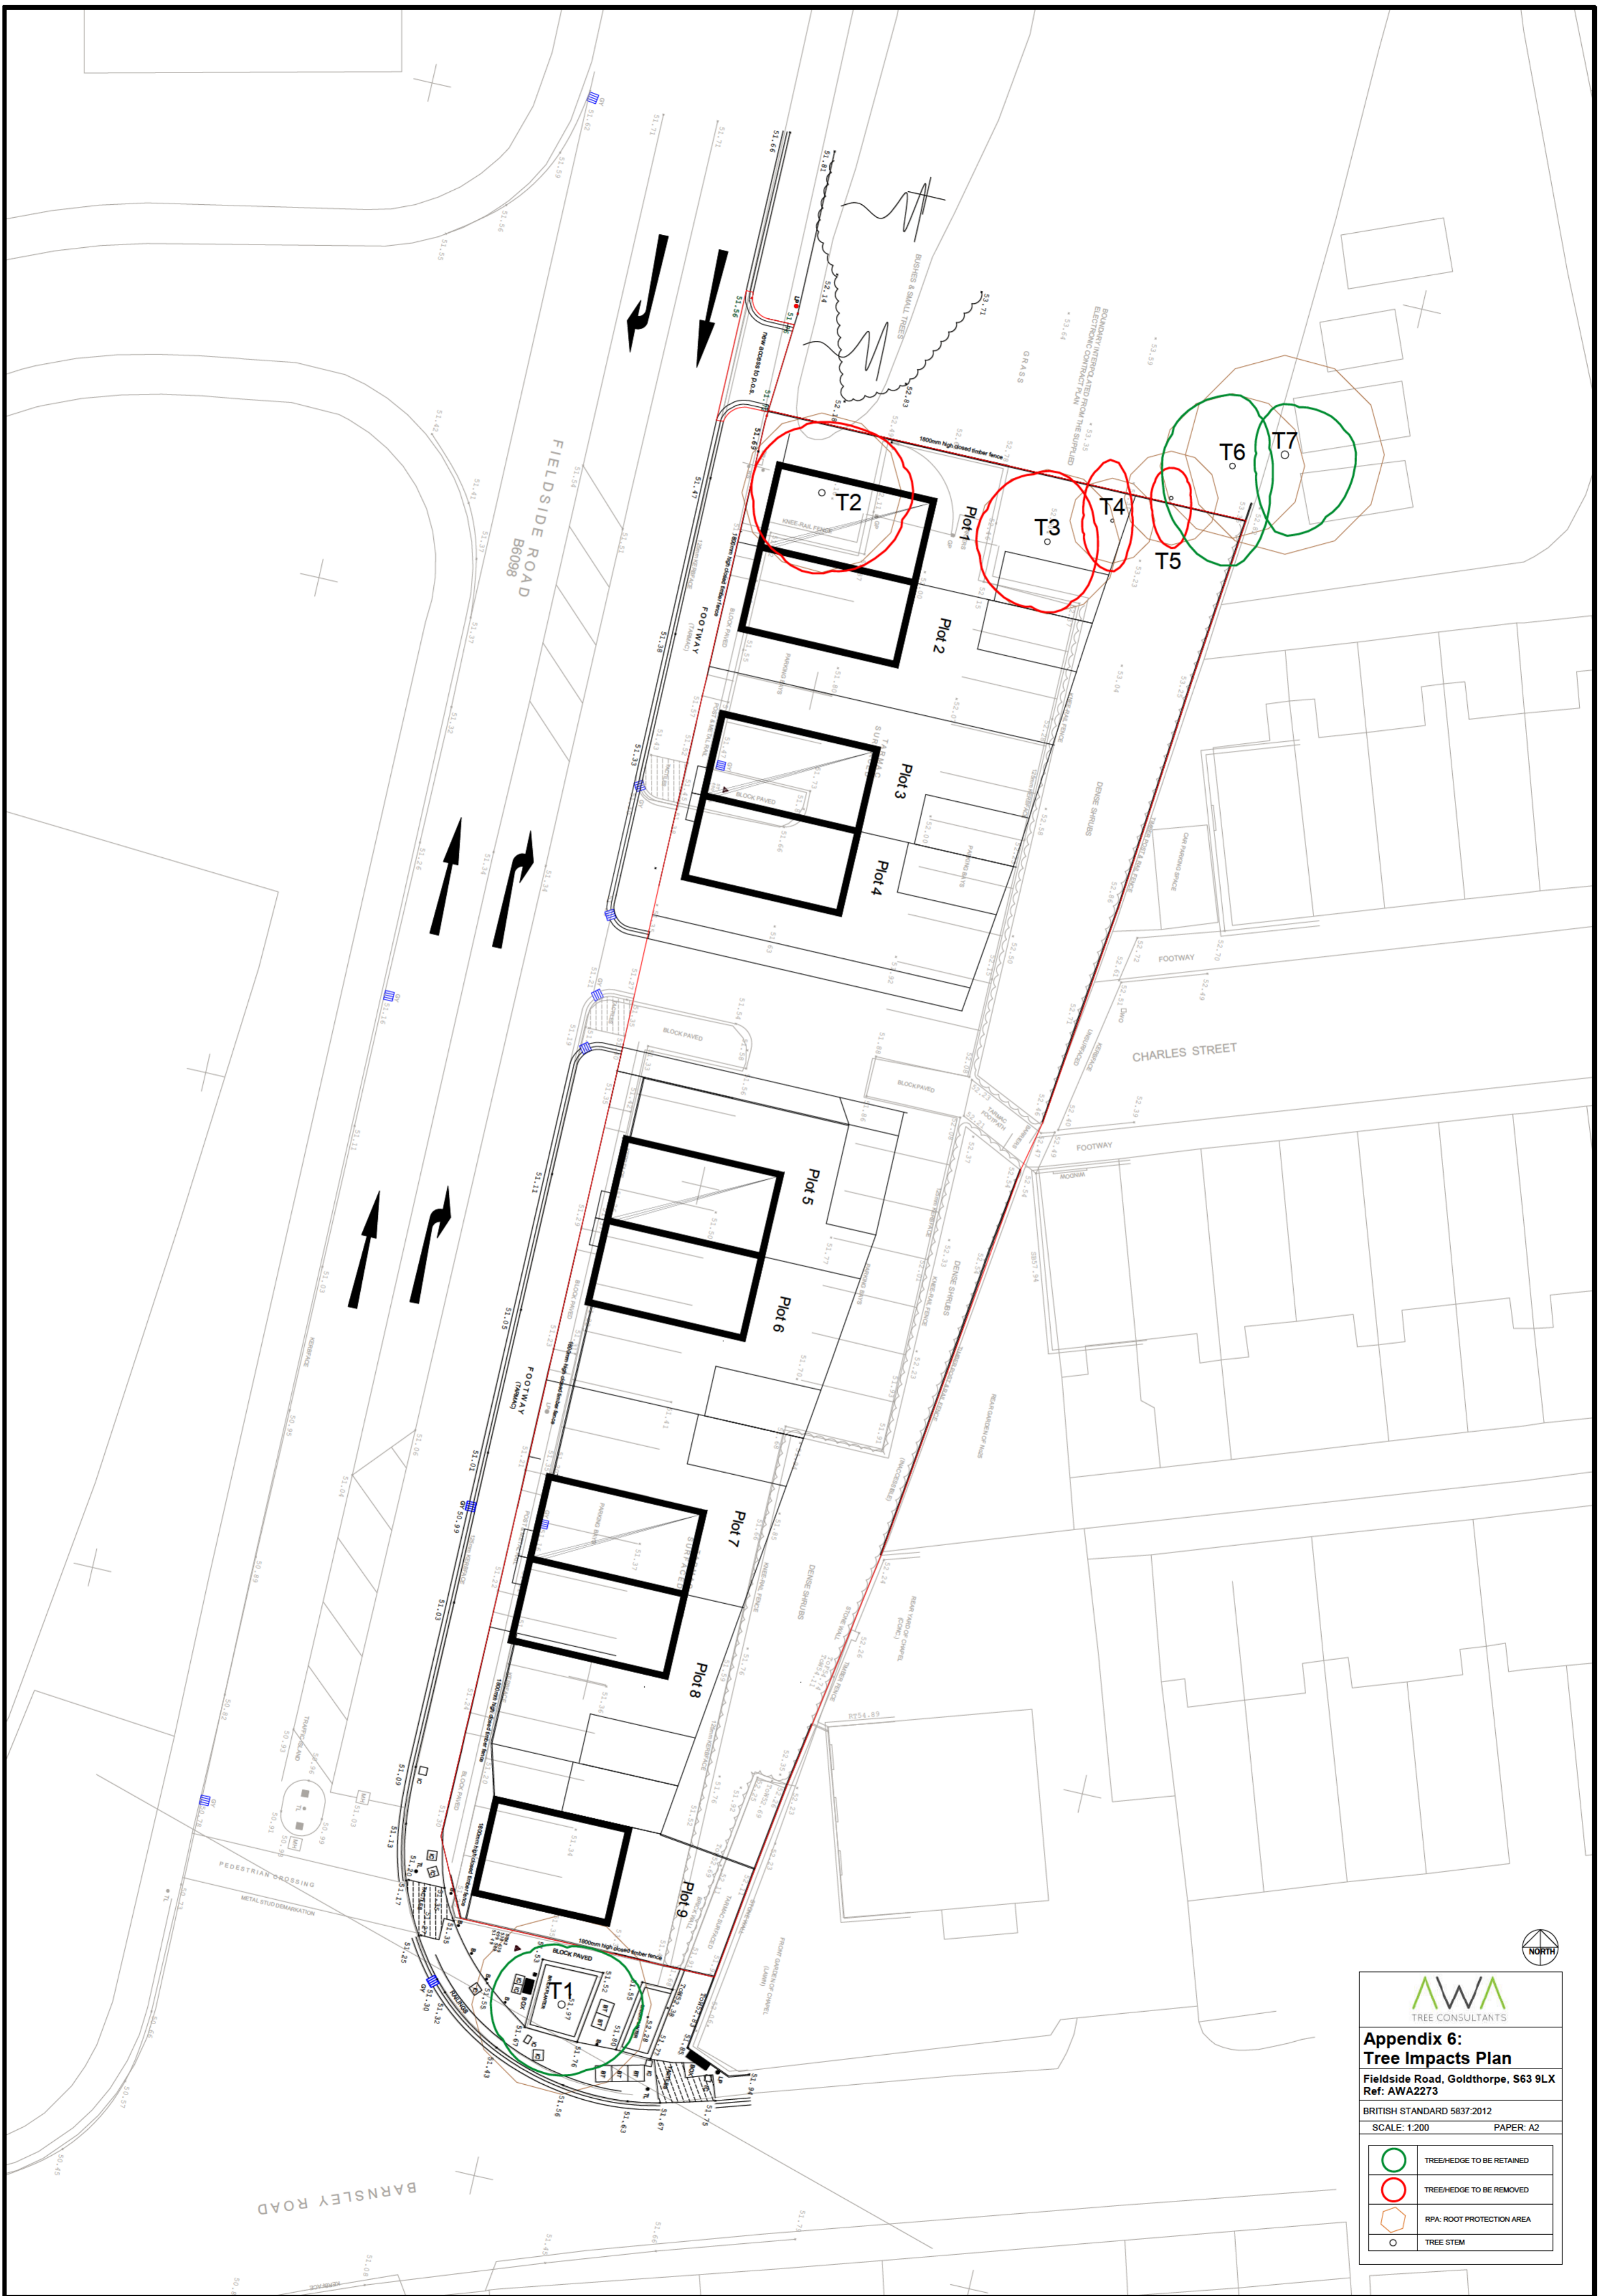
Appendix 6:
Tree Impacts Plan
 Fieldside Road, Goldthorpe, S63 9LX
 Ref: AWA2273
 BRITISH STANDARD 5637:2012
 SCALE: 1:200 PAPER: A2

- 4.2.1 From assessing the new development proposals, 4 trees will require removal as they are situated in the footprint of the structure or their retention and protection throughout the development is not suitable.
- 4.2.2 The trees that require removal are T2, T3, T4 and T5.

- 4.2.3 The trees that require removal are all low value, retention category 'C'. Trees T2 and T3 are Maple trees with defects that limit their value and long-term prospects. Trees T4 and T5 have sparse crowns with extensive deadwood and dieback and are only of negligible arboricultural value.
- 4.2.4 Due to the low value of the trees to be removed the removals will have only a negligible negative arboricultural impact.

- 4.3.2 Development activities are proposed in the vicinity of retained trees. The new development encroaches close to and into the edge of the RPA of T1. Construction within the RPA, can have negative impacts on tree roots. However, the encroachment is very minor, and the detailed RPA for this tree is likely to be an exaggerated representation of the trees actual rooting area, due to the topography and surrounding structures and hard-surfaces. As such, it is unlikely that significant roots will be within this area and the retained tree should remain largely unaffected by the works, provided care is taken during construction.

- 4.3.3 New landscaping is proposed that encroaches into the edge of the RPA of T6 and T7. The construction of hard surfaces within the RPA can have negative impacts on tree roots. However, the encroachment is very minor, and as such, it is unlikely that significant roots will be within this area and the retained trees should remain largely unaffected by the works, provided care is taken during construction

- 4.5.1 The retained trees will require protection by fencing in accordance with BS 5837: 2012, during the development phase.
- 4.5.2 In this instance, if acceptable to the Local Authority, a suitable level of tree protection could be provided through robust site boundary fencing/ site hoardings.
- 4.5.3 If required by the Local Planning Authority, an associated Arboricultural Method Statement, detailing protective fencing specifications and construction methods close to the retained trees can be provided.
