**Tree Report: Project at Oak Road,
Thurnscoe, Barnsley, S63 0AN.**

Project at Oak Road, Thurnscoe.

Tree protection method statement.

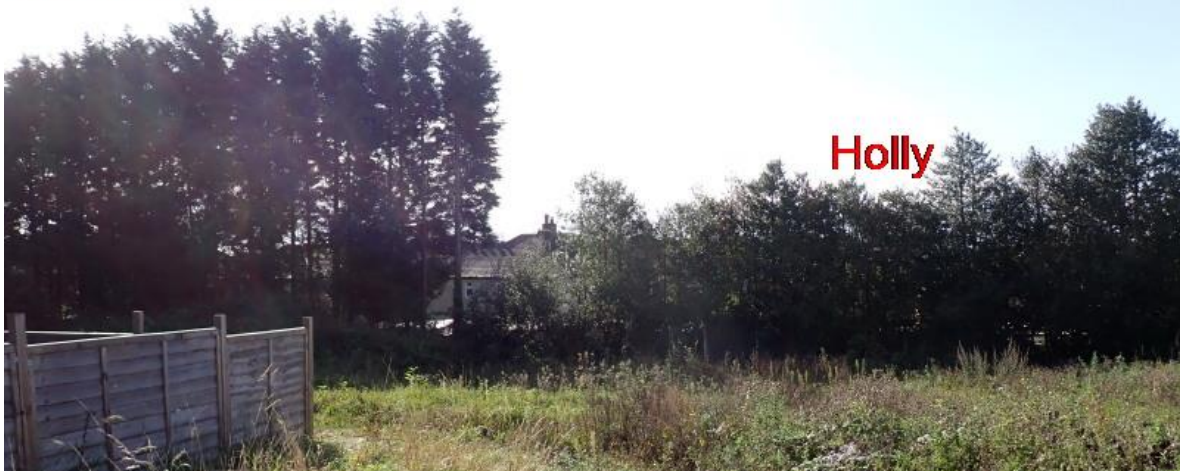
Photograph 1.

Photograph 1 is a view looking roughly south, from the site entrance. The fence in the left foreground is the boundary with the neighbouring house, Tulloch. All the trees in this photo are along the boundary. The taller ones to the left are Leyland Cypress and the row extends beyond the site's confines. It is not clear whether the trees are within the site or outside, perhaps even straddling the boundary. The less tall trees at the right are Holly.

The Leyland Cypress are approximately 14 metres tall. It's difficult to measure heights accurately as the rangefinder devices used for measuring tree height require a clear view of the top and bottom of the tree, and due to a pile of soil in that corner of the site, this was not available. Also the site is somewhat overgrown so that's another obstruction to the view.

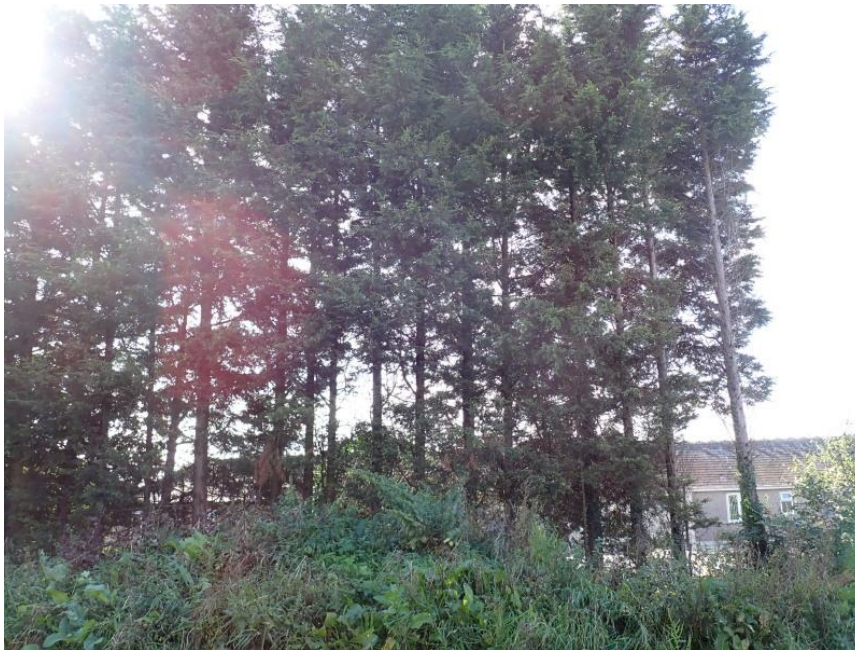
Photograph 2.

Photograph 2 is another view of the Leylands. The fattest trunk on any tree was approximately 250 mm.

I don't think there's any doubting that this is a hedgerow that's become overgrown.

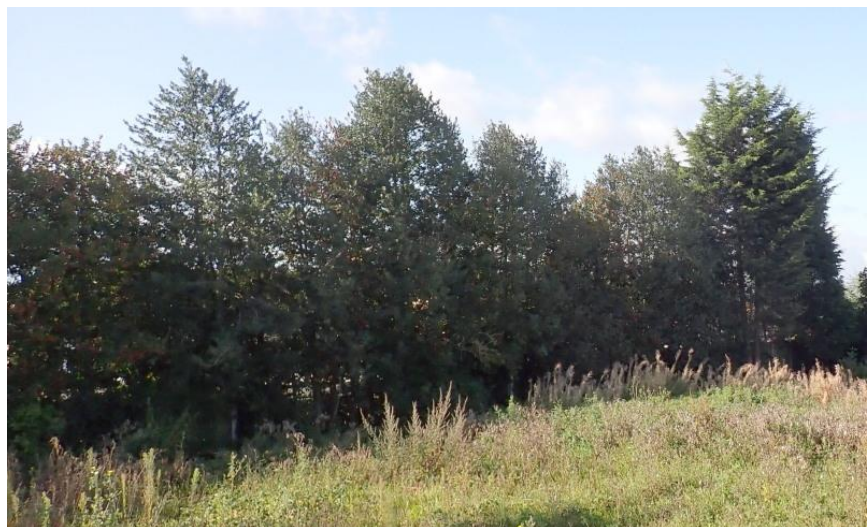
Photograph 3.

The tallest Holly is approximately 8 metres tall and while the hedgerow along the southern boundary is predominantly Holly. There is also a Leyland Cypress at the western corner, as can be seen in photograph 3, which was taken looking westwards along the boundary.

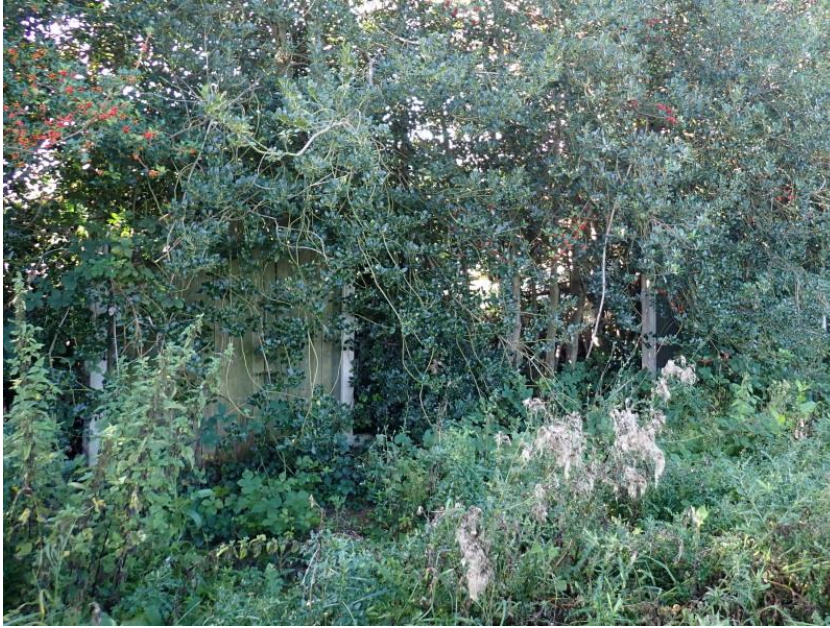
Photograph 4.

Photograph 4 shows the base of the Holly hedge, which I've included to show that it is planted on the outside of the fence at its base, which implies that the hedge does not belong to this site. That said, in one place it seemed that there was another fence at the other side of the Holly plants.

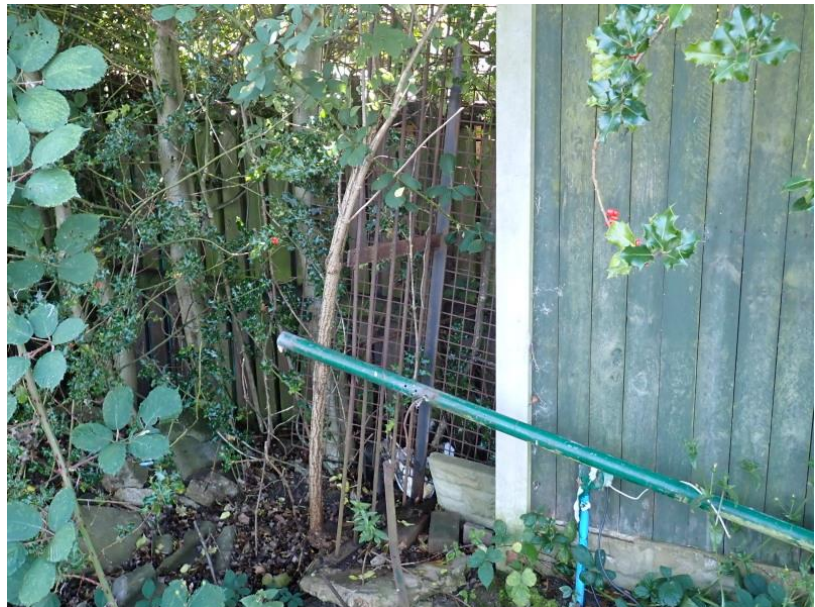
Photograph 5.

Photograph 5 shows the base of a couple of the Holly trees, seemingly squeezed between two fences and with yet more derelict fence tangled with Bramble.

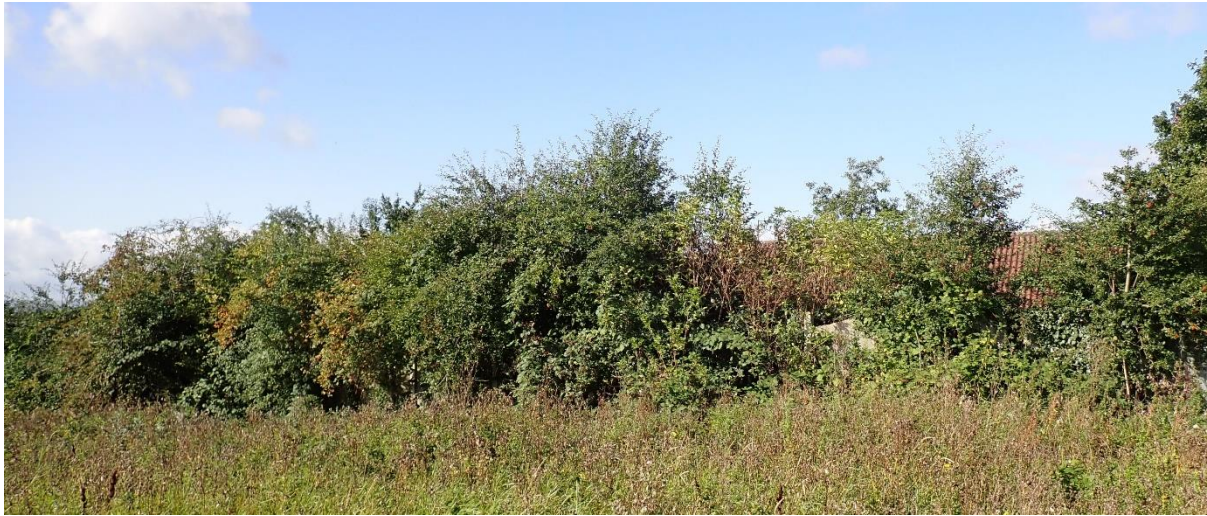
Photograph 6.

Photograph 6 below shows the western hedgerow, taken looking roughly west. While it's predominately Hawthorn there is some Elderberry and Ivy. At this time of year Elderberry is a popular source of food for small birds and the noise they were making while feeding there could be heard right across the site.

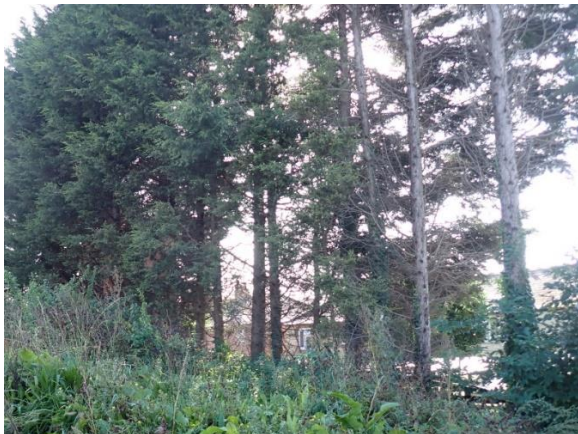
Photograph 7.

It's also worth noting that the Leyland Cypress in the south east corner are not providing very good cover, as can be seen in photograph 7. The branches of the Leylands are not very dense in this photo, which is possibly partly due to some nearby trees having been removed, but also because this particular cultivar of Leyland Cypress grows differently to others.

My reason for mentioning this rather esoteric topic is that the Leylands here, as seen in photo 7, do not appear to be growing the dense screen that might be anticipated. This is certainly not a good hedge and the reason might not be merely that it's become overgrown; it might be that the plants were wrongly chosen. Most pertinently, it is not providing a good roost site or cover for small birds. Unlike the Holly and the Hawthorn elsewhere on the boundaries, it's not adding much to local biodiversity. And to make matters worse, it's reached a size where chopping the tops off in an effort to turn it into a manageable hedge would probably not be successful. This is in contrast to the Holly and Hawthorn that could be remedially pruned to become more easily managed hedges.

1. I see no reason for the hedges adjacent to or on the boundary of this site to stand in the way of the proposed development.
2. I think it would be sensible to undertake remedial work to all the hedges before commencing construction work. In the case of the Leyland Cypressess this may mean their complete removal and replanting.
3. Before undertaking any work to the hedges it would be sensible to ascertain the precise boundary and ownership of the hedges.
4. Obviously the neighbours of the site need to be consulted before undertaking any work to the hedges, in order to ensure they are sympathetic to the objective of hedgerow restoration.
5. It's a difficult judgement to make but it's likely that in the long-term, a regularly and thoughtfully maintained hedgerow is of greater value to urban wildlife and biodiversity than an overgrown one.

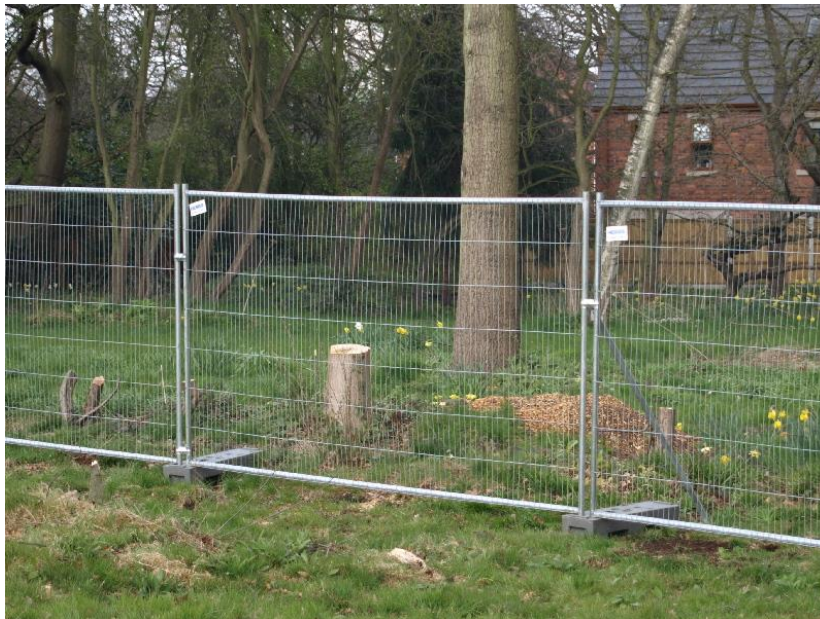
Photograph 1.

Photograph 1 shows tree protection fencing more than adequate for this project.

NB the foot blocks are entirely within the RPA and pinned to the ground to prevent casual disturbance. The diagonal braces are also pinned to the ground.
