## Annual Tree Health & Woodland Inspection.

4U2 View, Chantry Orchards, Dodsworth,  
Barnsley, S75 3HX,

1825.

8<sup>th</sup> November 2023.

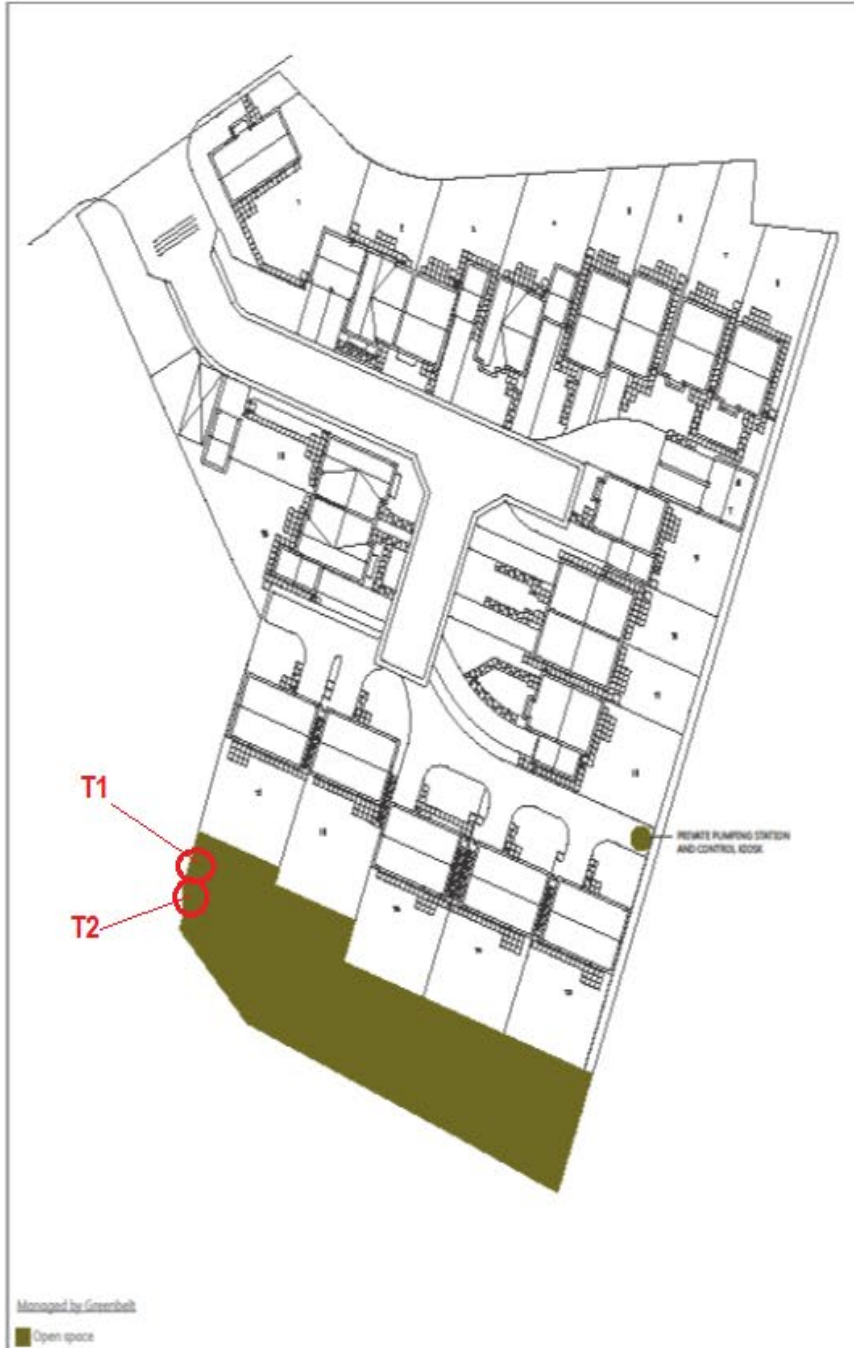
## 9.0 Location plan of 4U2 View, site No 1825.

The sycamore depicted on the plan is heavily hanging over the house and garden, foliage is smaller than usual, scars at the basal area, boundary tree. This tree now requires to be removed and pruning this tree would leave it in poor shape and open to distortional movement.

The neighbouring sycamore tree required two branches to be removed as they are almost touching the building and lion tailed.

Remove T1 due to lean over the house and not able to be pruned. Basal damage.

T2, remove branches almost hitting house. Priority 6 months.
