**ARBORICULTURAL REPORT  
AND  
ARBORICULTURAL IMPACT ASSESSMENT  
to BS 5837:2012  
at  
Land Between 73-77 Park Street  
Wombwell  
Barnsley  
South Yorkshire  
S73 0HJ**

**Client:**  
AR2 Architects Ltd

**JCA Ref:**  
13824/AJB

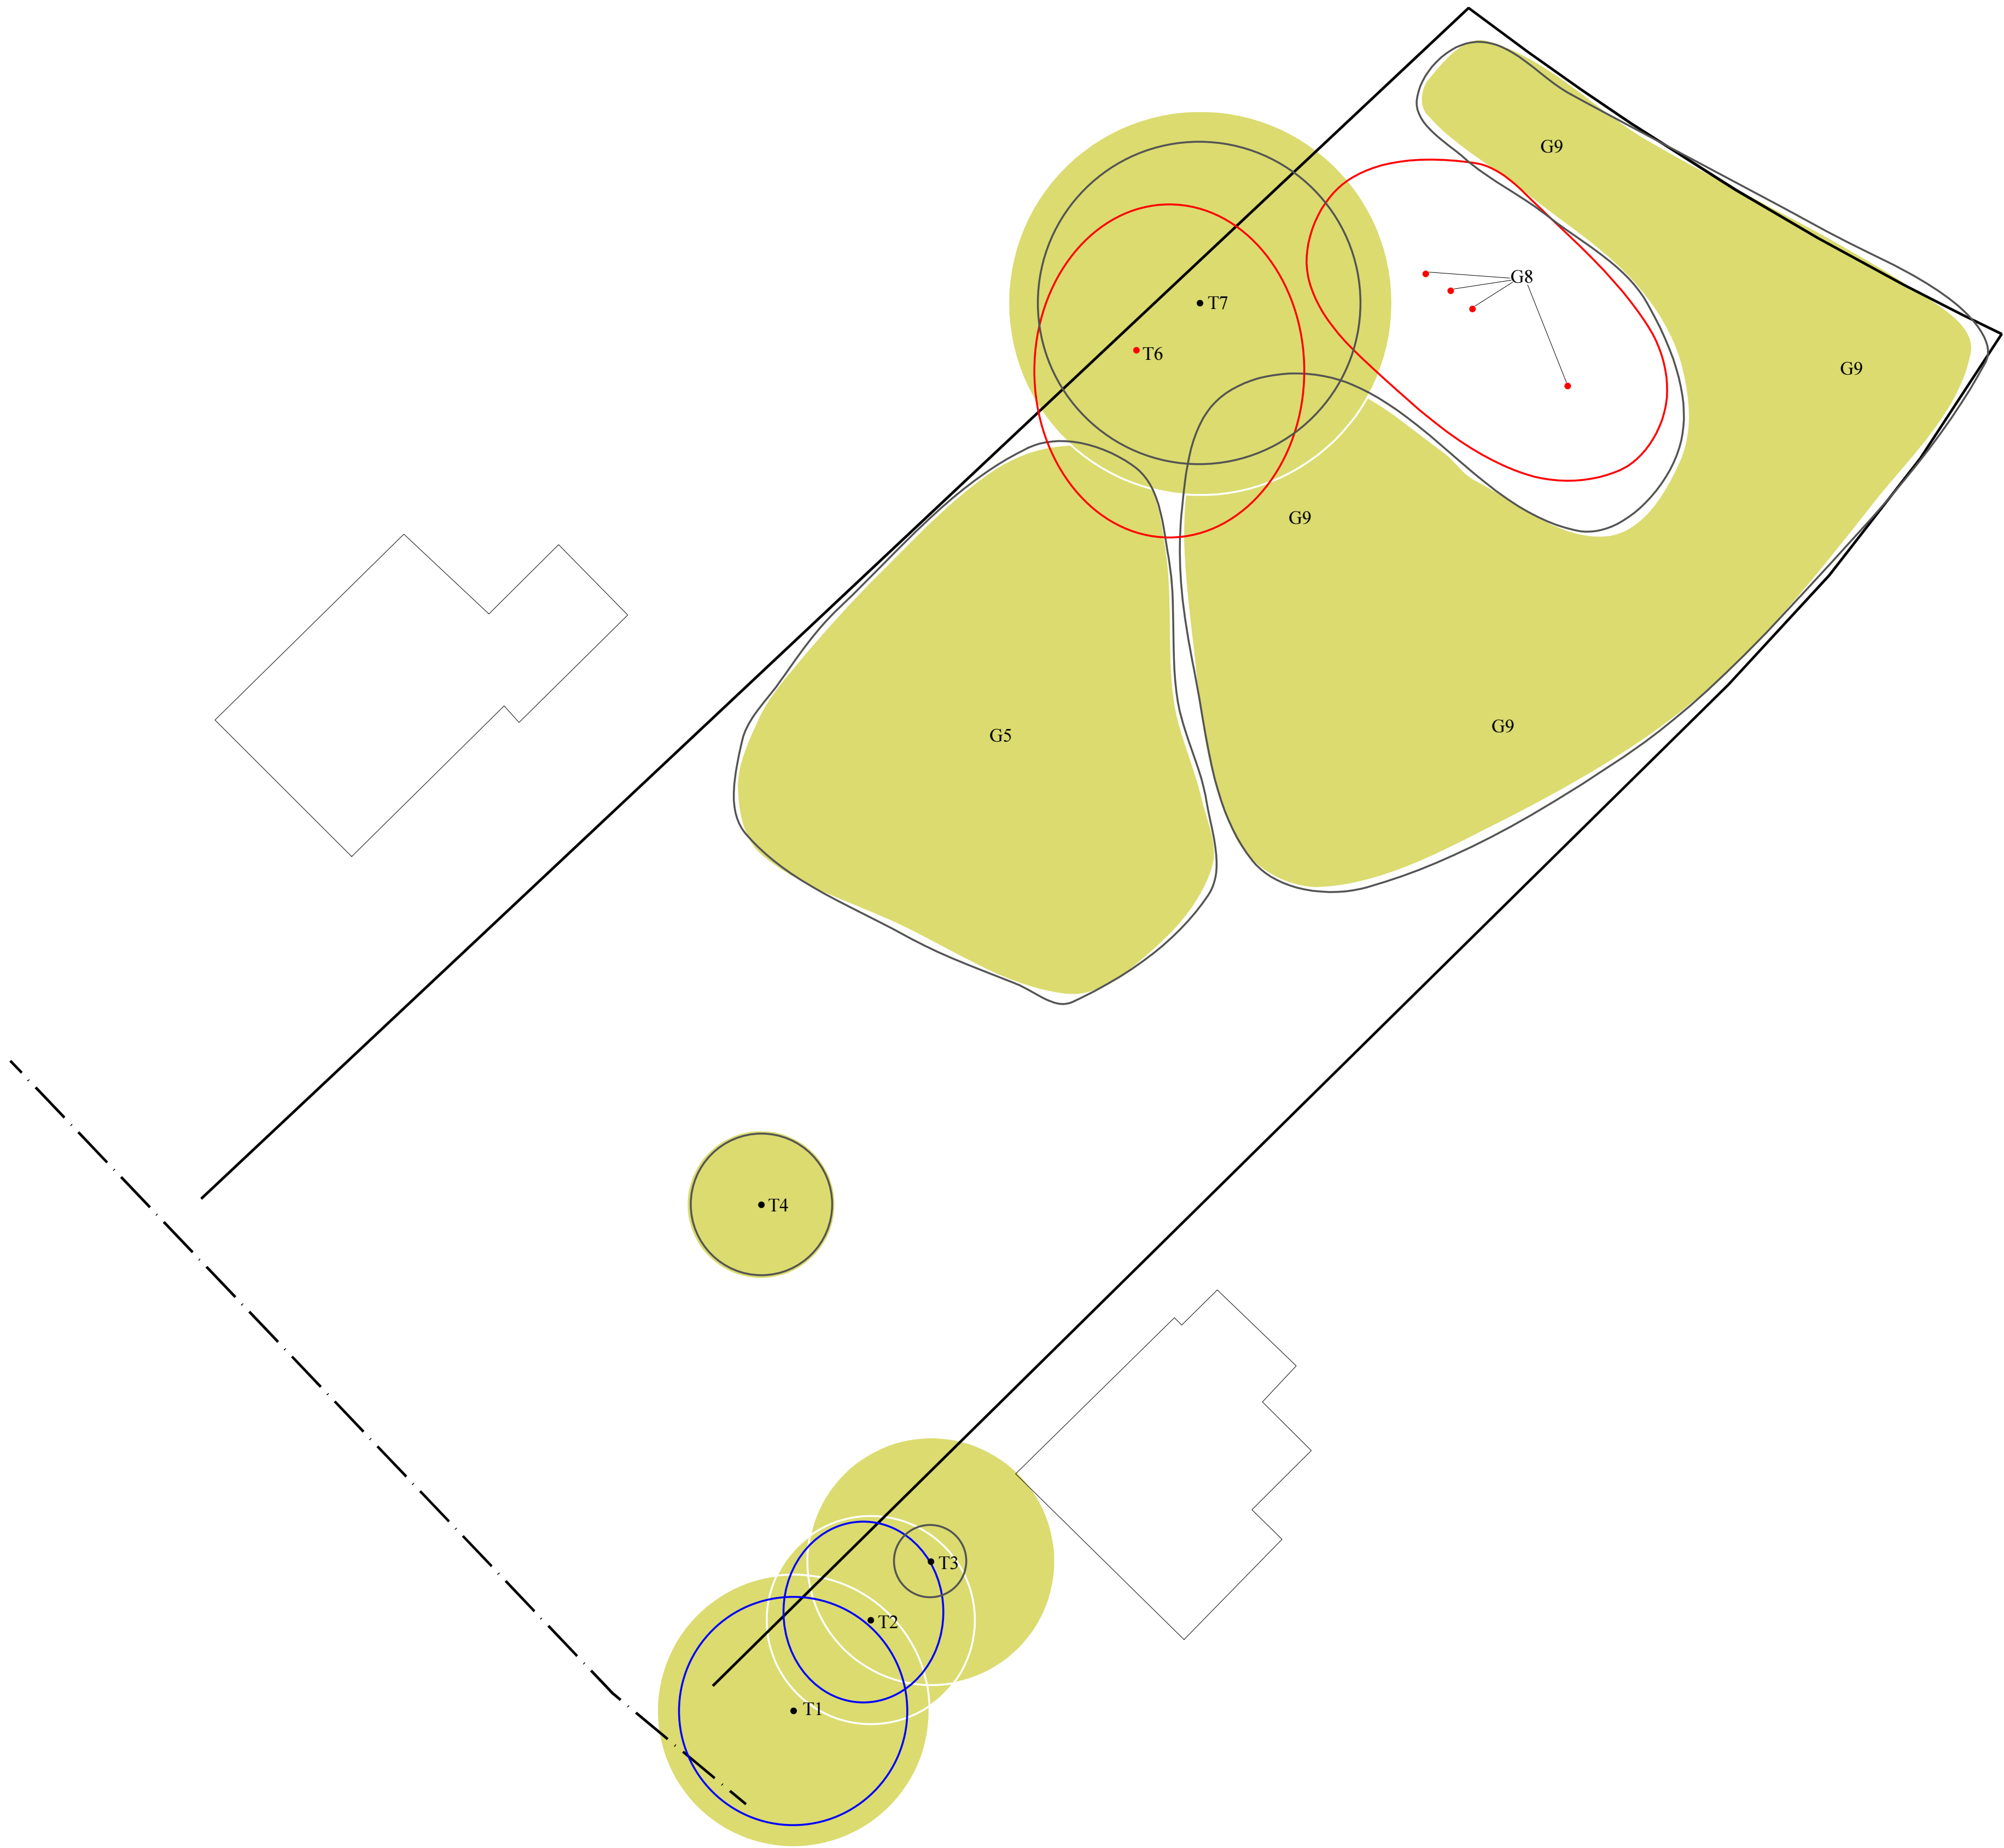
- 5.2.1 **T6** and **G8** were identified as retention category 'U'. These trees require removal as a matter of **low priority** (due to the low current public land use of the site) because they are considered likely to fail or die within the short term.

- 5.4.1 **T7** was noted to have structural defects, as detailed at **Appendix 1**. Although this tree was considered to be in an acceptable condition at the time of the inspection, the defects observed may lead to its early demise or render it unsafe in the future. As such, it is recommended that this tree be monitored (re-inspected and assessed) on an annual basis to assess if its condition is still acceptable.
- 5.4.2 In addition, all trees to be retained within the site should be re-inspected on a regular basis, in the interests of risk management.
- 5.4.3 A full detailed inspection of **T1, T2, T3, G5** and **G9** was inhibited by restricted access or by the presence of dense understorey vegetation. For these trees, it is advised that they are re-inspected for any possible defects once dense understorey vegetation has been removed or when access has been made available

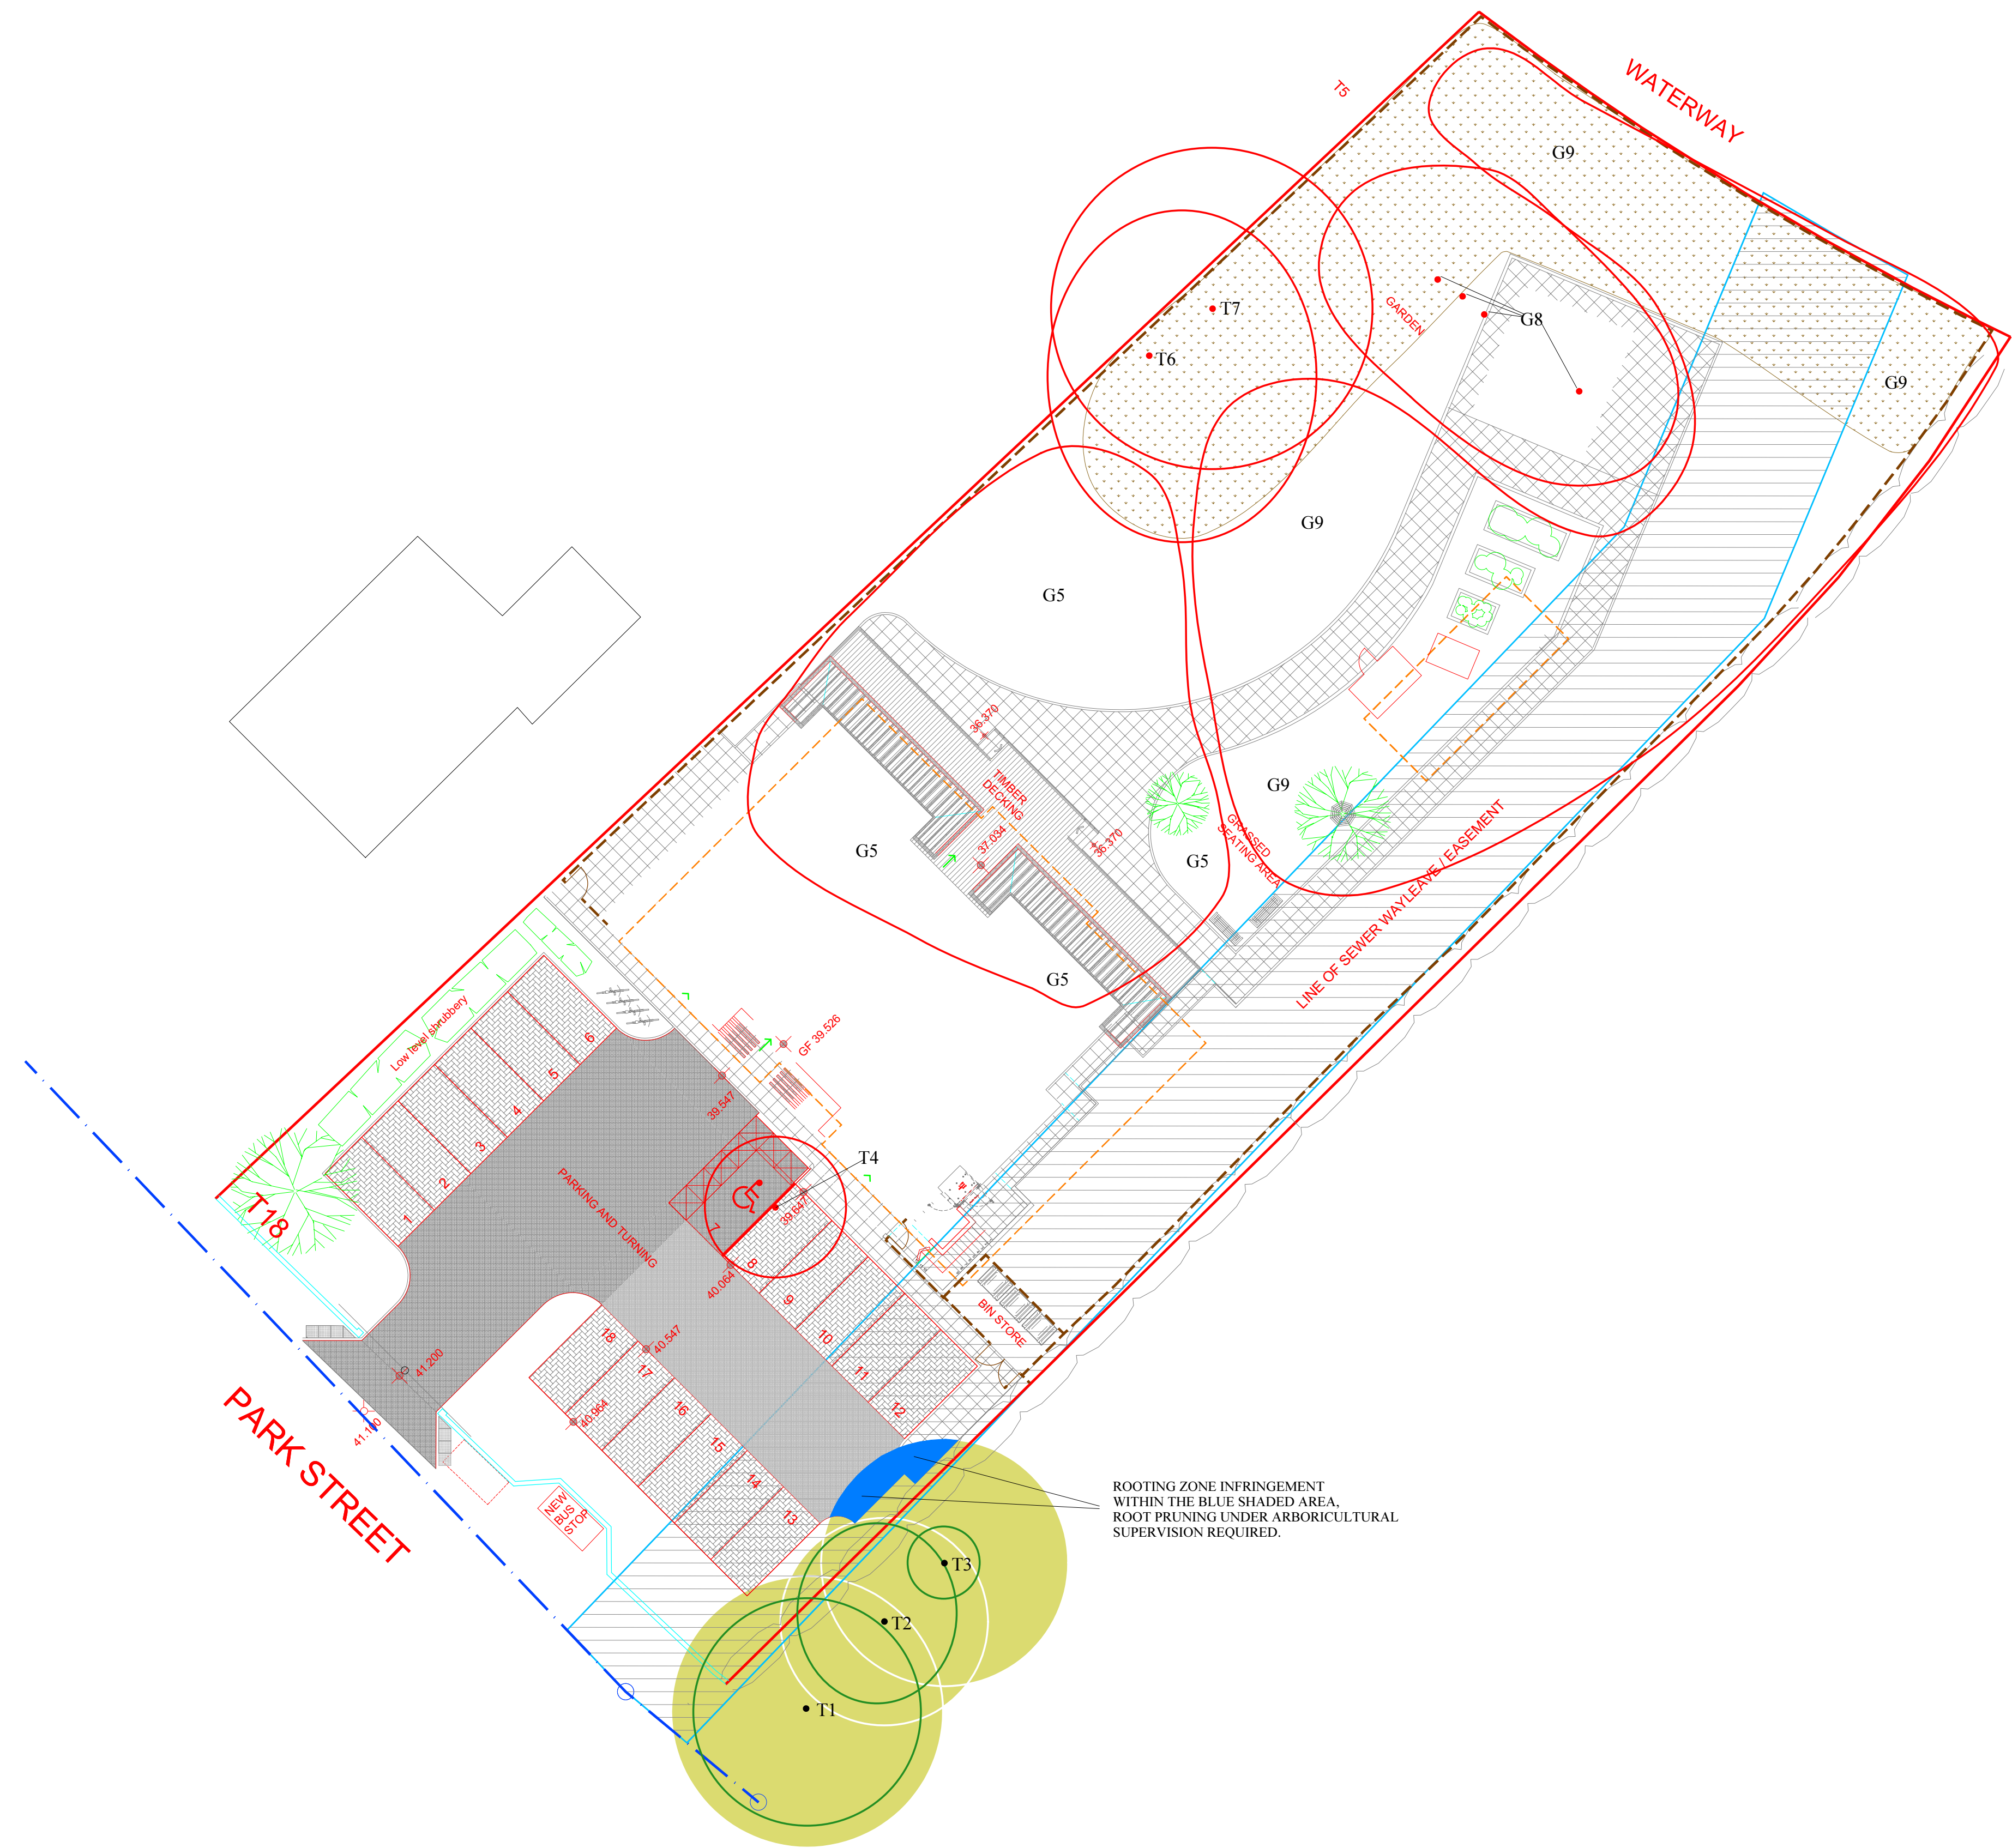
**Appendix 7: Arboricultural Implications Plan**

- 6.3.1 Where the footprint of the proposed hard standing passes within the RPA of **T3** (as shown in blue on the Arboricultural Implications Plan at **Appendix 7**), root pruning will be required, under the supervision of an appointed arboriculturist. Root pruning will accommodate the proposed structure structures whilst preventing any ‘ripping’ damage, a problem commonly associated with mechanical excavations.

- 6.4.2.1 Proposed hard surfacing is located within the RPA of **T3**. Due to the minimal nature of the incursion, it is not considered necessary to install specialised surfaces. Instead, root pruning will be undertaken under the supervision of an appointed arboriculturist to minimise potential damage to tree roots and prevent 'ripping' damage, which is commonly associated with mechanical excavation.

| | ROOT PROTECTION AREA ENCROACHED BY THE PROPOSED HARD STANDING. ROOT PRUNING UNDER ARBORICULTURAL SUPERVISION REQUIRED. |

- 6.2.1 As part of the development, all trees within the site boundary are proposed to be removed (**T6** and **T8**, to be removed for arboricultural reasons, and **G5**, **T7** and **G9**, to be removed to facilitate the development) and replaced with new trees within the area shown in brown hatch on the attached plan at **Appendix 7**.

| | AREA TO BE SET ASIDE FOR NEW TREE PLANTING IN ORDER TO PROVIDE A REPLACEMENT PROTECTED WOODLAND GROUP/ WILDLIFE CORRIDOR |
