**Residential & Commercial Development
Land at Midland Road, Royston**

Existing Highway Condition Survey

**For
Kier Property Developments Limited
&
Persimmon Homes West Yorkshire**

Report Ref	Issue	Prepared by	Reviewed by	Date
11120	2	J Mitchell	A Liddell	August 2013

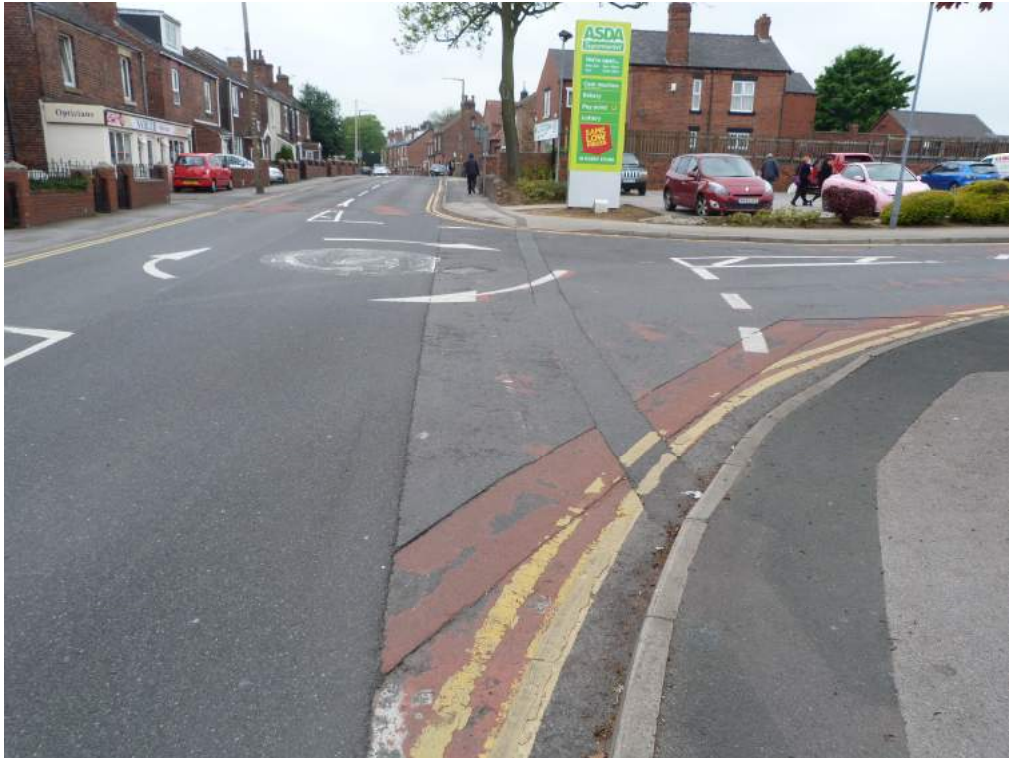
Inspection Items	Defects Identified
Carriageway	<p>Midland Road recently resurfaced up to the channel line of The Lane.</p> <p>Cracking and settlement evident on Midland Road immediately to the west of the mini roundabout. Existing trench reinstatement failure. Numerous potholes previously patched in this area.</p>

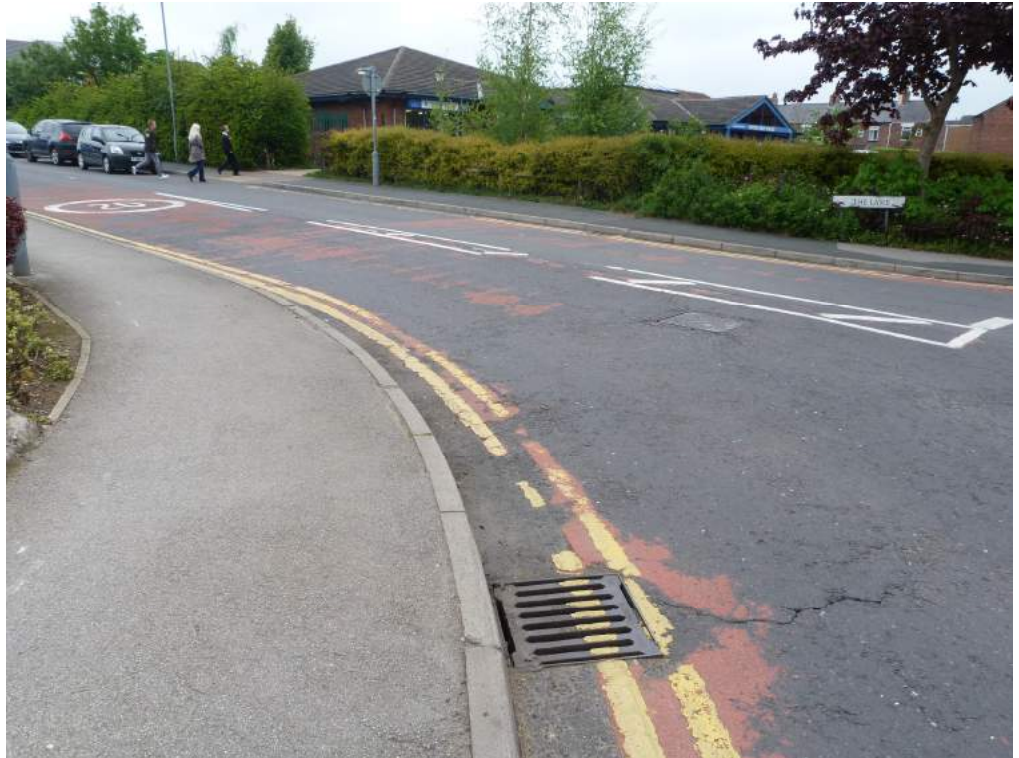
<p>Trench reinstatements evident at junction of Midland Road and The Lane. Slight opening of joints with existing carriageway. No settlement of trench noted.</p>

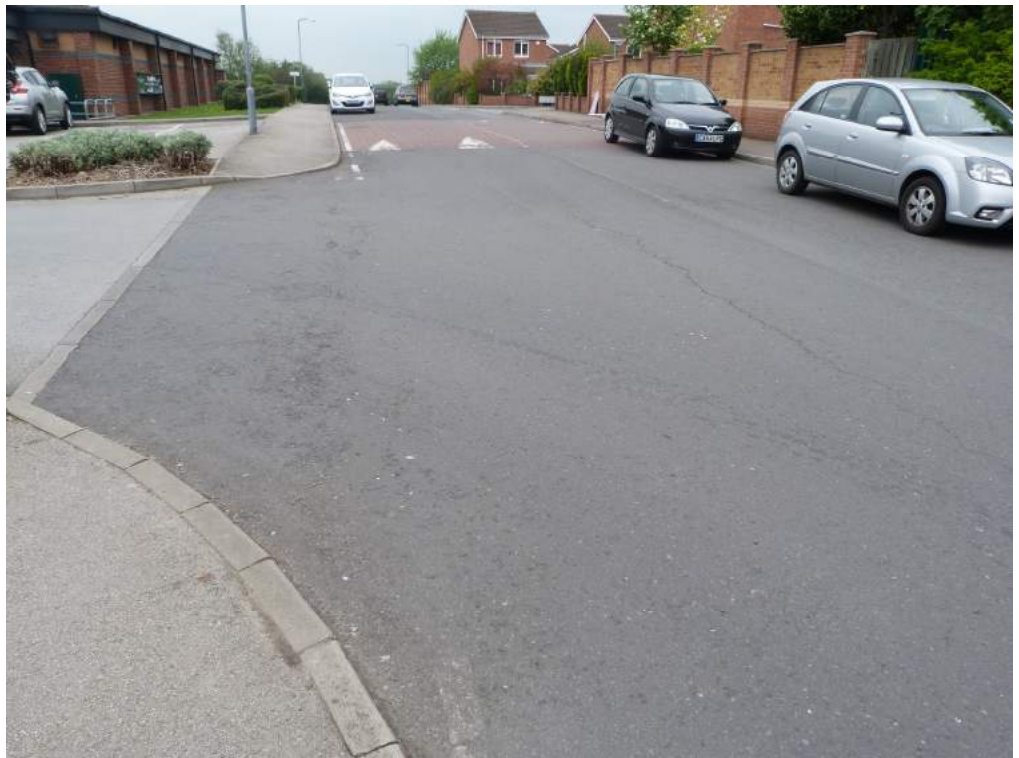
Surface cracking evident adjacent LHS gully at junction with Midland Road.

Cracking also evident around manhole covers approx 7m from junction.

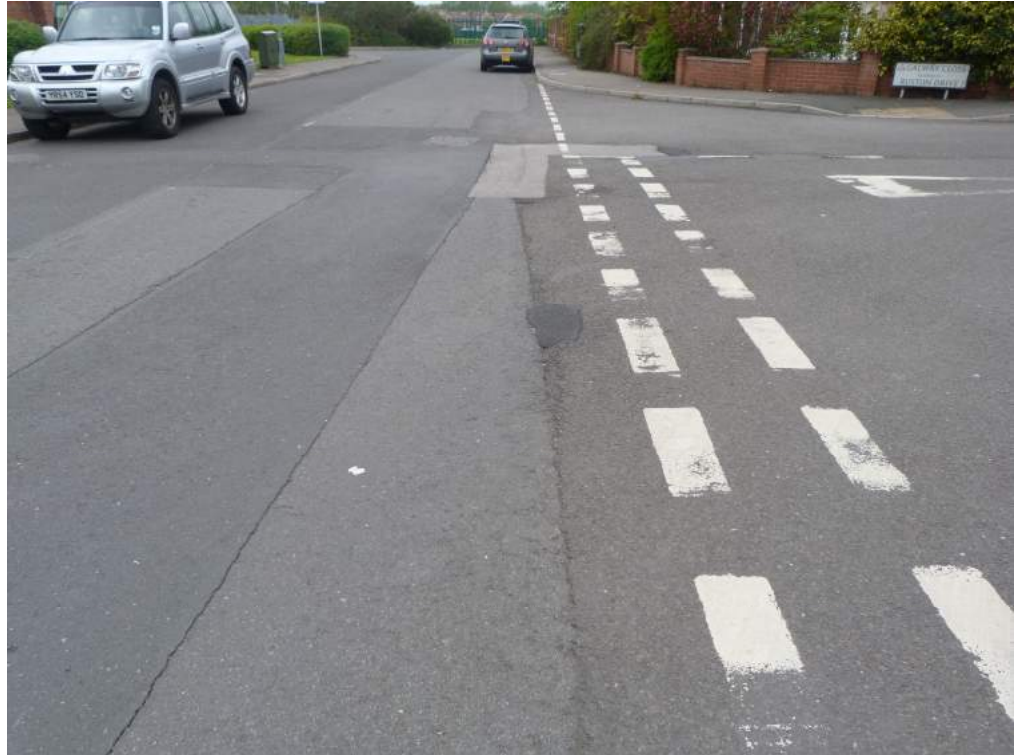
Slight cracking obvious along centre of carriageway adjacent ASDA entrance.

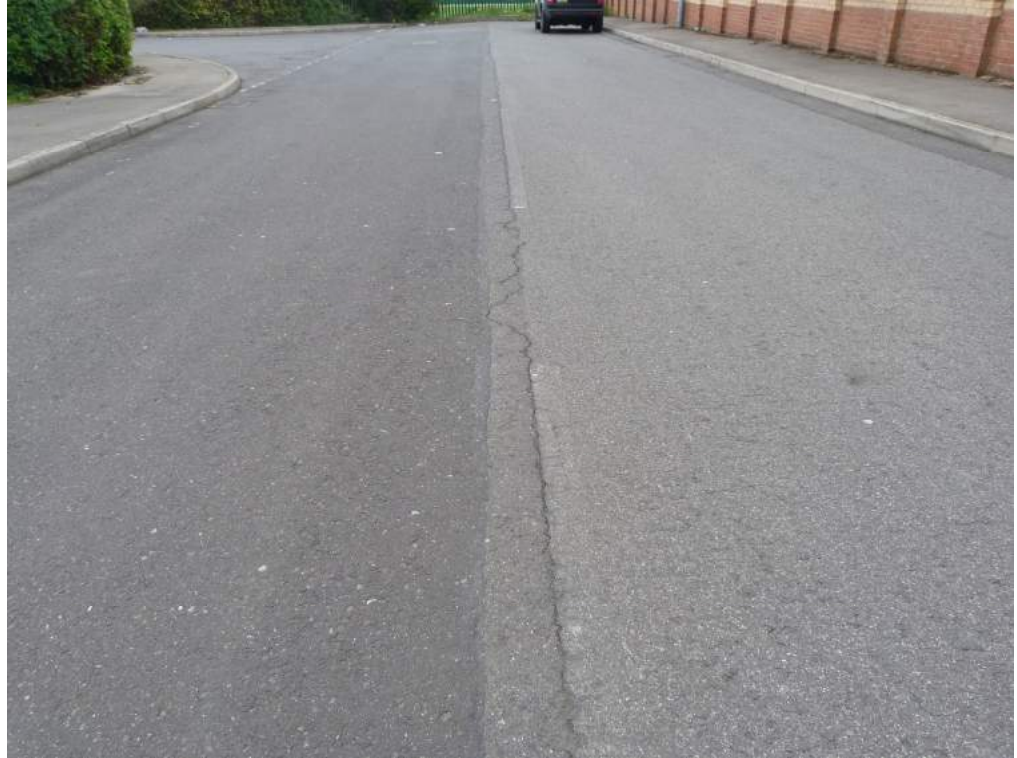
Numerous trench reinstatements evident at the junction with Galway Close. Several of these reinstatements, including a sewer reinstatement running perpendicular to the carriageway, have deformed slightly leading to undulations in the surface course.

Several potholes filled along the channel line of the junction with Galway Close.

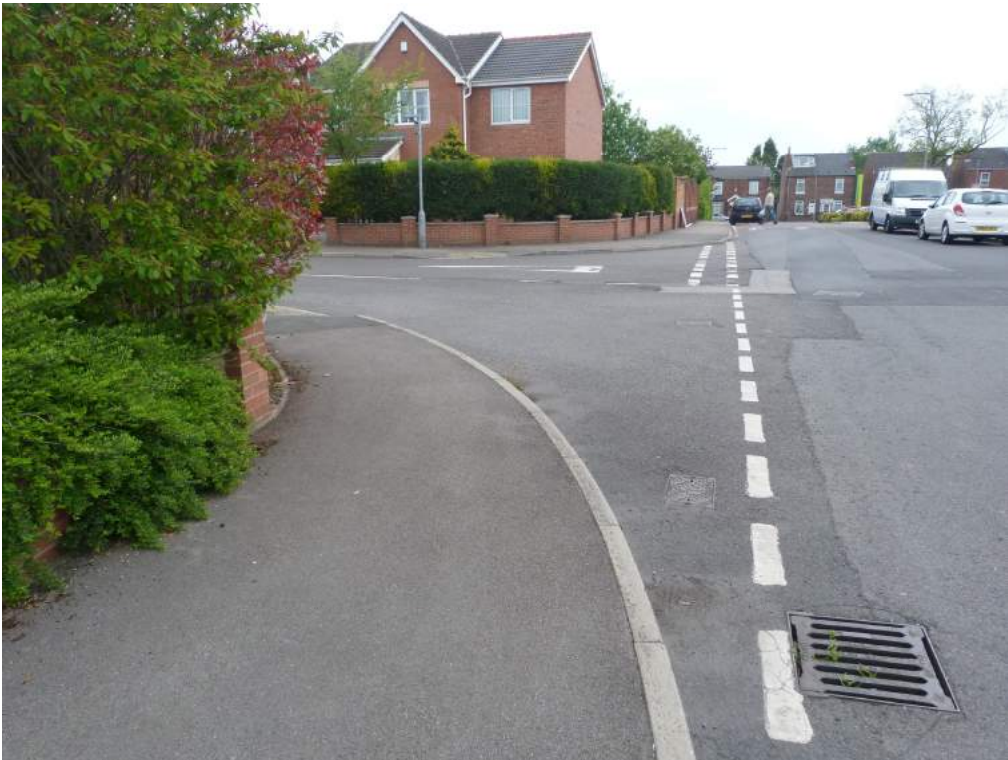
<p>Several trench reinstatements to centreline of carriageway at the junction with The Lane. Some signs of surface deterioration and minor deformation. Several filled and un-filled potholes also present.</p>

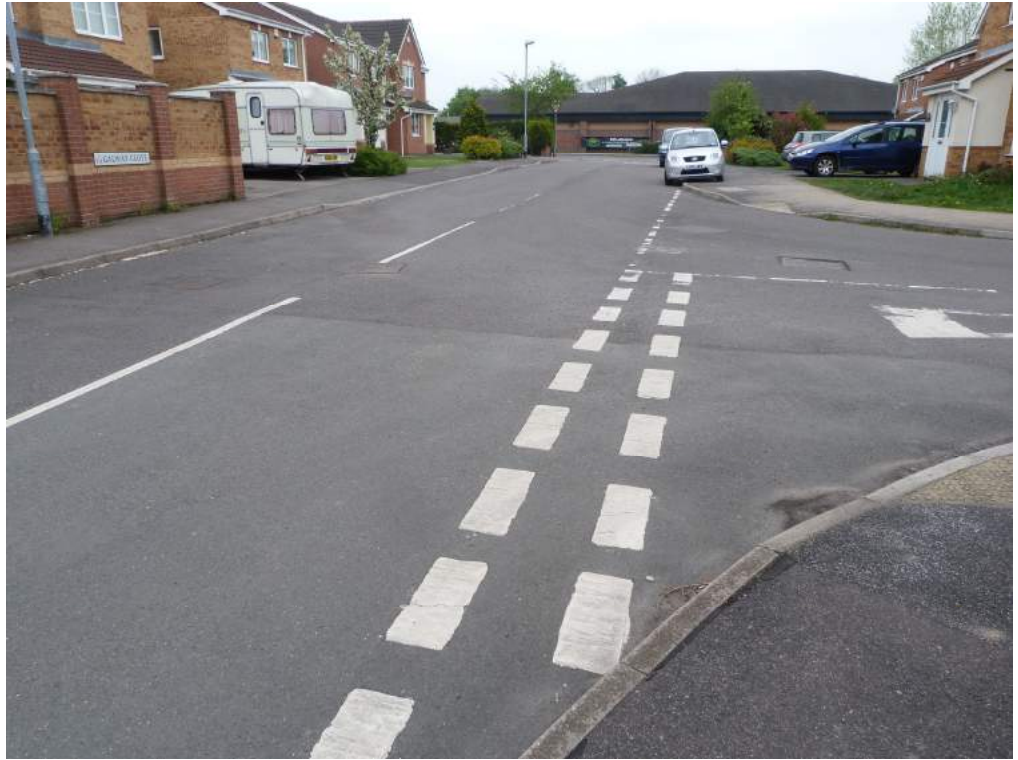
Carriageway in generally good condition along its full length. However, some small areas of open joints along the centreline of the carriageway are evident.

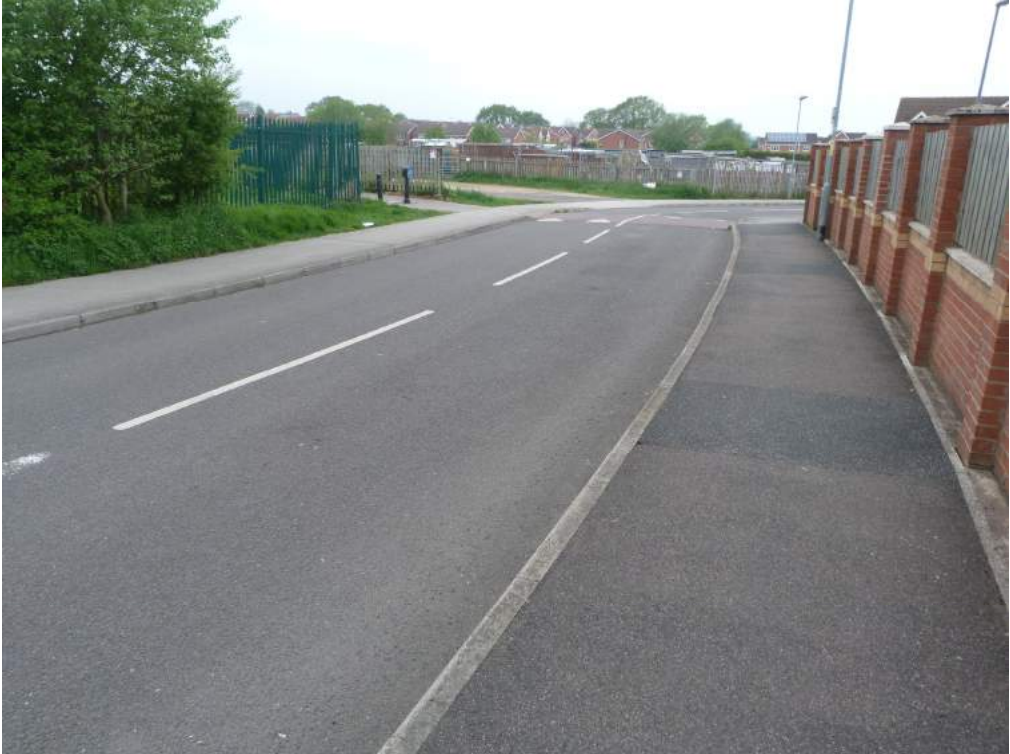
<p>Sunken manhole cover and frame located at the junction of Galway Close and Ruston Drive.</p> <p>No other defects noted. Carriageway in good condition overall.</p>
Footway/verge	Minor surface cracking to rear of footway on LHS adjacent red imprint detail.
Kerbs & edgins	Kerbing & edgings in good condition throughout.
Covers, gratings and stats boxes	All gullies on RHS of carriageway require jet vac to remove silt and debris. All gullies to LHS of carriageway in good working order.
Road markings	All road markings are in reasonable condition. Red imprint in good condition.
Other	None.
