**Lower Eastfield Farm  
Thurgoland, Sheffield  
Existing Farm and Outbuildings  
Visual Structural Survey**

Visual Structural Survey of Existing Farm and Out Buildings

At Lower Eastfield Farm, Thurgoland, Sheffield

Ref : dp2 / 1718

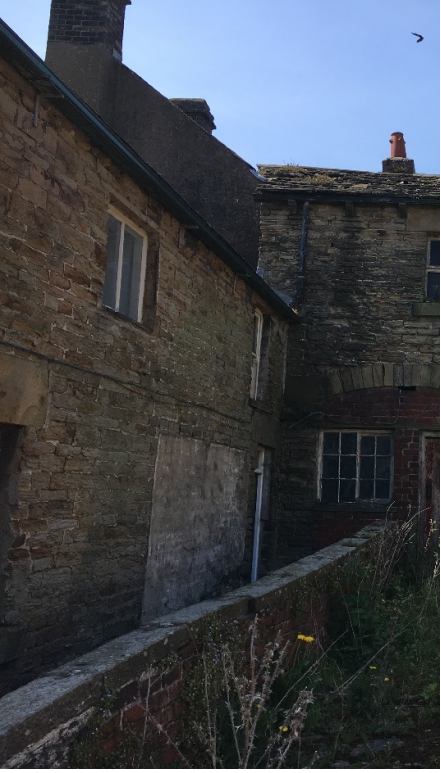
| Location | Description |
|---|---|
| | <p>Rear elevation of the original farmhouse building.</p> <p>The adjacent barn and farmhouse extension have been built on top of the existing walls to the farmhouse. Care should be taken when demolishing or rebuilding these elements to not disturb the support to the adjacent structures.</p> <p>The stone is in good condition. There are no signs of movement or cracking, and the pointing appears to be in a reasonable condition.</p> |

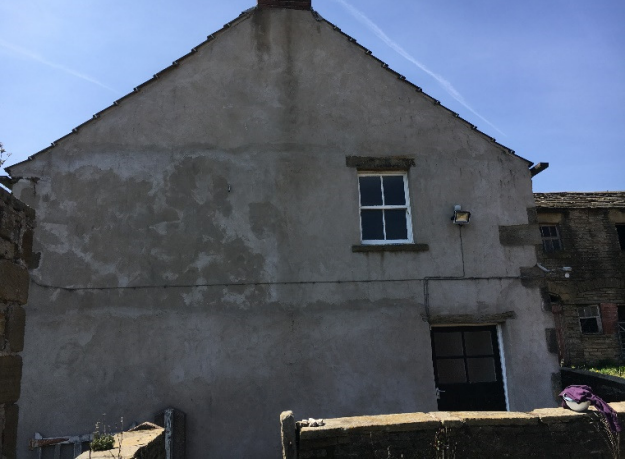
| Location | Description |
|---|---|
| | <p>Side elevation</p> <p>The quality of the stone cannot be assessed due to the presence of the render. However, there are no signs of any cracking within this.</p> |

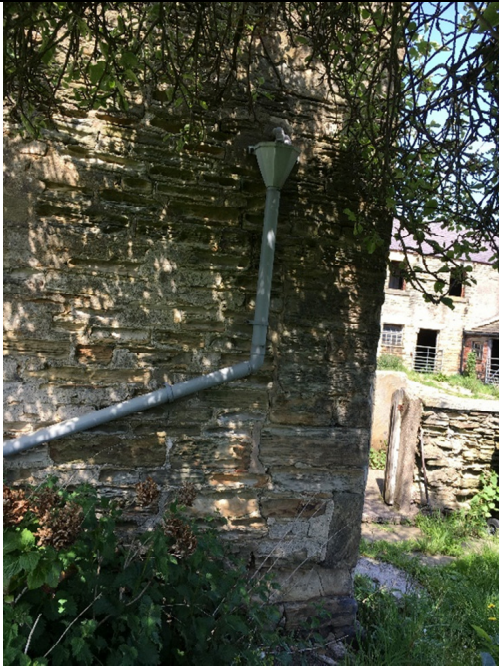
#### Front elevation

There is a vertical crack running up the corner of this elevation.

It is not significant and could be repaired with bed joint reinforcement. The movement is likely a result of poor drainage in the corner.

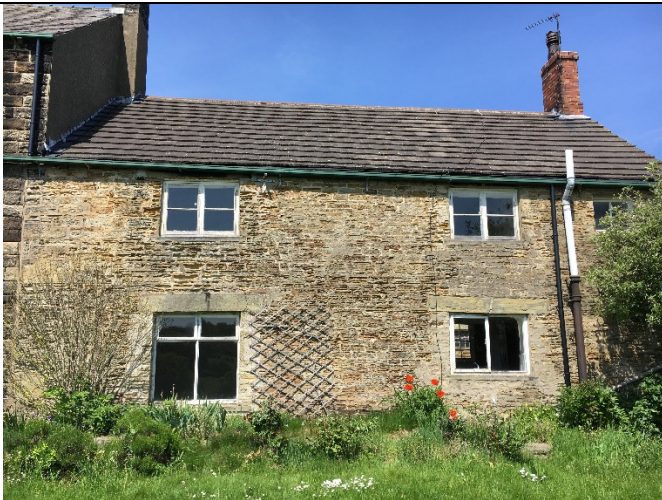
#### Front Elevation

The stonework is in poor condition - heavily pitted in several places due to exposure. Damp issues identified within ground floor space due to retaining earth externally.

The roof structure couldn't be accessed, but there are no signs of movement, however roof tiles are a concrete product.

Several lintols severely cracked and require replacement.

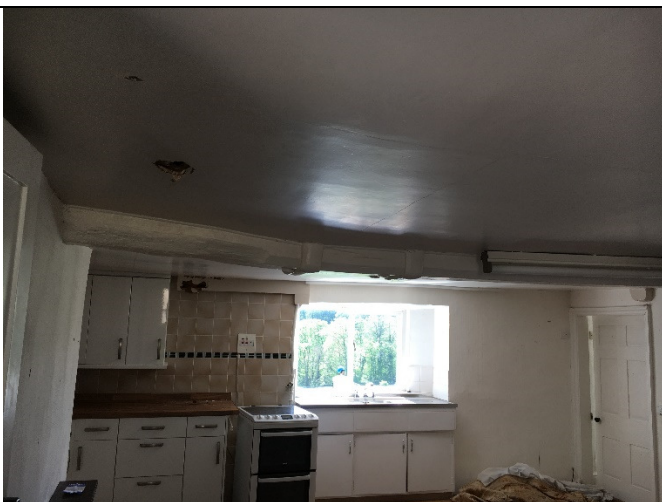
#### Kitchen

The large timber beam across the kitchen supports a masonry wall at first floor level. The wall doesn't appear to be supporting the roof, but the weight of the masonry has caused long term creep in the timber and significant deflection in the beam.

If the wall is to be kept the timber beam should be replaced with a steel one. If the wall is to be removed then new timber joists could be installed to level the floor.

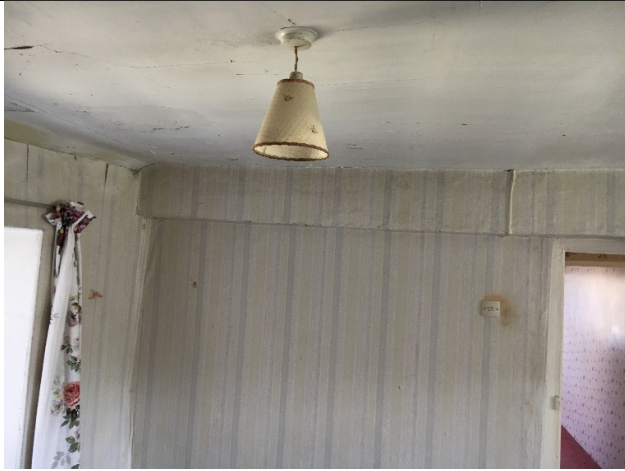
### Second Floor

The bottom boom of the truss can be seen above the wall. There are two trusses equally spaced supporting the roof.

It was not possible to access the roof space and view the timber.

As works progress with the refurbishment a timber specialist should be appointed to survey and check the timber for rot, infection and decay.

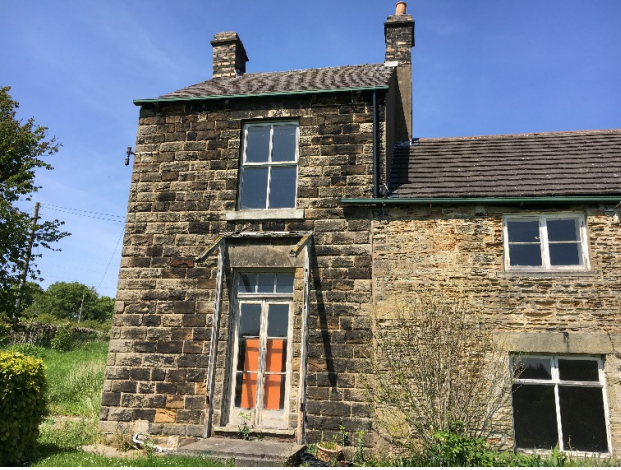
| Location | Description |
|---|---|
| | <p>The Farmhouse extension has been built off the party wall to the original house. The chimney stack on the junction serves the original farmhouse.</p> <p>There is a vertical joint between the two properties, but no signs of movement or settlement.</p> <p>If the original farmhouse is to be taken down then the party wall will need to be tied in to the extension to minimise any future movement.</p> |

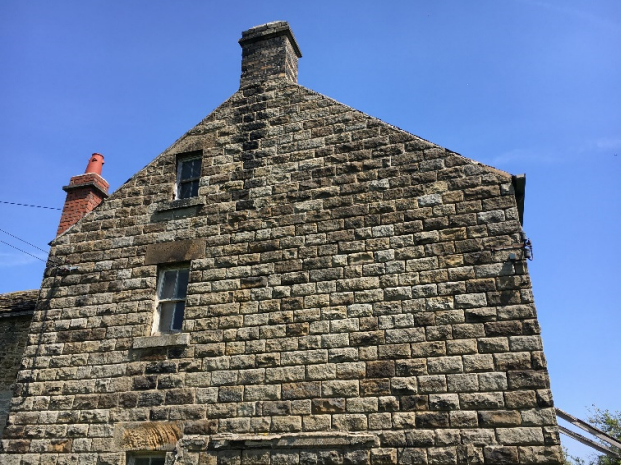
| Location | Description |
|---|---|
| | <p>Side elevation</p> <p>The stone to the back of the chimney is heavily stained with soot. The chimney stack should be rebuilt and a new flue liner installed if the chimney is to be reused.</p> |

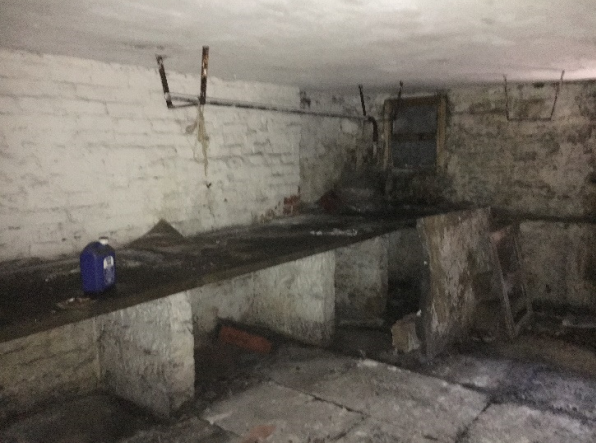
| Location | Description |
|---|---|
| | <p>There is a cellar under the extension, with a stone flagged floor. The walls are damp as they are built back to the earth.</p> <p>It's not clear whether there was originally a cellar under the existing house, as the party wall follows through to the rooms above. However, there are no signs of movement in either building, so the construction has not affected the property.</p> |

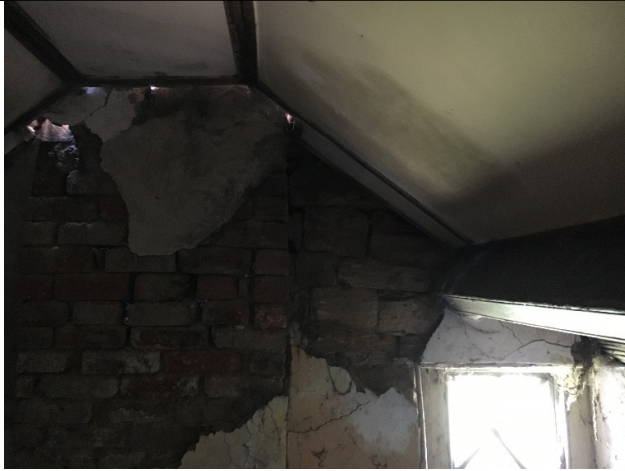
At roof level the timber around the chimney has deteriorated and these are now open to the elements. This should be patched up to prevent any further water ingress causing deterioration of the floor.

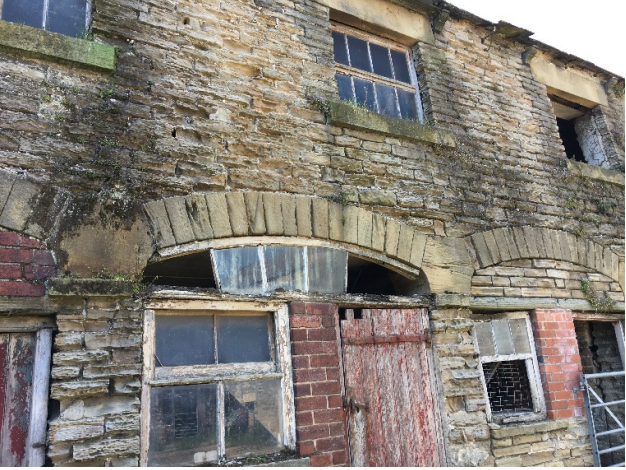
| Location | Description |
|---|---|
| | <p>The arched gable to the courtyard is in a poor condition with displaced arches, poor quality stone, and significant deflection in the walls.</p> <p>This elevation should be taken down and rebuilt with new support to form the arches.</p> |

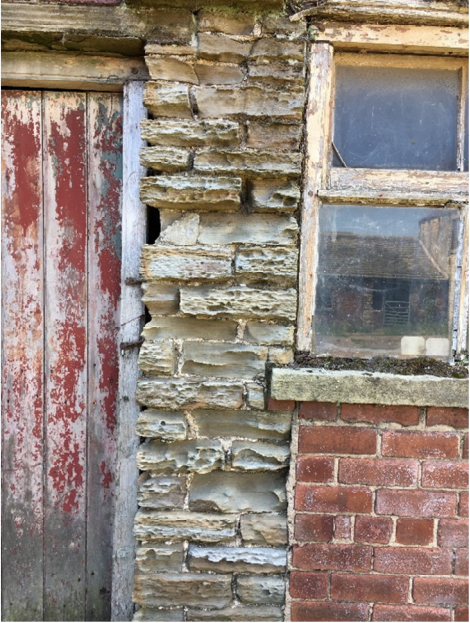
| Location | Description |
|---|---|
| | <p>A lot of the stone is severely weathered. Where it has been used in the slender piers it should be replaced with new or reclaimed stone.</p> |

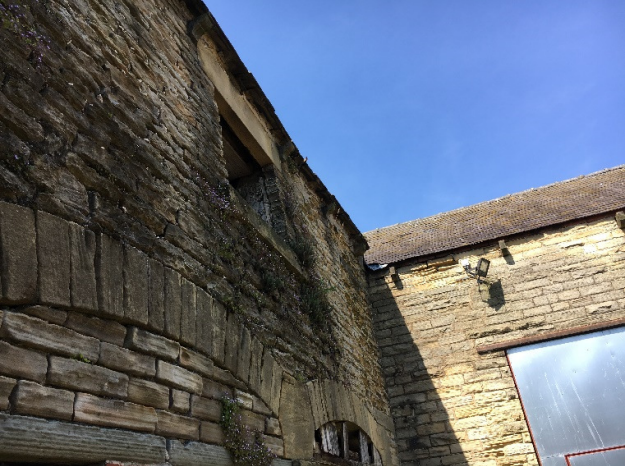
| Location | Description |
|---|---|
| | <p>The upper section leans in at a significant angle and should be rebuilt.</p> |

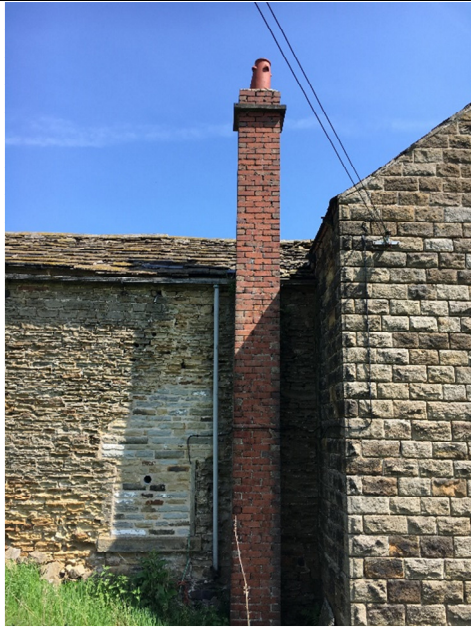
The barn is built over the external walls of the farmhouse and extension.

The roof is in a poor condition and should be taken off and rebuilt.

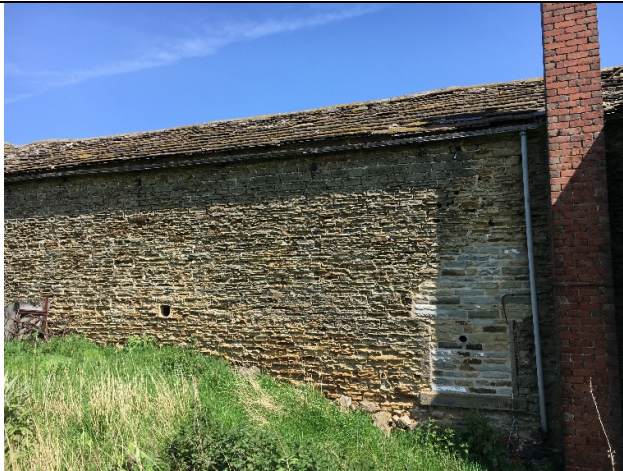
Although the stone is heavily weathered there are no signs of movement or settlement on the rear elevation.

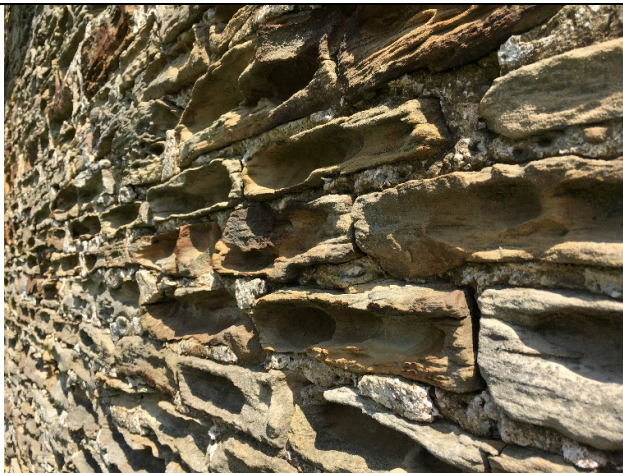
The structural integrity of the wall isn't affected by this pitting, but the longer term performance as a weather barrier may be affected, and the recessed shape leaves the wall more susceptible to frost damage.

The stone could be sealed to prevent any further deterioration, but advice should be sought from a specialist to see if this is possible.

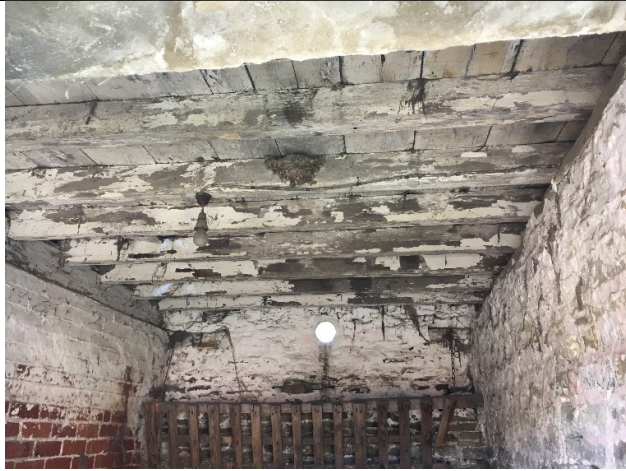
The internal floors are in a poor condition due to water ingress from above.

All the timber should be replaced.

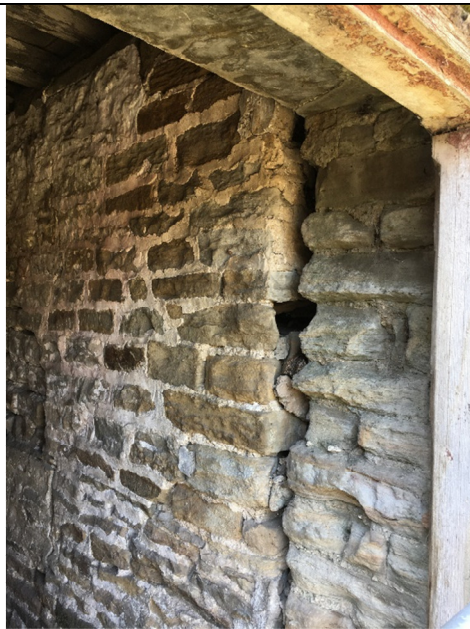
The internal walls have separated from the external wall.

All the internal walls should be rebuilt.

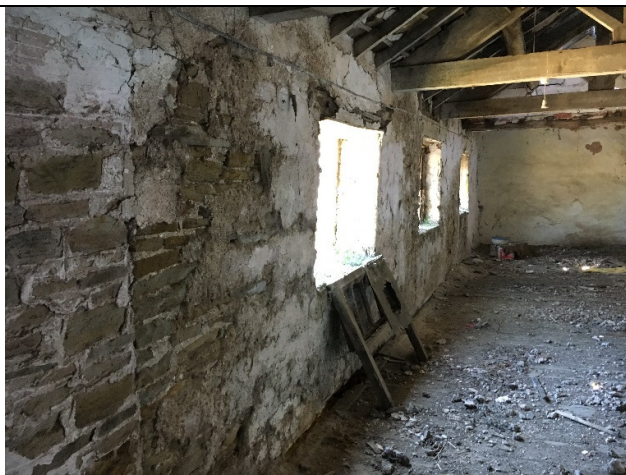
Some of the roof timbers look okay.

Once the building has been made safe they should be inspected to confirm that they can be reused in the rebuilt structure.

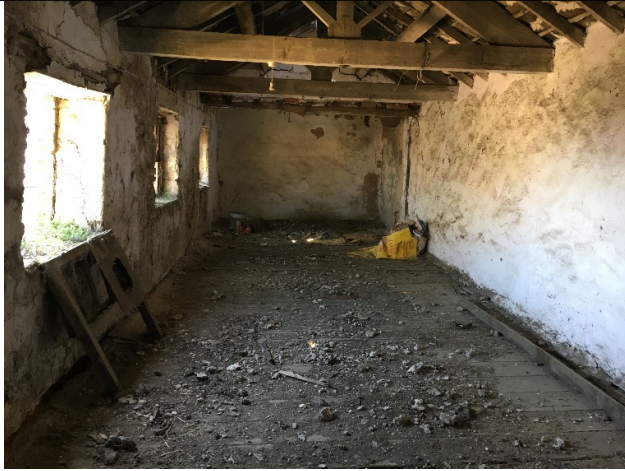
The roof has failed in several places and this has caused deterioration to other elements.

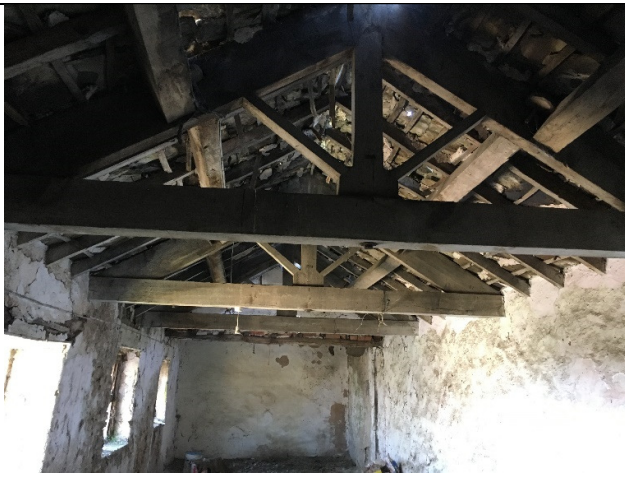
The trusses appear okay, subject to further testing.

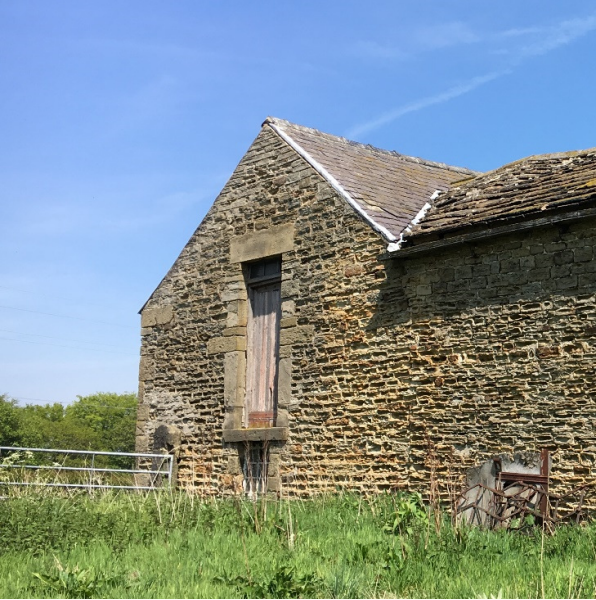
| Location | Description |
|---|---|
| | <p>The Main Barn is in a relatively good condition.</p> <p>The end gable has the same pitted stone as the Arch Barn and this should be similarly protected.</p> |

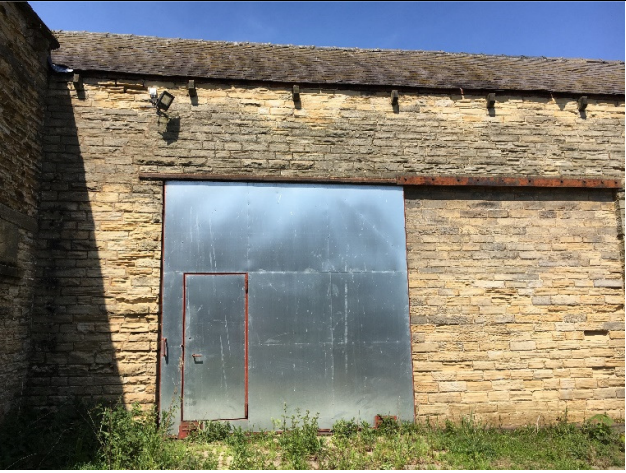
| Location | Description |
|---|---|
| | <p>There are two large doors into the barn. The lintel is a steel plate bedded into the wall. This appears to be okay, but should be cleaned and painted to protect it.</p> |

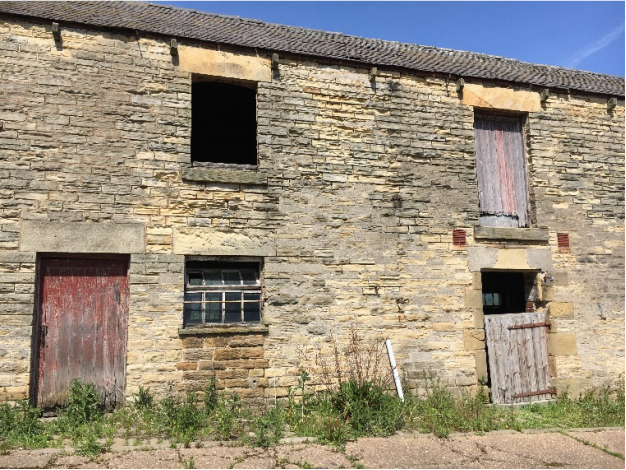
| Location | Description |
|---|---|
| | <p>All of the stone lintels appear to be in good condition with no splits or cracks.</p> <p>There are no signs of settlement in the walls.</p> <p>The foundations are likely to be relatively shallow and the new floor build up will need to take account of this when setting new internal levels.</p> |

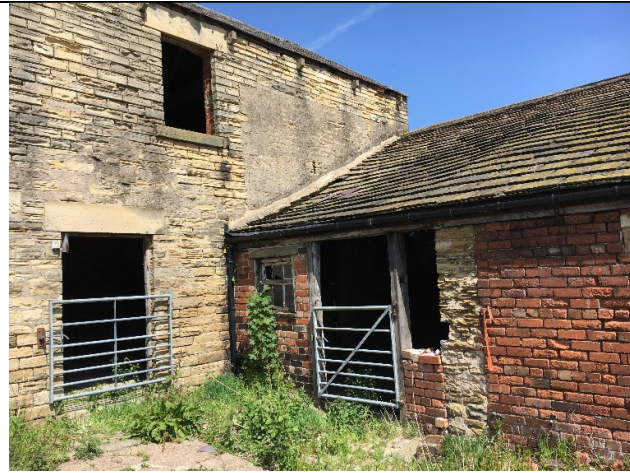
The roof adjoining the barn has failed, but it has not impacted on the main barn.

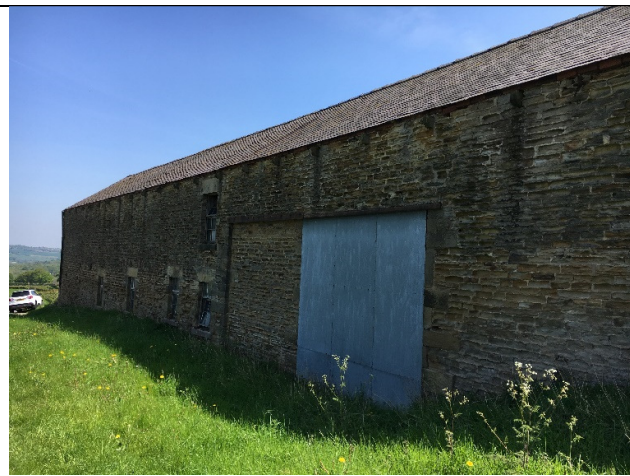
The rear elevation appears to be in good condition with no signs of settlement.

The embankment against the external wall will be causing damp to penetrate the wall and this should be pulled back to prevent any further deterioration.

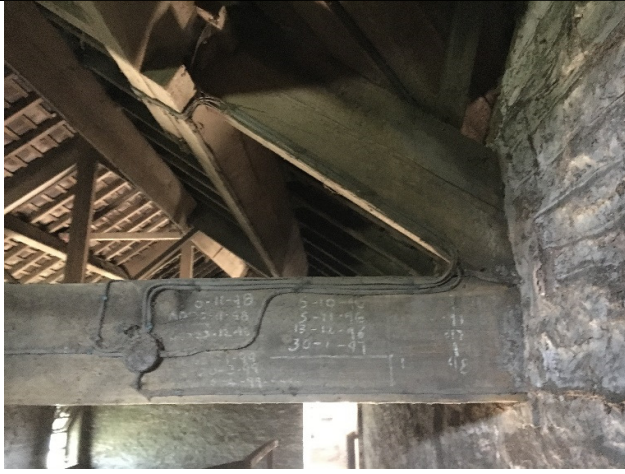
The roof trusses appear to be in good condition, but all of the bearings should be checked for rot and decay.

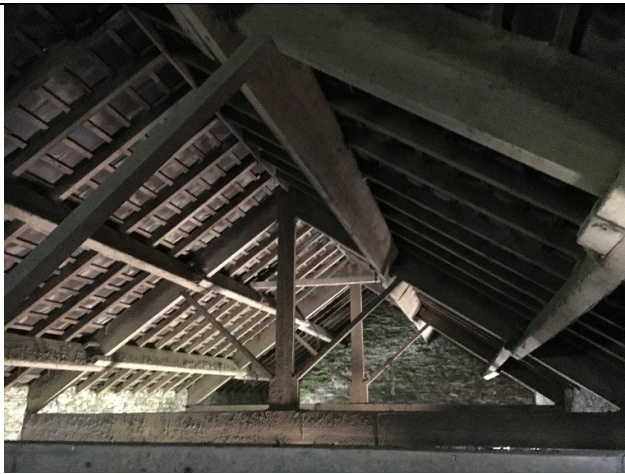
The roof structure is in good condition with no signs of movement.

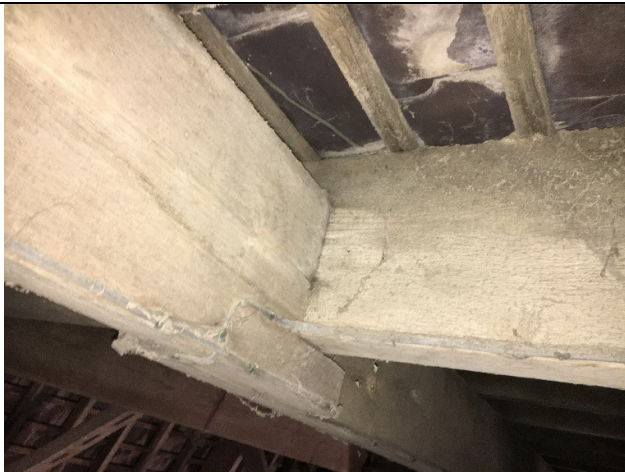
The purlins are "halved" over the trusses, but do not appear to have deteriorated.

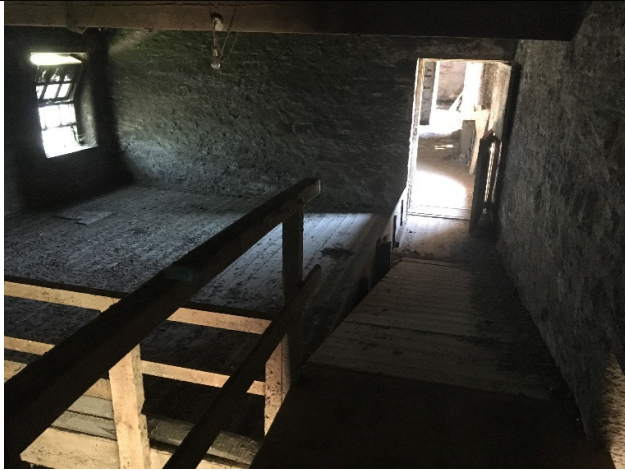
The floors are supported on joists from the main walls. There are signs of decay and deterioration and the floor should not be accessed until it is propped and has been inspected.

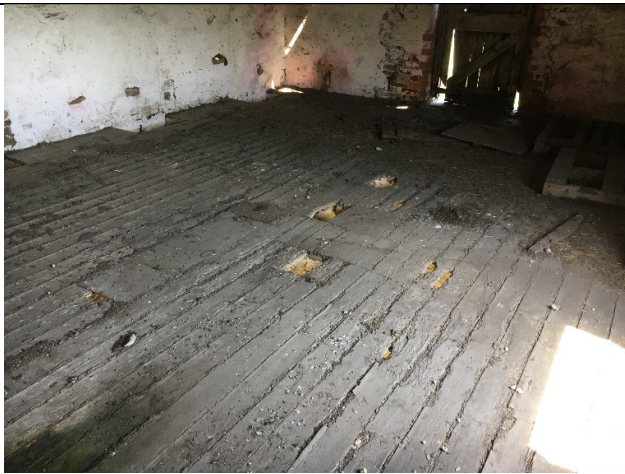
There are signs of rot and decay in all of the floor boards.

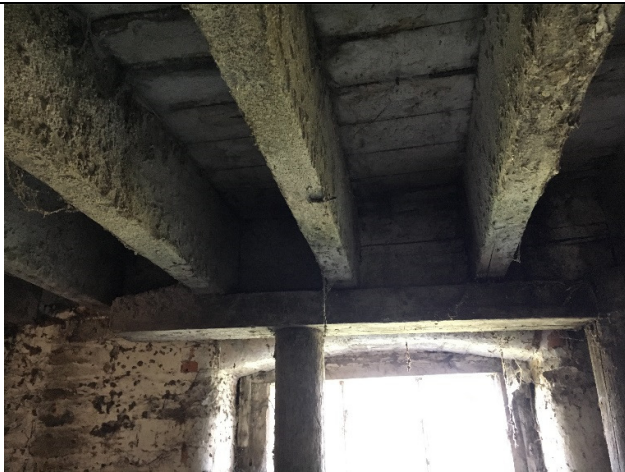
Some of the floor joists are supported on improvised props. The floor should be removed and replaced.

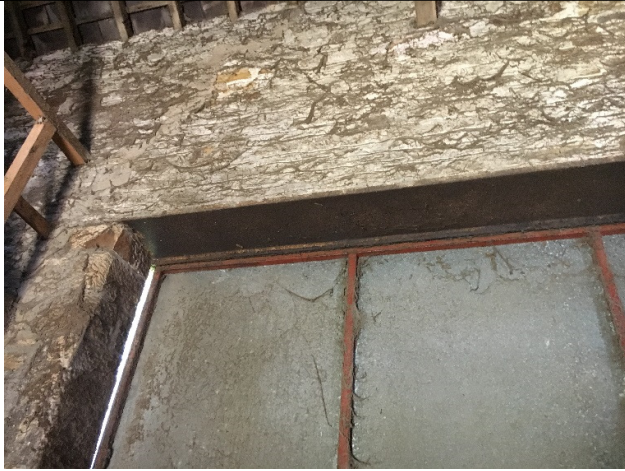
View of the steel plate to the main doors. It is possible that this has an upstand element buried in the wall. The steel appears to be in good condition. It should be cleaned and painted to prevent any future deterioration.

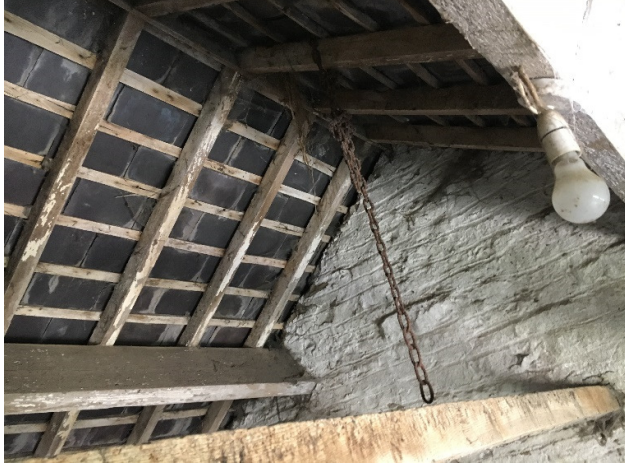
| Location | Description |
|---|---|
| | <p>The roof is in a mixed condition and should be replaced.</p> |

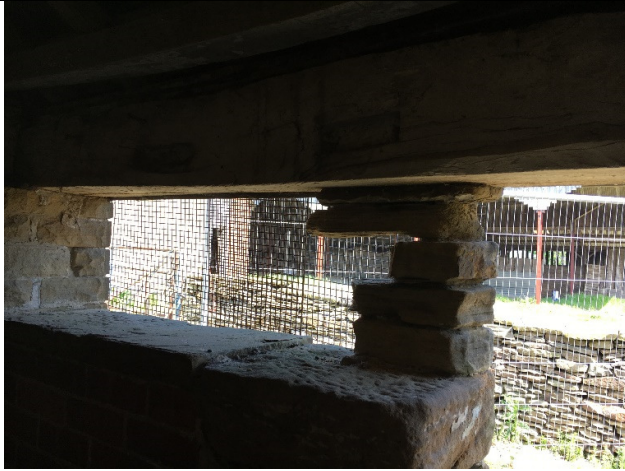
The side elevation with the openings consists of a mix of piers in poor condition. This elevation should be rebuilt.

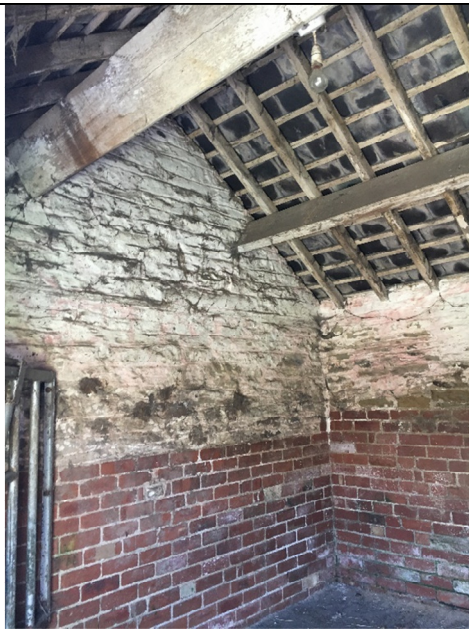
Subject to a timber inspection some of the roof timbers could be reused in the rebuilt structure.

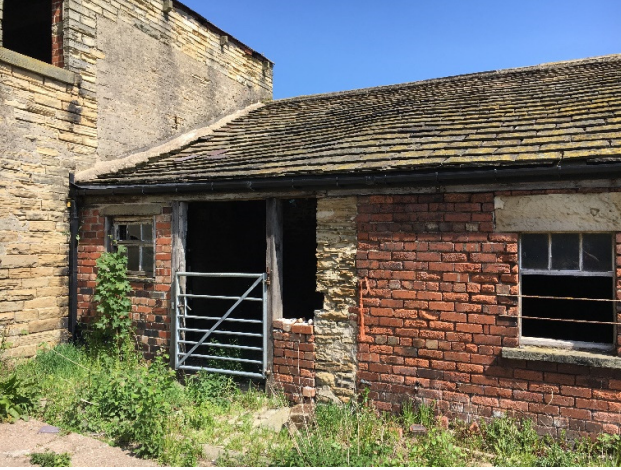
| Location | Description |
|---|---|
| | <p>The section of roof adjacent to the main barn has failed.</p> <p>We would recommend that the entire roof is rebuilt to provide a more robust structure.</p> |

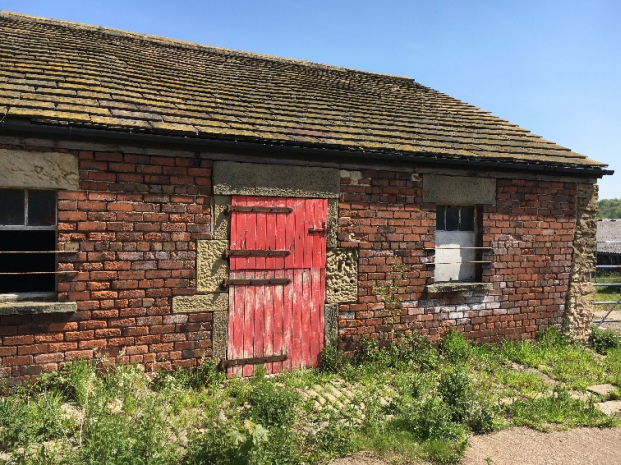
| Location | Description |
|---|---|
| | <p>The brickwork and stone is in a reasonable condition and could be repaired or rebuilt where necessary.</p> |

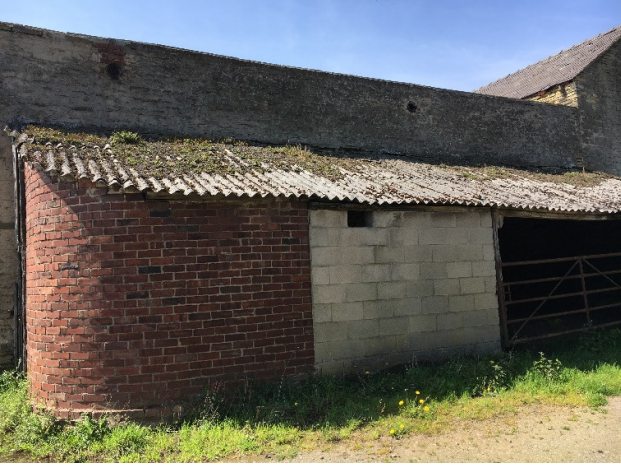
| Location | Description |
|---|---|
| | <p>The rear gable is behind the small extension. The section that is visible looks to be in a reasonable condition and may only need patch repairs.</p> |

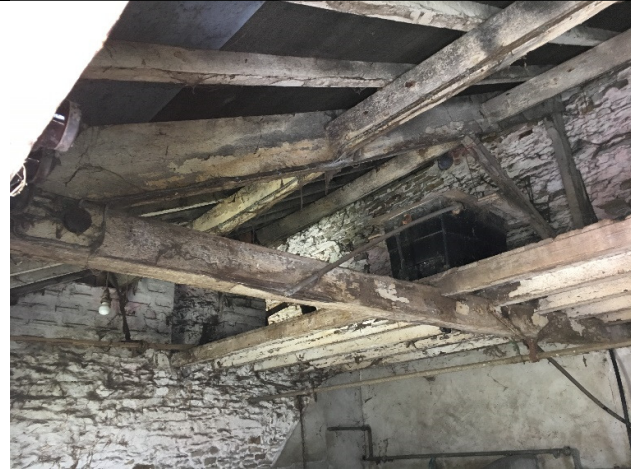
The roof structure is in a very poor condition and should be replaced.

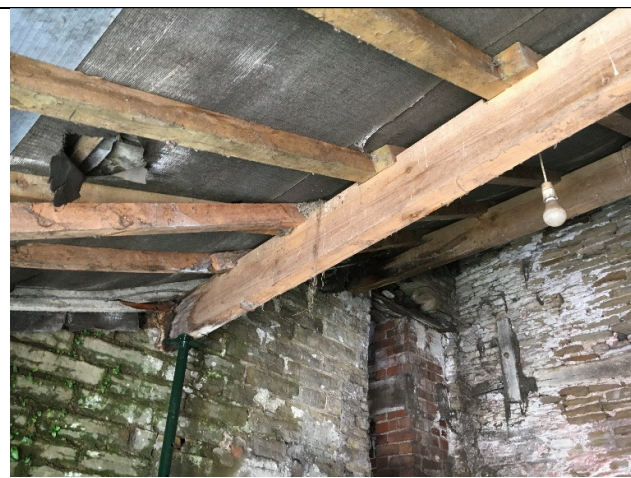
View of the failed section. It would be prudent to install a second prop under the upper failed purlin.

| Area | Remedial Measure |
|---|---|
| Out Building 2 | Prop the upper failed purlin |

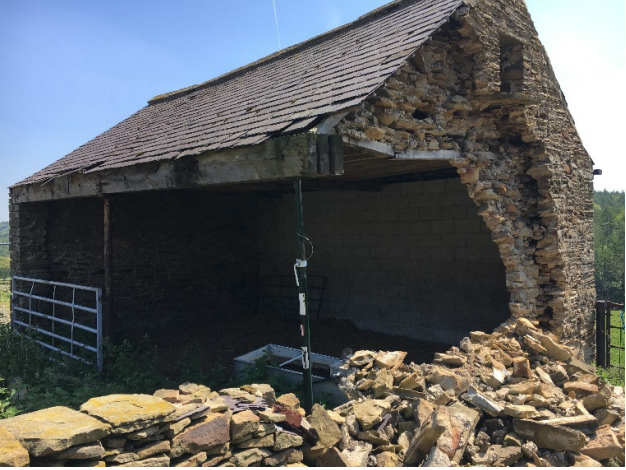
| Location | Description |
|---|---|
| | <p>This building is in a very precarious state and could collapse at any moment.</p> |

| Area | Remedial Measure |
|---|---|
| Out Building 3 – VERY URGENT | Take down the roof and failed gable, make remaining walls safe.<br><br>If this work cannot be done immediately provide a secure hoarding line around the full building, approximately 5m from each elevation. |

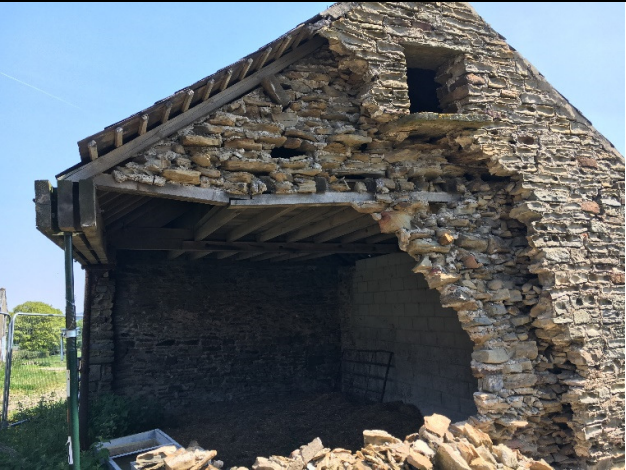
| Location | Description |
|---|---|
| | <p>The small timbers at the end will fail leading to a progressive collapse of the entire building.</p> <p>It is not safe to access the building to prop it, and a method should be sought to take the structure down and store the material on site.</p> |

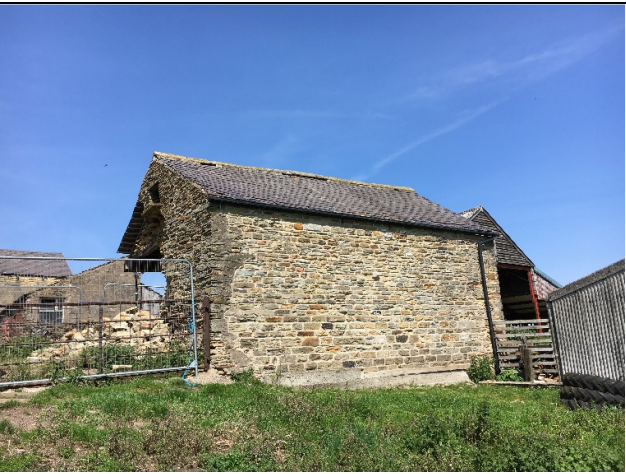
| Location | Description |
|---|---|
| | <p>The elevation to the field is in relatively good condition and if the roof is taken down carefully it could be kept.</p> |

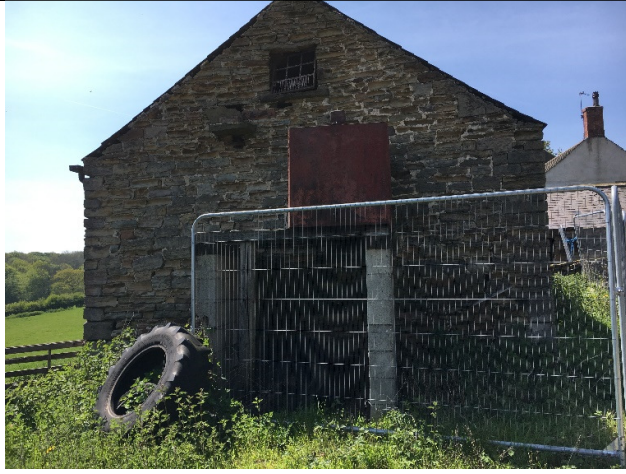
Similarly, the side elevation could remain if the roof is removed safely.

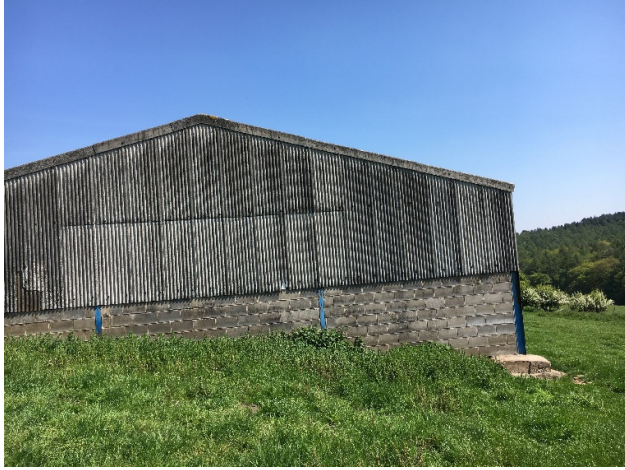
| Location | Description |
|---|---|
| | <p>The Cow Shed will have been designed as a typical agricultural building, with minimal capacity for additional loads.</p> <p>The main features of the design would be:</p> <ul style="list-style-type: none"><li>-Lightweight roof and cladding</li><li>-Minimal bracing</li><li>-Open sides to reduce wind loading</li><li>-Shallow foundations</li></ul> |

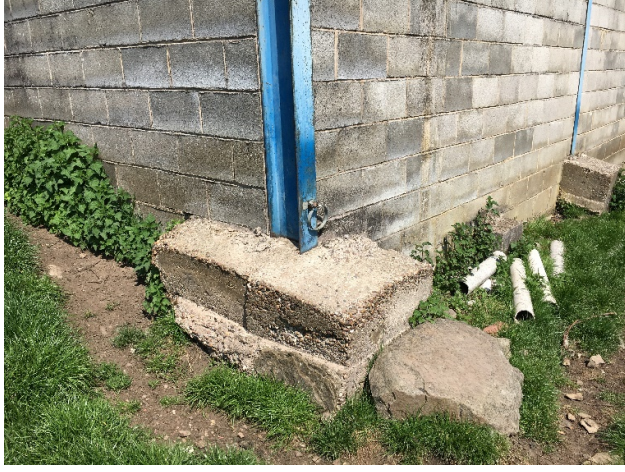
| Location | Description |
|---|---|
| | <p>The foundations appear to be cast at the existing ground level. Whilst this is okay for an agricultural building it would not be acceptable for a dwelling.</p> |

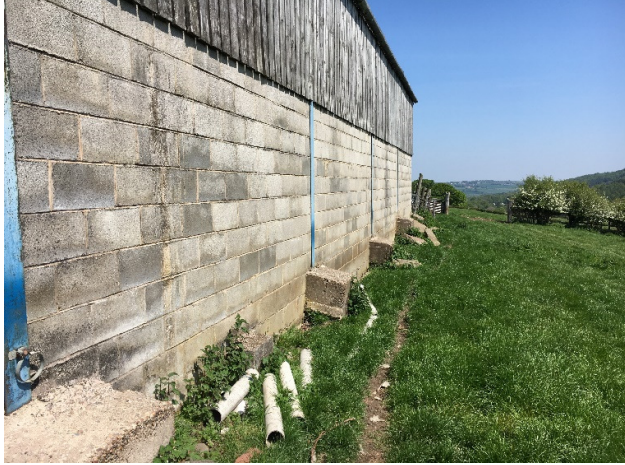
| Location | Description |
|---|---|
| | <p>The steel stanchions are cast in to the concrete. This could trap rainwater leading to decay of the steelwork.</p> |

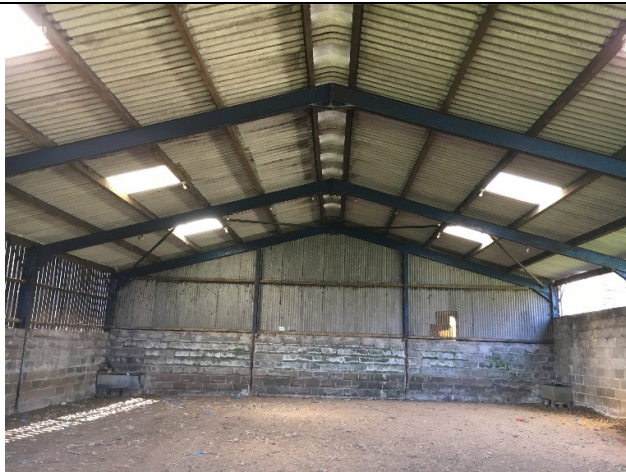
Internally the structure appears to be in a relatively good condition, but with little sign of any maintenance.

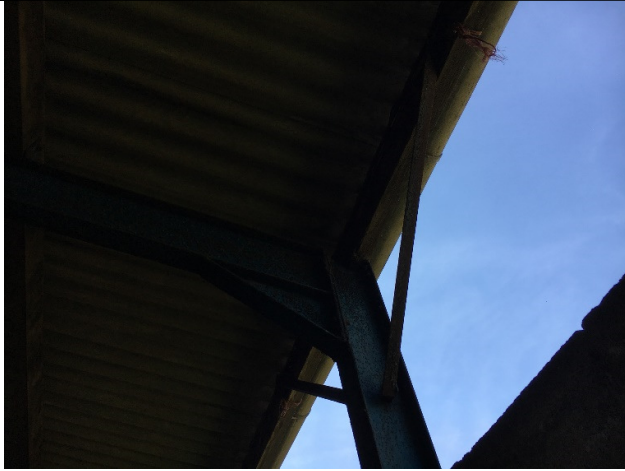
The side bracing connects the steel stanchion to a timber purlin. This would not be permitted under current regulations.

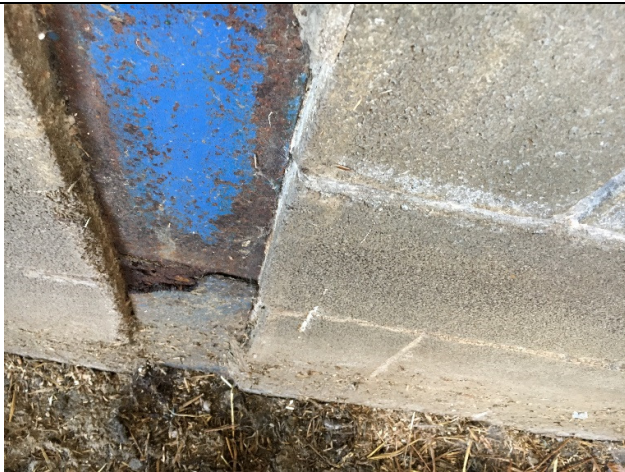
There are signs of deterioration to the stanchions.
