# DRAINAGE INVESTIGATION REPORT

CLIENT Eastwood & Partners

SITE OAK CLOSE, HOYLAND

DATE 26/05/2010 JOB No. 3499

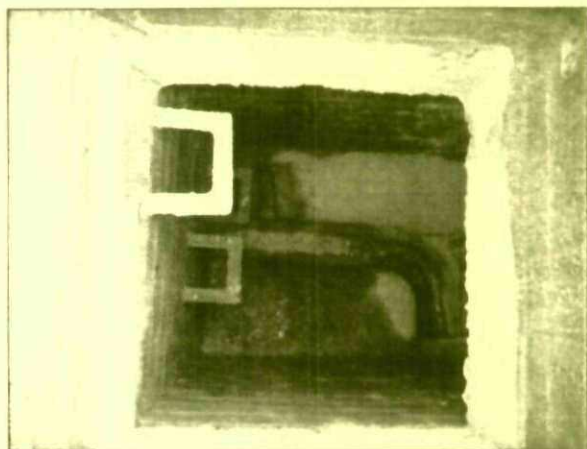
Title: GP1

Description: EDS1

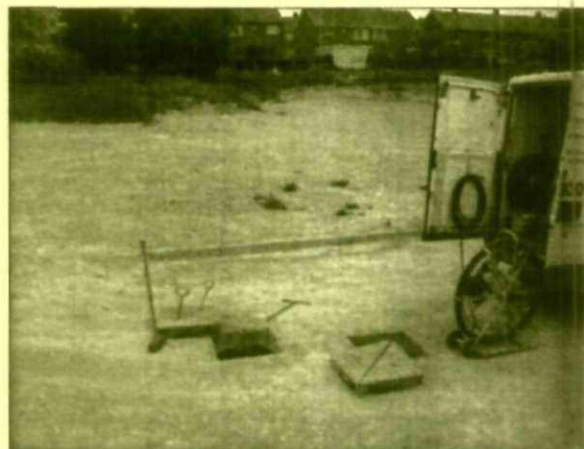
Title: GP2

Description: EDS1 - LOCATION

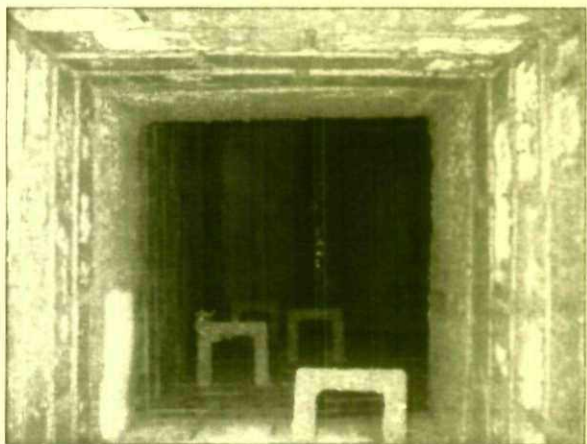
Title: GP3

Description: EDS2

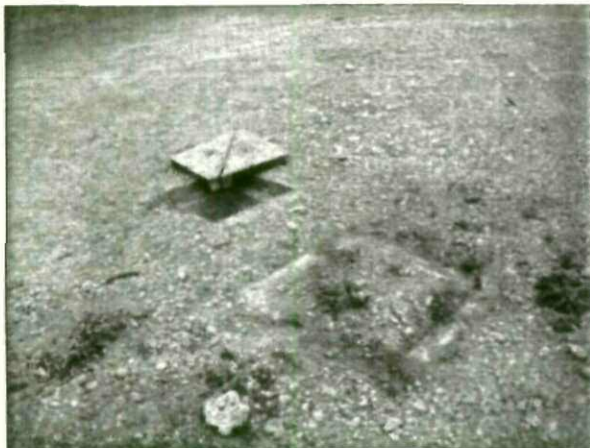
Title: GP5

Description: BURIED SURFACE WATER  
MANHOLE ADJ. TO EDS3

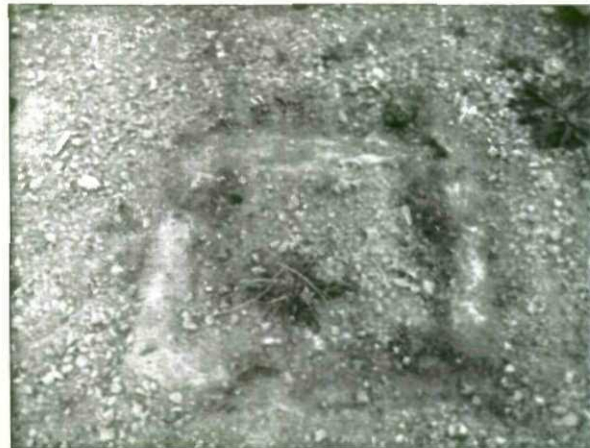
Title: GP6

Description: BURIED SURFACE WATER  
MANHOLE ADJ. TO EDS3

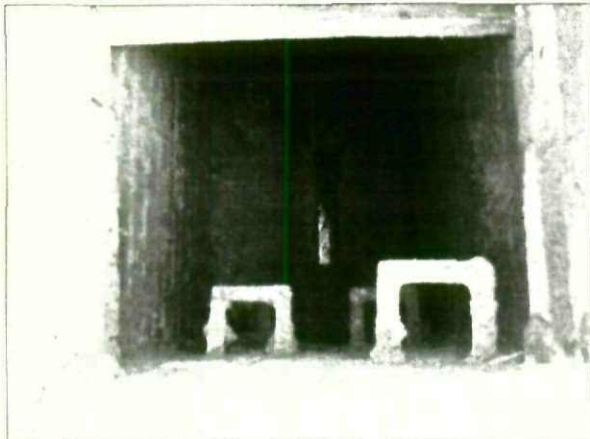
Title: GP7

Description: EDS3

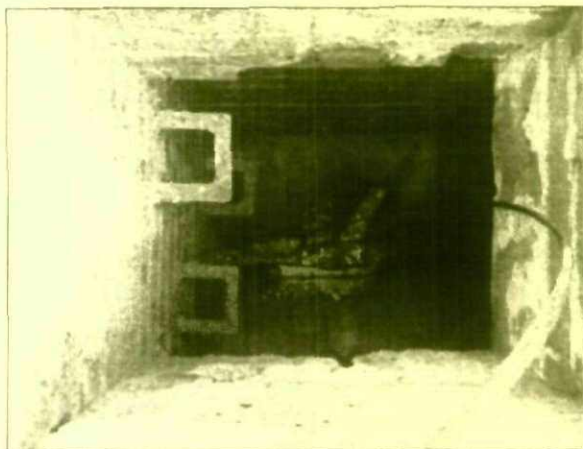
Title: GP9

Description: EDS4

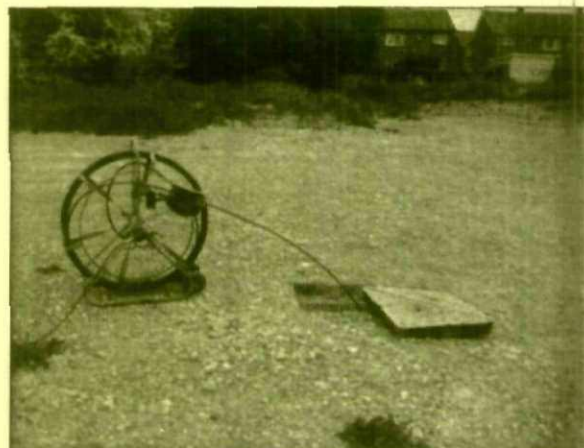
Title: GP10

Description: EDS4 - LOCATION

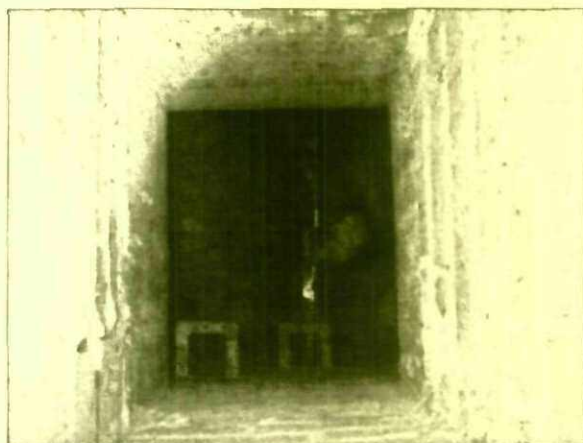
Title: GP11

Description: EDS5

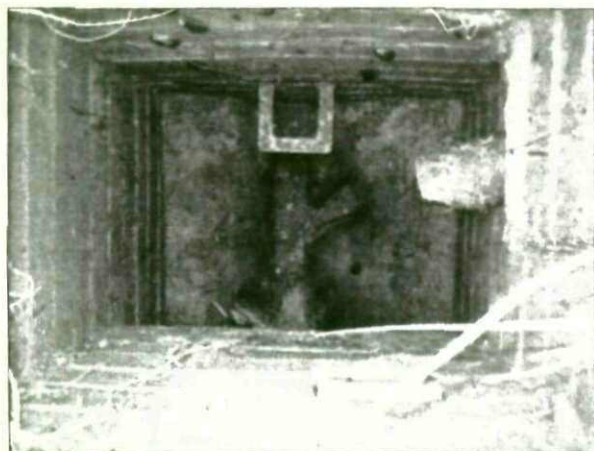
Title: GP13

Description: EDS6

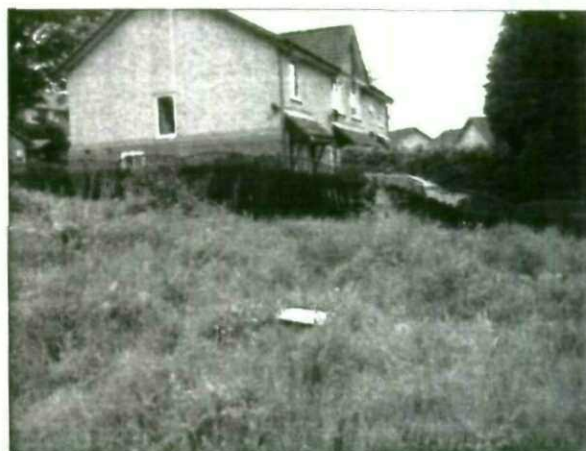
Title: GP14

Description: EDS6 - LOCATION

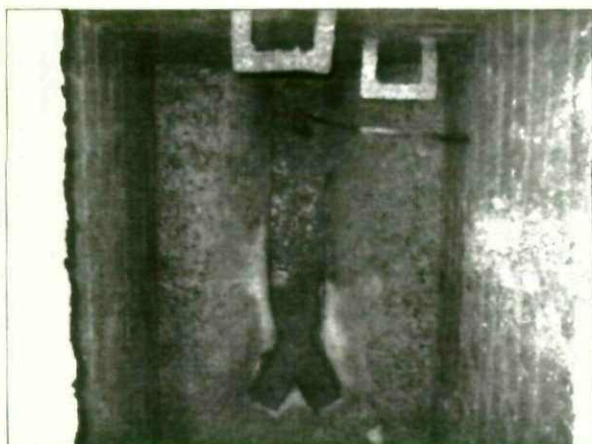
Title: GP15

Description: EDS7

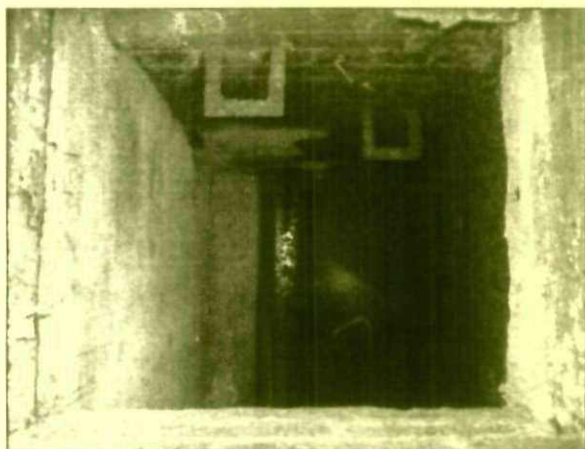
Title: GP17

Description: EDS11

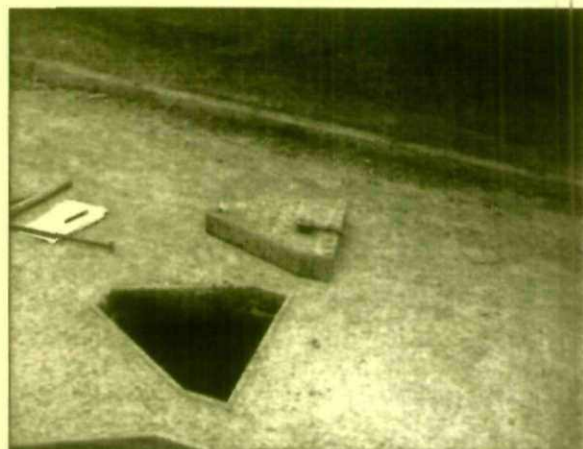
Title: GP18

Description: EDS11 - LOCATION

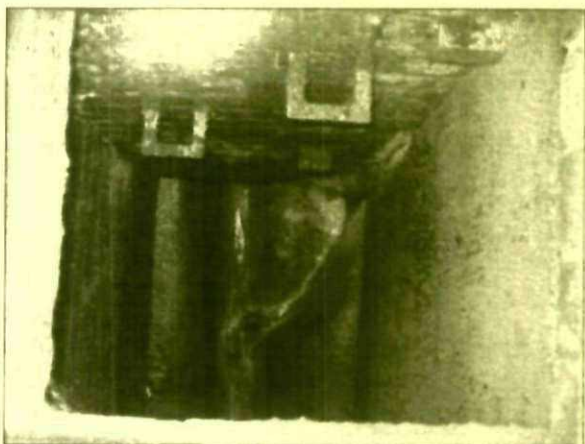
Title: GP19

Description: EDS12

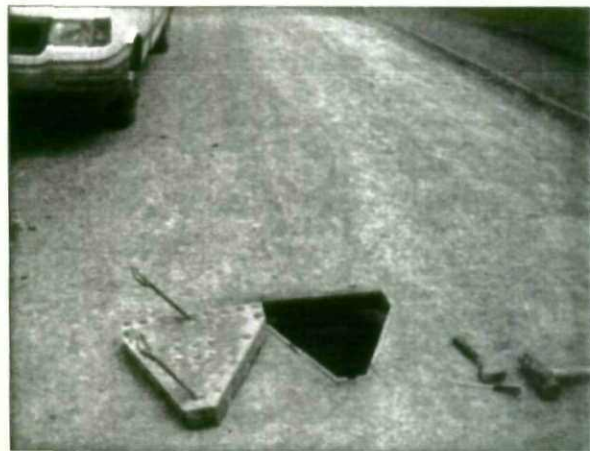
Title: GP22

Description: EDS13 - LOCATION

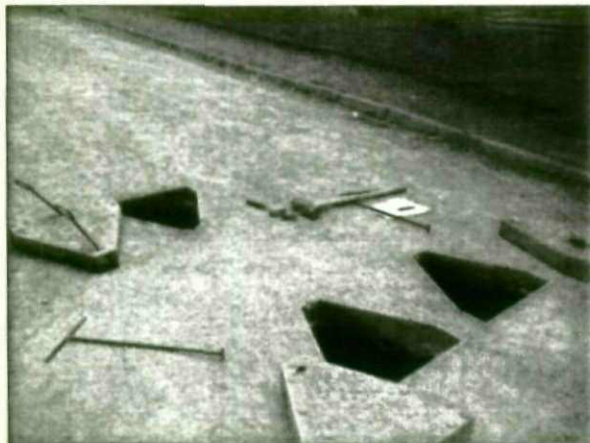
Title: GP23

Description: EDS11.EDS12 & EDS13 - LOCATION

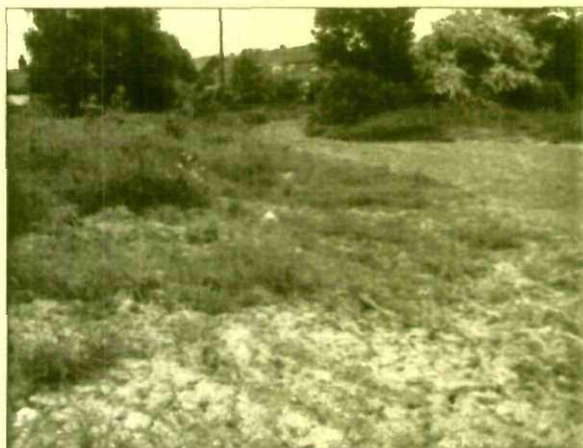
Title: GP25

Description: AREA OF BURIED PUBLIC  
MANHOLE - TRACED POINT

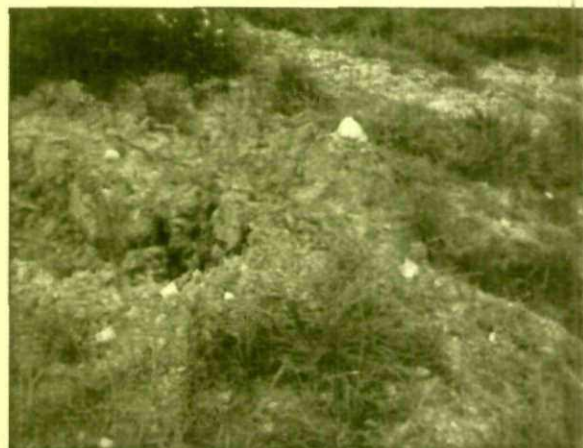
Title: GP26

Description: AREA OF BURIED PUBLIC  
MANHOLE - TRACED POINT

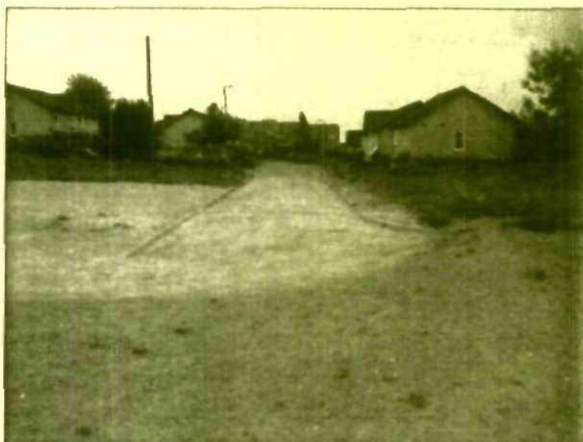
Title: GP27

Description: GENERAL SITE VIEW - LOOKING  
ONTO OAKS CLOSE

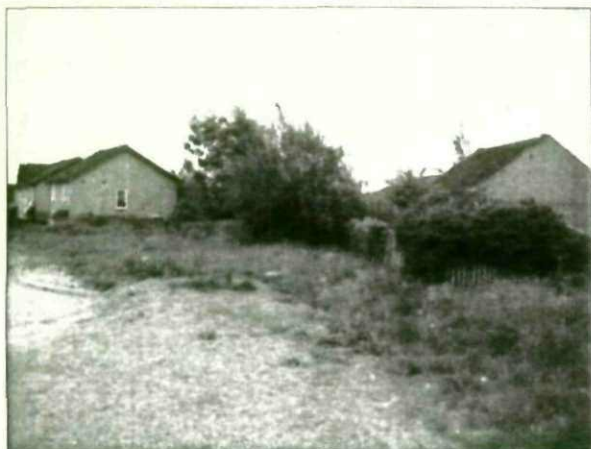
Title: GP29

Description: GENERAL SITE VIEW
