10th February 2015

Ref: AWA13:14

Arboricultural Report

TOLSON COURT, HUDDERSFIELD ROAD, PENISTONE

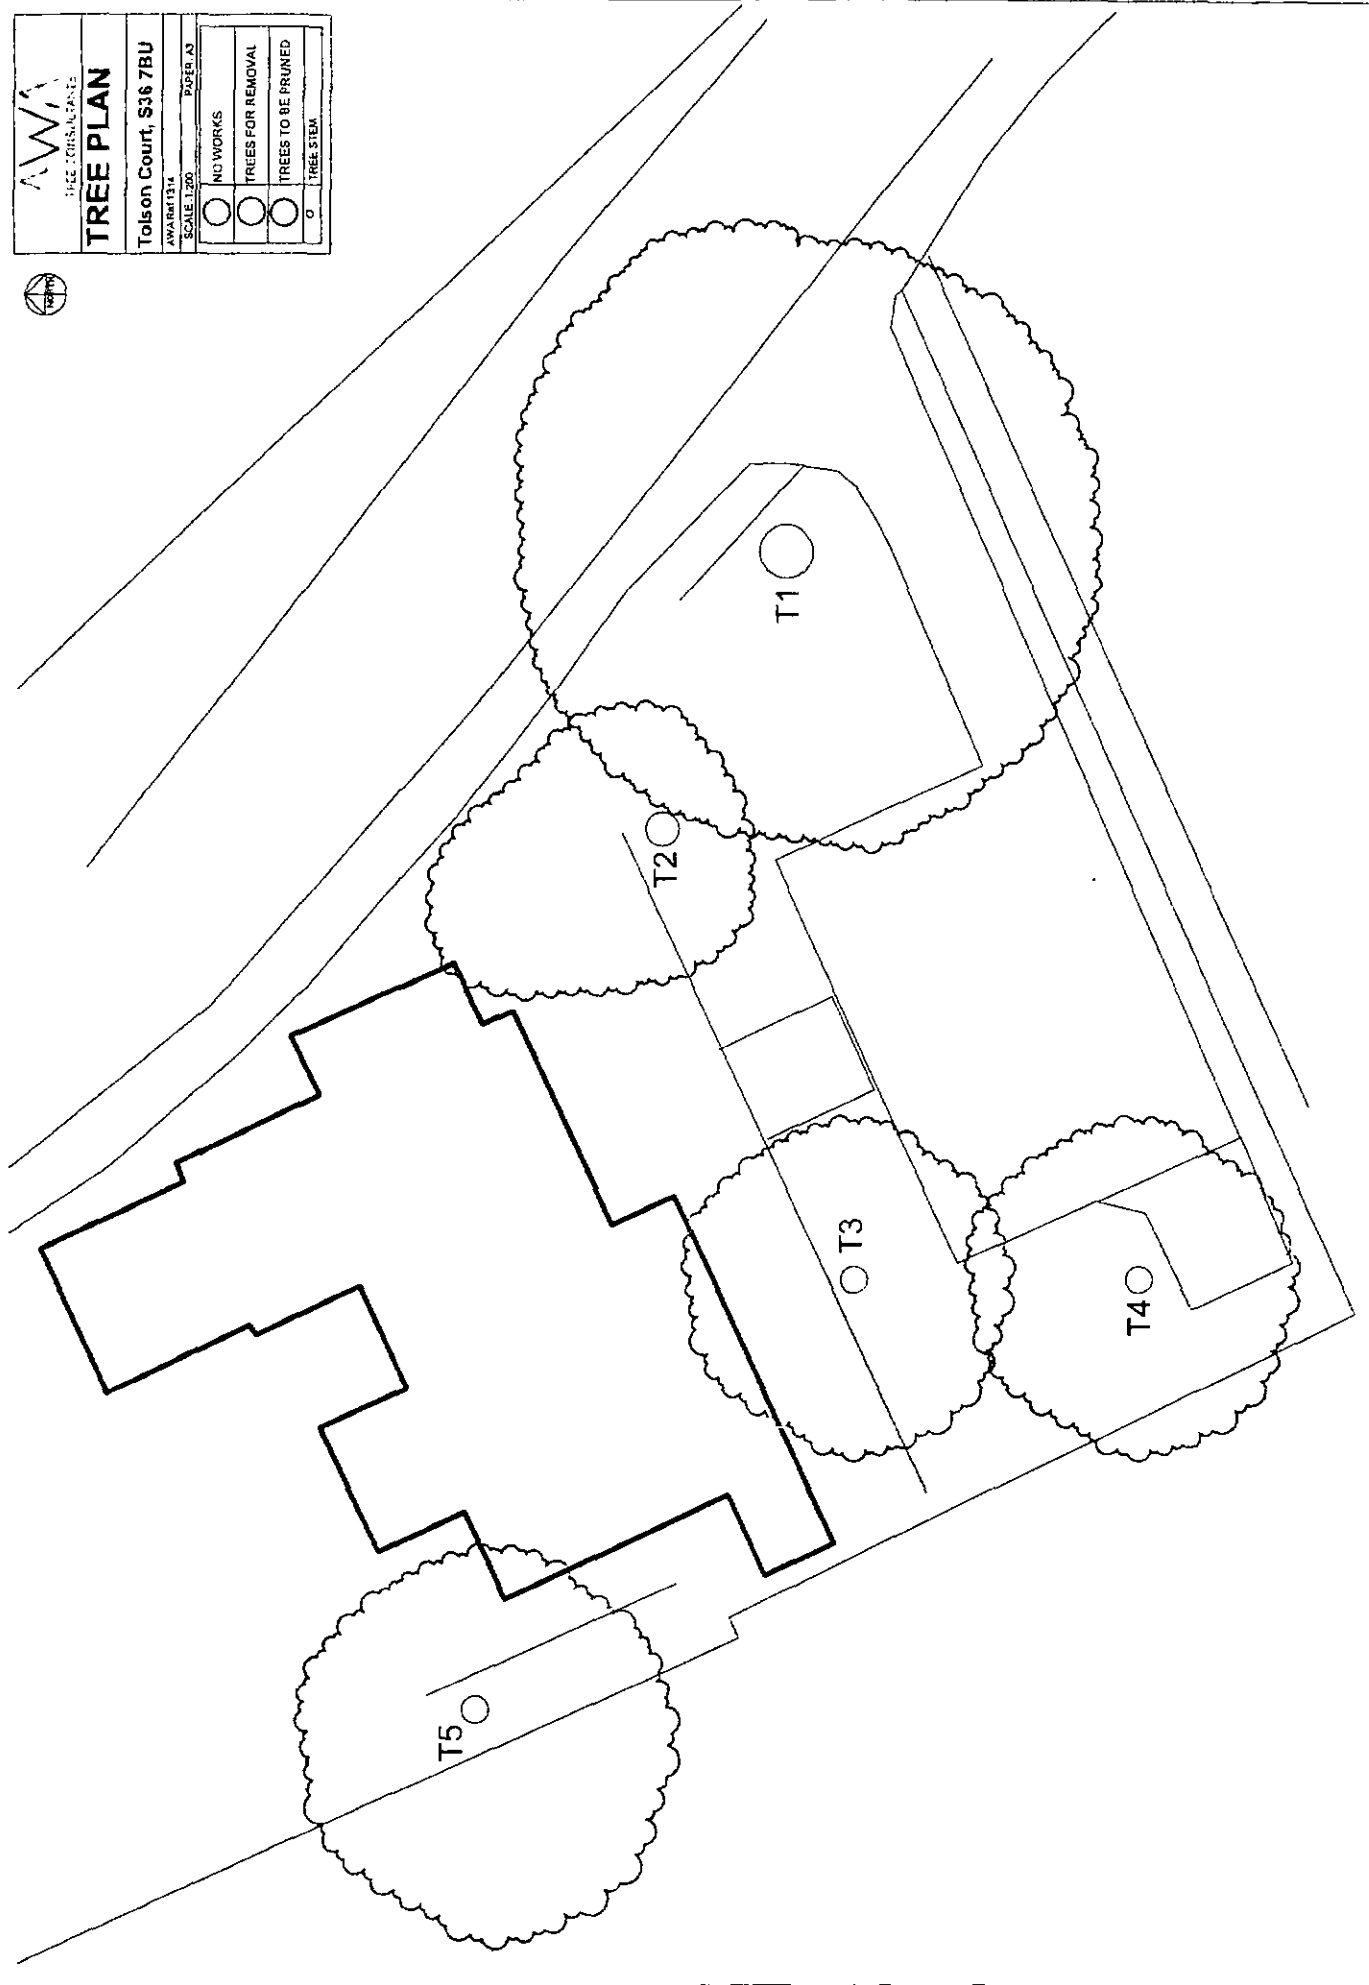
TREE PLAN

Five trees were inspected. The Beech tree T1 and the Ash tree T2 have structural defects and can be retained more safely with crown pruning works.
