Oak Tree Development  
Wath Road, Elsecar  
Project Address

Sheet Name: Ambulance Store Schedule

Drawing No: H4005-BOW-ZZ-ZZ-ZZ-A-0006

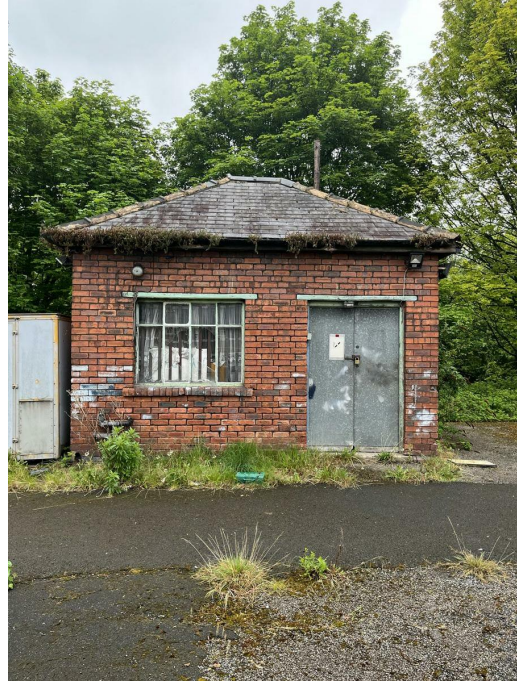
1) Front elevation - Existing

Description: Double skin brickwork with external red brick face. Mortar appears to be a Pulverised Fuel Ash (PFA) based mix.

Condition: Overall satisfactory, discolouration with age and minor cracking. Some sections of brick(s) absent with damage occurred due to alterations such as the sill &/or general wear and tear. Mortar condition is weathered extensively in areas with a large number of open joints especially to front elevation.

-Brickwork to be retained unless stated, such as individual bricks.  
-Brickwork to be cleaned, including extensive graffiti removal, and joint brushed to remove debris and review condition.  
-Mortar to be carefully raked out by hand and repointed with a lime mortar, allow for a raked or recessed joint, depth to match joint to clear brick edge shape. Colour to match existing (dark grey).

Repair / Replace brickwork: Carefully remove bricks in location indicated.

A1 Sections &/or individual brickwork to be replaced.  
A2 Gas valves to be carefully disconnected, capped and removed. Once removed, wall to rear made good.

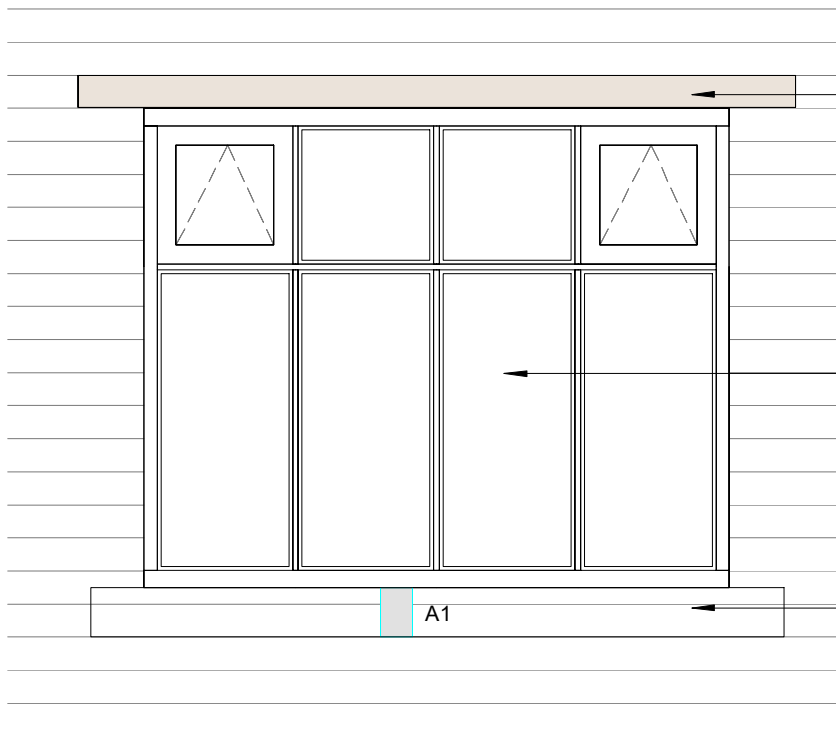
D Front elevation - Window Detail

Description: Four light timber window with slim glazing bars and single glazing panels. Opening vents removed with later glass repair. Mastic or putty seal. Frame sat on brick external sill, timber or plasterboard internal sill.

Condition: Glass smashed in a number of panels, timber deteriorated and subject to further investigations.

D1 Existing timber lintel to be repaired locally or replaced entirely subject to condition, any significant repair to be done with matching timber. Lintel prepared for decoration and then decorated with appropriate paint.  
D2 Existing window to be removed. Window to be replaced in similar arrangement to existing with painted timber double glazed unit.  
D3 Existing brick sill to be retained and brick special to be replaced to match the existing.

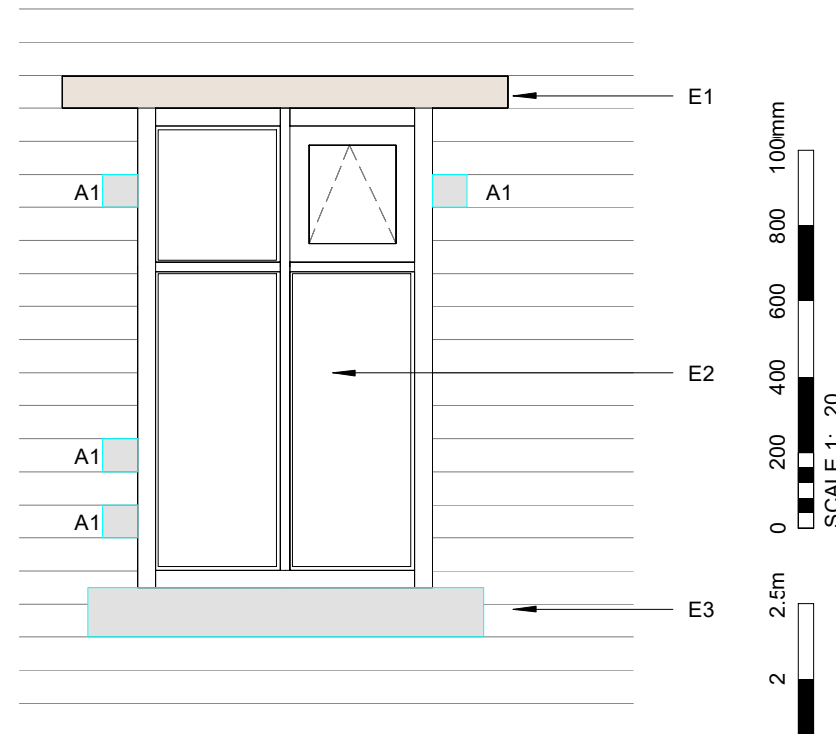
E Side elevation A - Infill Detail

Description: Brick infill to former opening, probably a window, filled to face rather than recess

Condition: Poorly layed and surrounding brickwork adjusted to suit. Possibly not using brick dimensions to match.

E1 Existing timber lintel to be repaired locally or replaced entirely subject to condition, any significant repair to be done with matching timber. Lintel prepared for decoration and then decorated with appropriate paint.  
E2 Existing red brick infill to be carefully removed, surrounding brickwork to be retained and considered during removal. New window to replace infill to match Note D-2.  
E3 Former brick sill previously removed and replaced with new brickwork to be reinstated with brick to match existing. Profile to be solder coarse with radius profile.
