Project Name: High Street Royston D39325
Project Description: CCTV Survey
Project Number: D39325
Project Status: Complete
Project Date: 13/03/2026
Inspection Standard: MSCC5 Sewers & Drainage GB (SRM5 Scoring)

Section Inspection - 01/12/2025 - MH1X

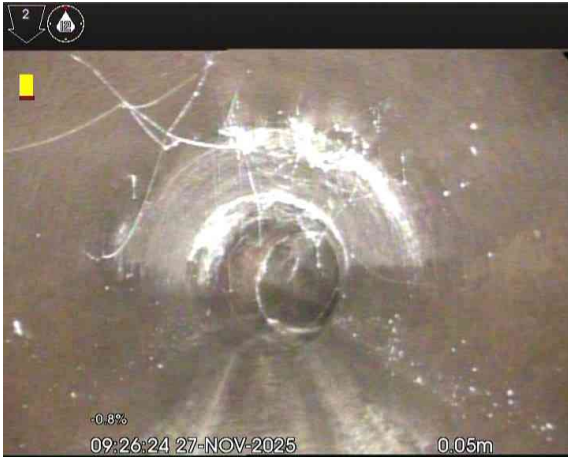
<table><tr> <td style="text-align: right;">0.00</td> <td style="width: 5%;">MH</td> <td>Start node, manhole, reference: MH1</td> <td style="text-align: right;">00:00:00</td> <td></td> <td></td> <td></td> </tr><tr> <td style="text-align: right;">0.05</td> <td>S01</td> <td>DEG Attached deposits, grease from 5 o'clock to 7 o'clock, 5% cross-sectional area loss, start</td> <td style="text-align: right;">00:00:07</td> <td>MH1X_1ef 76ac6-41e 7-4ec6-ae</td> <td></td> <td></td> </tr></table>

MH1X_1ef76ac6-41e7-4ec6-aeab-63b885e3d126_20260313_110729_063.jpg, 00:00:07, 0.05 m
Attached deposits, grease from 5 o'clock to 7 o'clock, 5% cross-sectional area loss, start

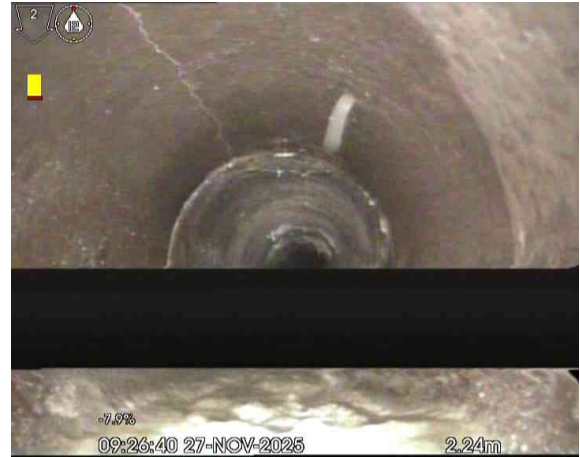
<table><tr> <td style="text-align: right;">0.00</td> <td style="width: 5%;">MH</td> <td>Start node, manhole, reference: MH1</td> <td style="text-align: right;">00:00:00</td> <td></td> <td></td> <td></td> </tr><tr> <td style="text-align: right;">2.24</td> <td>DEG</td> <td>Attached deposits, grease from 4 o'clock to 8 o'clock, 10% cross-sectional area loss</td> <td style="text-align: right;">00:00:23</td> <td>MH1X_52 e127da-39 93-4244-b</td> <td></td> <td style="text-align: center;">3</td> </tr></table>

MH1X_52e127da-3993-4244-b0b5-3e04b4c125a6_20260313_110819_280.jpg, 00:00:23, 2.24 m
Attached deposits, grease from 4 o'clock to 8 o'clock, 10% cross-sectional area loss

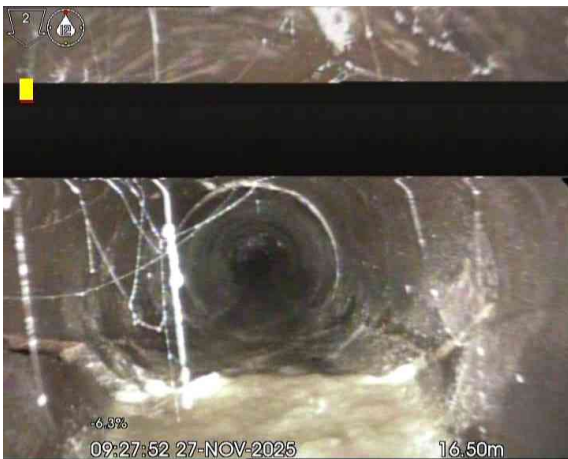
<table><tr> <td style="text-align: right;">0.00</td> <td style="width: 5%;">MH</td> <td>Start node, manhole, reference: MH1</td> <td style="text-align: right;">00:00:00</td> <td></td> <td></td> <td></td> </tr><tr> <td style="text-align: right;">16.50</td> <td>DEG</td> <td>Attached deposits, grease from 4 o'clock to 8 o'clock, 10% cross-sectional area loss</td> <td style="text-align: right;">00:01:35</td> <td>MH1X_c5e 72bca-ab1 e-47e4-b2</td> <td></td> <td style="text-align: center;">3</td> </tr></table>

MH1X_c5e72bca-ab1e-47e4-b2b0-fdf1b0bdf871_20260313_10916_248.jpg, 00:01:35, 16.50 m
Attached deposits, grease from 4 o'clock to 8 o'clock, 10% cross-sectional area loss

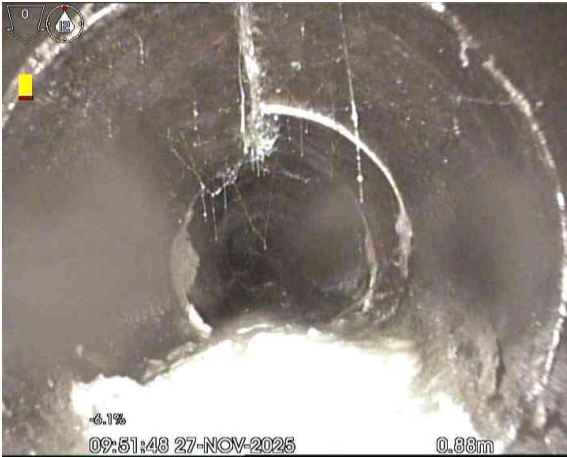
MH2X_818ccc4f-4d18-4b40-a918-19a349e1c481_20260313_111212_214.jpg, 00:00:12, 0.88 m
Attached deposits, grease from 4 o'clock to 8 o'clock, 10% cross-sectional area loss

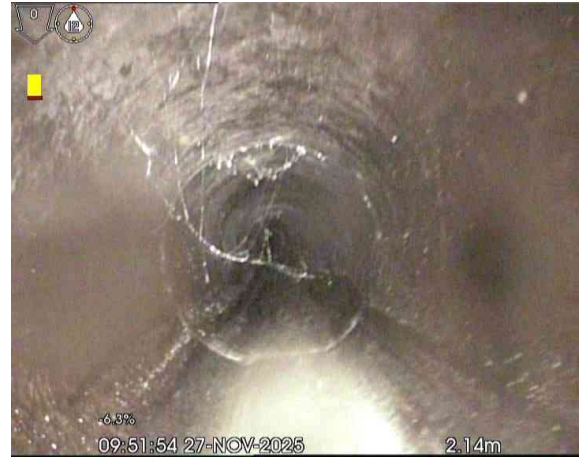
MH2X_5fe242ca-51cd-474f-ba45-63dcfa0048c7_20260313_11228_184.jpg, 00:00:18, 2.14 m
Attached deposits, grease from 5 o'clock to 7 o'clock, 5% cross-sectional area loss, start

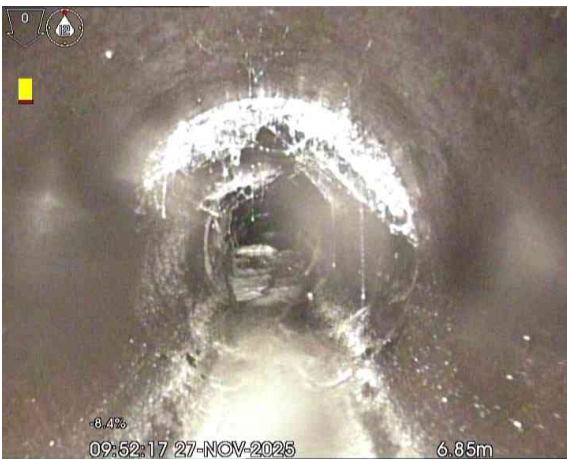
MH2X_2cd86d5a-0bc1-4e9f-bfdd-121cd456e43b_20260313_111249_014.jpg, 00:00:40, 6.85 m
Roots, mass at joint, 10% cross-sectional area loss

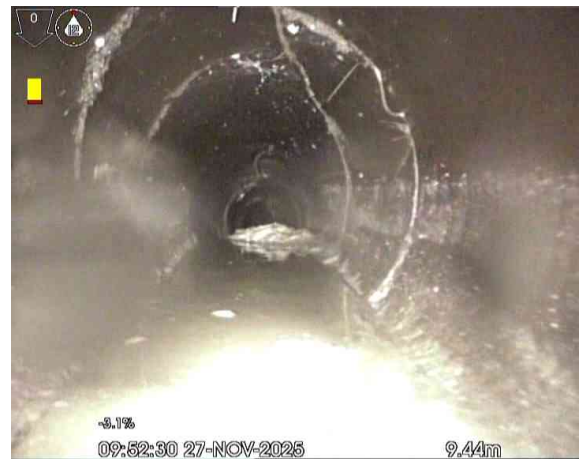
MH2X_0a784509-5fd1-46b5-a05f-f4a0b1826d82_20260313_11325_191.jpg, 00:00:54, 9.44 m
Fracture, circumferential from 1 o'clock to 10 o'clock

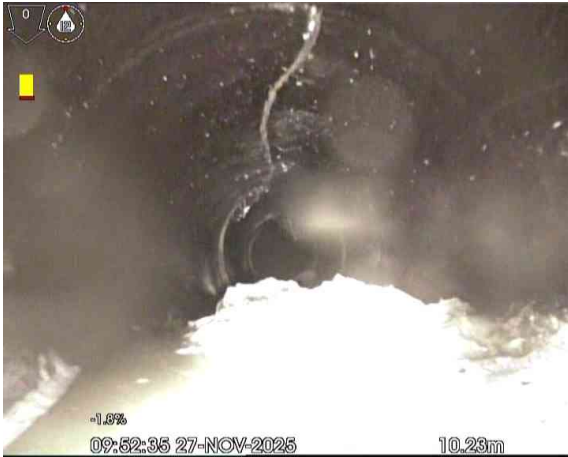
MH2X_2427d6f1-13ad-4109-b593-68367503c7bf_20260313_111343_072.jpg, 00:00:58, 10.23 m
Attached deposits, fouling from 4 o'clock to 8 o'clock, 30% cross-sectional area loss

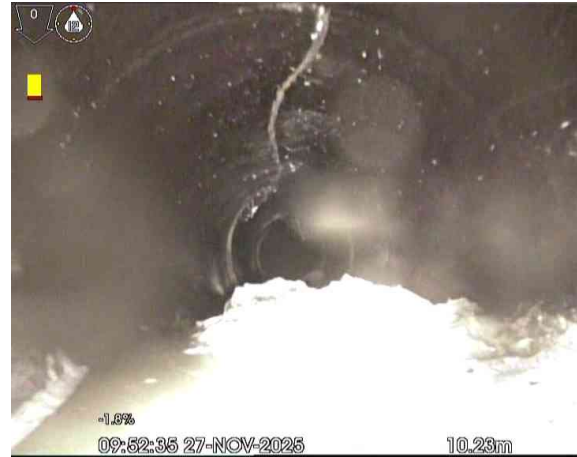
MH2X_b1274143-8e96-4b84-9351-5c0bf6a2b666_20260313_111354_664.jpg, 00:00:58, 10.23 m
Fracture, longitudinal at 11 o'clock

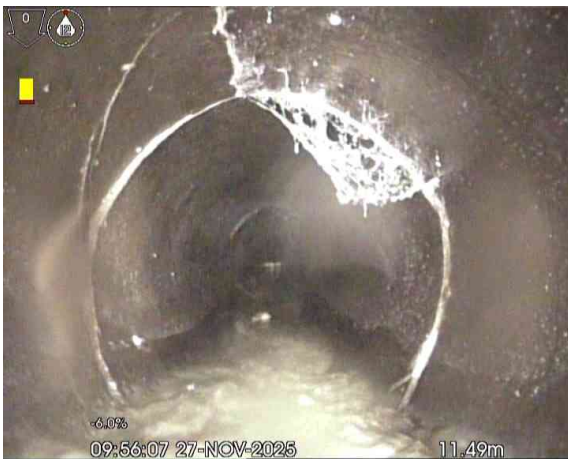
MH2X_3bcb78c7-9466-4ae2-86ac-98095ff7e9eb_20260313_111527_995.jpg, 00:04:30, 11.49 m
Fracture, circumferential from 7 o'clock to 5 o'clock

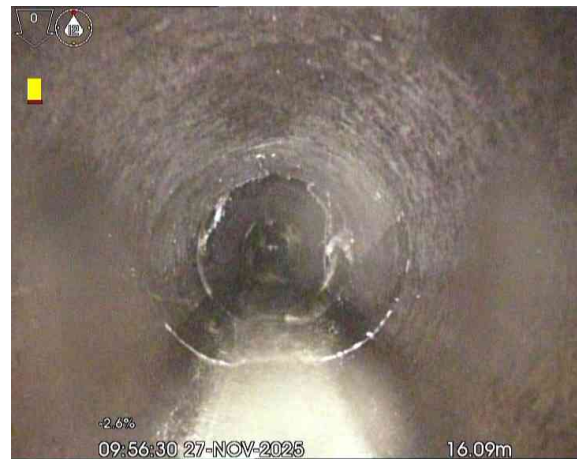
MH2X_192a24cd-58bd-432e-b754-3e98566dda8c_20260313_112316_114.jpg, 00:04:53, 16.09 m
Fracture, circumferential from 3 o'clock to 7 o'clock

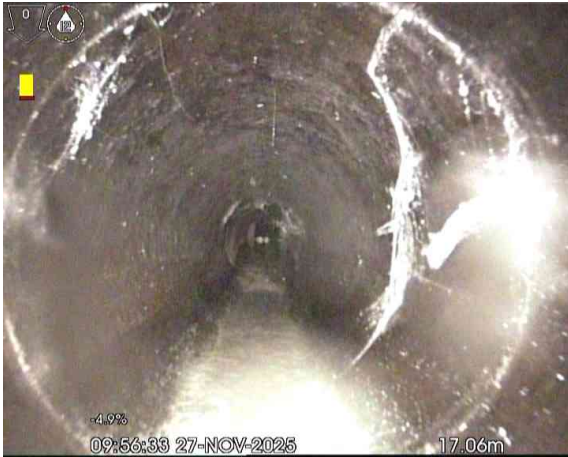
MH2X_6e421cfa-6512-4c62-974d-99e43f12887c_20260313_112330_536.jpg, 00:04:56, 17.06 m
Roots, fine at joint

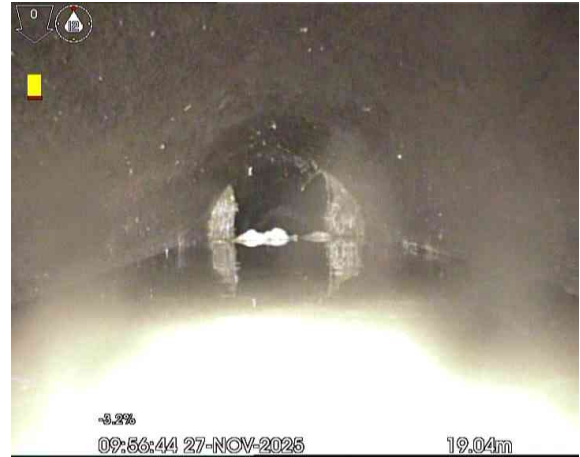
18.34	WL	Water level, 30% of the vertical dimension	00:05:04		
		19.04	RMJ	Roots, mass at joint, 30% cross-sectional area loss	00:05:08	MH2X_d9c e8218-a95 4-494d-88f	5

MH2X_d9ce8218-a954-494d-88f3-7a2f89db1e44_20260313_112415_637.jpg, 00:05:08, 19.04 m
Roots, mass at joint, 30% cross-sectional area loss

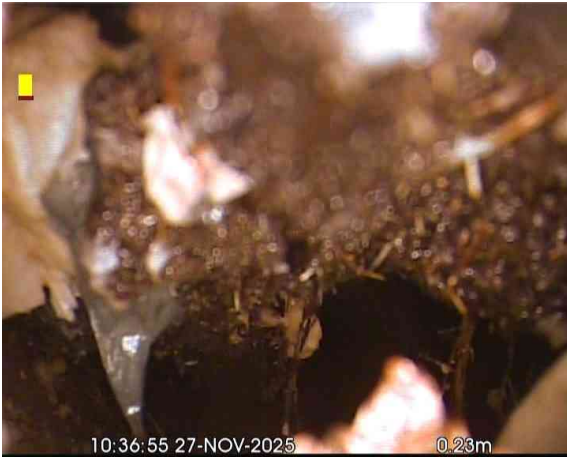
MH3X_997f848b-1e5d-4734-b350-3ab92a034d98_20260313_112930_322.jpg, 00:00:07, 0.23 m

<table><tr> <td style="text-align: right;">0.00</td> <td>MH</td> <td>Start node, manhole, reference: MH3</td> <td>00:00:00</td> <td></td> <td></td> </tr><tr> <td style="text-align: right;">0.23</td> <td>S01</td> <td>RM Roots, mass, 20% cross-sectional area loss, start</td> <td>00:00:07</td> <td>MH3X_99 7f848b-1e 5d-4734-b</td> <td></td> </tr><tr> <td style="text-align: right;">2.34</td> <td>F01</td> <td>RM Roots, mass, 20% cross-sectional area loss, finish</td> <td>00:00:14</td> <td></td> <td>5</td> </tr></table>

Roots, mass, 20% cross-sectional area loss, start

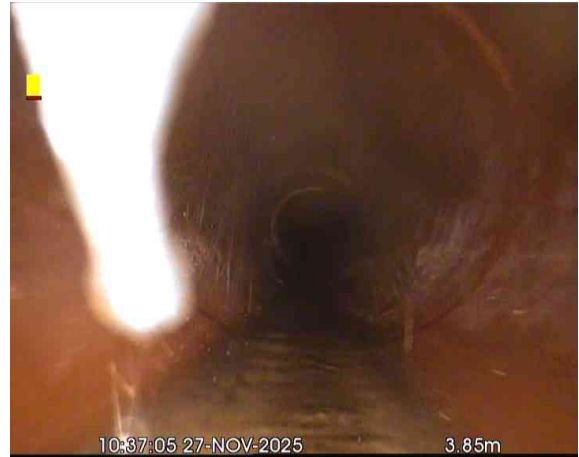
MH3X_d6fc7cb8-51b5-4d4c-8c74-65c1ccf00065_20260313_13004_240.jpg, 00:00:16, 3.85 m

<table><tr> <td style="text-align: right;">0.00</td> <td>MH</td> <td>Start node, manhole, reference: MH3</td> <td>00:00:00</td> <td></td> <td></td> </tr><tr> <td style="text-align: right;">3.85</td> <td>S02</td> <td>DEG Attached deposits, grease from 5 o'clock to 7 o'clock, 5% cross-sectional area loss, start</td> <td>00:00:16</td> <td>MH3X_d6f c7cb8-51b 5-4d4c-8c</td> <td></td> </tr></table>

Attached deposits, grease from 5 o'clock to 7 o'clock, 5% cross-sectional area loss, start

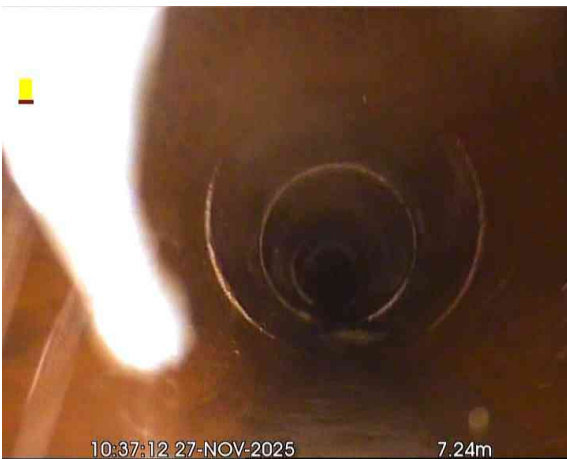
MH3X_3a311c70-7328-4fe9-a986-f99fe5a1b1a1_20260313_13040_118.jpg, 00:00:24, 7.24 m

<table><tr> <td style="text-align: right;">0.00</td> <td>MH</td> <td>Start node, manhole, reference: MH3</td> <td>00:00:00</td> <td></td> <td></td> </tr><tr> <td style="text-align: right;">7.24</td> <td>FC</td> <td>Fracture, circumferential from 3 o'clock to 9 o'clock</td> <td>00:00:24</td> <td>MH3X_3a 311c70-73 28-4fe9-a9</td> <td>3 / 2</td> </tr></table>

Fracture, circumferential from 3 o'clock to 9 o'clock
