ARBORICULTURAL REPORT RELATING TO PROPOSED DEVELOPMENT  
ON LAND ADJACENT TO SILKSTONE SEWAGE WORKS, SILKSTONE.

| Part 1 | Tree Survey | DATE COMPLETED | 10 <sup>th</sup> May 2011 |
| Part 2 | Implication Assessment | DATE COMPLETED | 7 <sup>th</sup> October 2011 |
| AUTHOR | Ian Barnes | OUR REF. | BA3262.2 |

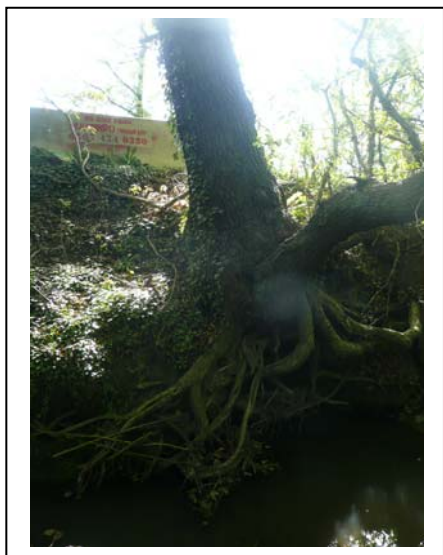
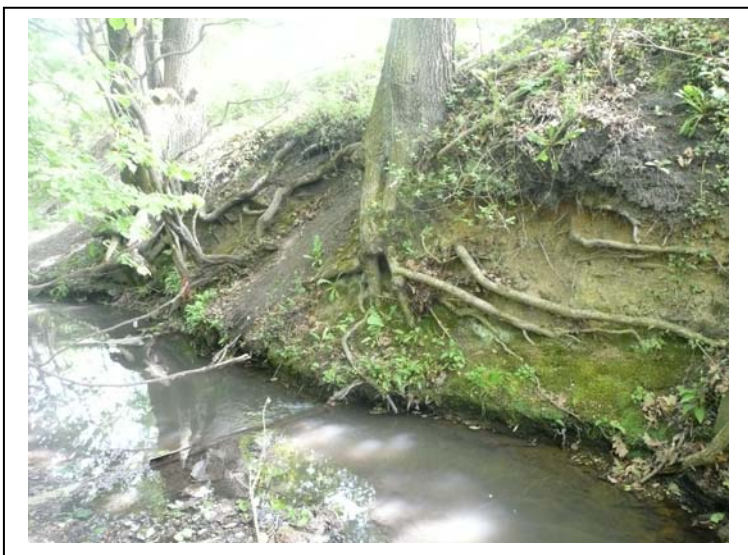
**Photograph 1** – Typical examples of the erosion seen on the southern bank, below the line of mature trees.

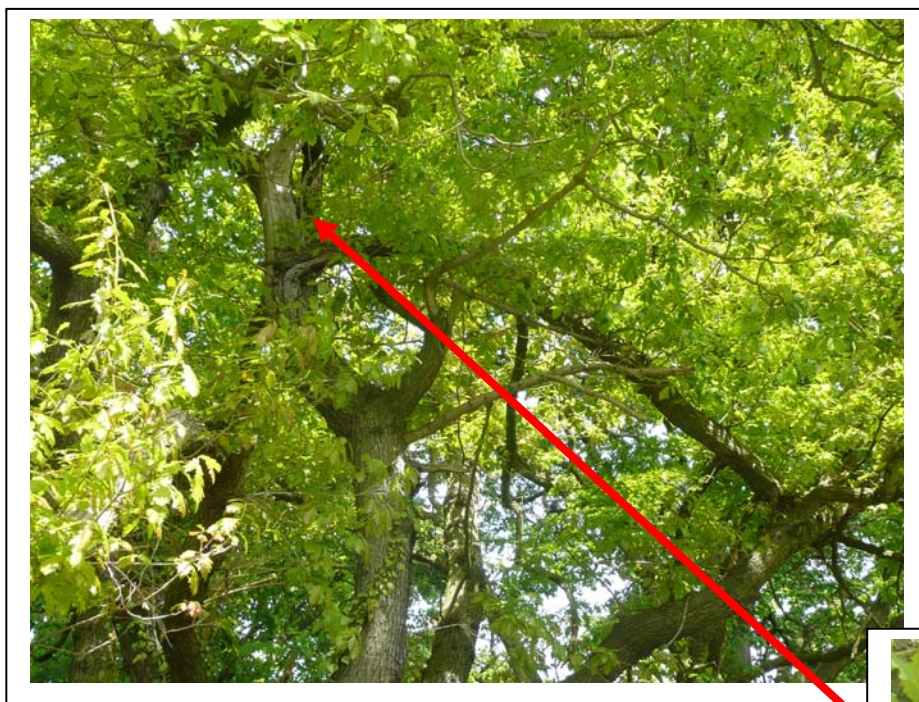
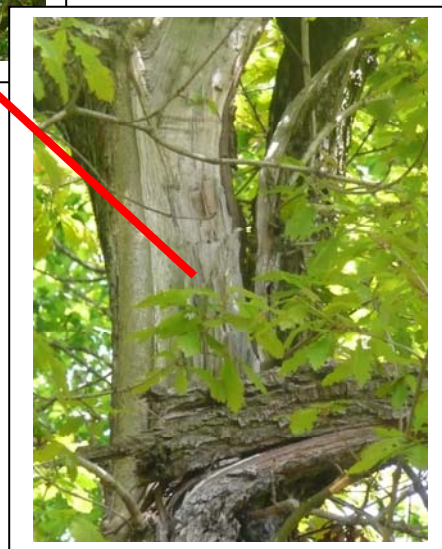
- 21.2. Several of the large Oaks have suffered localised branch failures in particular T2 shown in the photograph 2 in Appendix 3 which has a large hanging limb which poses a risk to site users.

- 21.3. A number of the trees have been affected by historical excavations, in particular T2, which has localised root damage associated with the installation of the brick surrounded drainage outfall.

**Photograph 2** – The historically failed limb in the canopy of Oak T2 - located above the access Track.

| TAG No. | Species | Age | Height | Canopy Height | North Canopy | South Canopy | East Canopy | West Canopy | Vitality | Safe Life | Category | Diameter @ 1.5m (mm) | Observations / Comments | Recommendations | Minimum RPA (Radius) (m) | Minimum RPA (Area) (m <sup>2</sup> ) |
|---|---|---|---|---|---|---|---|---|---|---|---|---|---|---|---|---|
| 2 | Oak | M | 18 | 3 | 8 | 7 | 7 | 7 | Good | 20-40 | C2 | 750 | Single stem with a slight lean with trunk shooting.<br>Growing next to hard landscaping.<br>Soil level has been reduced by recent excavation.<br>Erosion can be seen below the buttress on the riverside.<br>Ivy has started to develop on the main stem.<br>Significant quantities of deadwood can be seen within the canopy.<br>Branch failures are visible within the canopy.<br>Loose branches are visible above the road.<br>Crossing and rubbing branches are visible throughout the canopy.<br>Good habitat potential. | Treat Ivy to prevent further growth.<br><br>Crown clean conservation only. | 9 | 254.5 |

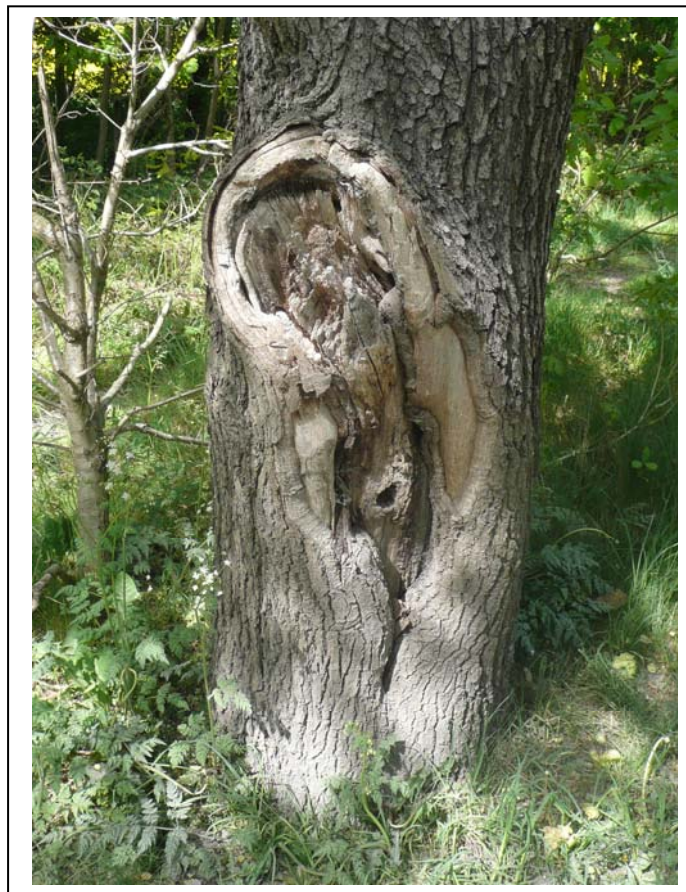
**Photograph 3** – Impact damage on the lower stem of T9, which shows a lack of buttress formation.

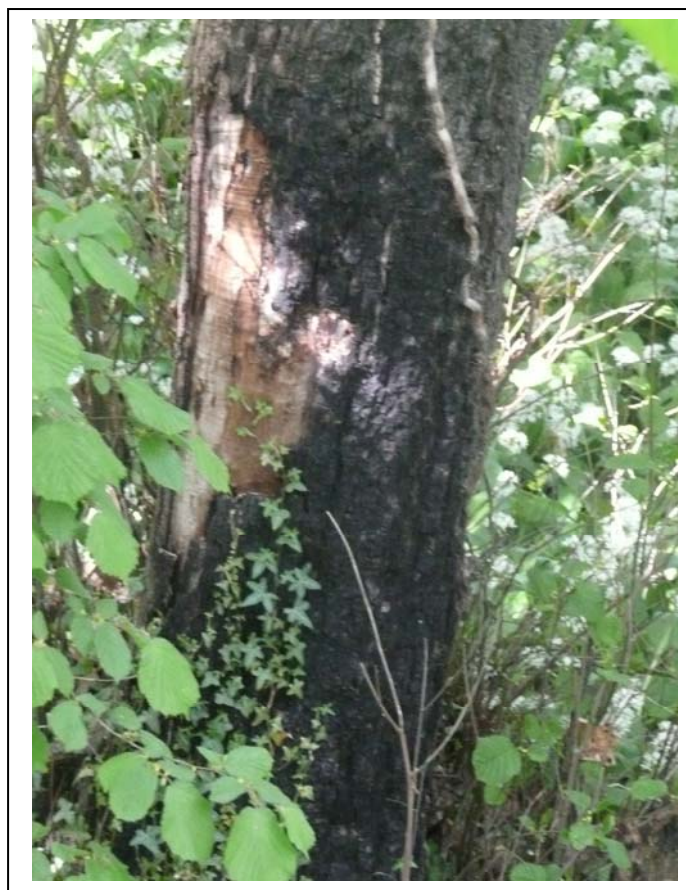
- 21.5. The Alder T11 is located on the opposite side of the water course, this tree has suffered from historical fire damage shown in the photograph 4 in Appendix 3. This tree can be expected to fail in the near future; ideally, this tree should ideally should be removed in the near future.

| TAG No. | Species | Age | Height | Canopy Height | North Canopy | South Canopy | East Canopy | West Canopy | Vitality | Safe Life | Category | Diameter @ 1.5m (mm) | Observations / Comments | Recommendations | Minimum RPA (Radius) (m) | Minimum RPA (Area) (m <sup>2</sup> ) |
|---|---|---|---|---|---|---|---|---|---|---|---|---|---|---|---|---|
| 11 | Alder | M | 18 | 2 | 4 | 4 | 9 | 4 | Declining | <5 | R | 400 | <p>Single stem with a significant lean. Significant structural defect is visible. Large cavity is visible within the main stem. Recent fire damage to the stem. Retention not thought to be sustainable.</p> | <p>Remove and treat stump to prevent regrowth.</p> <p>High Priority for Safety.</p> | 4.8 | 72.4 |

**Photograph 4** – Fire Damaged stem of the poor condition Alder T11.

23. **Conclusions.** The majority of trees do not represent an abnormal risk to site users.
- 23.1. Although the condition of The Alder T11 and the number of loose branches and deadwood located above the access track should be made safe, as soon as possible.
