**PROPERTY ADDRESS:** 25 & 27 Millhouses Street, Hoyland, Barnsley S74 9BQ

**REPORT TYPE:** Asbestos Refurbishment/Demolition Survey

**REPORT NUMBER:** B-21809

**REPORT DATE:** 25/07/2024

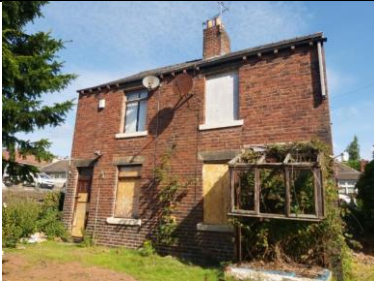
| 25 & 27 Millhouses Street, Hoyland, Barnsley S74 9BQ | | | | |
|---|---|---|---|---|
| External | R001 | External - Windows | Windows / Mastic (S001 - No Asbestos Detected) - Putty to the windows | |

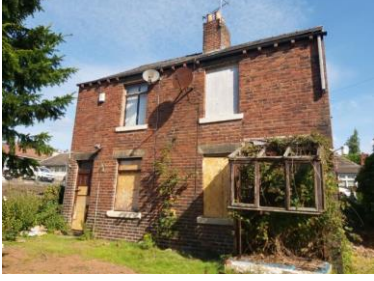
| 25 & 27 Millhouses Street, Hoyland, Barnsley S74 9BQ | | | | |
|---|---|---|---|---|
| External | R001 | External - Windows | Windows / Mastic (S002 - No Asbestos Detected) - Mastic to the window frames | |

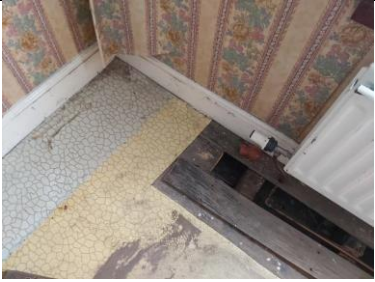
| 1st Floor | R002 | Bedroom - Floor | Floor / Vinyl Products (S003 - No Asbestos Detected) - Linoleum below the carpet | |

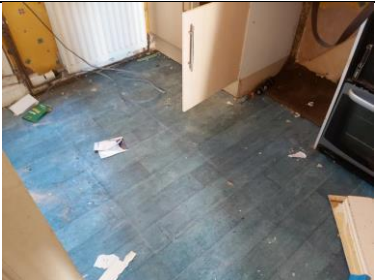
| Ground Floor | R005 | Kitchen - Floor | <p>Floor / Vinyl Products (S005 - No Asbestos Detected) - Linoleum on stone flags</p> | |

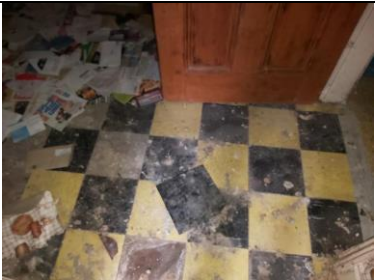
| Ground Floor | R012 | Kitchen - Floor | Floor / Vinyl Products (S006 - No Asbestos Detected) - Yellow vinyl tiles | |

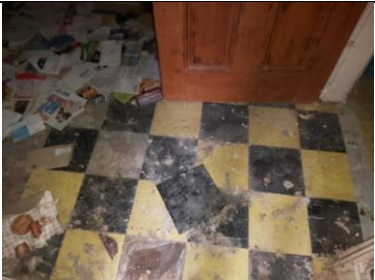
| Ground Floor | R012 | Kitchen - Floor | Floor / Vinyl Products (S007 - No Asbestos Detected) - Black vinyl tiles | |

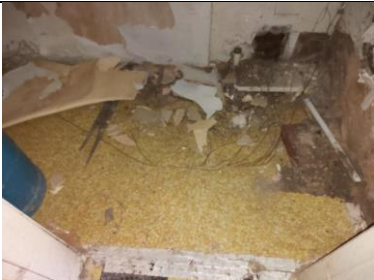
| Ground Floor | R013 | Pantry - Floor | Floor / Vinyl Products (S008 - No Asbestos Detected) - Linoleum | |

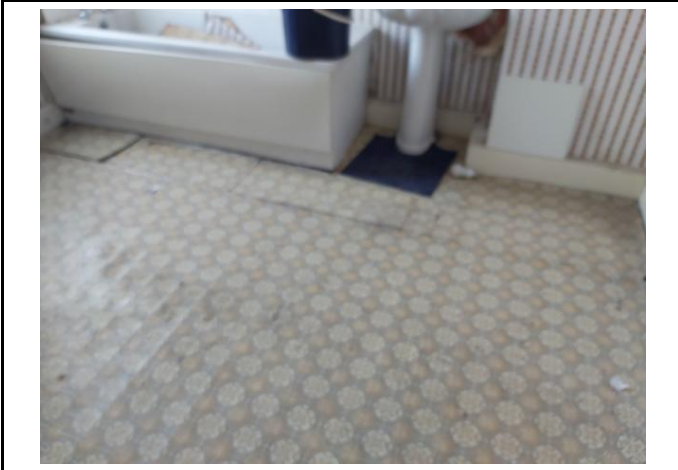
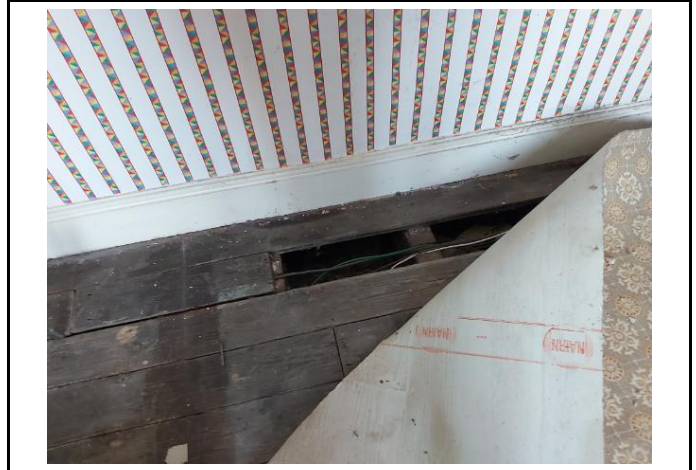
| Ref Number | 674921 |

| 25 & 27 Millhouses Street, Hoyland, Barnsley S74 9BQ | | | | | |
|---|---|---|---|---|---|
| 674921<br>S004 | 1st Floor<br>Bathroom<br>R004<br>Floor | Vinyl Products<br>12m <sup>2</sup> | Chrysotile | 5 | Remove<br>Add to asbestos register and<br>Monitor - Removal/repair works should be undertaken by a competent contractor following an appropriate risk assessment which includes adequate disposal to landfill. |

| ACM | | |
|---|---|---|
| Asbestos Type Description: | Chrysotile | Comments |

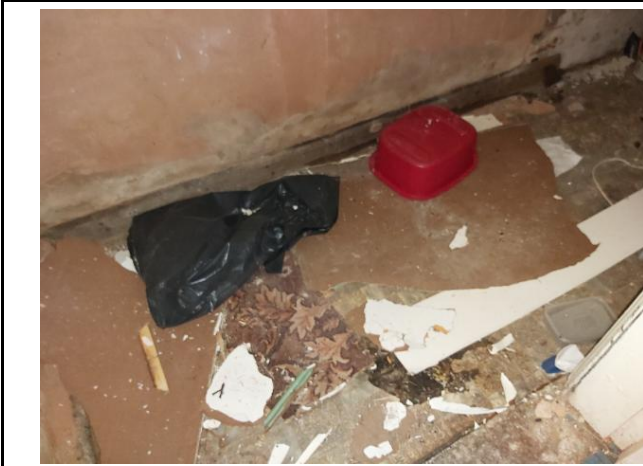
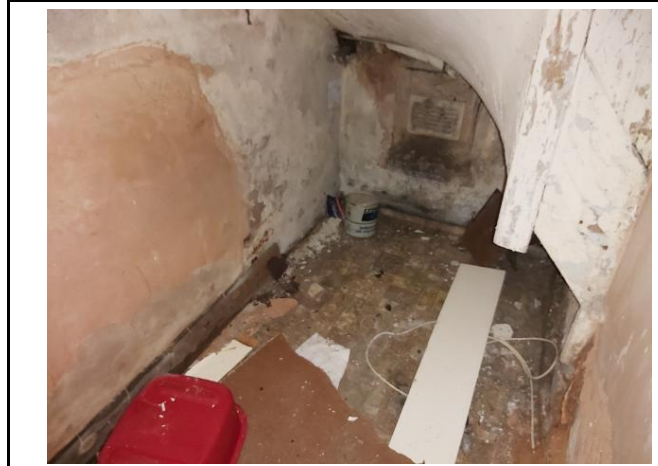
| Ref Number | 674956 |

| 25 & 27 Millhouses Street, Hoyland, Barnsley S74 9BQ | | | | | |
|---|---|---|---|---|---|
| 674956<br>As Sample<br>S004 | Ground Floor<br>Pantry<br>R006<br>Floor | Vinyl Products<br>3m <sup>2</sup> | Chrysotile | 5 | Remove<br>Add to asbestos register and<br>Monitor - Removal/repair works should be undertaken by a competent contractor following an appropriate risk assessment which includes adequate disposal to landfill. |

| ACM | | |
|---|---|---|
| Asbestos Type Description: | Chrysotile | Comments |

| ACTION | | |
|---|---|---|
| Inspection Cycle | 12 monthly | Add to asbestos register and Monitor - Removal/repair works should be undertaken by a competent contractor following an appropriate risk assessment which includes adequate disposal to landfill. |
