**INGLEFIELD FARM BARN NEW ROW LANE INGBIRCHWORTH**

**1.0 Introduction**

- 1.1 We are instructed by Mrs D Knowles care of JR Planning Consultants, 40 Northern Common, Dronfield, S18 8XJ to undertake a survey of the buildings associated with Inglefield Farm and report on the suitability for conversion to residential property.

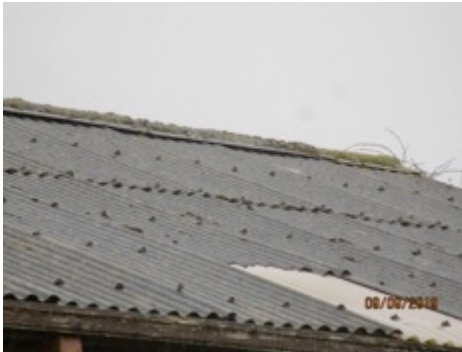
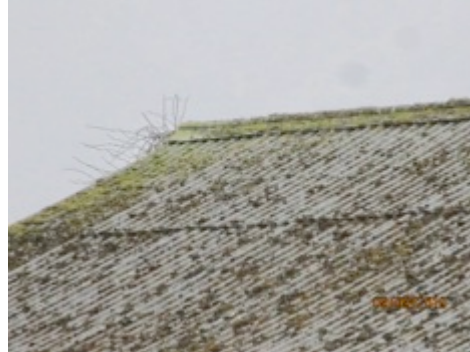
- 3.1 The roof was inspected from ground level, with the aid of binoculars. The roof is simple pitched configuration with a covering of corrugated asbestos cement sheet.

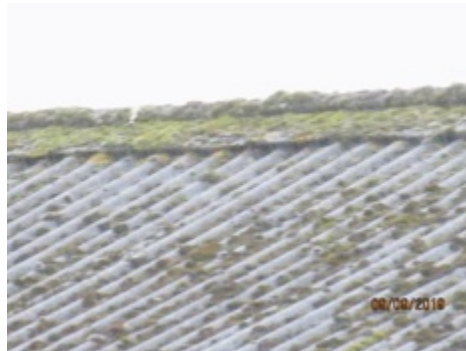
- 3.2 The ridgeline has an asbestos capping, which is acceptably level and even along its length; no significant defects were noted.

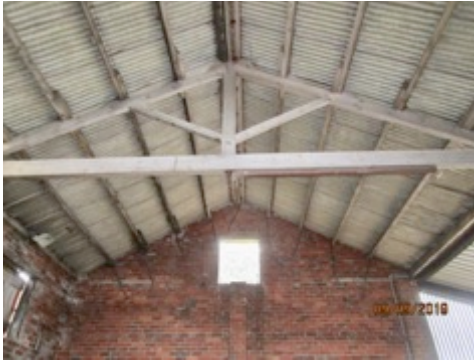
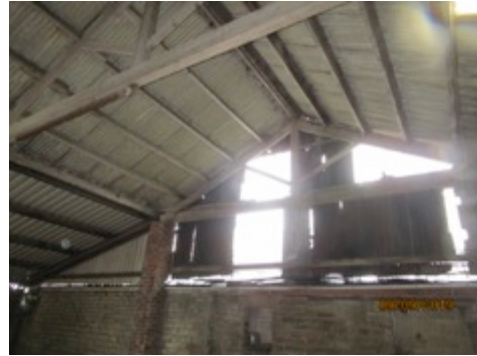
- 3.5 The supporting structure visible inside the building comprises of five timber purlins, (the horizontal members) to each roof slope with intermediate support from of two timber King Post truss rafters. The trusses span front to rear. The structure appears adequate to support the covering.

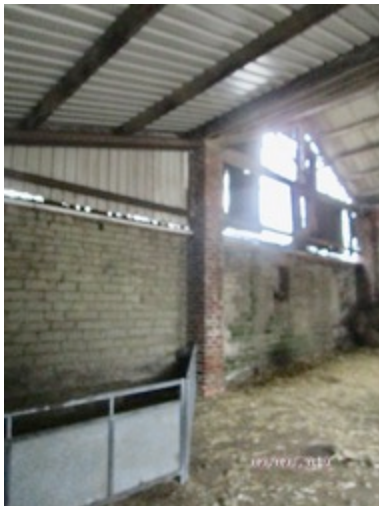
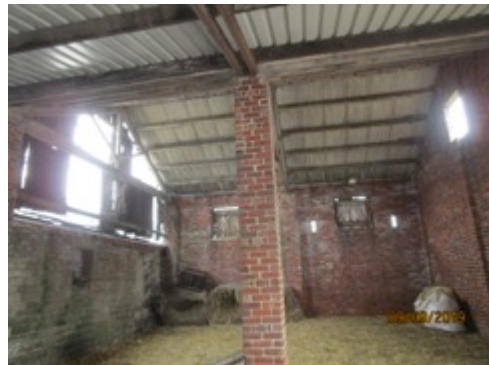
- 3.6 450mm square brick pillars support the King Post Truss at the rear. As is typical of farm buildings, small areas of brickwork have been cut out; localised patching of the masonry will be required.

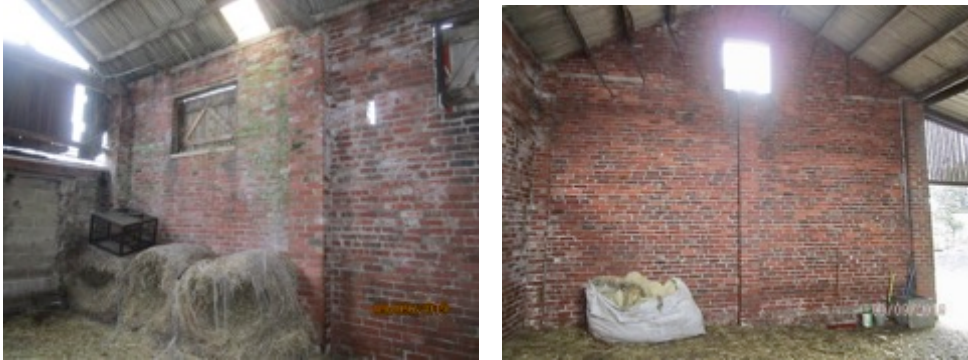
- 4.1 Walls are 225mm thick brick with intermediate brick piers to strengthen the masonry. The piers are as built and not a later addition. Solid walls are more prone to penetrating dampness and are generally colder than those of cavity construction. It is therefore important that the external finishes are well maintained.

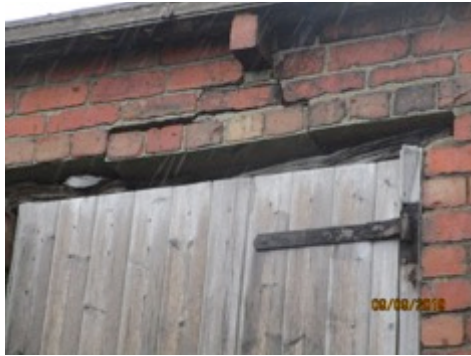
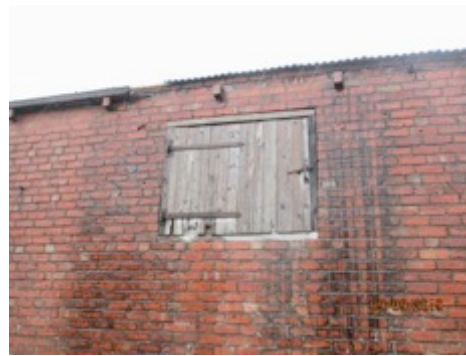
4.7.1 To the road side elevation the timber lintel over the window head has decayed allowing the brickwork to drop. A new lintel should be installed. It would be prudent to cut out any other embedded timbers and replace with protected metal lintels.

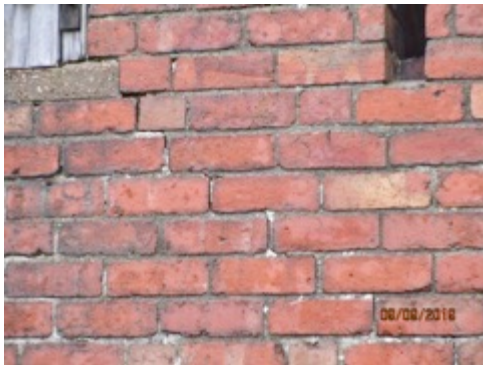
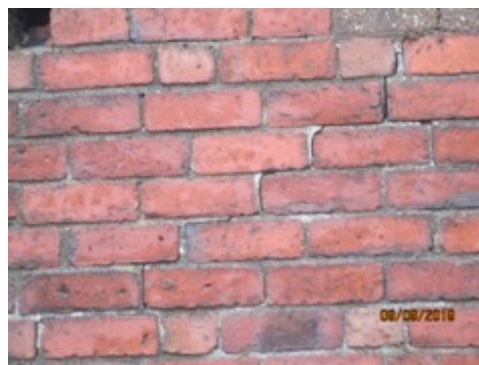
4.7.2 In the odd area cracking to some 3-4.0 mm through the mortar joints has occurred. Localised repair of the damage is required. It should be noted that the fracturing is not visible on the inside face of the brickwork.

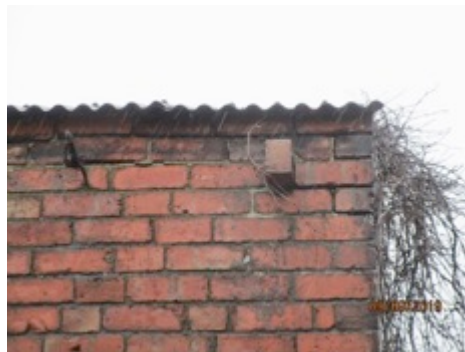
4.7.3 Metal embedded into the mortar bed joint, below the eaves, at the right hand side, is corroding and causing the brickwork to lift. The embedded metal requires removing and brickwork repairing.

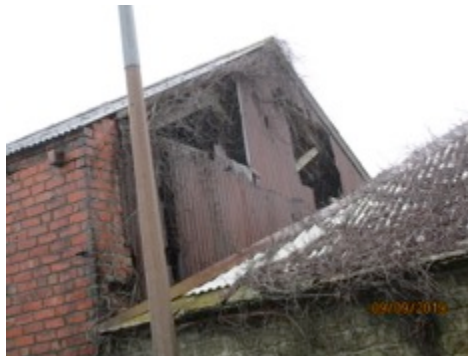
- 4.7.4 The upper part of the right hand gable is clad with steel sheet; repair to the face of the wall is required.

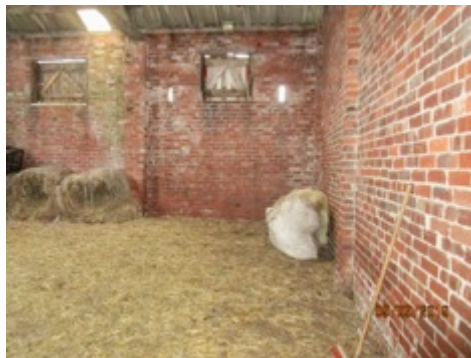
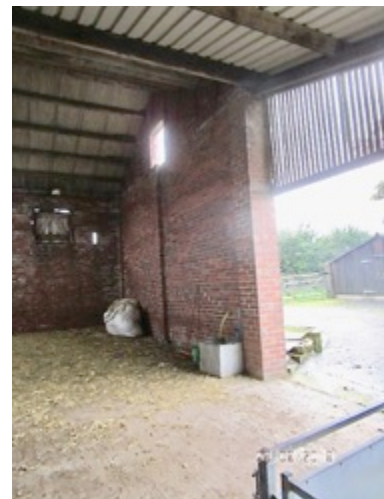
- 6.1.1 The floor is concrete. The floor is satisfactory for the building's current use. In any refurbishment of the building there will be a requirement to ensure the floor complies with the requirements of the Building Regulations.

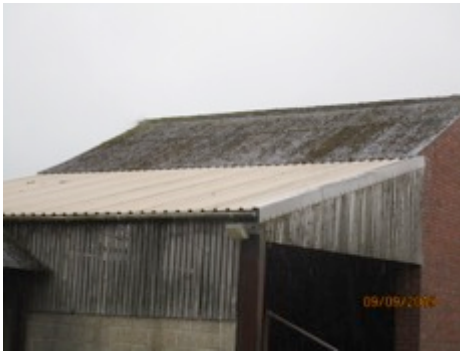
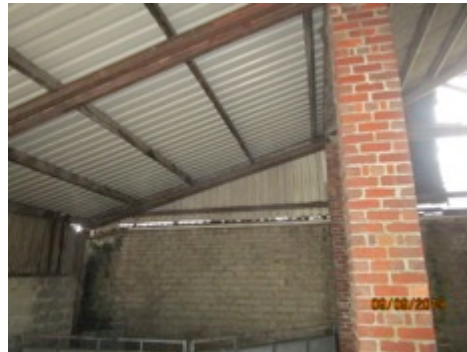
- 7.1.1 A lean-to construction comprising of a profiled metal sheet supported by six timber purlins and a metal frame. No significant issues were identified in the construction or condition of the metalwork.

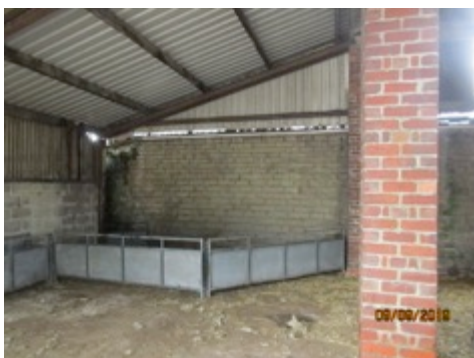
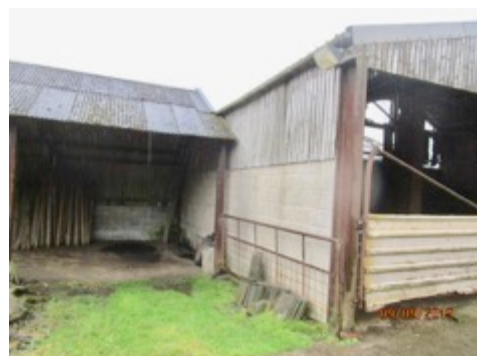
- 7.2.1 Infill walls are concrete block to approximately 1800mm high with a timber slat infill extending up to the eaves. The walls are in a satisfactory condition; no structural defects or immediate maintenance items were evident.

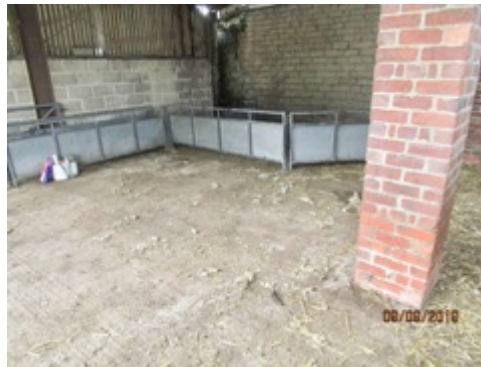
- 7.3.1 The floor is concrete. The floor is satisfactory for the building's current use. In any refurbishment of the building there will be a requirement to ensure the floor complies with the requirements of the Building Regulations.

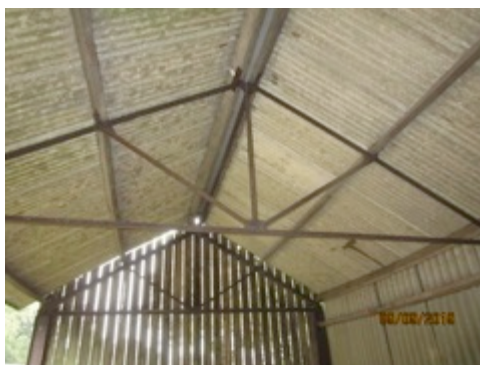
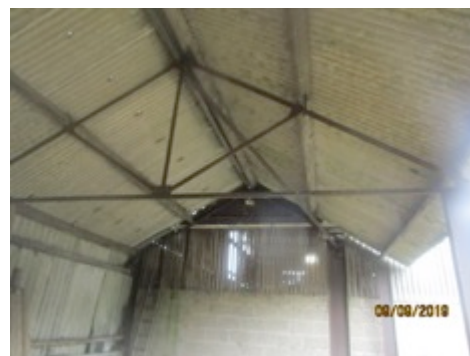
- 8.2.1 The roof has a steel truss supporting framework with a covering of profiled sheets. The structural frame has a degree of surface corrosion typical of unprotected steel. The corrosion is not to such an extent that renewal of structural members is required.

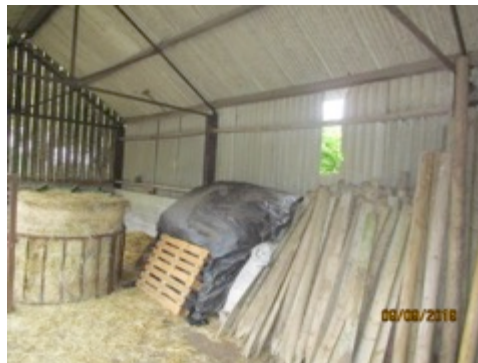
8.3.2 The asbestos sheet covering is damaged in several areas. The broken sheets are considered to be a hazard to health. It is recommended that all the covering be removed as a matter of course.
