Tree Survey Mount Vernon Hospital - Ward 3, Barnsley

REPORT TITLE: **TREE SURVEY**

Mount Vernon Hospital, Barnsley

DATE: October 2009

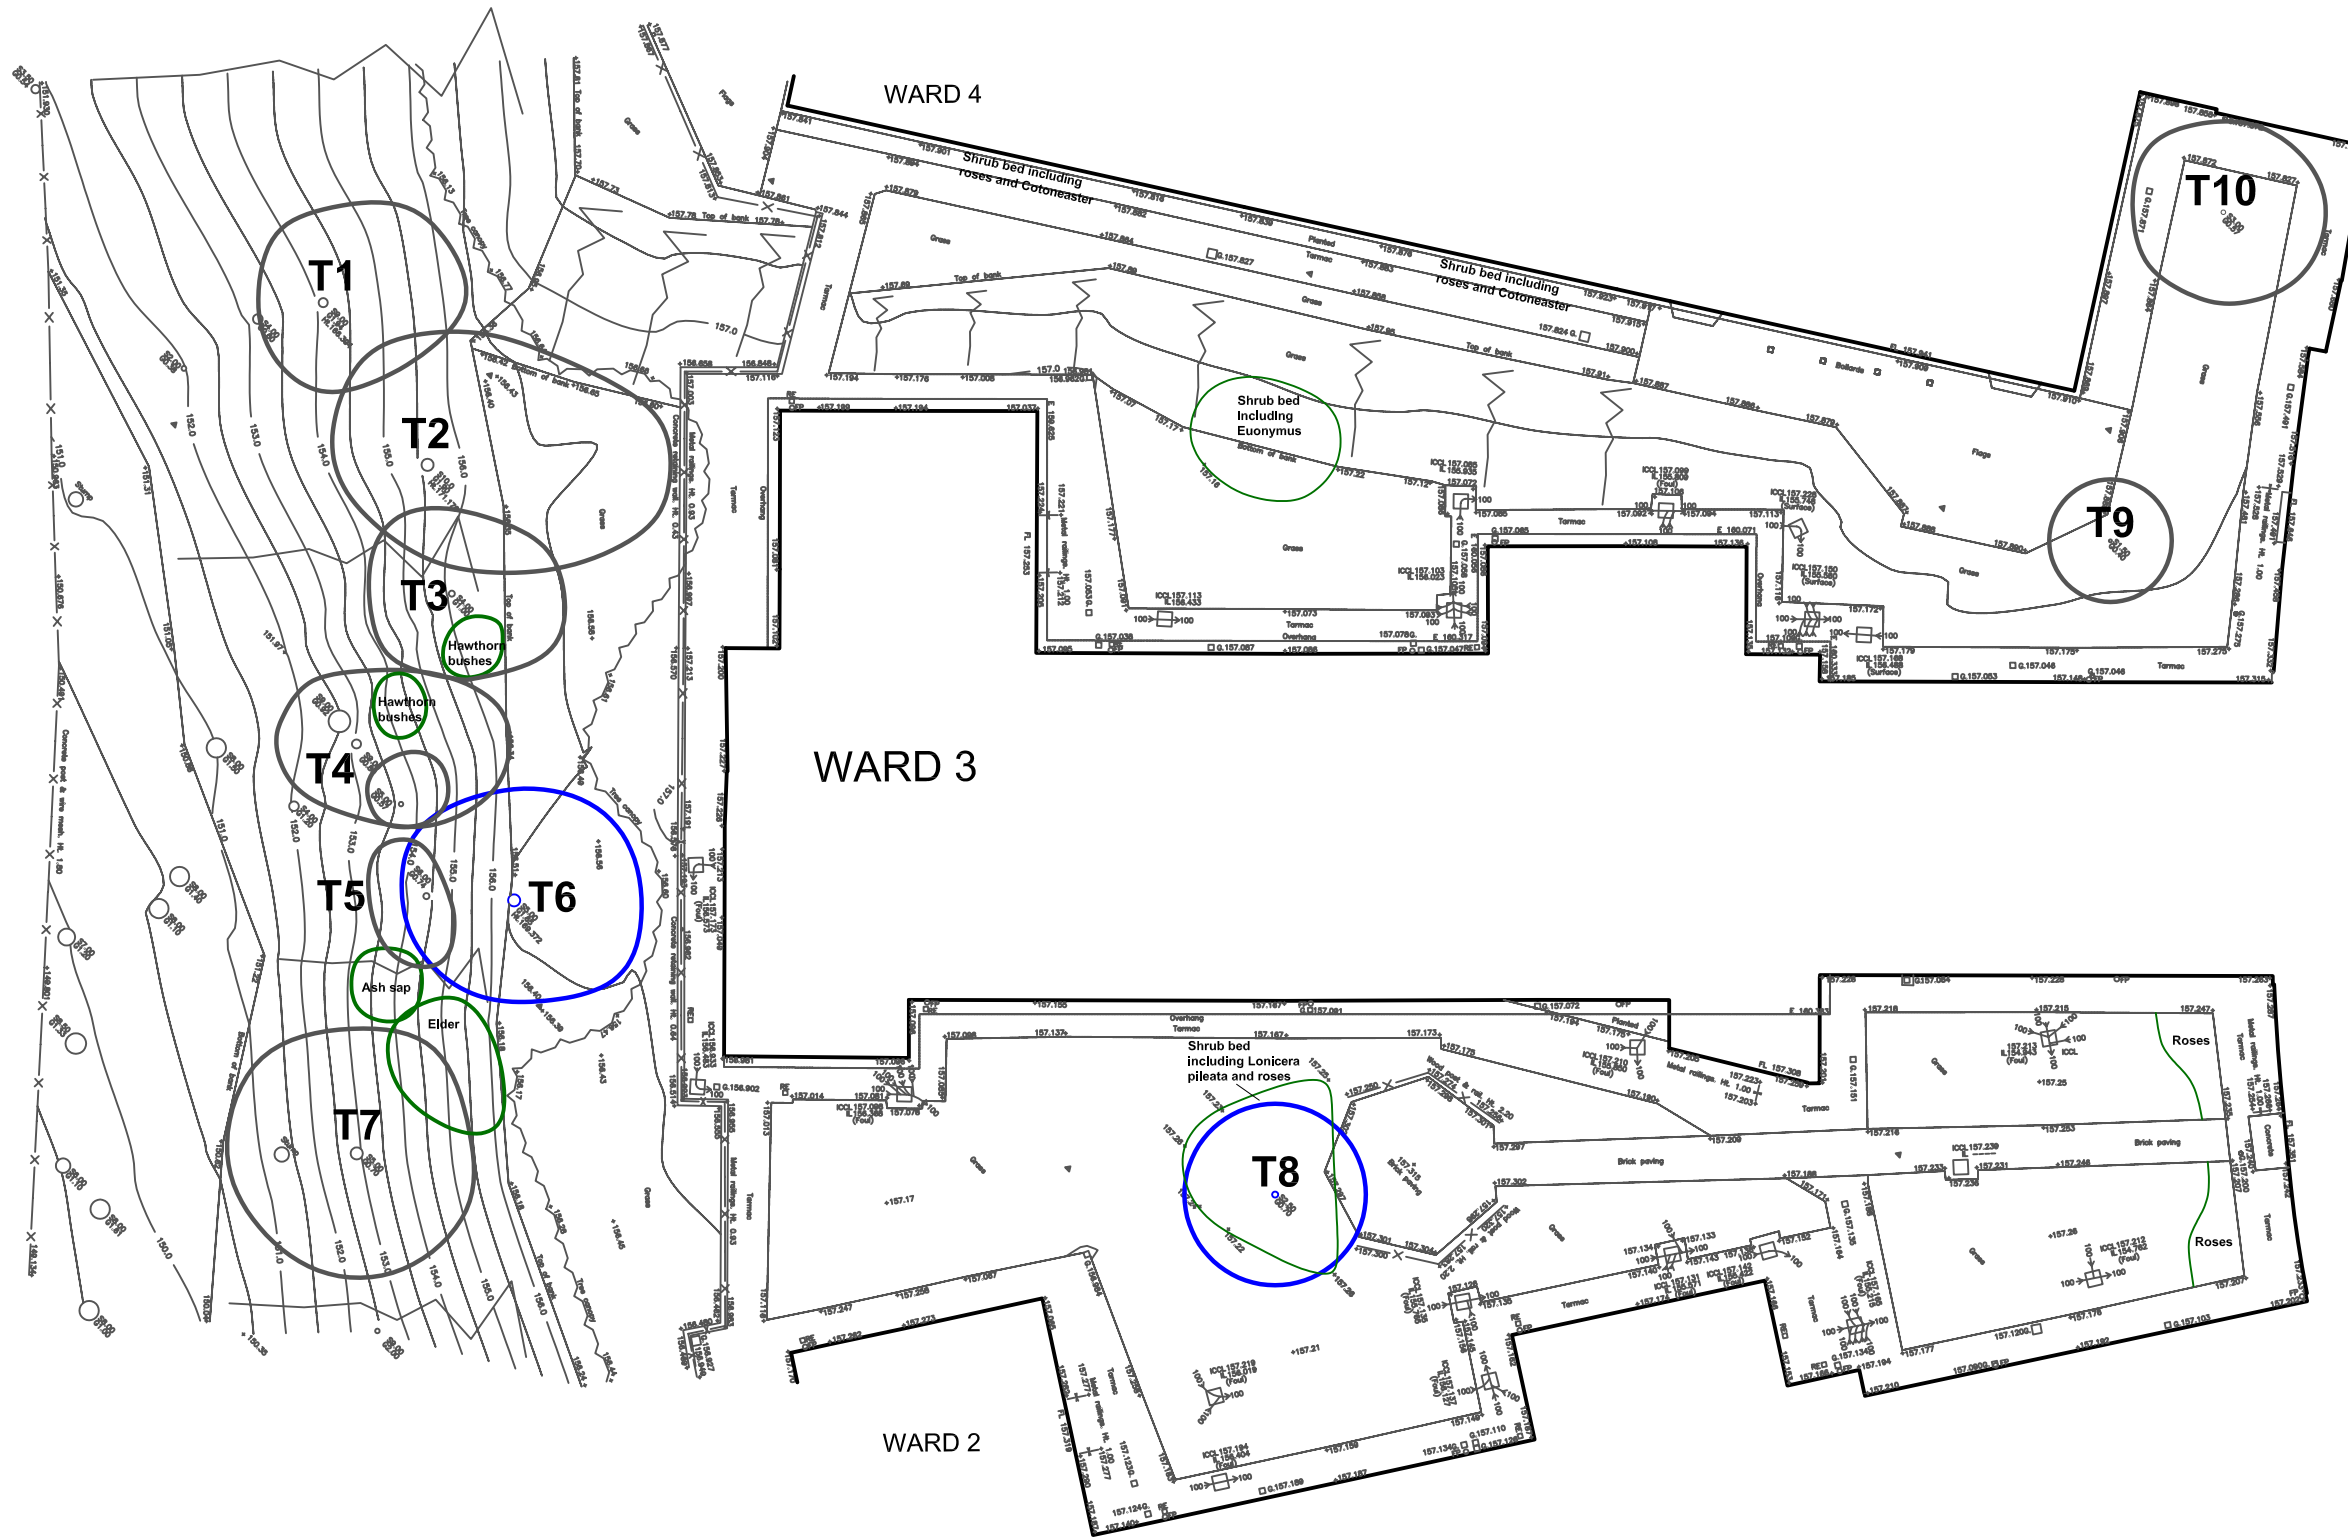
3.2.2 Table 1 describes the results of the trees surveyed and should be read in conjunction with Figure 2 Tree Survey Plan, which illustrates the location of the trees surveyed and the extent of their canopies.

3.2.3 Two trees on site have been classified as category B (moderate quality and value) and the remaining trees have been classified as category C (low quality and value). There were no category A trees (high quality and value) or category R trees (remove) identified on site.

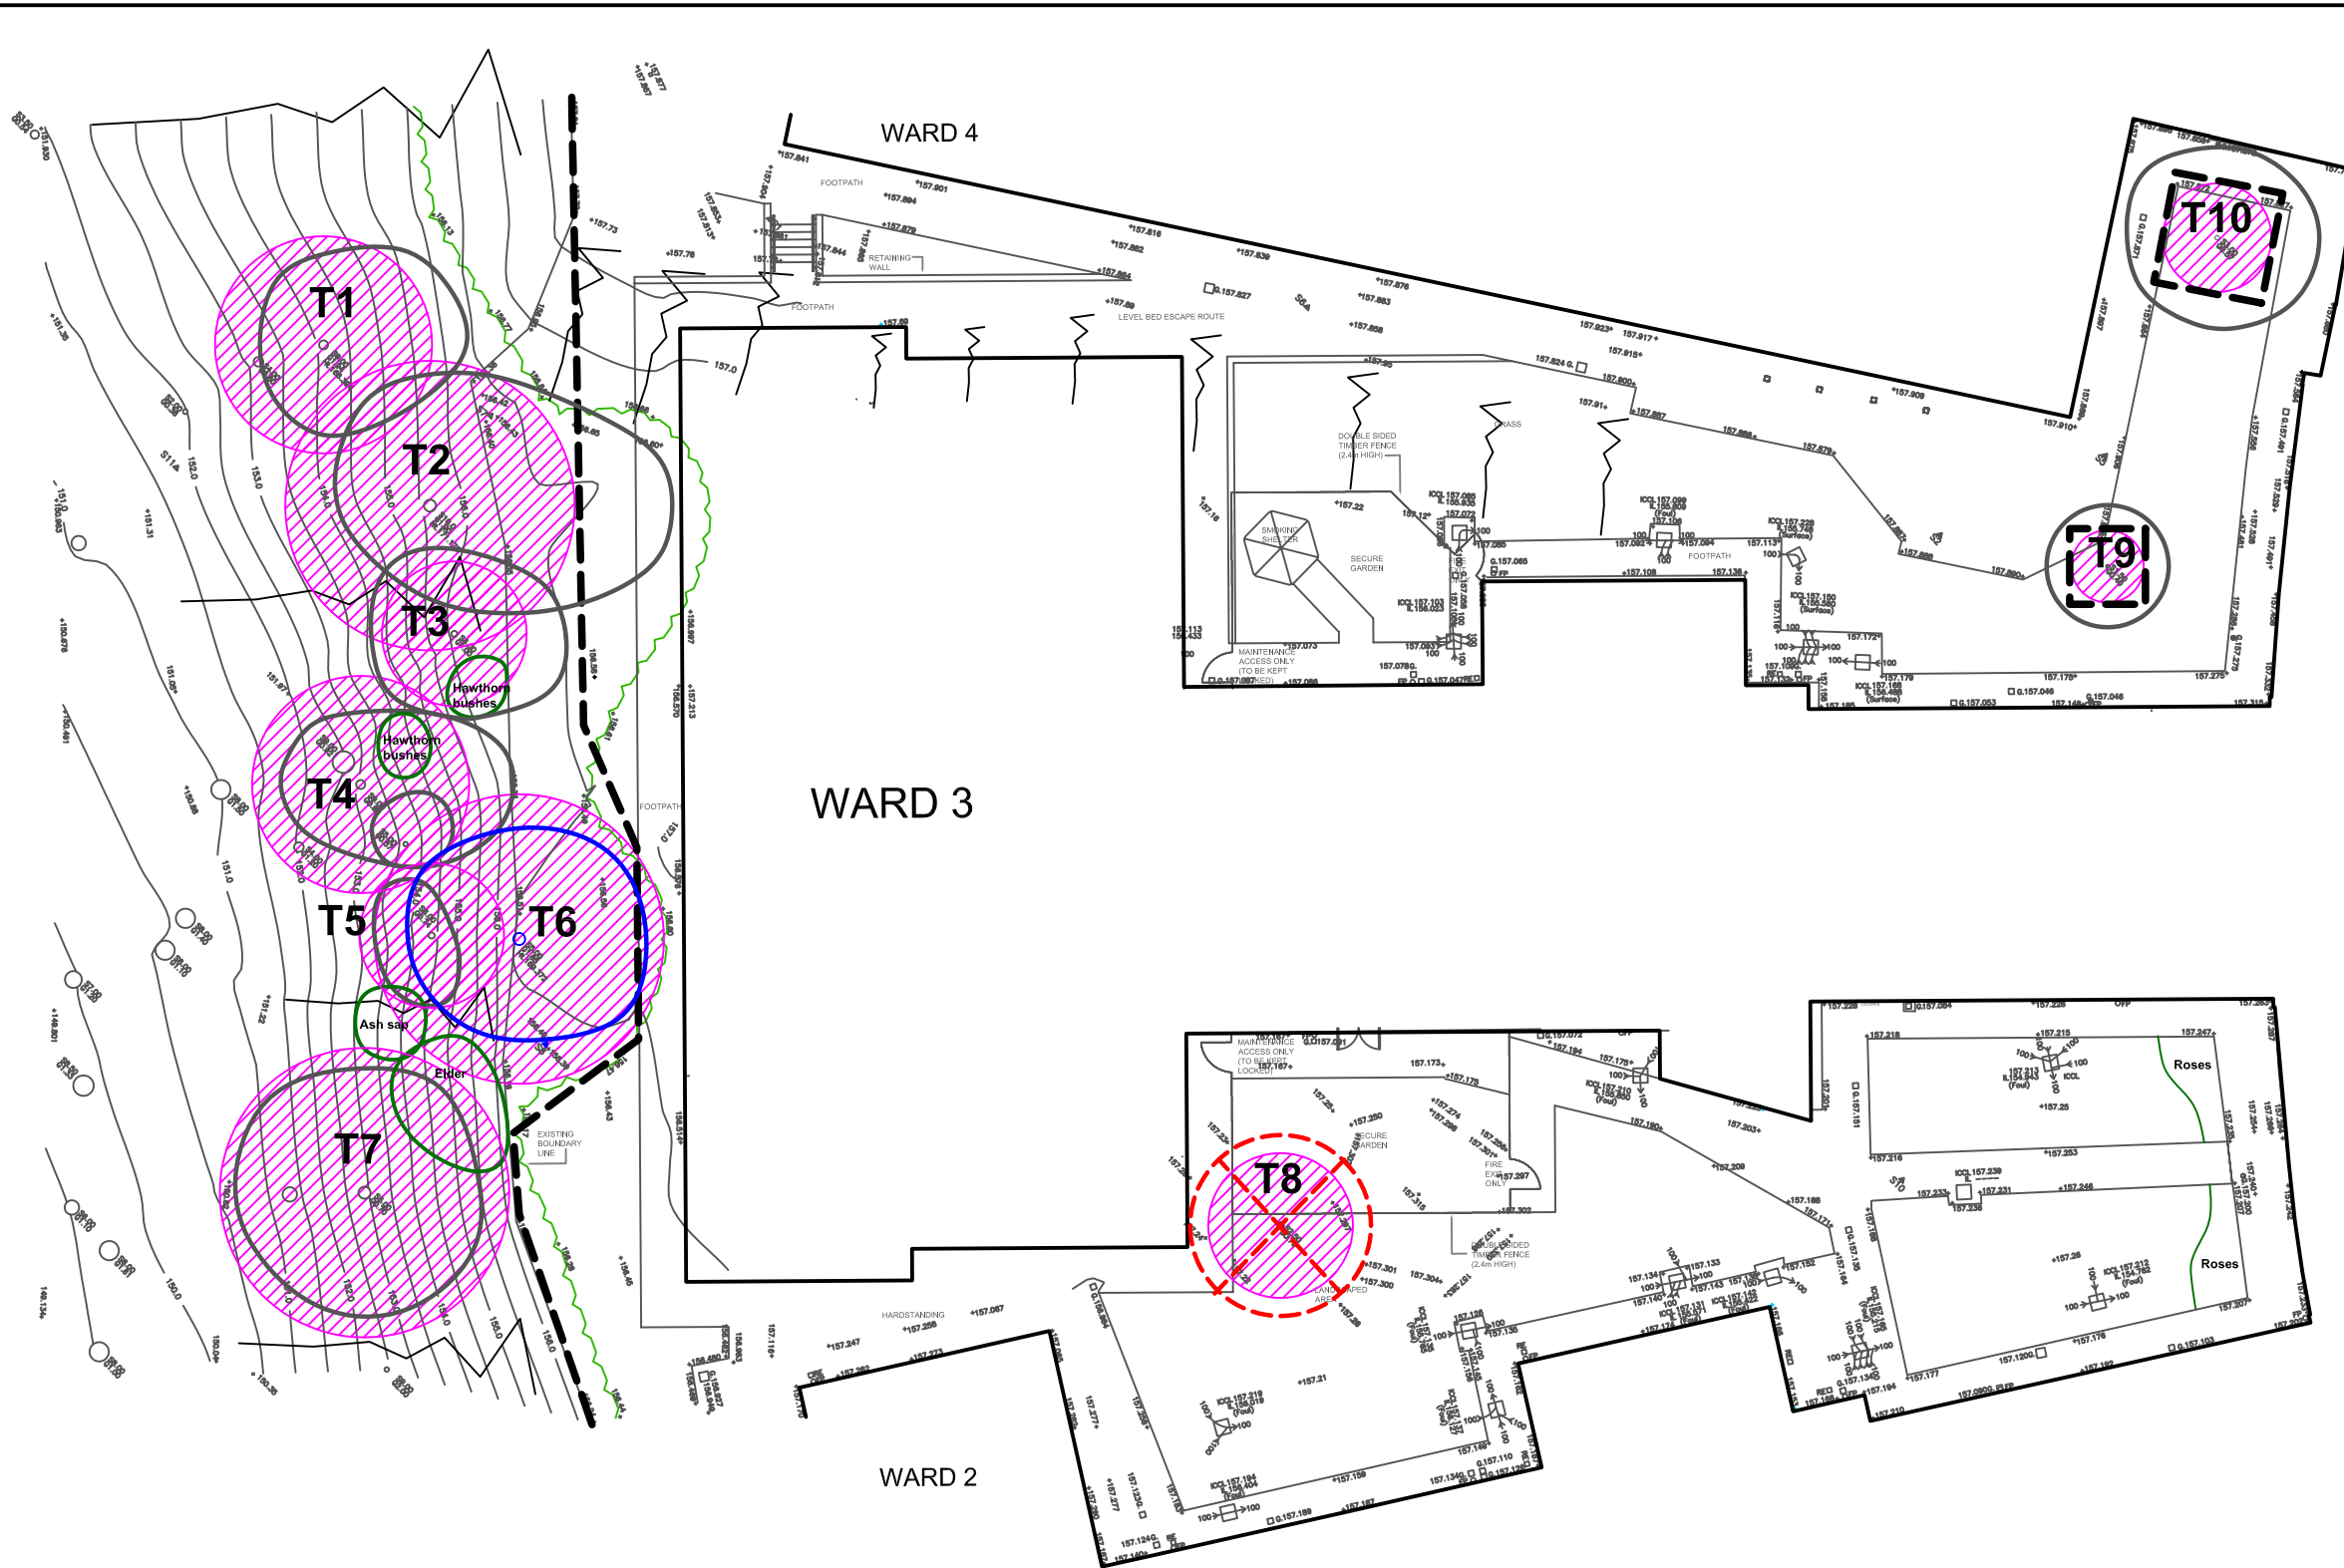
4.2.2 The majority of the trees surveyed are to be retained. T8 is proposed for removal to accommodate the development. The canopy of T8 conflicts with the proposed building and the proposed footpath impinges on its Root Protection Area.

4.2.3 The proposed footpath to the south west of the site conflicts with the Root Protection Area of T6. The use of porous paving for the construction of the footpath should be considered and disturbance to ground levels should be minimised to prevent potential damage to the tree roots.

4.3.2 The root protection areas of all retained trees should be fenced and protected from site preparation and construction activities in accordance with *BS5837:2005 Trees in relation to construction*.

4.3.3 Care should be taken to protect trees during the preparation for construction works (site clearance) and during the construction works themselves to minimise the potential for damage to the trees during construction from site machinery and inappropriate storage of materials. To limit the likelihood of damage occurring during construction, we recommend that locations for the site compound and storage of materials should be specified away from retained trees. In addition, protective fencing should be erected outside the root protection area prior to construction commencing and retained throughout the construction period to physically separate the trees from the development works. The protected area should not be used for the storage of building materials and vehicles should be prevented from running over this area. The location of the protective fencing is shown on Figure 3.
