**Pear Tree Farm  
Church Street, Brierley, Barnsley,  
South Yorkshire**

**Section 278 Highway Works**

**Road Safety Audit Stage 1**

**TMS Reference No: 19217  
Date: 5<sup>th</sup> June 2025  
Revision: 0**

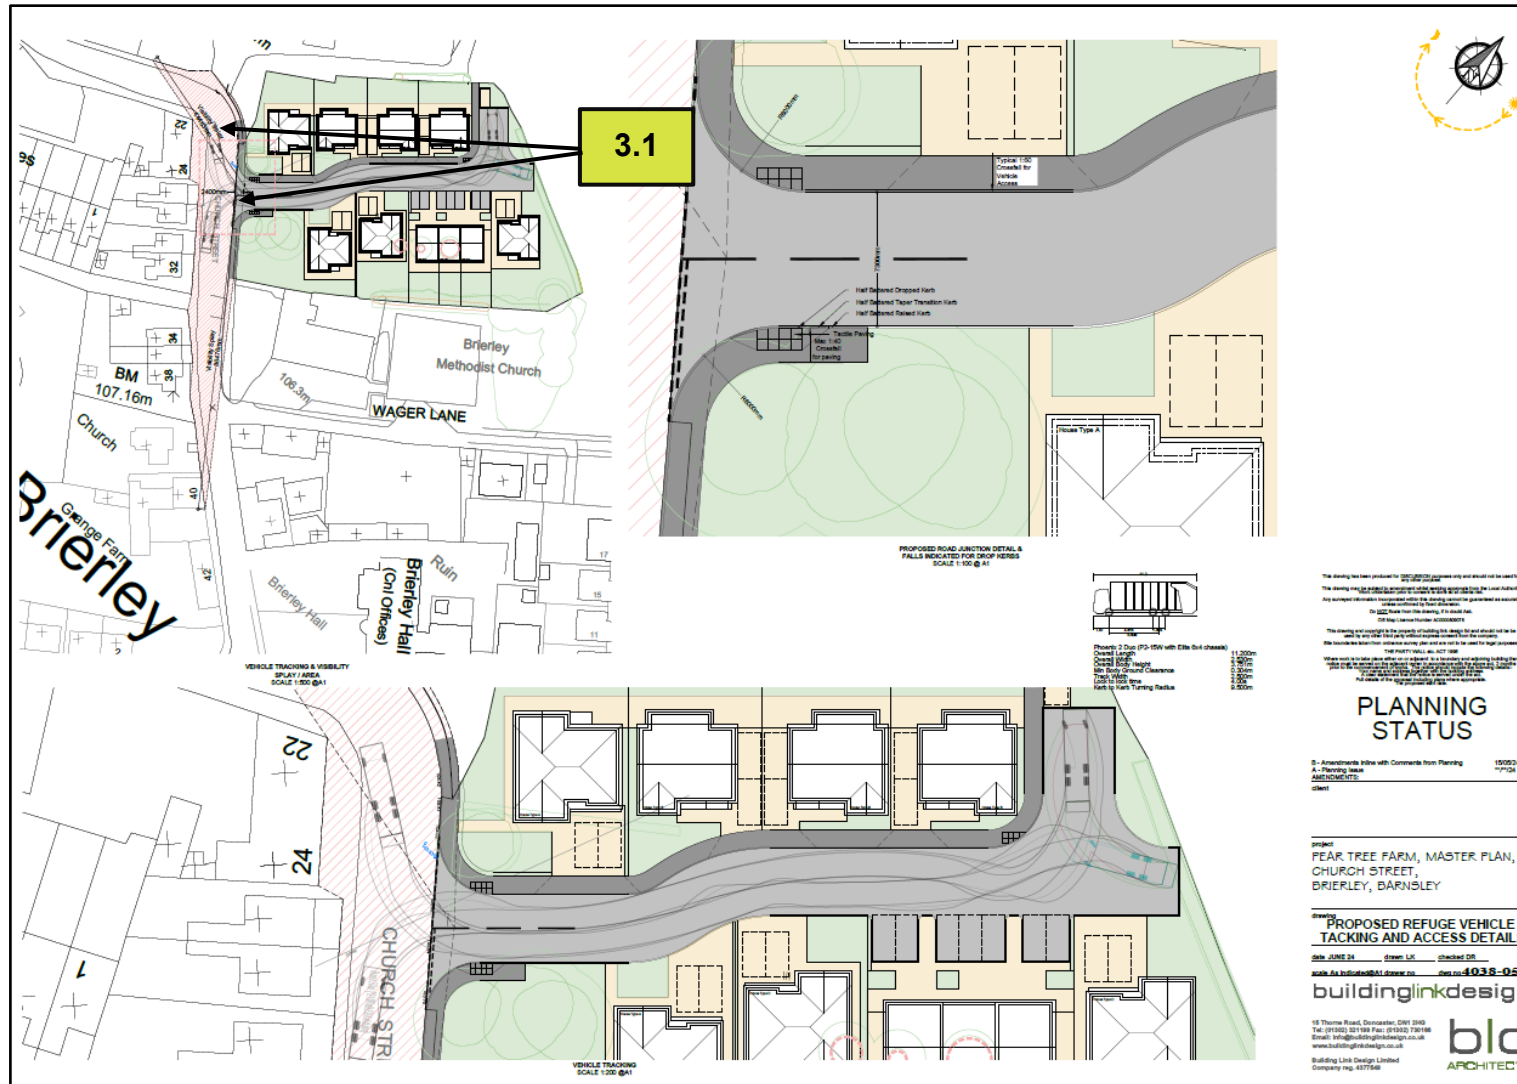
Location: Church Street; site access

Summary: High vehicle speeds around the bend may result in pull-out type vehicle collisions

Although a suitable visibility is shown to be proposed from the site access onto Church Street, from site observations the vehicle speeds around the right-hand bend towards the site access appeared to be high. The proposed visibility splay may be insufficient for the actual speeds of vehicles, which may increase the risk of pull-out type vehicle collisions at the site access junction.

A speed survey should be undertaken to ascertain actual vehicle approach speeds. If these results do confirm that speeds are high, additional measures should be provided to reduce approach speeds such as, but not exclusively, provision of 'slow carriageway' markings, physical traffic calming features, markings to reduce carriageway width etc.
