# **Conversion of Existing Workshop to a Dwelling To rear of 27 Hoyle Mill Road**

## **Preliminary Bat Survey**

Report Date: 15/12/22

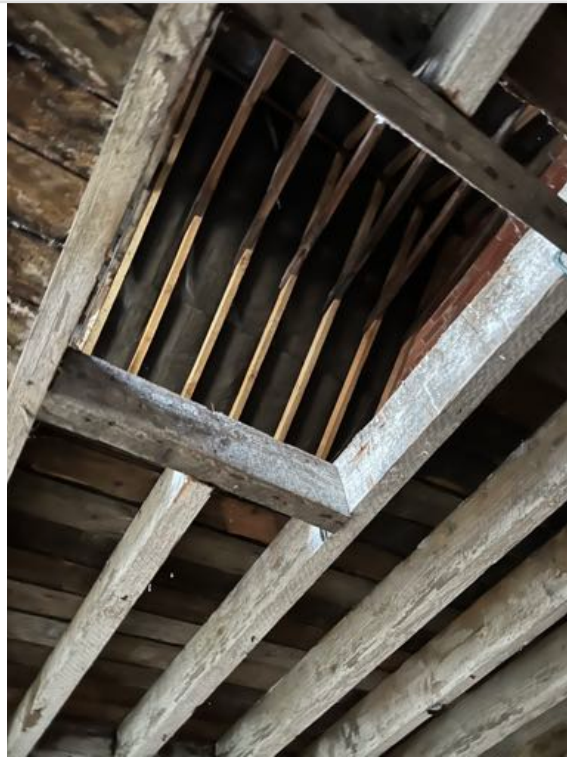
Photo 12 - Underside of first floor with felted roof above.

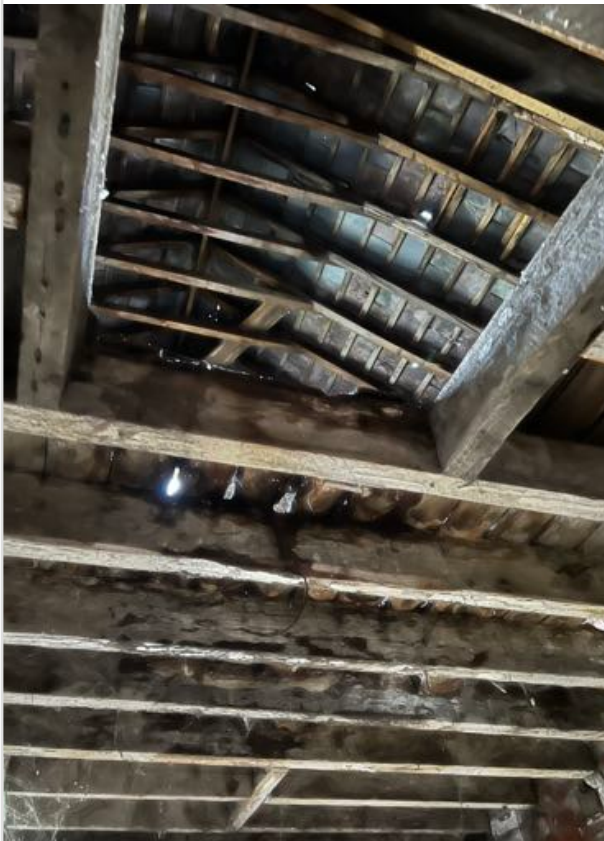
Photo 14 - Underside of first floor with exposed roof structure above.
