**6 Bourne Walk, Staincross, Mapplewell, Barnsley,
S75 6JQ**

Preliminary Roost Appraisal

Final Report v1

22 May 2026

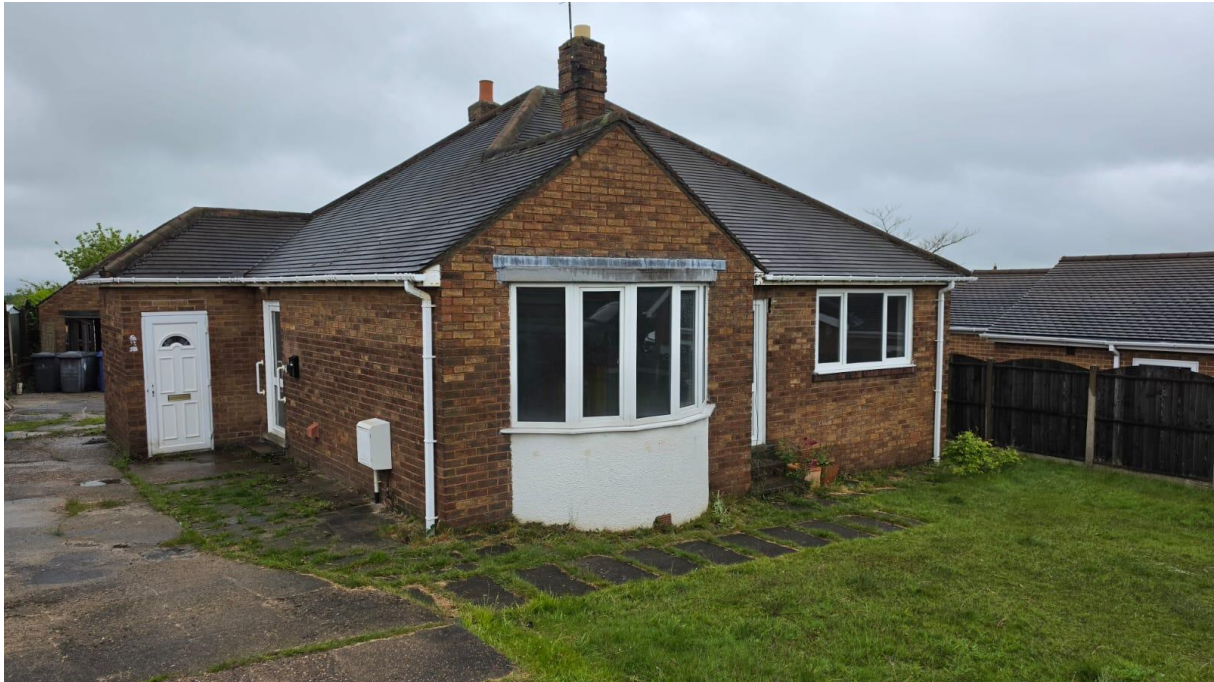
Photograph 1: Front of the main house.

- 3.6 The following was noted:
- The building is a brick single storey bungalow
 - Pitched and hipped roof with clay tiles
 - PVC windows and door frames
 - Wooden soffits
 - There are slipped tiles around the chimney
 - There are gaps under the mortar of the hip tiles
 - There are some missing tiles on the roof

- 3.7 The bungalow is considered to hold moderate potential to support roosting bats.

- 4.1 The bungalow is considered to hold moderate potential to support roosting bats. The garage and outbuilding are considered to hold negligible potential to support roosting bats. Therefore, two further surveys to establish if roosting bats are present in the bungalow has been recommended.

- 4.2 Buildings with a moderate potential, in accordance with The Bat Conservation Trust (BCT) guidelines (Collins, 2023), require two evening emergence survey visits for presence/absence to be confirmed.

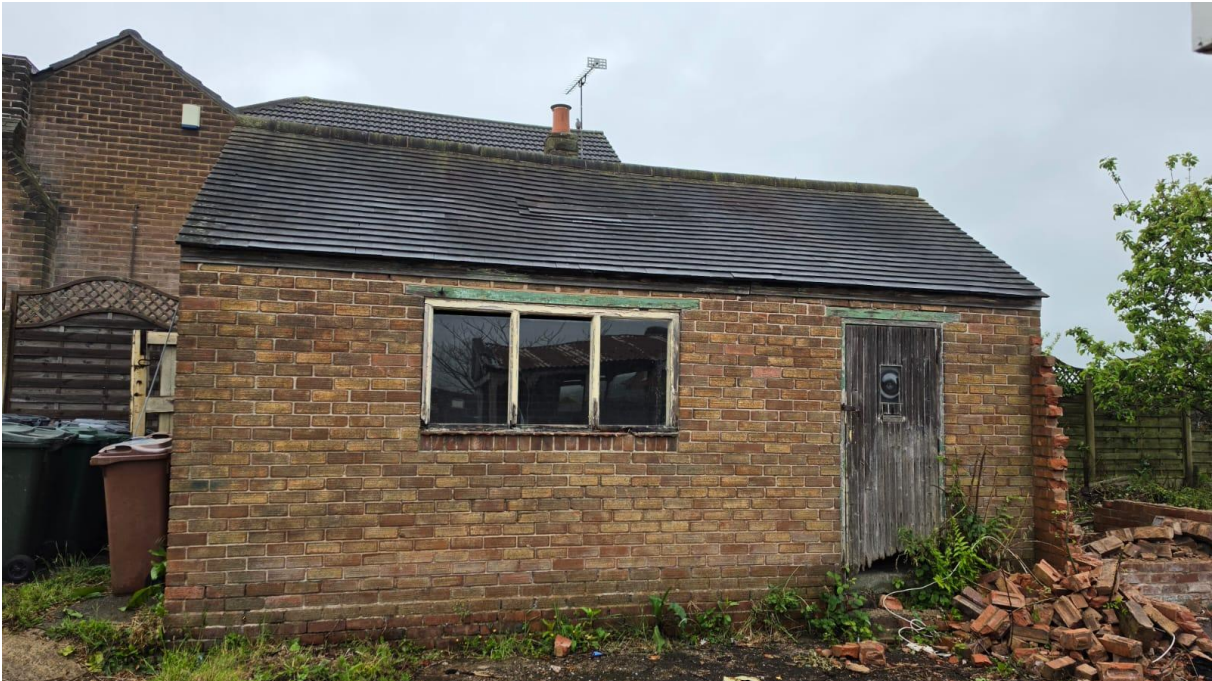
Photograph 4: front of external garage.

- 3.8 The following was noted:
- The building is a single storey brick garage.
 - The roof is pitched with interlocking clay roof tiles in good condition

- Wooden doors – open
- Wooden window frames with gaps above the glass

3.11 The garage and outbuilding are considered to hold negligible potential to support roosting bats.

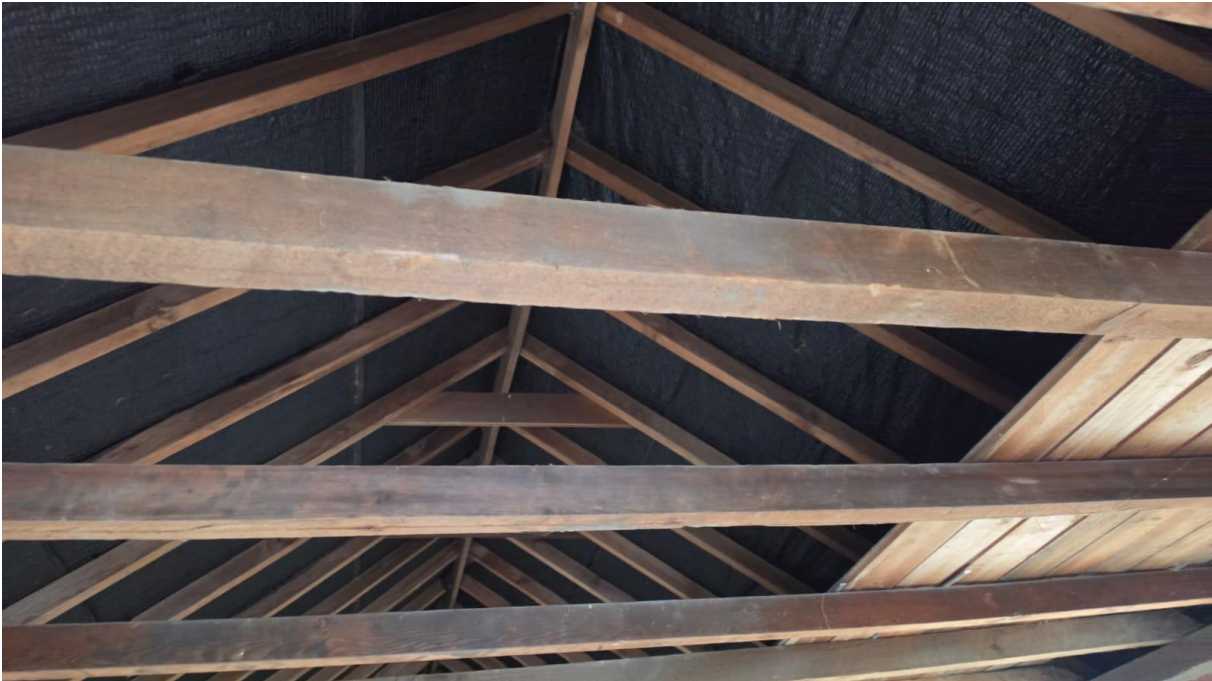
Photograph 6: Internal garage.

- Wooden beams
- Bitumen felt liner in good condition
- Open to the garage
- No signs of bat droppings

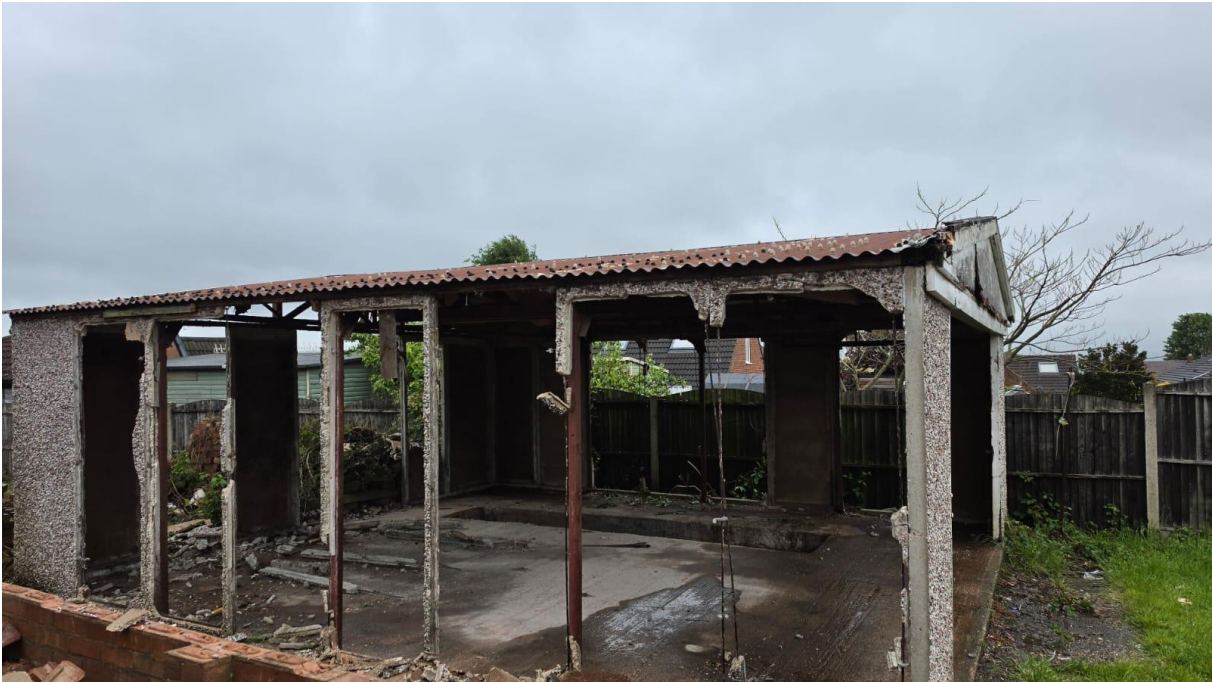
Photograph 7: View of outbuilding with side elevation.

- Concrete prefabricated garage
- Corrugated sheet metal roof
- Missing panels at the sides
- Wooden fascia
