**REPORT OF AN ENVIRONMENTAL SITE  
SURVEY OF THE MONCKTON COKE  
AND CHEMICALS WORK**

**Prepared for:** R J B Mining

**Date:** January 1994

**Reference:** 7102

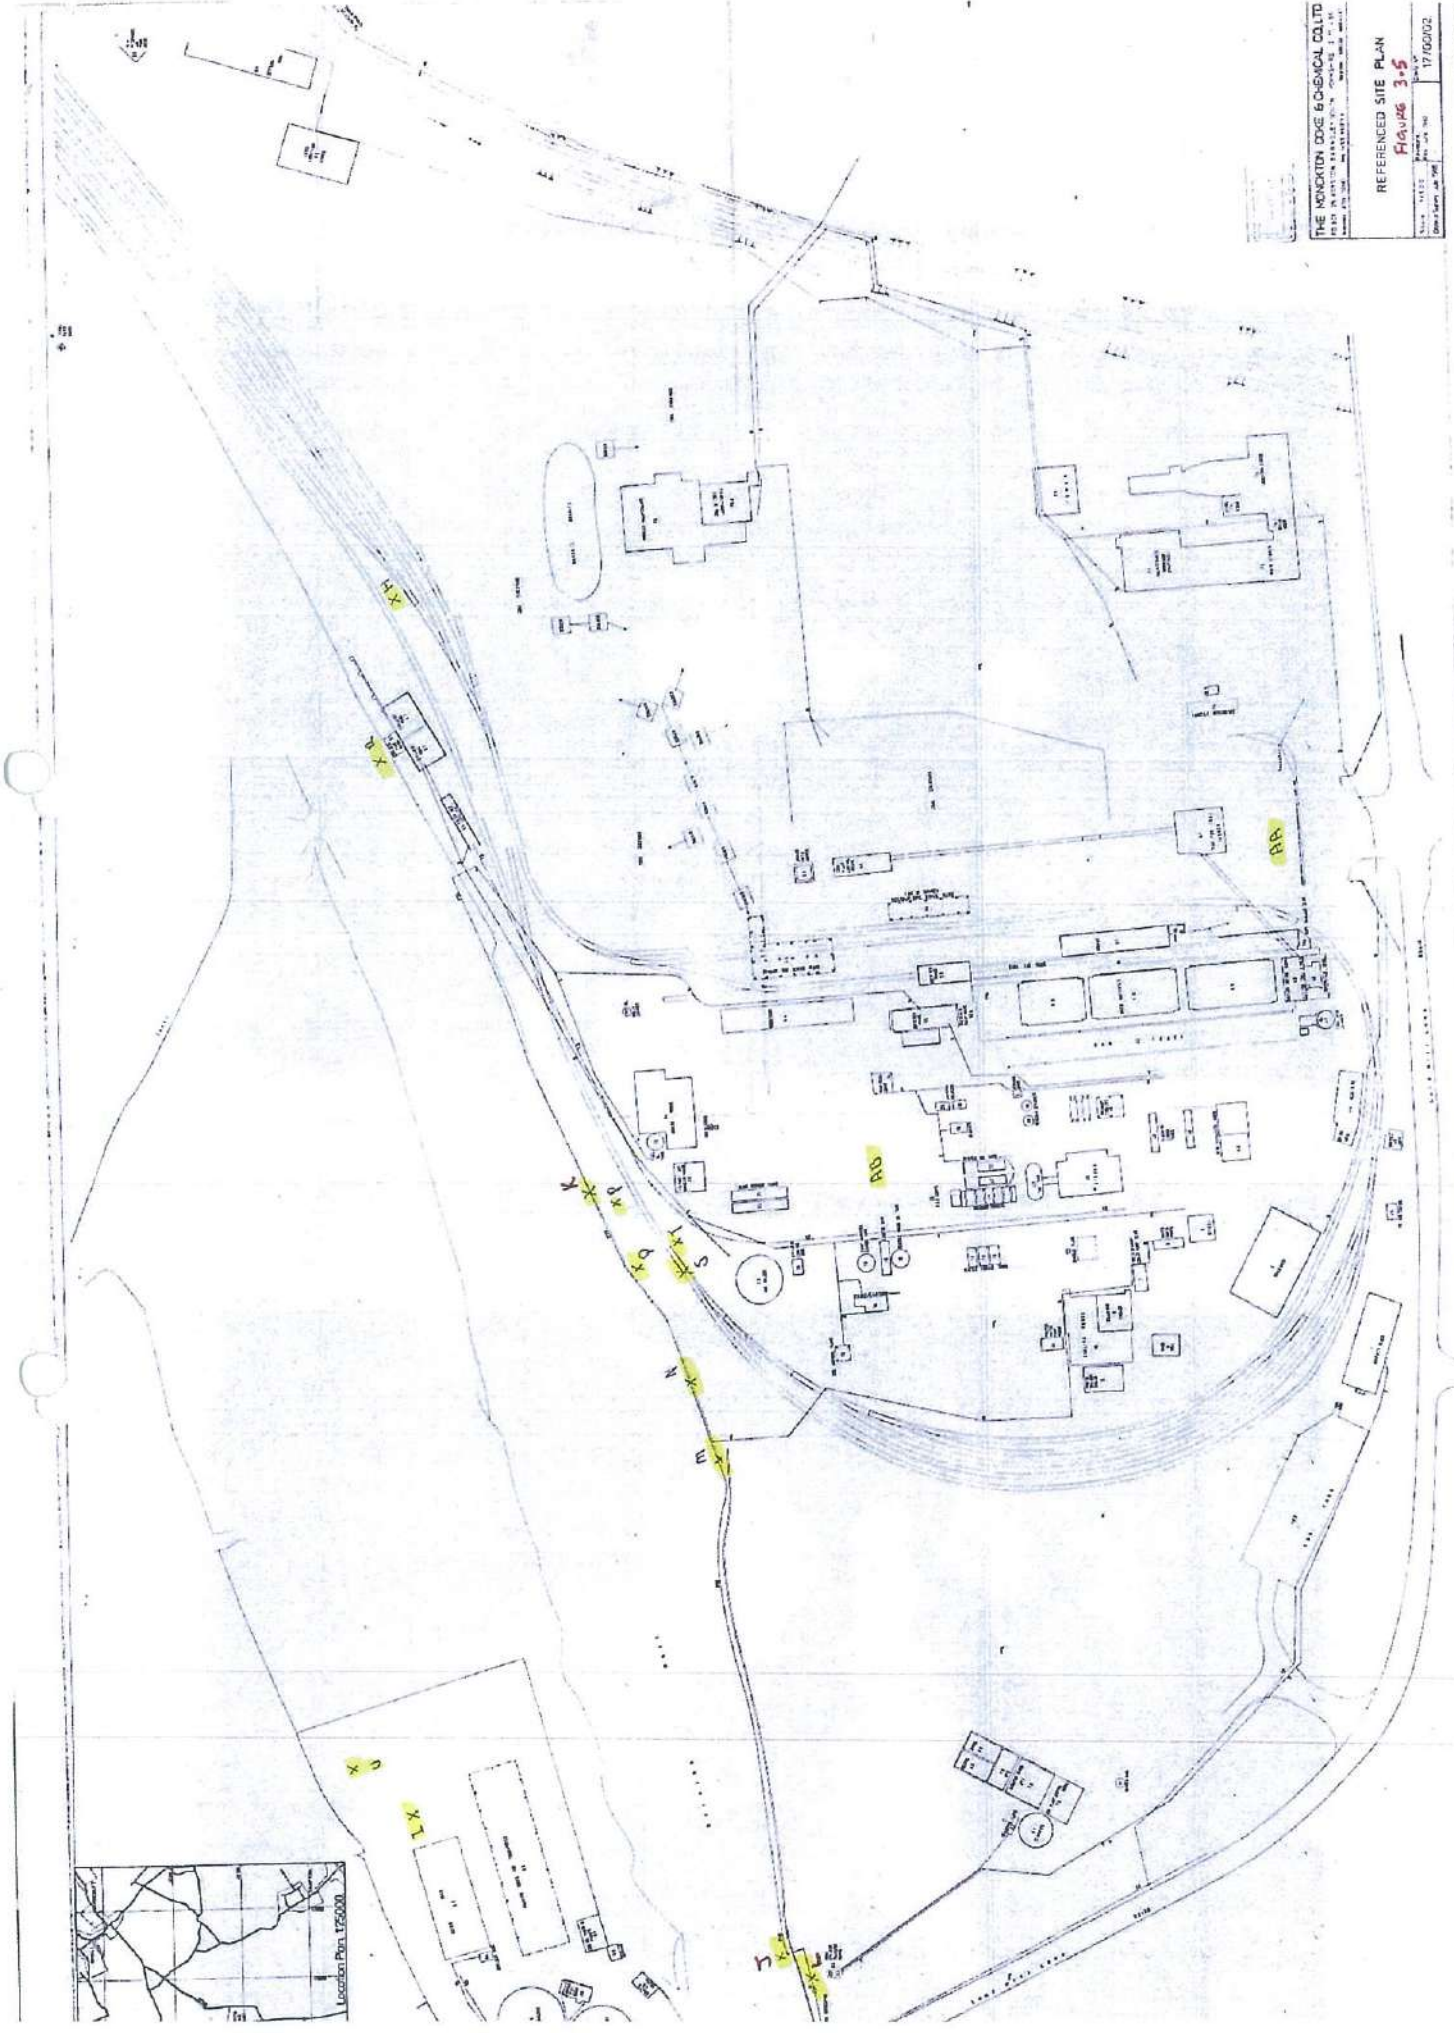
Figure 5.1 Plan of the main production area , showing observation points.

The three crude benzole product tanks are of 34m<sup>3</sup> capacity each and are in a bunded area (D, figure 5.1). Two new tanks are in the process of being installed, to replace these. It was observed that the current tanks were all open to vent to atmosphere, through their "dip points". This will allow the volatile liquor to escape.

A pressure gauge on the side of Still B was observed to be leaking liquor onto the ground (E, figure 5.1).

The three liquor storage tanks and the offspec CAL tank were inspected. There was no bunding around these vessels and there was a distinct smell of ammonia in the area from the sample points. A tar runoff line comes from the tanks and there was evidence on the ground of previous tar spills, possibly from the open inspection points (G, figure 5.1 and photograph, figure 5.12).

If tankers are overfilled with by product the excess product is returned to the liquid/ tar decanter tanks. At this location there is evidence of spilt tar/ oil on the ground, which is not hard standing (V, figure 5.1). In fact most of the process area is not hard standing which allows any spills, leaks or accidental releases to penetrate the ground.

There is also evidence of tar spillage underneath the primary coolers probably originating from the seal pots (W, figure 5.1).

Until recently, the site contained two underground liquor tanks from the ammonia washers (X, figure 5.1). MCC have now removed these tanks and reported that the brickwork was in excellent condition. Clearly, if the brickwork was cracked this would have led to ground contamination.

There is evidence of spillage of lubricating or hydraulic oil under the building containing the export gas boosters (Y, figure 5.1). This is a hard standing area and some of the contamination is being carried away by run-off.

It is recommended that bunding is provided around all storage tanks, the benzole plant pumps and the CAL plant.

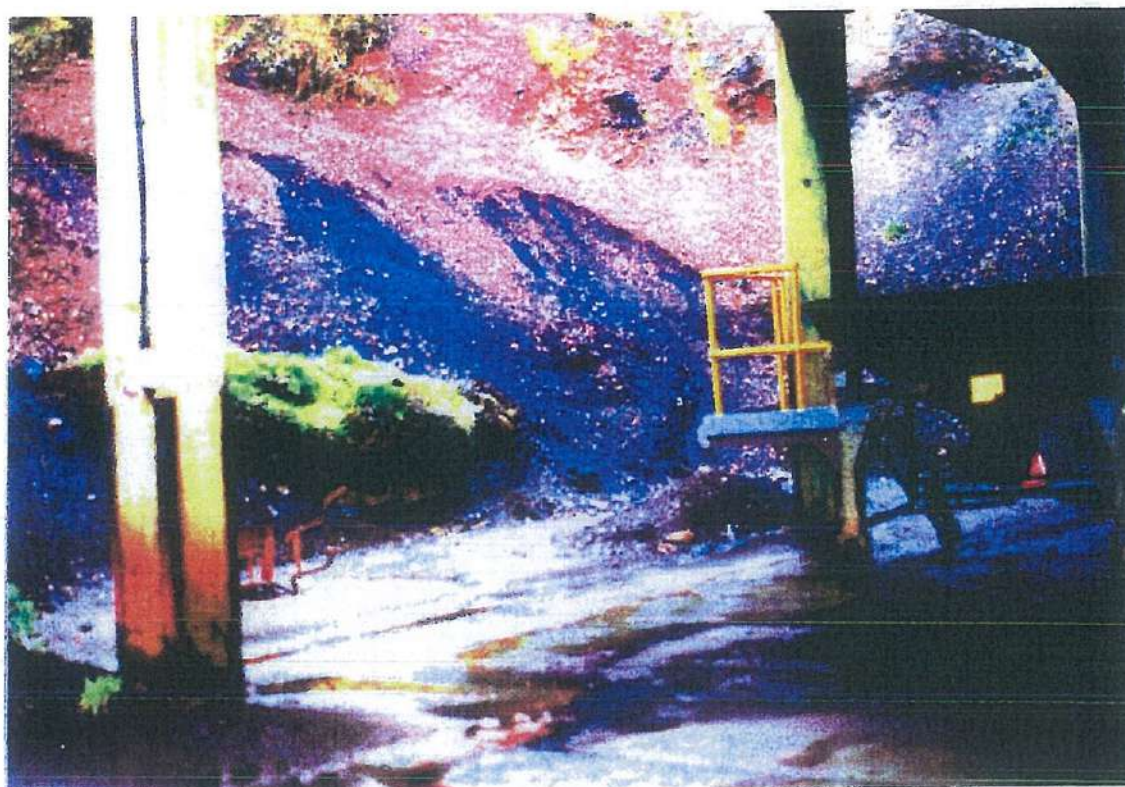
Figure 5.9 Blue coloration at Gas Purification Plant

| Area/Section | Conclusion | Type of Issue | Regulatory Body | Action | Estimated Cost (£K) |
|---|---|---|---|---|---|
| Leachate at gas purification plant, section 5.4. | Red coloured leachate in surface water at the gas purification is a potential contaminant of BET and may exceed YW consent conditions. | Non compliance, general environmental improvement. | YW | Analyse contents of the sump at the gas purification plant. | 5/year |

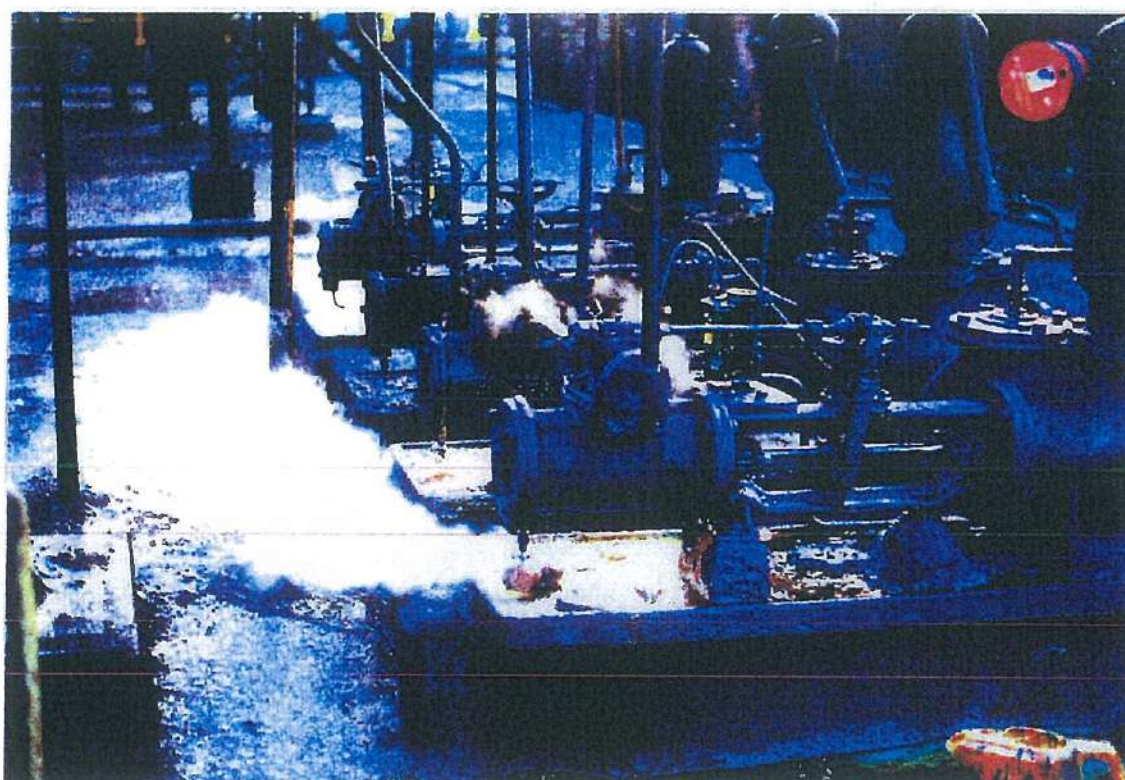
The six benzole plant steam pumps will not operate unless the glands are loosened. As a result there are leaks from seals around the flanges. The pumps have to be topped up regularly with oil. The pumps are not banded and, hence, there is gross contamination of the ground around these pumps (B, figure 5.1 and photograph, figure 5.10). Tar flows from the pump area into an open gully and then to the tar drains tank. The ground is contaminated with tar, oil and benzolised oil.

Figure 5.10 Benzole plant pumps showing ground contamination.

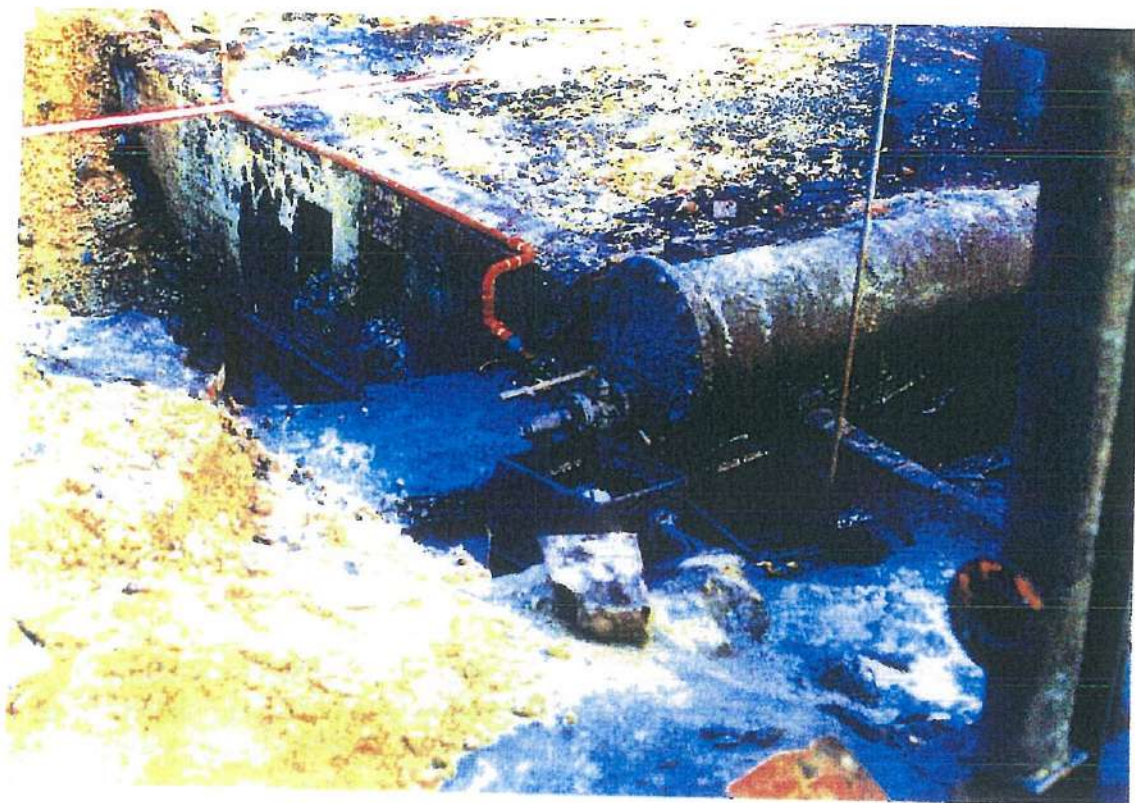
The ram road deposit underground sump is no longer used and is in the process of being decommissioned. The sump used to accept tar from three of the primary coolers via a tar gully. The primary coolers provide crude separation of tar and liquor and it is likely that the tar was contaminated with ammonia liquor and benzole. The ram road sump also accepted water separated from crude benzole in the Woolfe Coolers. It was not possible to examine the integrity of the sump but this is another potential source of ground contamination (Z, figure 5.1). The sump cannot be fully decommissioned until some other drains are diverted. This work is in hand. The ram road sump still had oily effluent flowing into it at the time of the site survey. The area around the ram road sump was heavily contaminated with oily tar (photograph, figure 5.13).

Figure 5.13 Contamination around the ram road sump.
