# ARBORICULTURAL REPORT

***Stairfoot Roundabout,  
Stairfoot,  
Barnsley,  
S71 5DS***

Prepared for: ***Barnsley Metropolitan Borough Council***

Reference: *AWA7043*

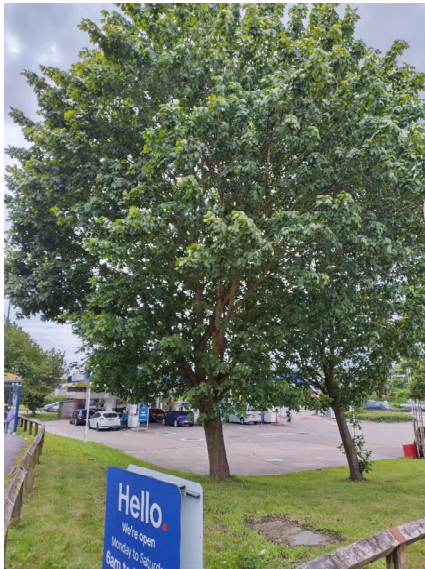
Photo 1: T6 from north.

| Tree Species | | | | Measurements | | | Crown (m) | | | | Tree Condition | | | | | | | Value | | Management | | |
|---|---|---|---|---|---|---|---|---|---|---|---|---|---|---|---|---|---|---|---|---|---|---|
| T6 | Norway Maple | Acer platanoides | Early-mature | 14 | 1 | 450 | No | 1.5 | 7 | 7 | 5.5 | 5.5 | No visual defects | Single stemmed. Slight lean. Old pruning wounds. Stubs. Tight union | Old pruning wounds. Minor deadwood | Slight lean northeast. On banking. | Good | Good | >40 yrs | Moderate | B | No works required in current site context |

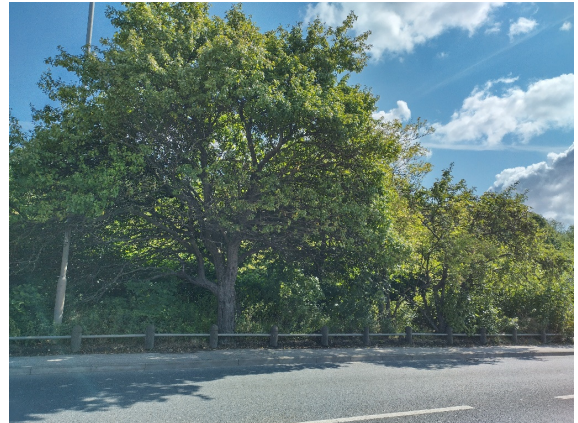
Photo 2: T21 from west.

| Tree Species | | | | Measurements | | | Crown (m) | | | | Tree Condition | | | | | | | Value | | Management | | |
|---|---|---|---|---|---|---|---|---|---|---|---|---|---|---|---|---|---|---|---|---|---|---|
| T21 | Apple | Malus domestica | Mature | 7 | 1 | 480 | No | 1.5 | 4.5 | 4.5 | 4 | 4 | No visual defects | Single stemmed. Epicormic growths. Old pruning wounds. Stubs. Tight union. Partially included bark. Minor cavities. Minor decay | Minor dieback. Moderate deadwood | Road and pavement to southwest. Crown raised over road. Lower crown over pavement mostly dead. | Fair | Fair | 20 to 40 yrs | Moderate | C | No works required in current site context |

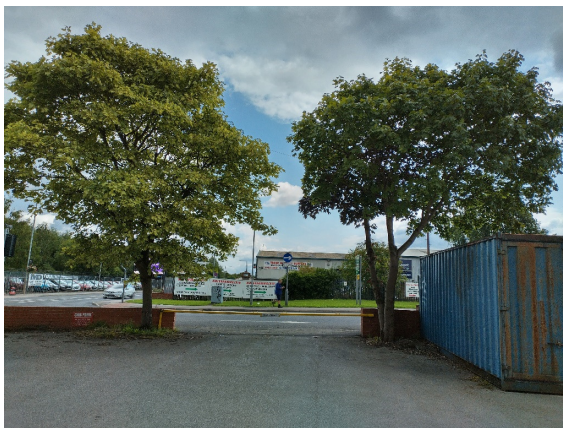
Photo 3: T41 and T42 from northwest.

| Tree Species | | | | Measurements | | | Crown (m) | | | | Tree Condition | | | | | | | Value | | | Management | | |
|---|---|---|---|---|---|---|---|---|---|---|---|---|---|---|---|---|---|---|---|---|---|---|---|
| | T41 | Norway Maple | Acer platanoides | Semi-mature | 7 | 1 | 280 | No | 1.5 | 4 | 3.5 | 3.5 | 4 | No visual defects | Single stemmed. Vertical. Old pruning wounds. Stubs | Old pruning wounds. Minor deadwood | Wall 0.5m to southeast. | Good | Good | 20 to 40 yrs | Moderate | B | No works required in current site context |

| Tree Species | | | | Measurements | | | Crown (m) | | | | Tree Condition | | | | | | | Value | | Management | | |
|---|---|---|---|---|---|---|---|---|---|---|---|---|---|---|---|---|---|---|---|---|---|---|
| | T42 | Norway Maple | <i>Acer platanoides</i> | Semi-mature | 7 | 2 | 280<br>260 | No | 3 | 4 | 3.5 | 3 | 4 | No visual defects | Twin stemmed at base. Old pruning wounds. Stubs. Tight union. Partially included bark | Minor dieback. Minor deadwood | Wall 0.5m to southeast. 1 stem leans over car park to northwest. Container situated below on RPA to west. | Good | Fair | 20 to 40 yrs | Moderate | B |

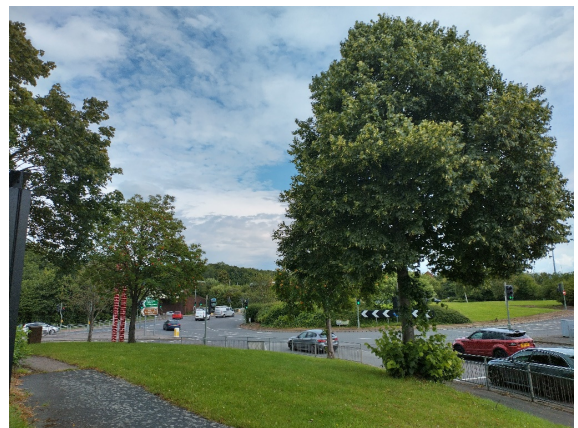
Photo 4: T45, T46 and T47 from southwest.

| Tree Species | | | | Measurements | | | Crown (m) | | | | Tree Condition | | | | | | | Value | | Management | | |
|---|---|---|---|---|---|---|---|---|---|---|---|---|---|---|---|---|---|---|---|---|---|---|
| T46 | Rowan | <i>Sorbus aucuparia</i> | Early-mature | 5 | 1 | 240 | No | 2 | 3 | 3.5 | 3 | 2 | No visual defects | Single stemmed. Slight lean. Old pruning wounds. Epicormic growths. Bark damage. Mower damage. Minor decay | Minor deadwood. Minor dieback. Old pruning wounds | Bark damage around base of stem. Slight lean to east. Overhanging pavement to south. | Fair | Fair | 10 to 20 yrs | Moderate | B | No works required in current site context |

| Tree Species | | | | Measurements | | | Crown (m) | | | | Tree Condition | | | | | | | Value | | | Management | |
|---|---|---|---|---|---|---|---|---|---|---|---|---|---|---|---|---|---|---|---|---|---|---|
| T47 | Rowan | Sorbus aucuparia | Early-mature | 6 | 1 | 220 | No | 2 | 2.5 | 2.5 | 3 | 3 | No visual defects | Single stemmed. Vertical. Bark damage. Mower damage | Minor deadwood | 2 co-dominant stems at 2m with tight union but possible supporting branch above. | Good | Fair | 20 to 40 yrs | Moderate | B | No works required in current site context |

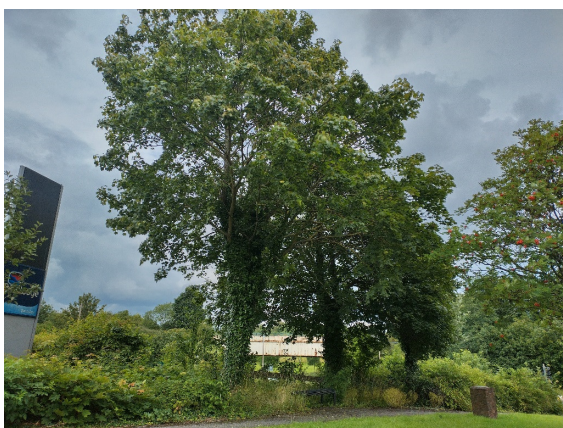
Photo 5: T49 and T50 from south.

| Tree Species | | | | Measurements | | | Crown (m) | | | | Tree Condition | | | | | | | Value | | | Management | |
|---|---|---|---|---|---|---|---|---|---|---|---|---|---|---|---|---|---|---|---|---|---|---|
| T50 | Norway Maple | Acer platanoides | Semi-mature | 9 | 1 | 470 | No | 2 | 5 | 4.5 | 4.5 | 4 | No visual defects | Single stemmed. Vertical. Ivy covered | Ivy covered. Minor deadwood | Overhanging pavement to south. Carpark 0.5m to north. | Good | Good | >40 yrs | Moderate | B | No works required in current site context |

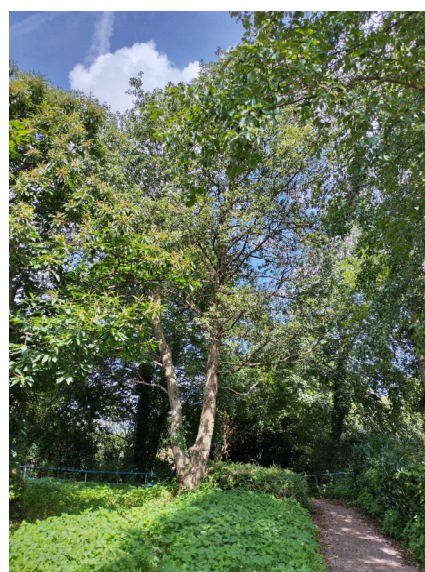
Photo 6: T71 from south.

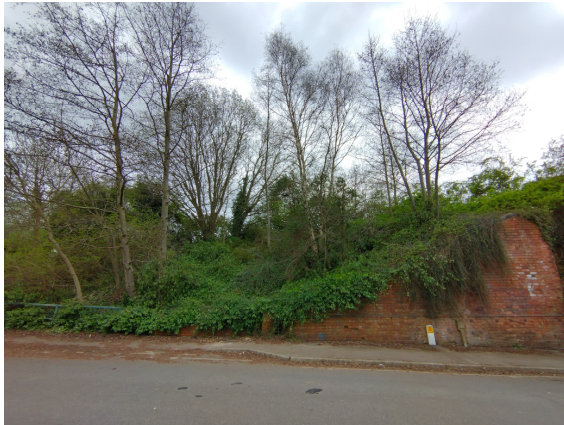
Photo 1: Northern edge of T79 from north.

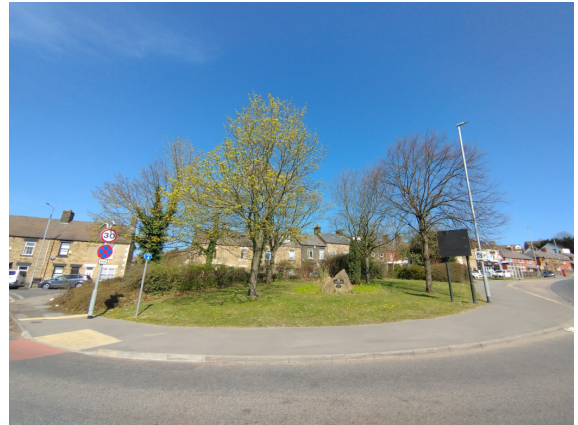
Photo 2: T153 to T156 from west.

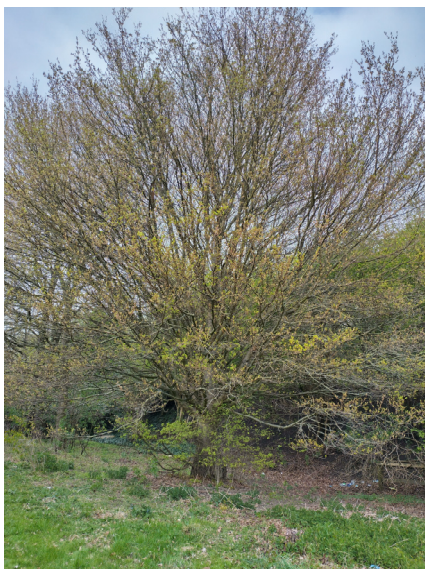
Photo 3: T226 from south

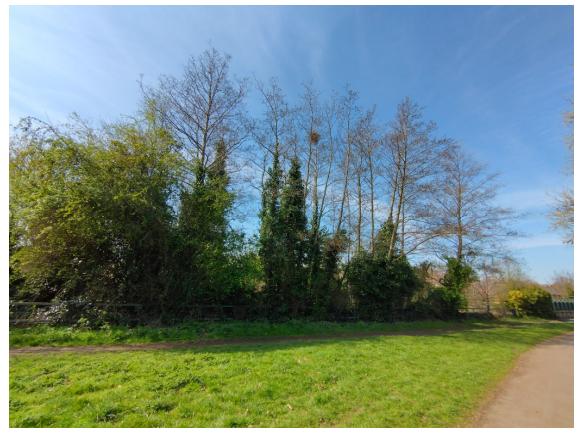
Photo 4: G77 from southeast.

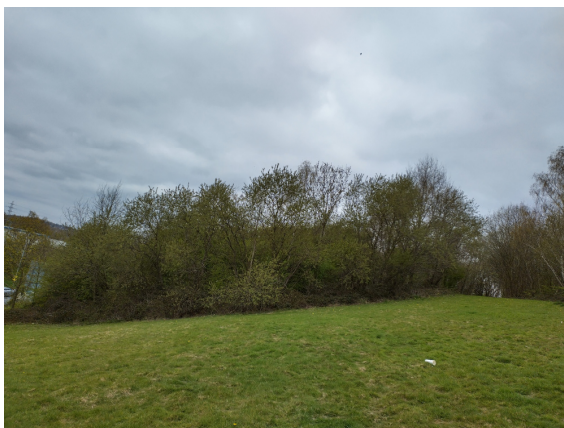
Photo 5: G247 from south.

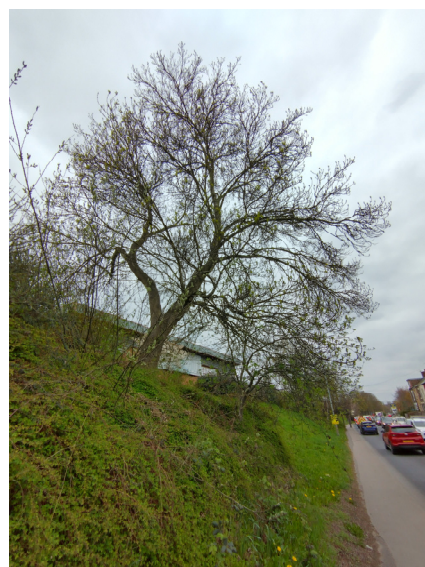
Photo 6: T242 from south.
