# Bearwood Associates Ltd

arboricultural impact assessment

## Wentworth Castle Gardens, Rebuilding Works – Collapsed Section of Battlements

August 2024

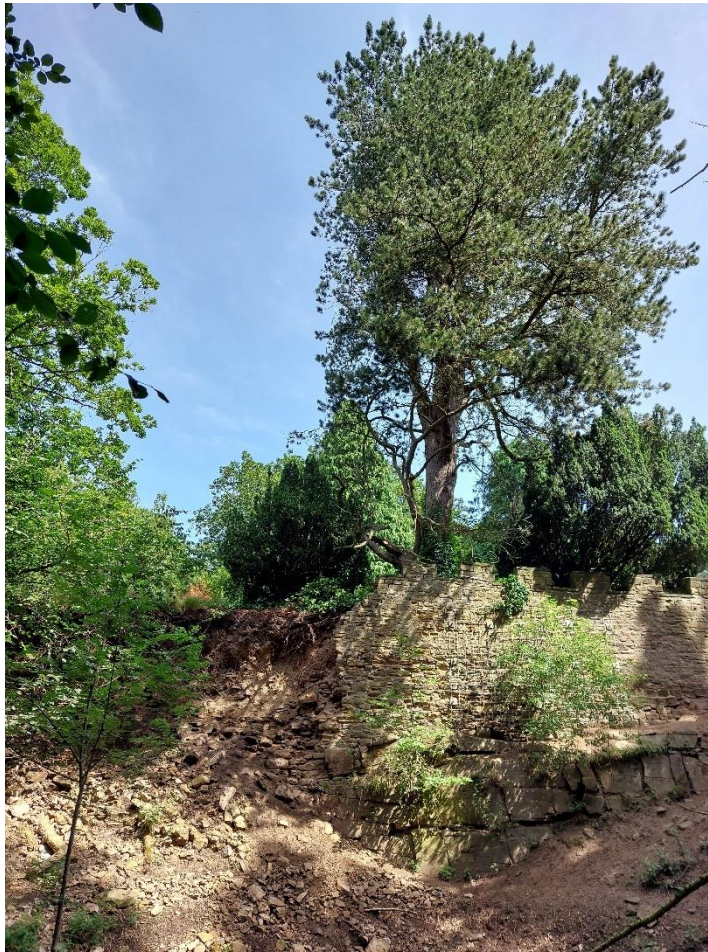
**Plate 01:** view of the collapsed and remaining sections of the Battlement wall, from the south. Trees 3873, 3947 and 3910 (left to right) are visible at the top of the wall. 15 July 2024.

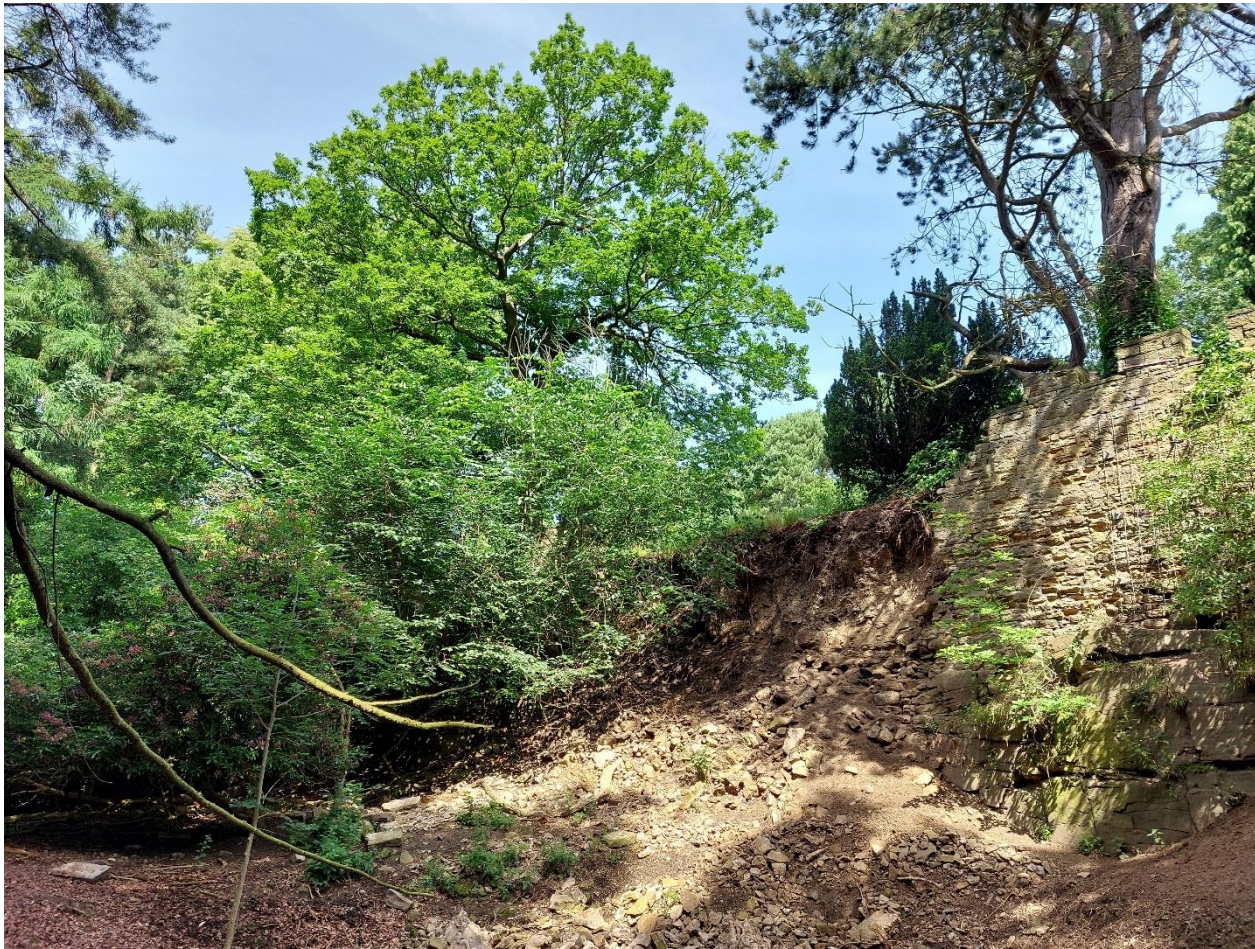
**Plate 02:** view of the collapsed and remaining sections of the Battlement wall, from the southeast. Trees 3978, 3958, 3875, 3873, 3947 and 3910 (left to right) are visible. 15 July 2024.

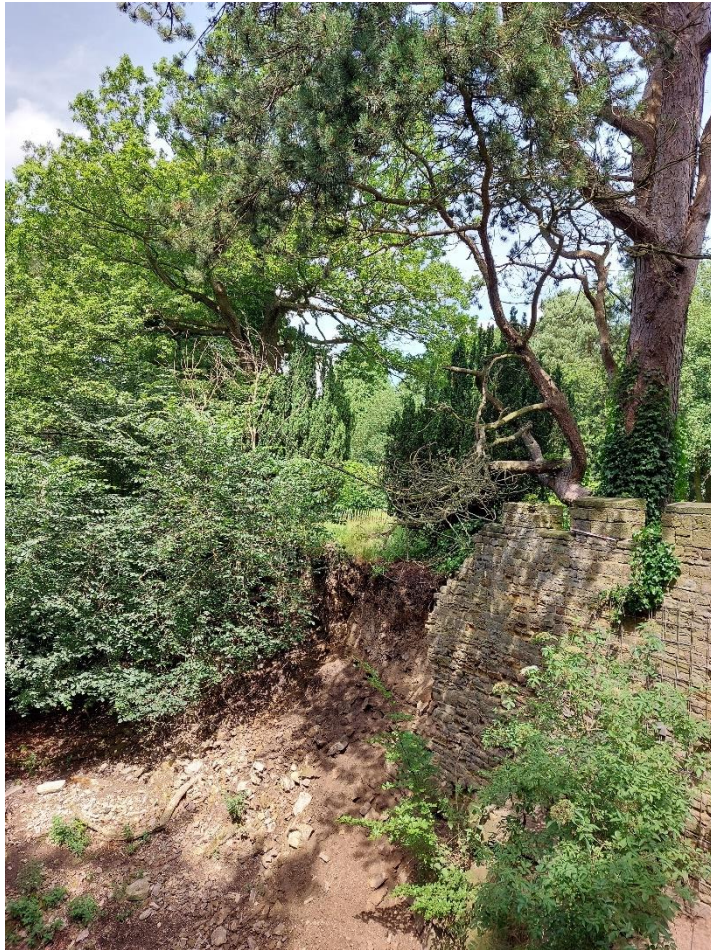
**Plate 03:** view of the collapsed and remaining sections of the Battlement wall, from wall-top level, from the southeast. Trees 3978, 3958, 3939, 3873 and 3947 (left to right) are visible. 15 July 2024.
