# **Woolley Colliery Road, Darton, Barnsley**

## **Visual Condition Survey**

PROPOSED RESIDENTIAL DEVELOPMENT  
WOOLLEY COLLIERY ROAD, DARTON, BARNSELY

Ref: 24-256-006.01

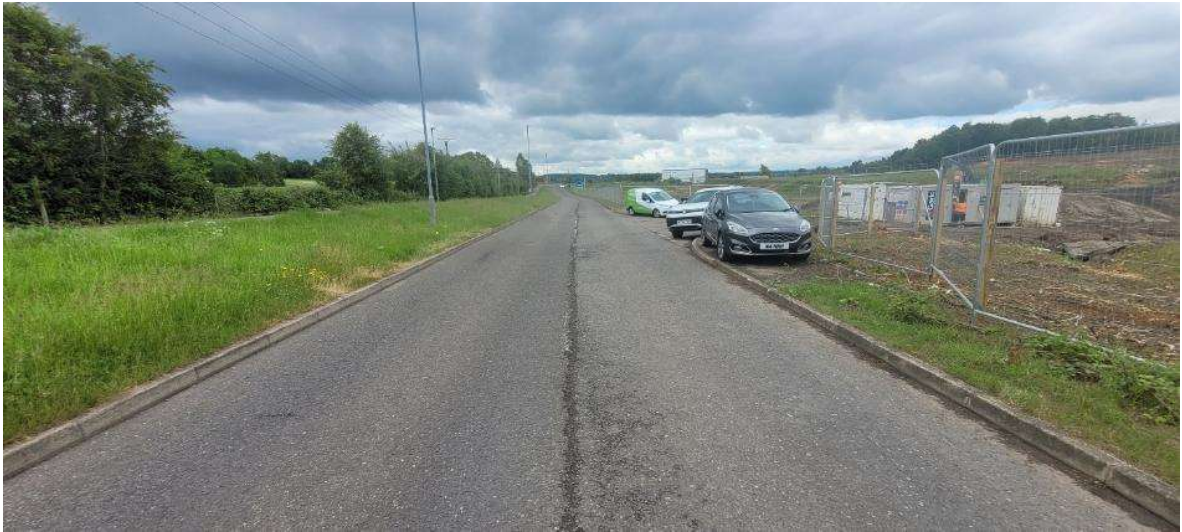
**Photo 1**

Woolley Colliery Road – Looking South

Surface course deterioration along the centreline joint.

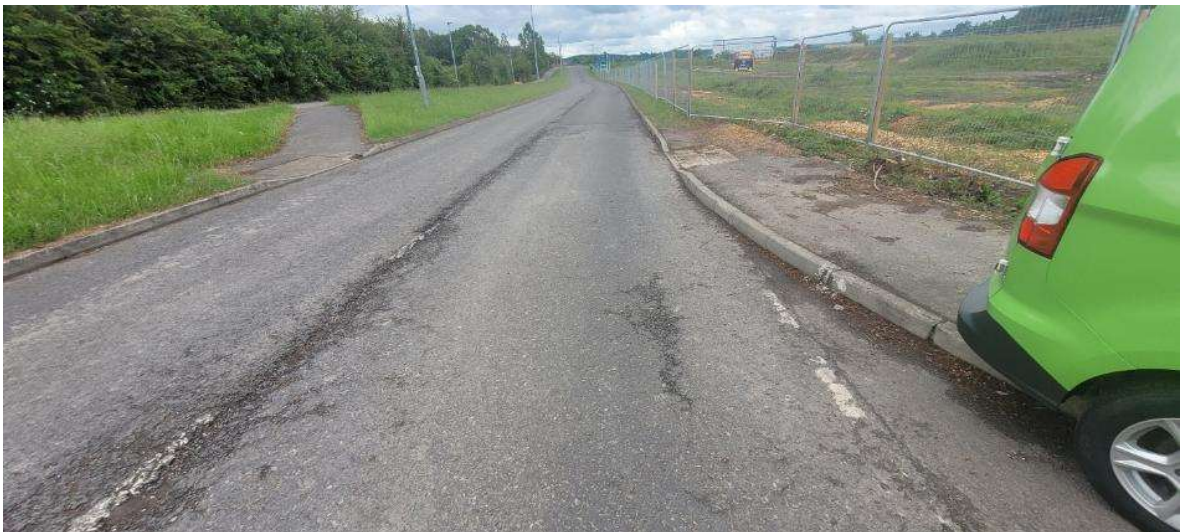
**Photo 2**

Woolley Colliery Road – Looking South

Surface course deterioration along the centreline joint. Visible damaged kerbs.

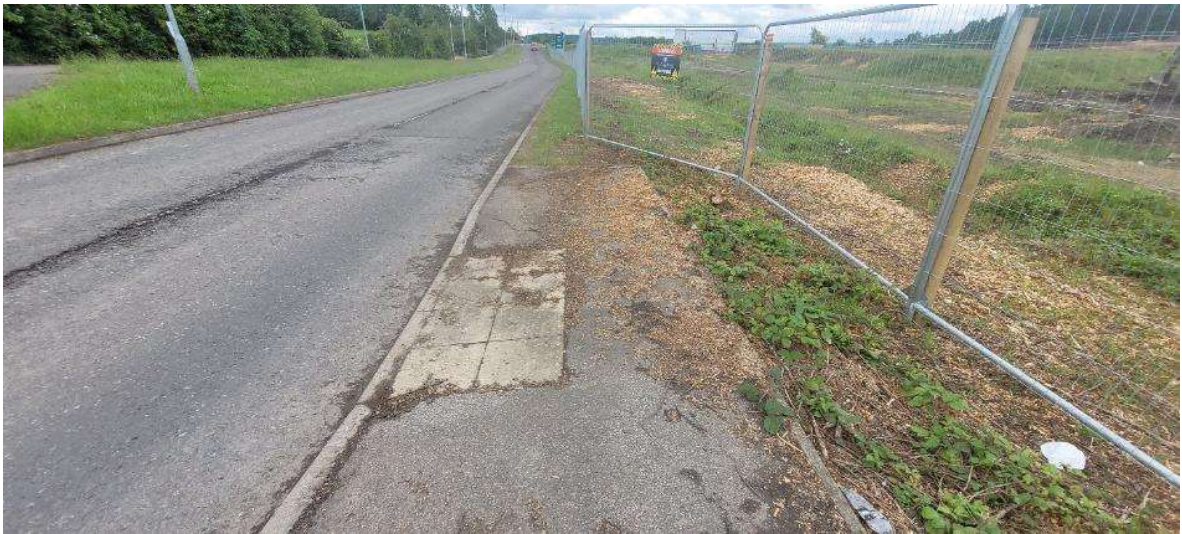
**Photo 3**

Woolley Colliery Road – Looking South

Vegetation overgrown on footway and tactile paving. Tactile paving slabs are worn.

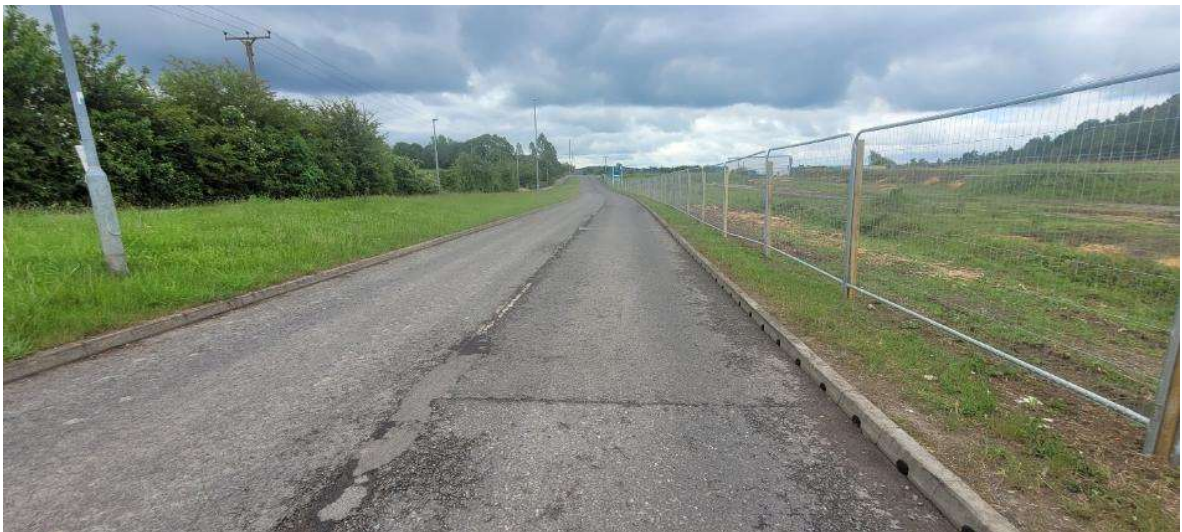
**Photo 4**

Woolley Colliery Road – Looking South

Surface course deterioration along the centreline joint has been previously repaired.

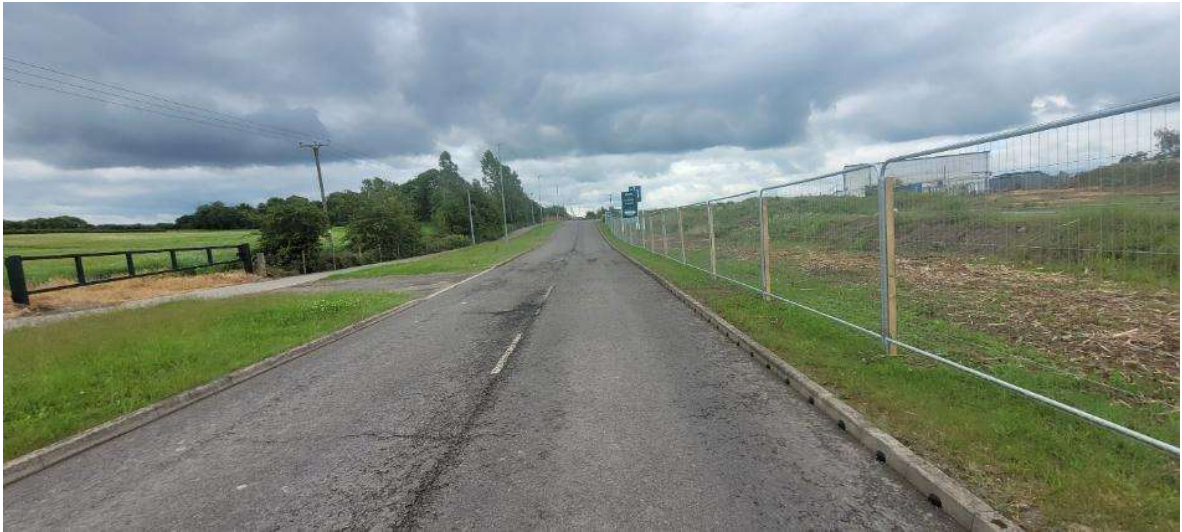
**Photo 5**

Woolley Colliery Road – Looking South

Surface course deterioration along the centreline joint.

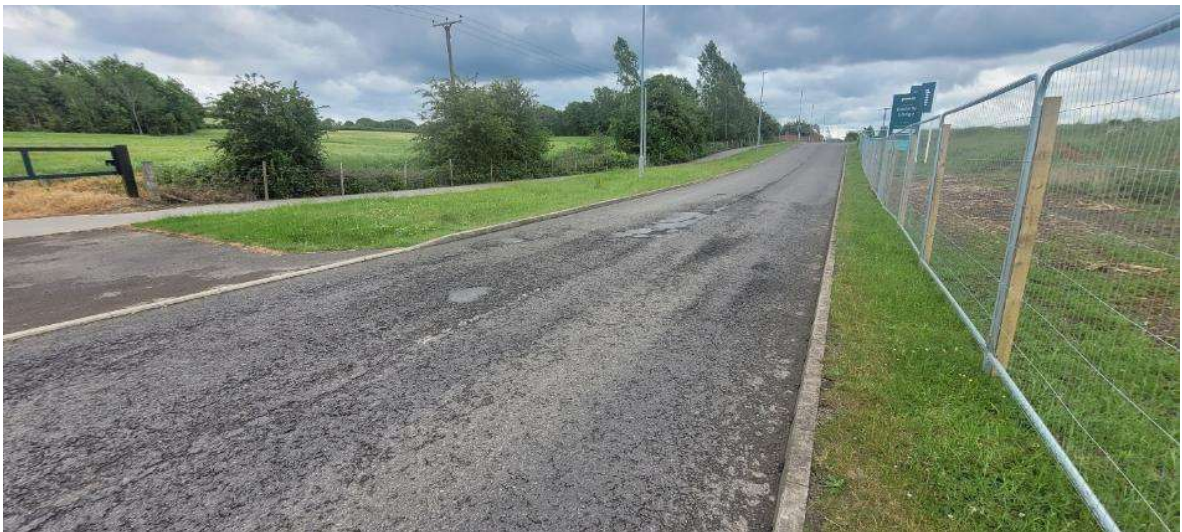
**Photo 6**

Woolley Colliery Road – Looking South

Visible repair patches on surface course material adjacent to the centreline joint.

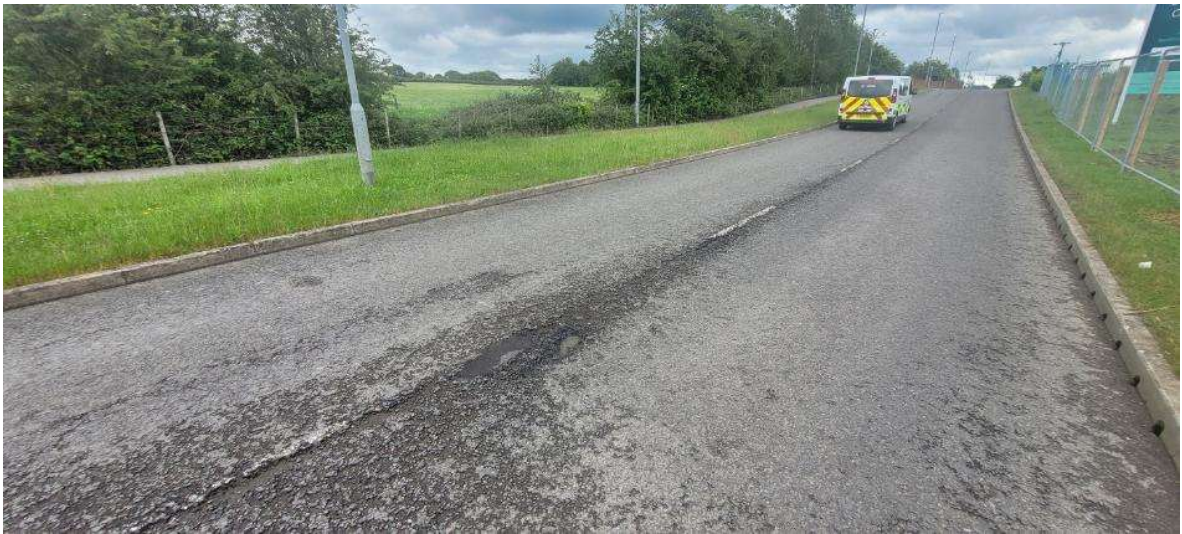
**Photo 7**

Woolley Colliery Road – Looking South

Surface course is plucked along the centreline joint with loose stones visible.

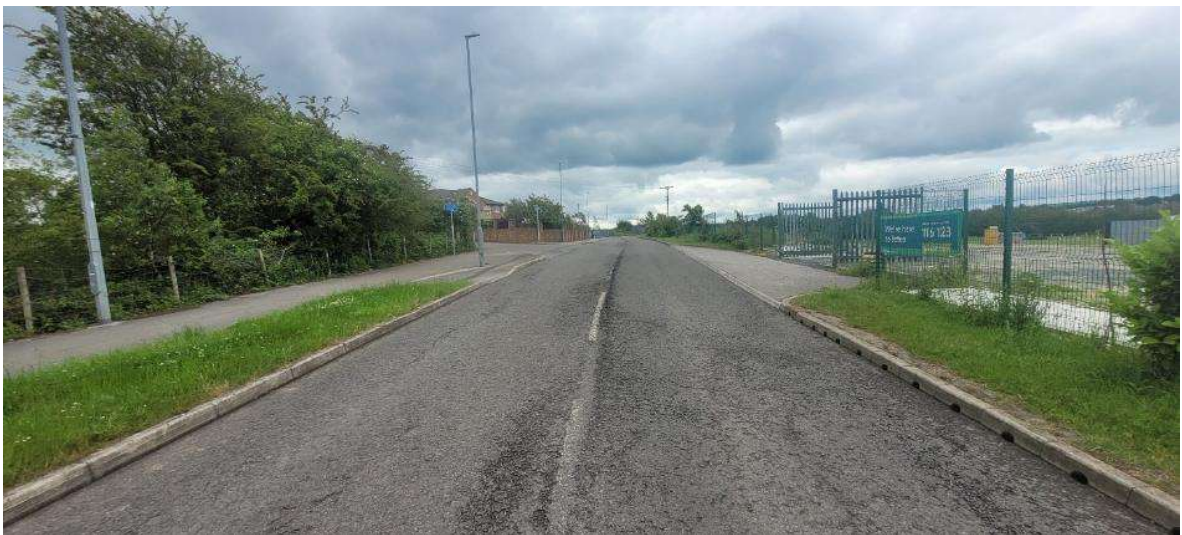
**Photo 8**

Woolley Colliery Road – Looking South

Surface course deterioration along the centreline joint with visible cracks across the road.

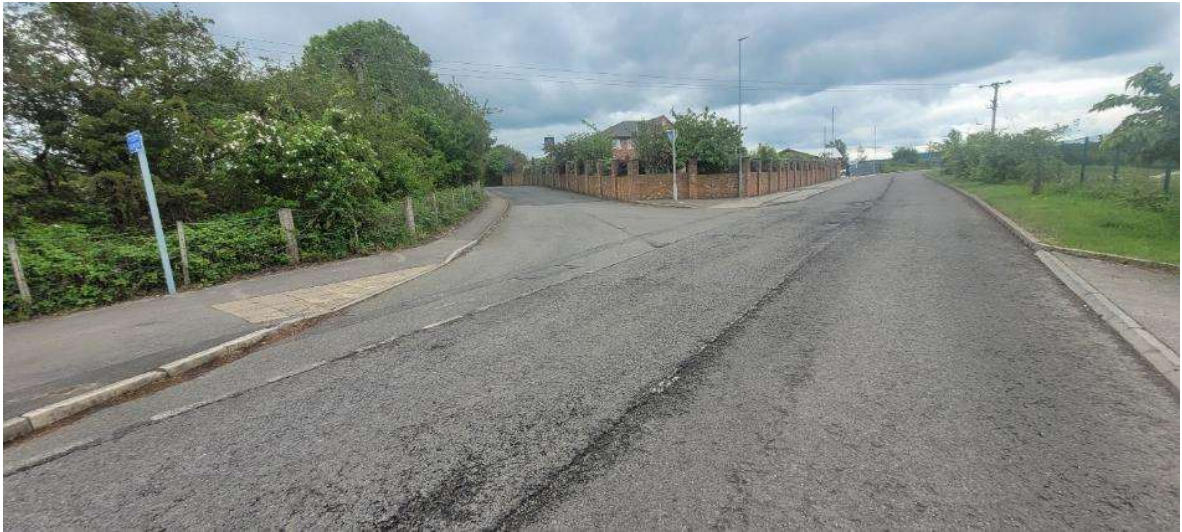
**Photo 9**

Woolley Colliery Road at Bloomhouse Lane (N) junction - Looking South

Surface course deterioration along the centreline joint.

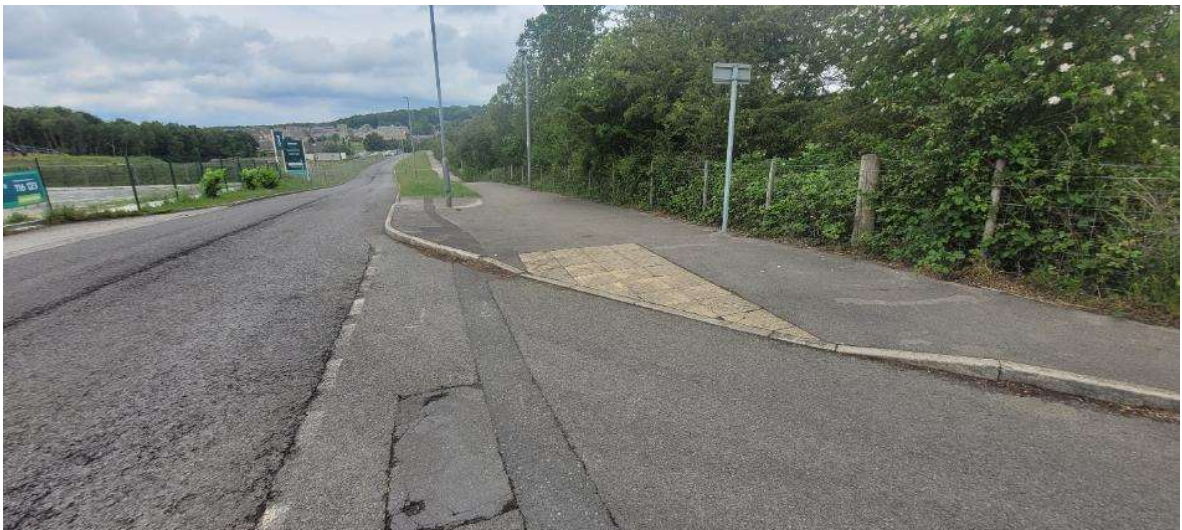
**Photo 10**

Woolley Colliery Road at Bloomhouse Lane (N) junction – Looking North

Surface course deterioration along the joint where the material changes and visible utility scars.

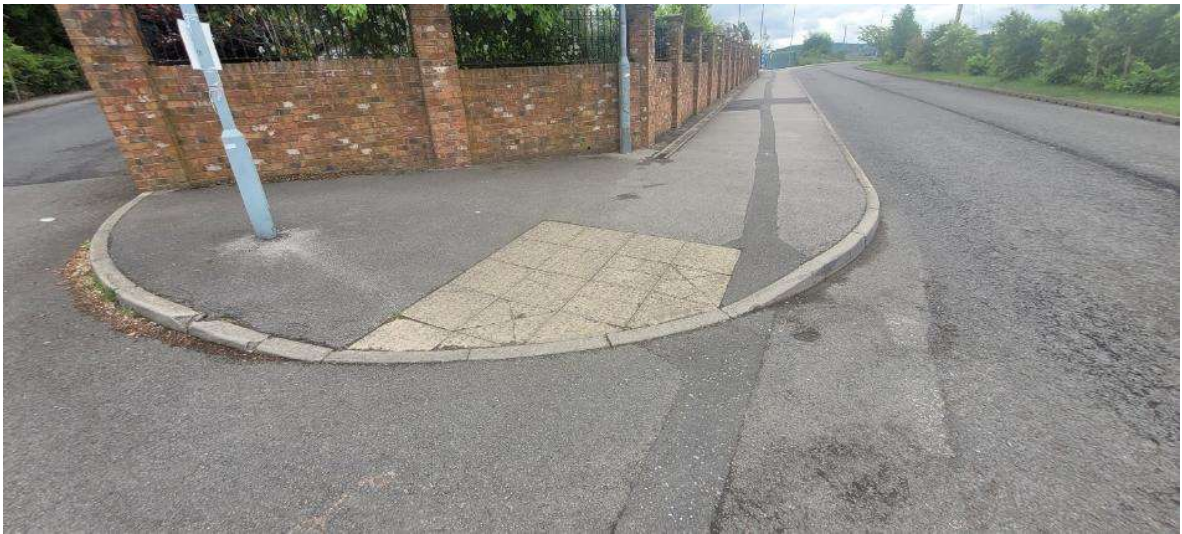
**Photo 11**

Woolley Colliery Road at Bloomhouse Lane (N) junction – Looking South

Broken Tactile pavements and visible utility scars.

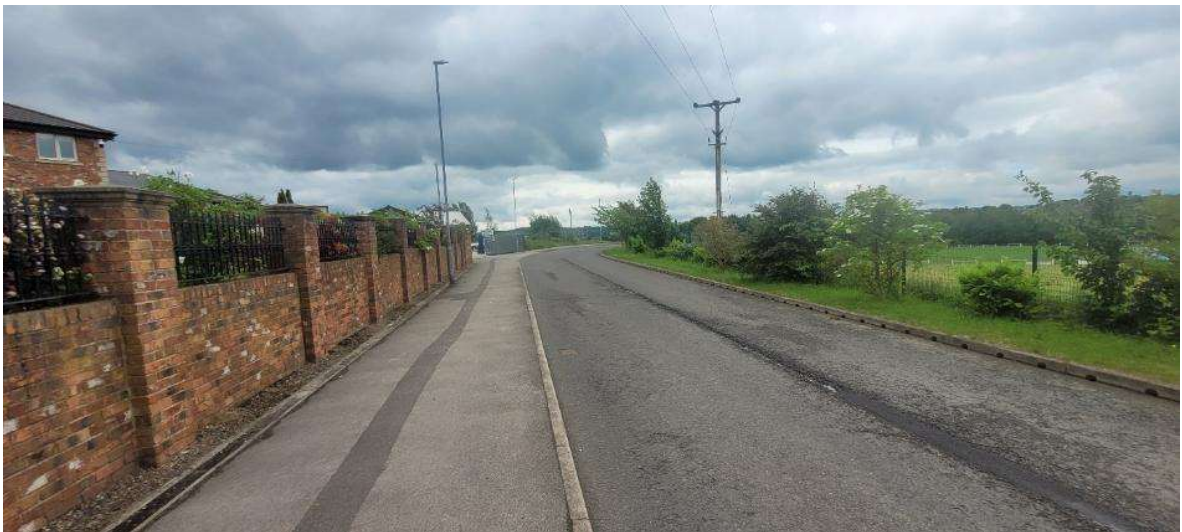
**Photo 12**

Woolley Colliery Road – Looking South

Surface course deterioration along the centreline joint and visible utility scar on the footway.

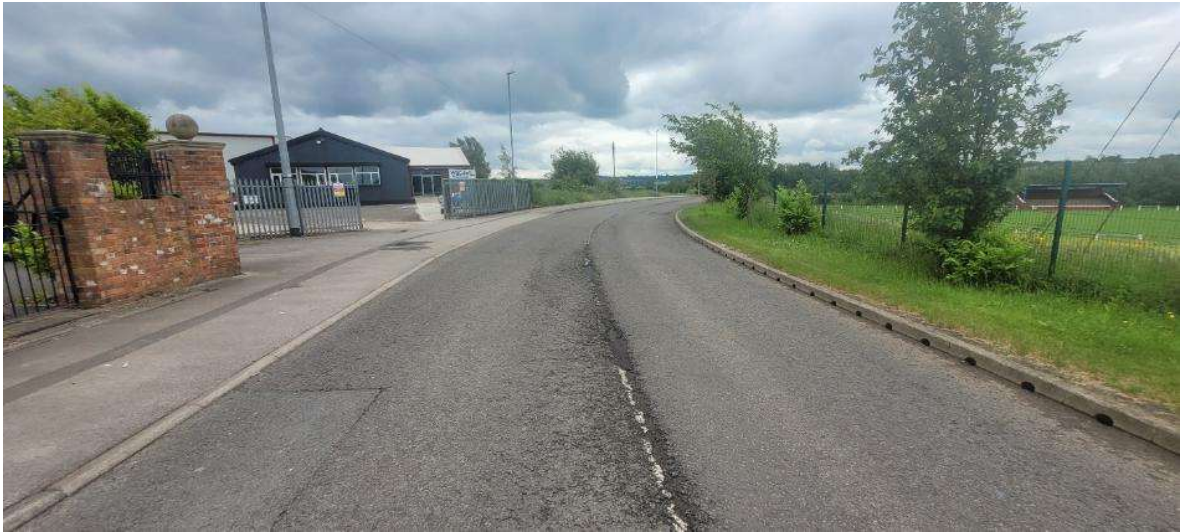
**Photo 13**

Woolley Colliery Road – Looking South

Surface course deterioration along the centreline joint and visible utility scar on the footway.

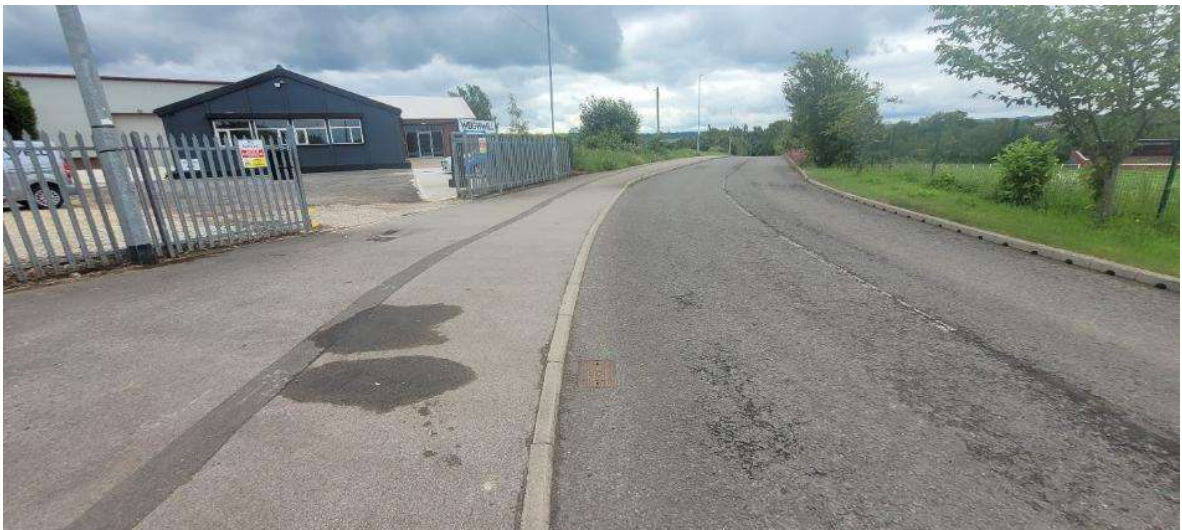
**Photo 14**

Woolley Colliery Road – Looking South

Surface course deterioration along the centreline joint and visible utility scar on the footway.

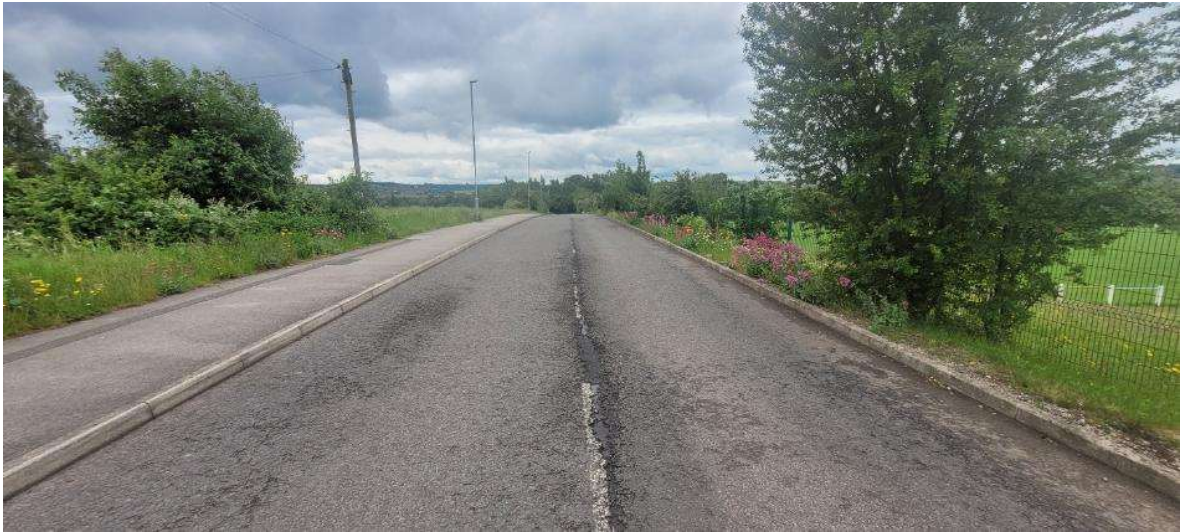
**Photo 15**

Woolley Colliery Road – Looking South

Surface course deterioration along the centreline joint and visible utility scar on the footway.

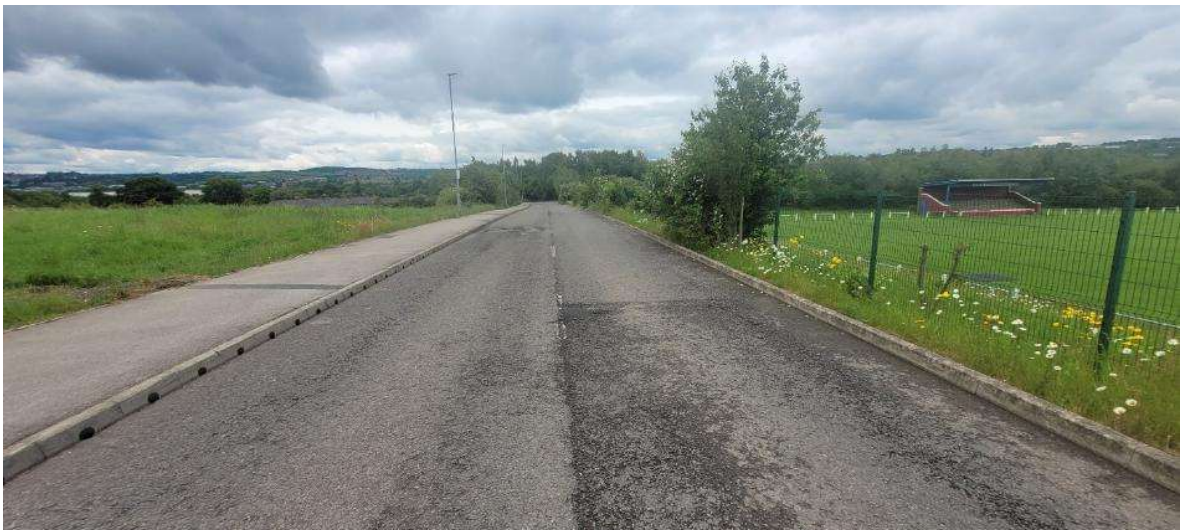
**Photo 16**

Woolley Colliery Road – Looking South

Surface course deterioration along the centreline joint and visible utility scar on the footway.

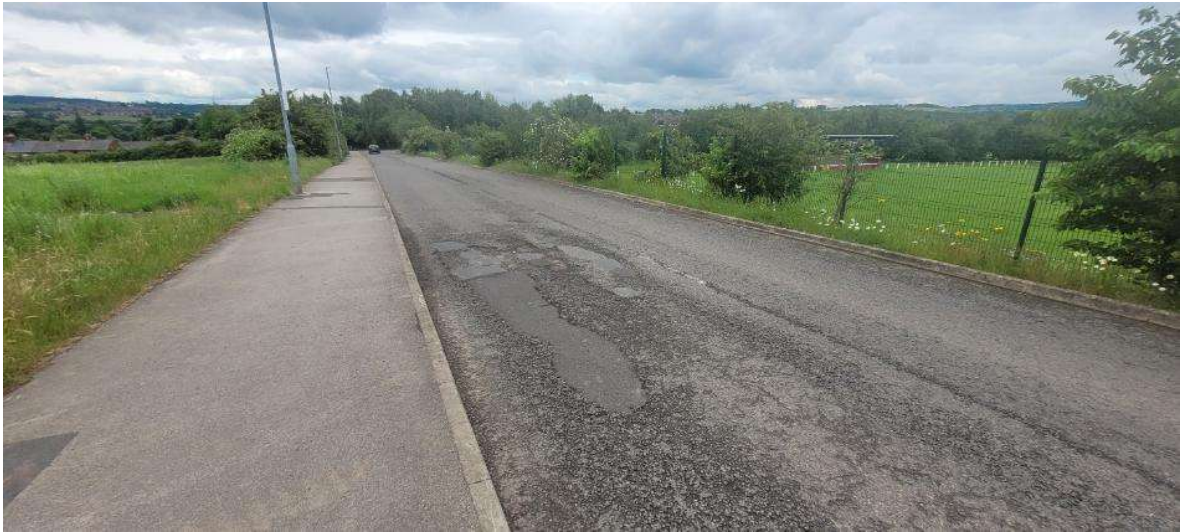
**Photo 17**

Woolley Colliery Road – Looking South

Surface course deterioration along the centreline joint, visible patch repair in carriageway.

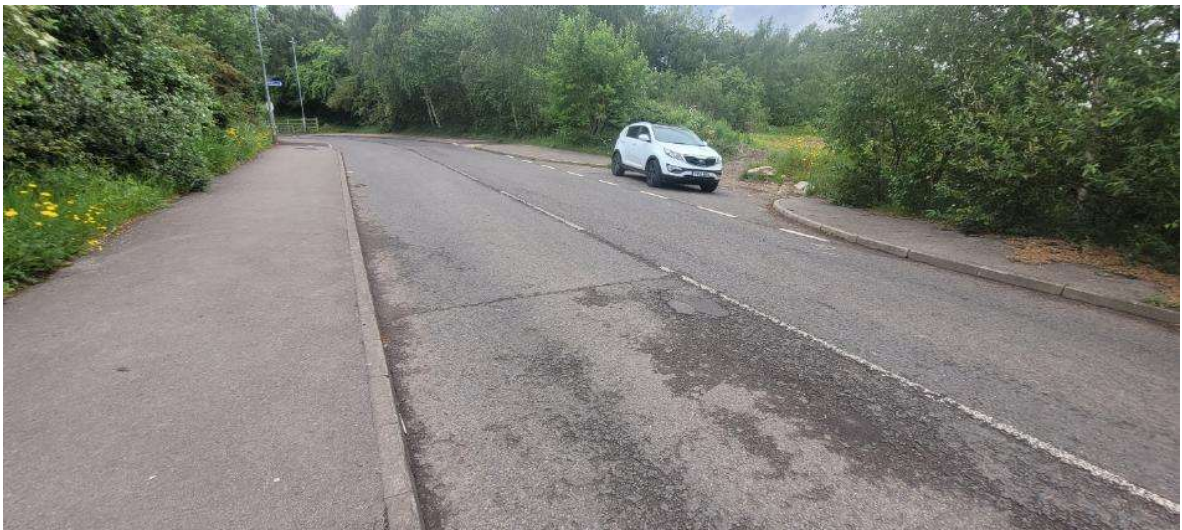
**Photo 18**

Woolley Colliery Road – Looking South

Surface course deterioration along the centreline joint, visible patch repair in carriageway.

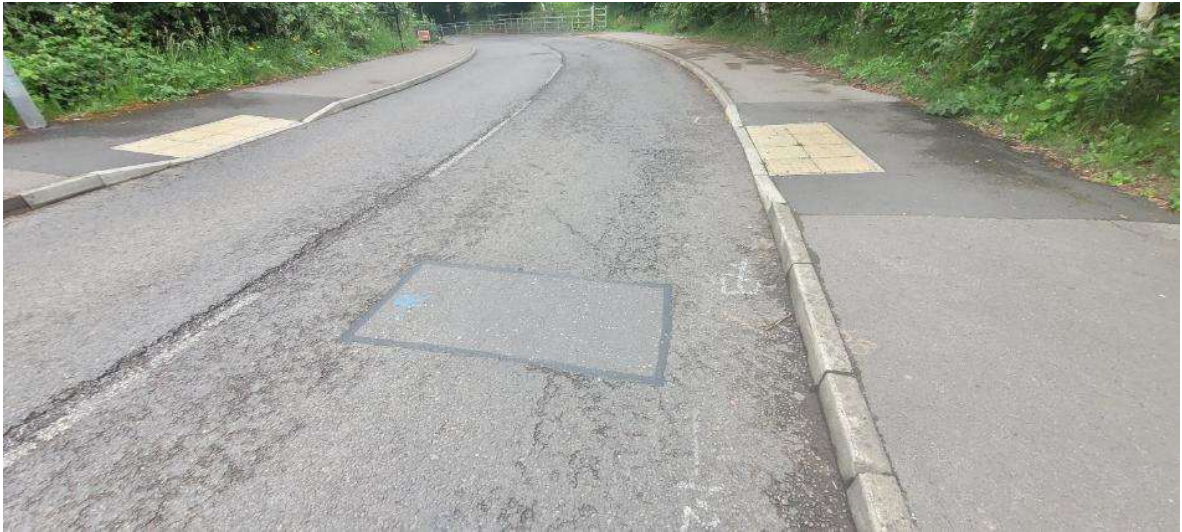
**Photo 19**

Woolley Colliery Road – Looking South

Surface course deterioration along the centreline joint, visible patch repair in carriageway.

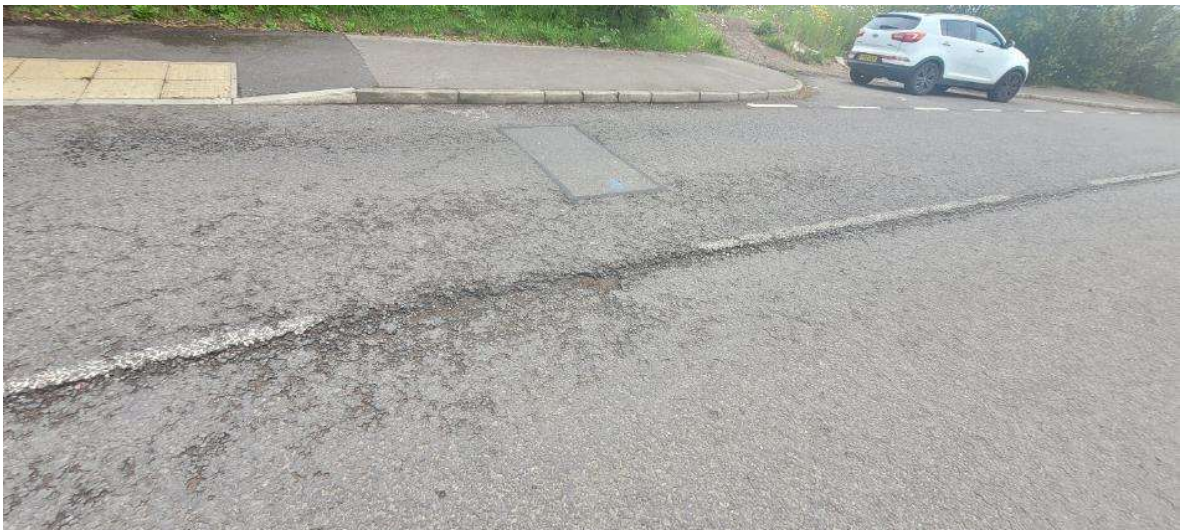
**Photo 20**

Woolley Colliery Road – Looking West

Surface course deterioration along the centreline joint, visible patch repair in carriageway.

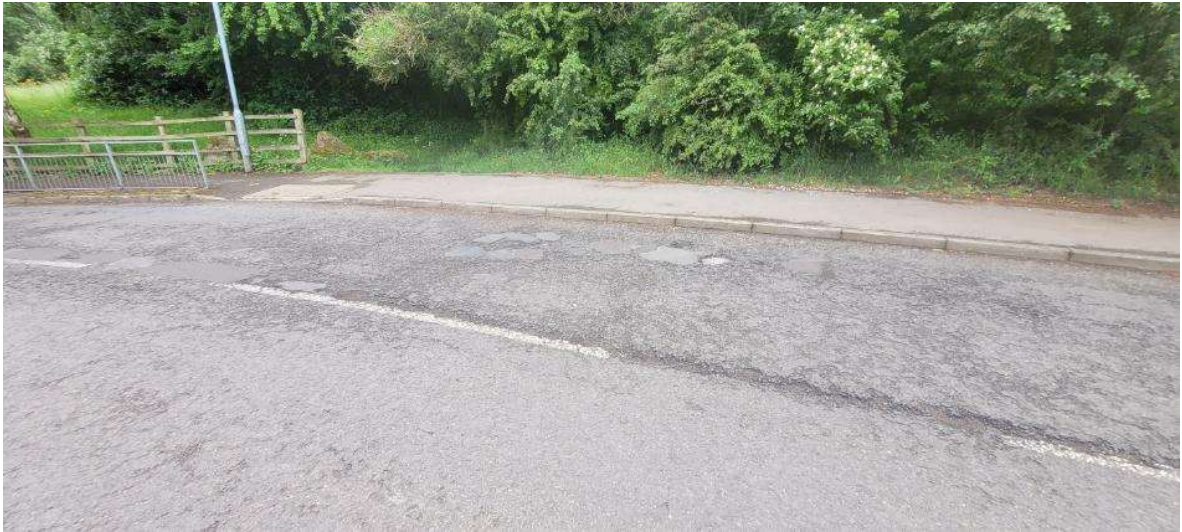
**Photo 21**

Woolley Colliery Road – Looking West

Surface course deterioration along the centreline joint, visible patch repair in carriageway.

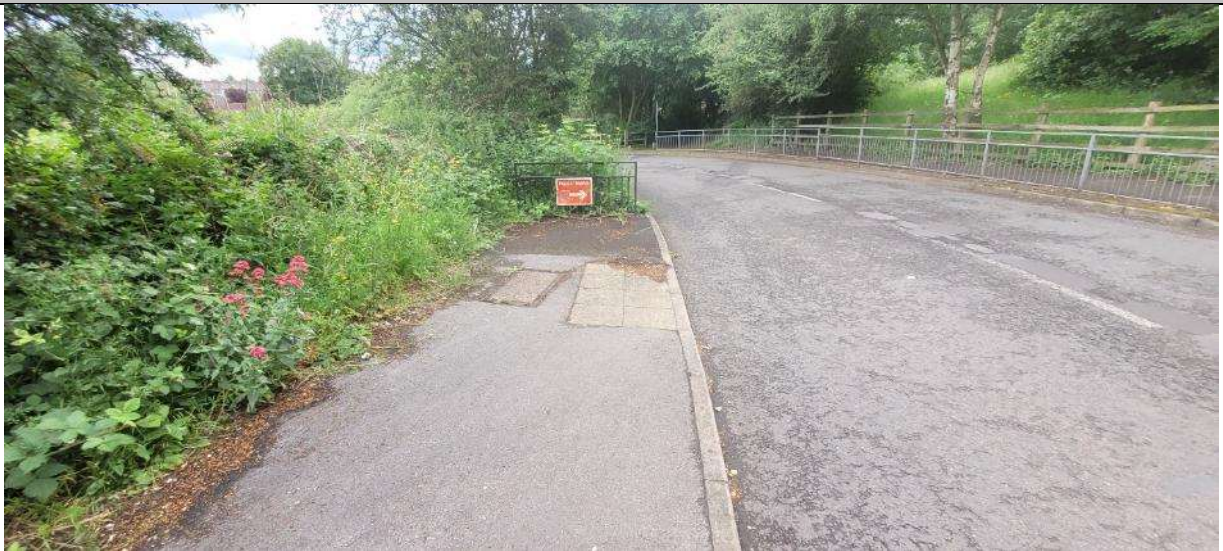
**Photo 22**

Woolley Colliery Road – Looking South

Surface course deterioration along the centreline joint, visible patch repair in carriageway.

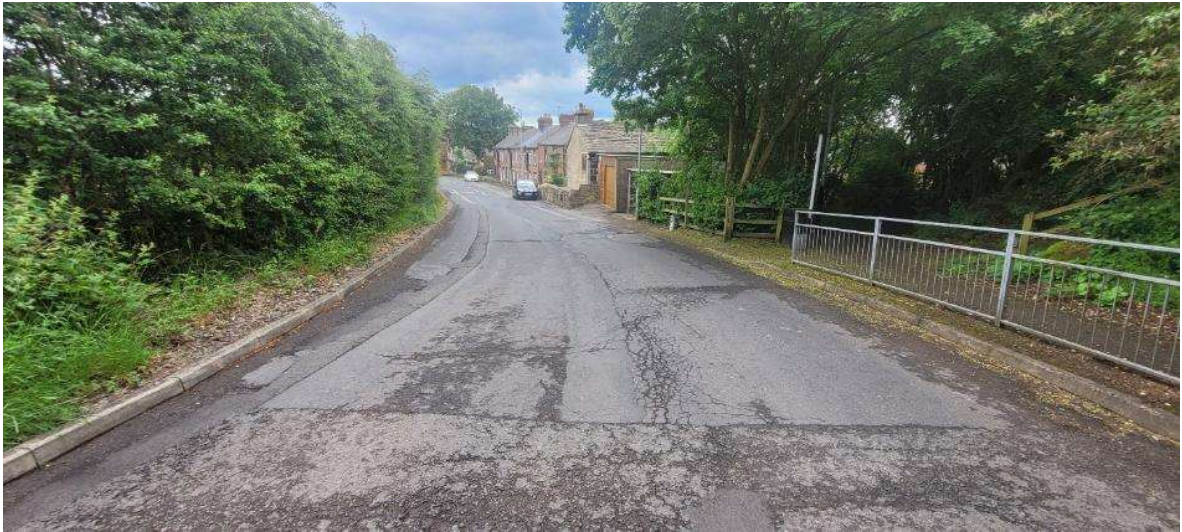
**Photo 23**

Woolley Colliery Road – Looking East

Surface deterioration along full width of carriageway and around a visible patch repair.

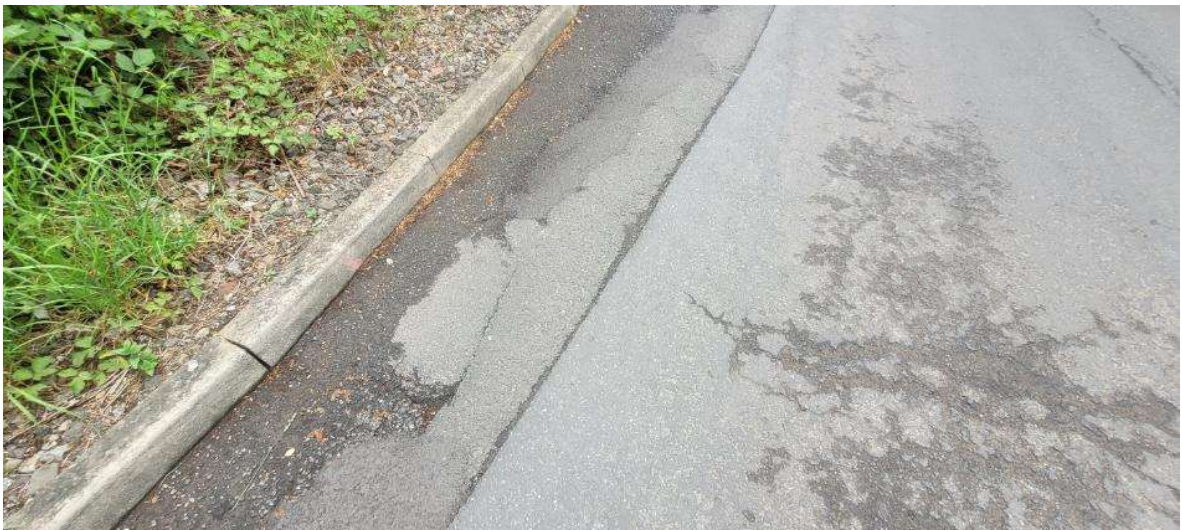
**Photo 24**

Woolley Colliery Road – Looking East

Damaged surface course material.

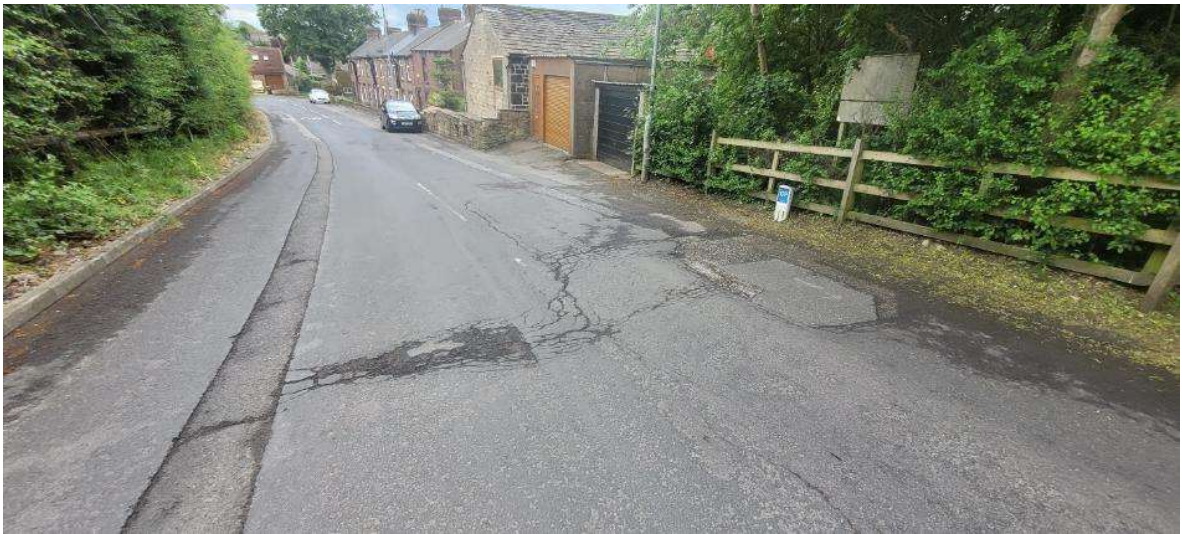
**Photo 25**

Woolley Colliery Road – Looking East

Visible cracking in carriageway, visible utility scar has dropped.

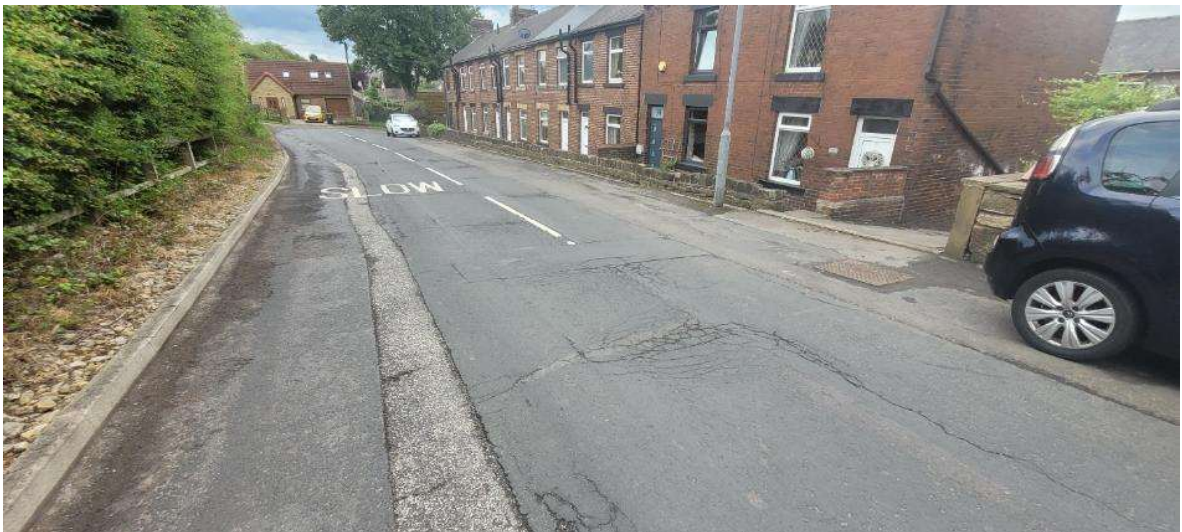
**Photo 26**

Woolley Colliery Road – Looking East

Visible cracking in carriageway, visible utility scar has dropped.

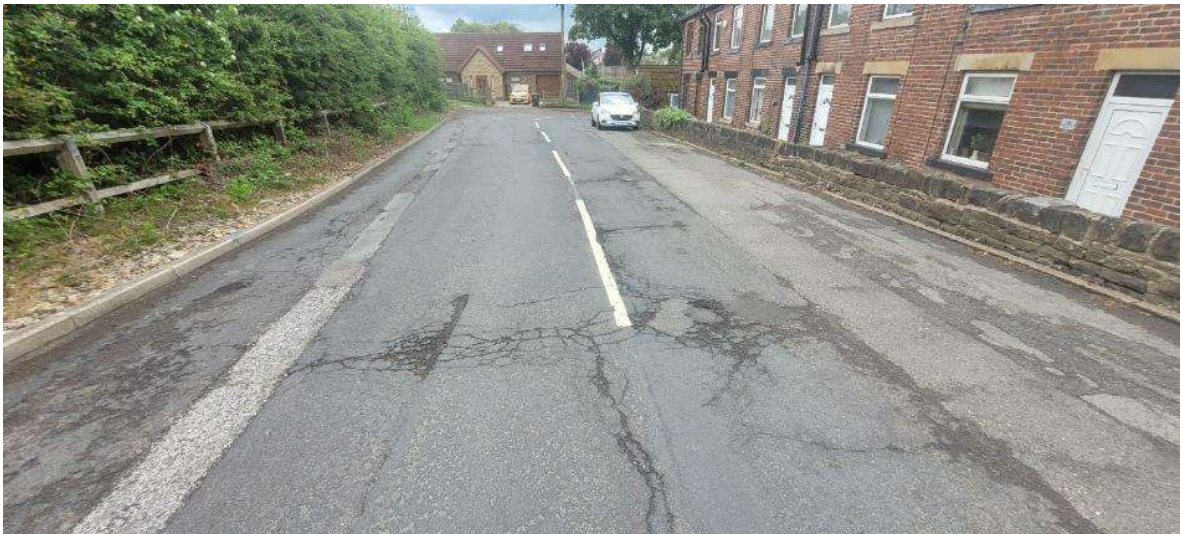
**Photo 27**

Woolley Colliery Road – Looking East

Carriageway is in a poor state of repair with visible cracking and numerous utility scars.

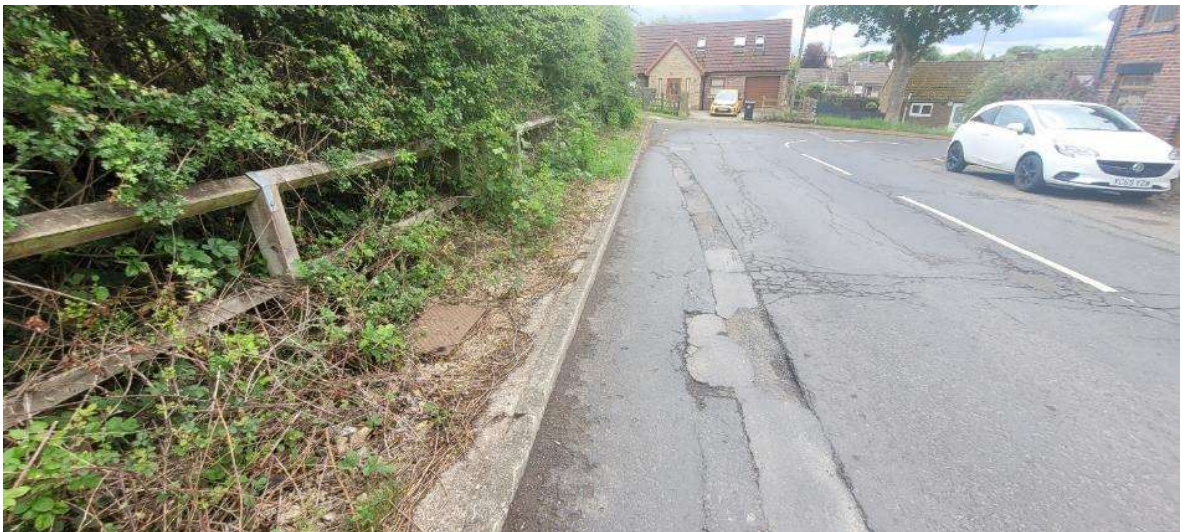
**Photo 28**

Woolley Colliery Road – Looking East

Visible cracking in carriageway, visible utility scar has dropped.

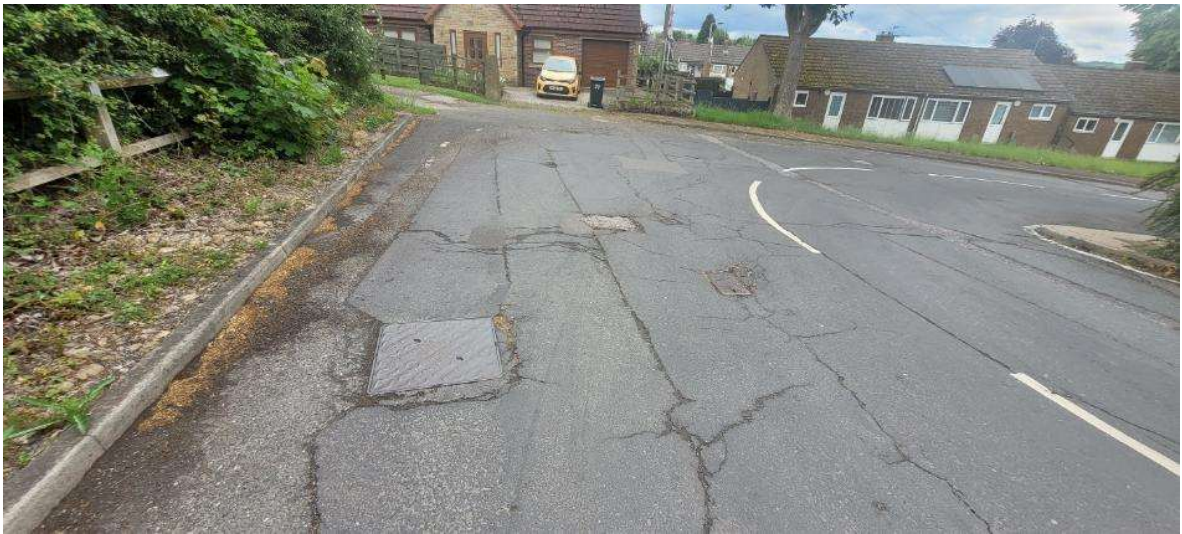
**Photo 29**

Woolley Colliery Road – Looking East

Visible cracking in carriageway, surface around manhole has dropped.

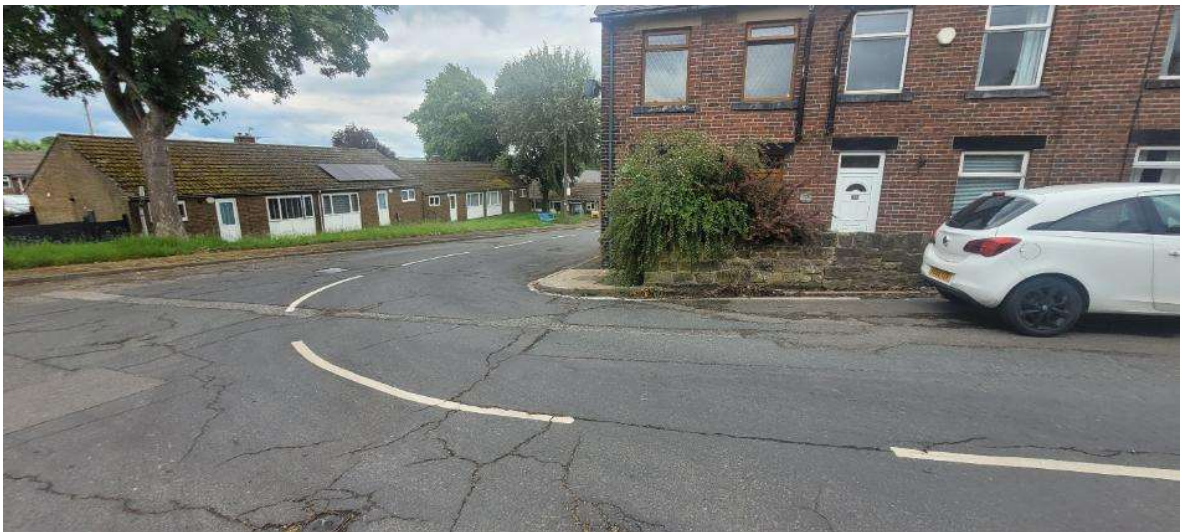
**Photo 30**

Woolley Colliery Road – Looking South

Carriageway is in a poor state of repair with visible cracking and numerous utility scars.

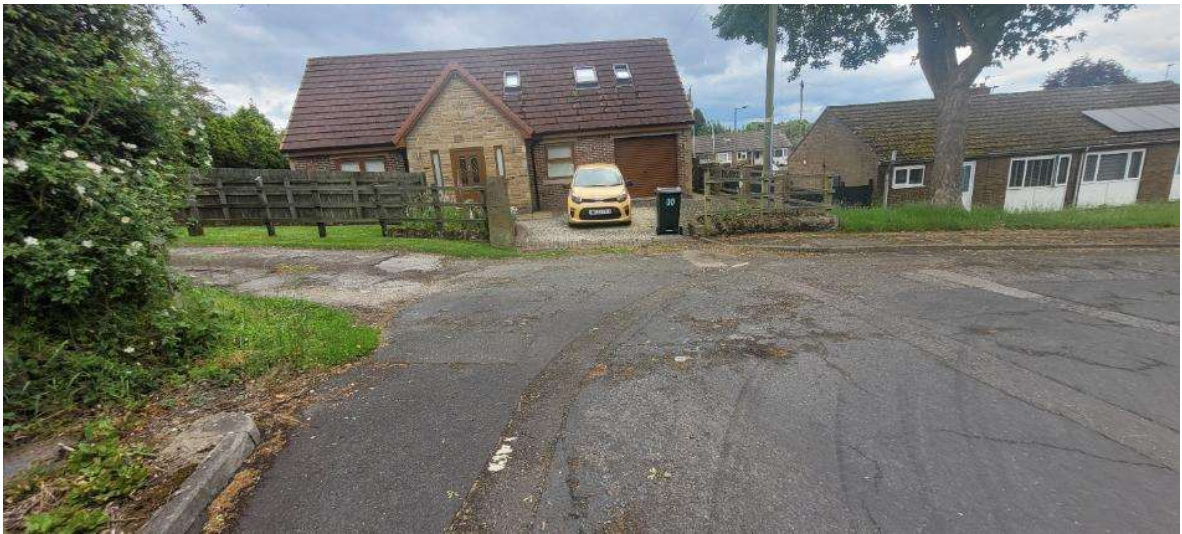
**Photo 31**

Woolley Colliery Road – Looking East

Carriageway is in a poor state of repair with visible cracking and numerous utility scars.

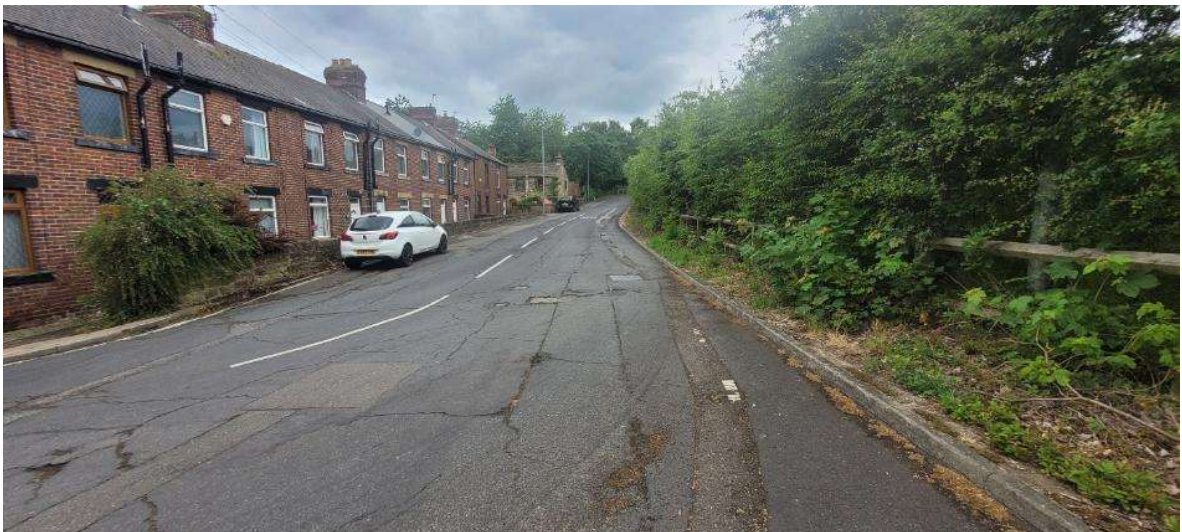
**Photo 32**

Woolley Colliery Road – Looking West

Carriageway is in a poor state of repair with visible cracking and numerous utility scars.

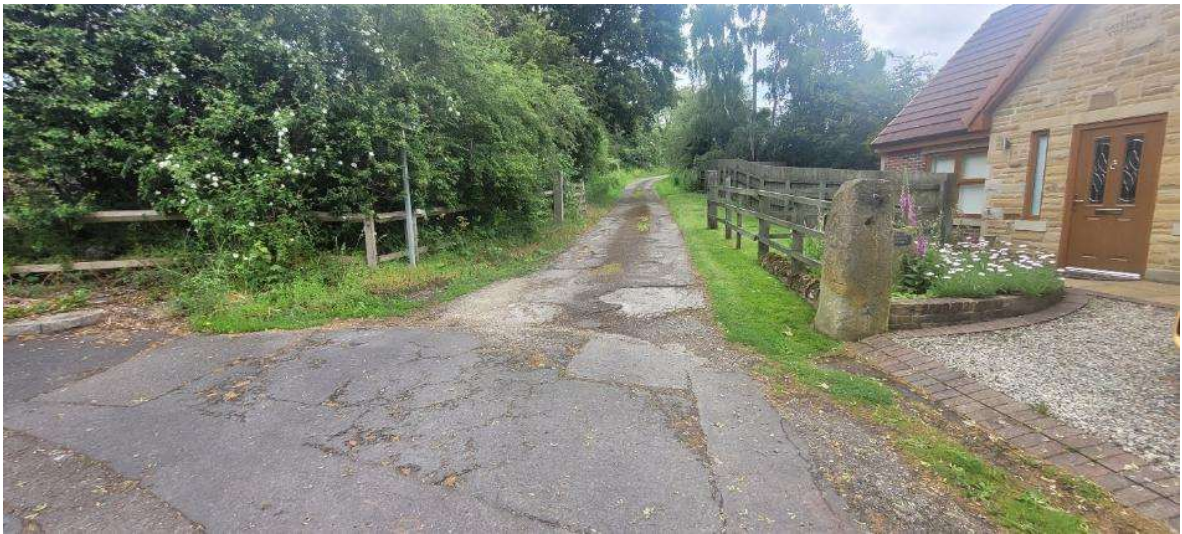
**Photo 33**

Woolley Colliery Road – Looking along Bloomhouse Lane (S)

Footway is worn at the end of its lifespan.

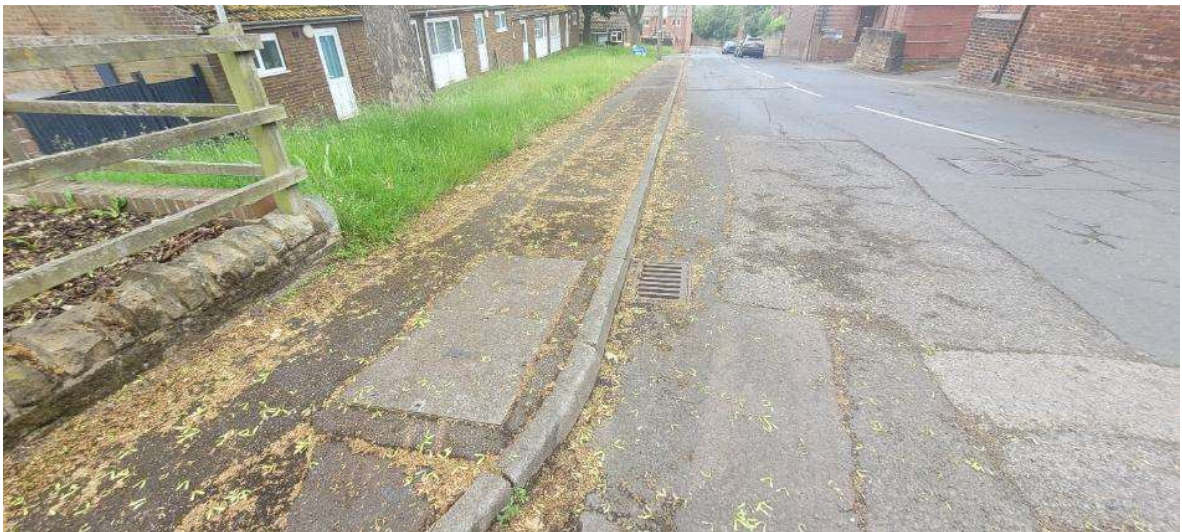
**Photo 34**

Woolley Colliery Road – Looking South

Visible cracking in carriageway, visible utility scars in carriageway and footway.
