# **Woolley Colliery Road, Darton, Barnsley**

## **Visual Condition Survey**

PROPOSED RESIDENTIAL DEVELOPMENT  
WOOLLEY COLLIERY ROAD, DARTON, BARNSELY

Ref: 24-256-006.01

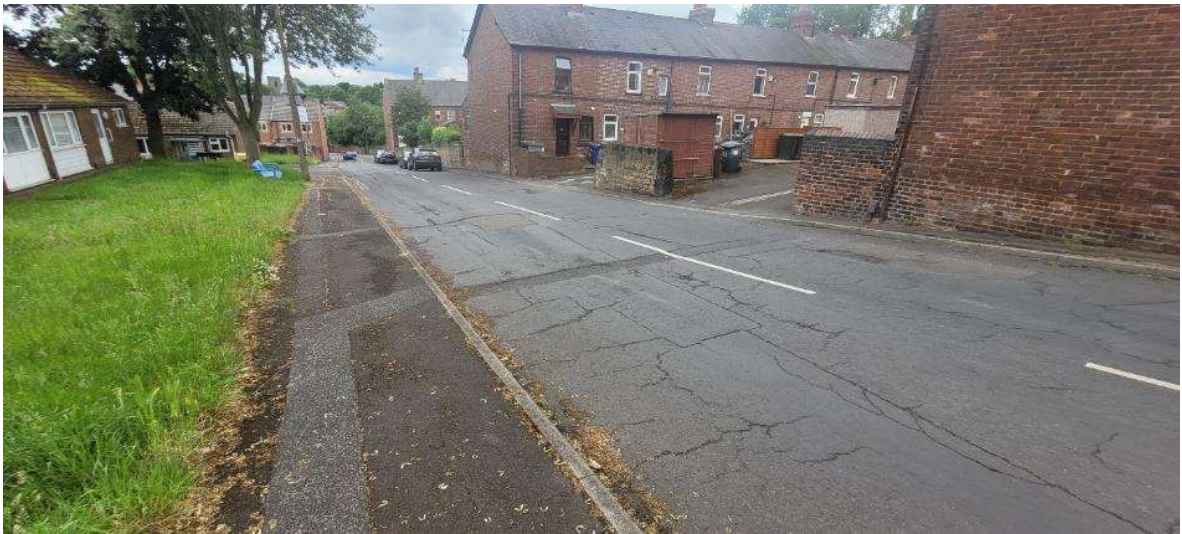
**Photo 35**

Woolley Colliery Road – Looking South

Visible cracking in surface course material, visible utility scars in carriageway and footway.

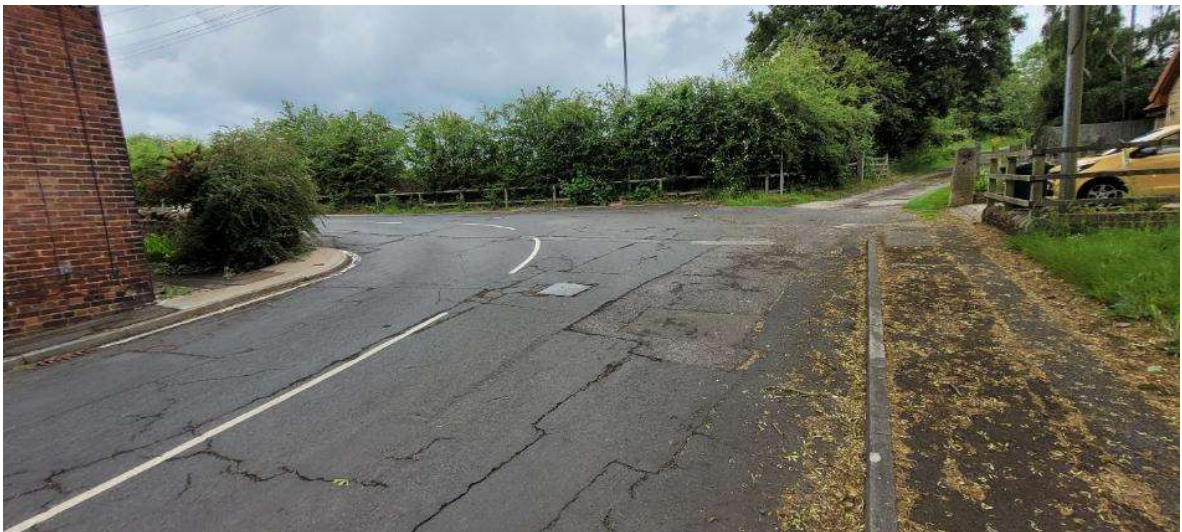
**Photo 36**

Woolley Colliery Road – Looking North

Visible cracking in surface course material, visible utility scars in carriageway and footway.

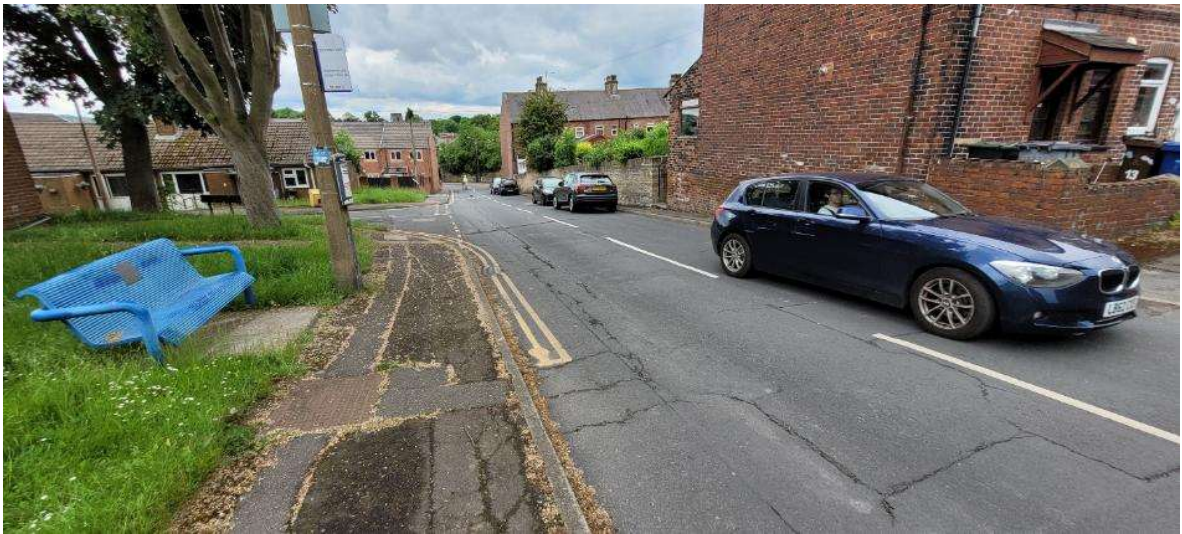
**Photo 37**

Woolley Colliery Road – Looking South

Visible cracking in surface course material, visible utility scars in carriageway and footway.

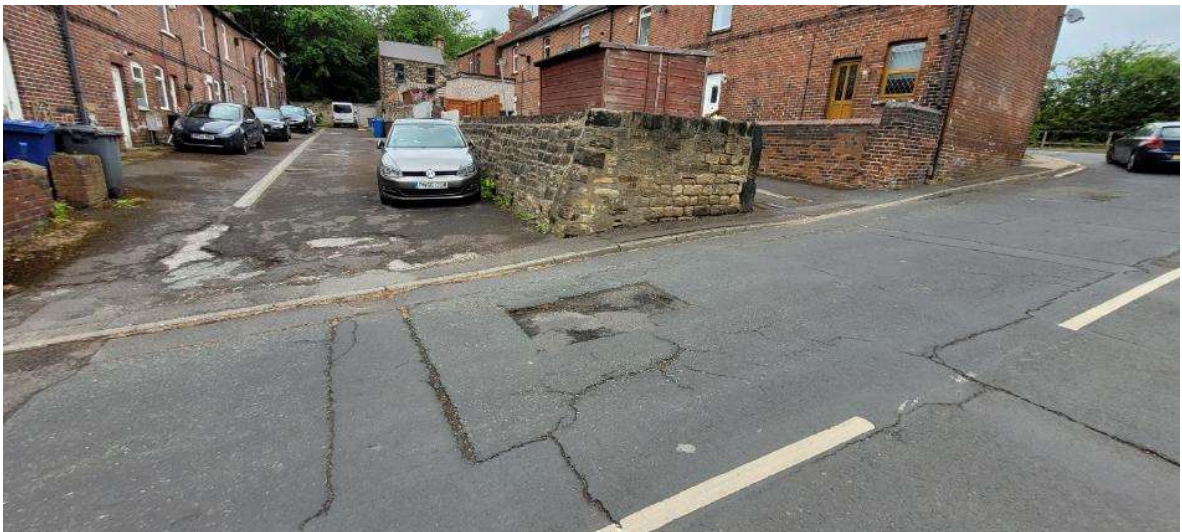
**Photo 38**

Woolley Colliery Road – Looking toward Fountain Square

Visible cracking in surface course material, visible utility scars in carriageway and footway.

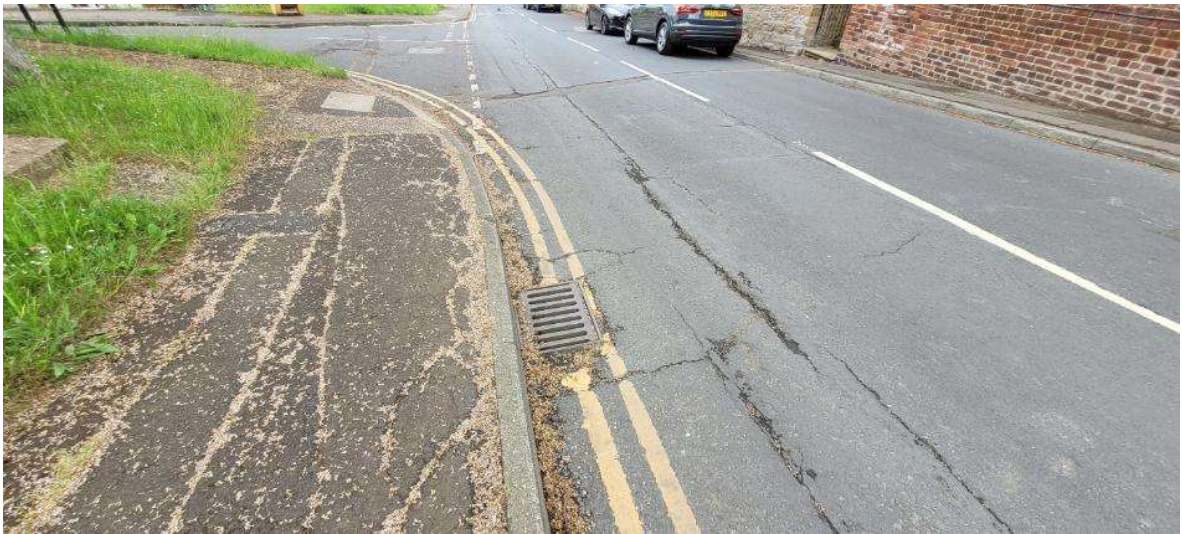
**Photo 39**

Woolley Colliery Road – Looking South

Visible cracking in surface course material, visible utility scars in carriageway and footway.

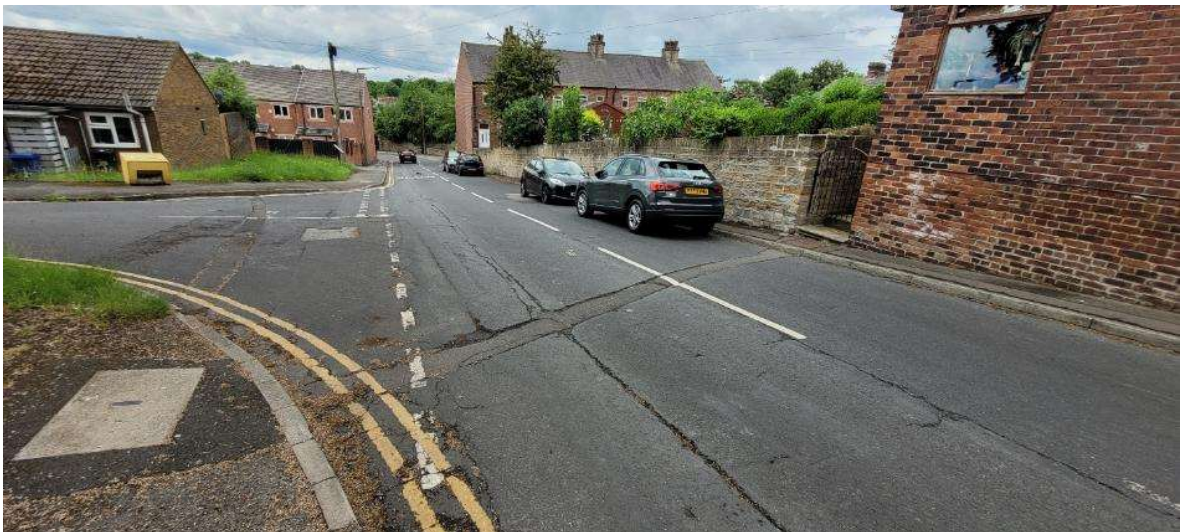
**Photo 40**

Woolley Colliery Road – Looking South

Visible cracking in surface course material, visible utility scars in carriageway and footway.

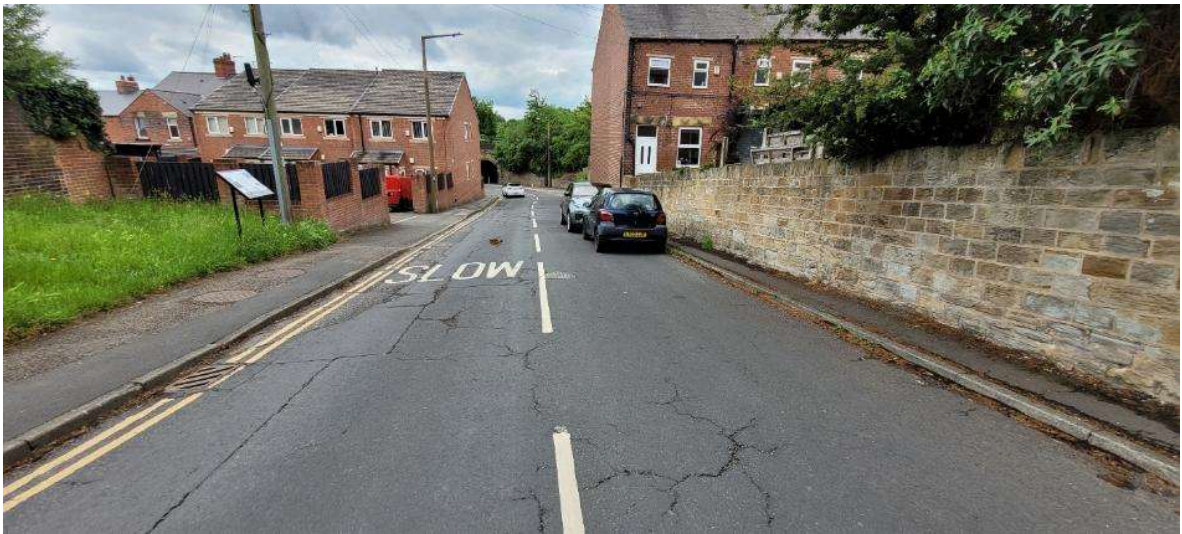
**Photo 41**

Woolley Colliery Road – Looking South

Visible cracking in surface course material, visible utility scars in carriageway and footway.

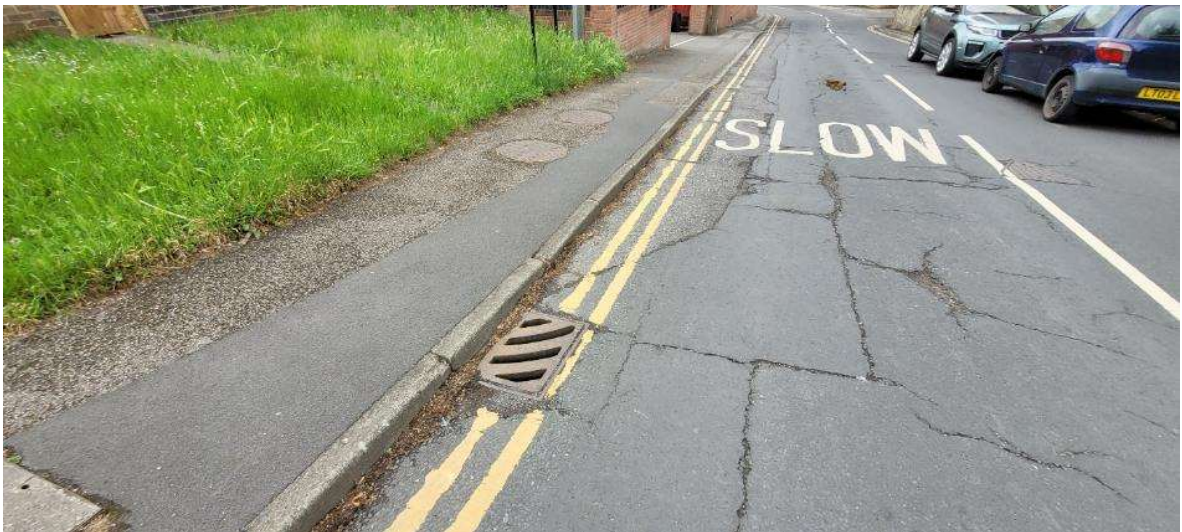
**Photo 42**

Woolley Colliery Road – Looking South

Visible cracking in surface course material, visible utility scars in carriageway and footway.

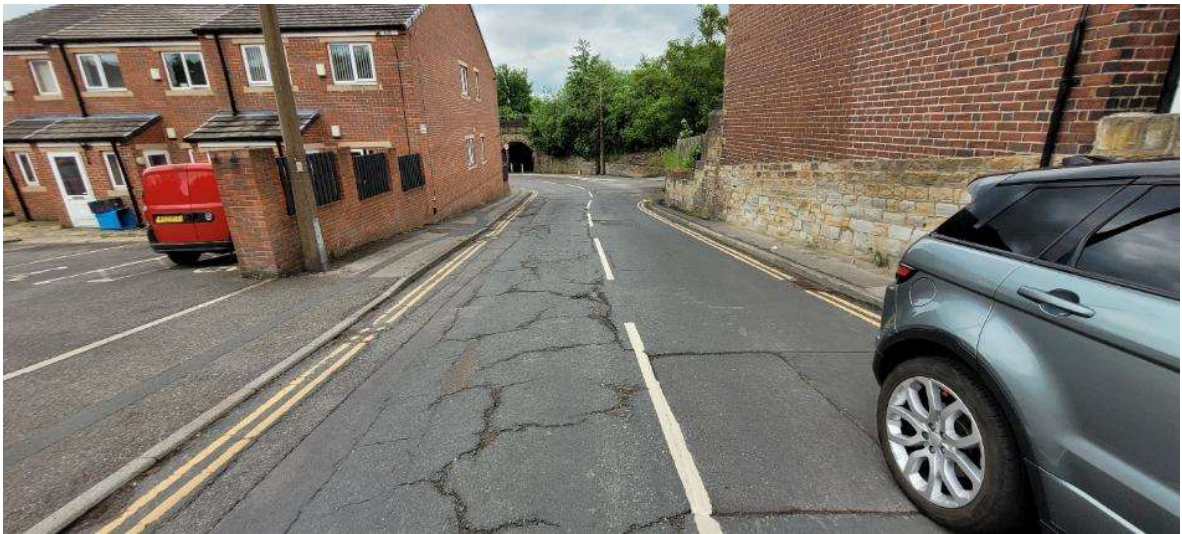
**Photo 43**

Woolley Colliery Road – Looking South

Visible cracking in surface course material, visible utility scars in carriageway and footway.

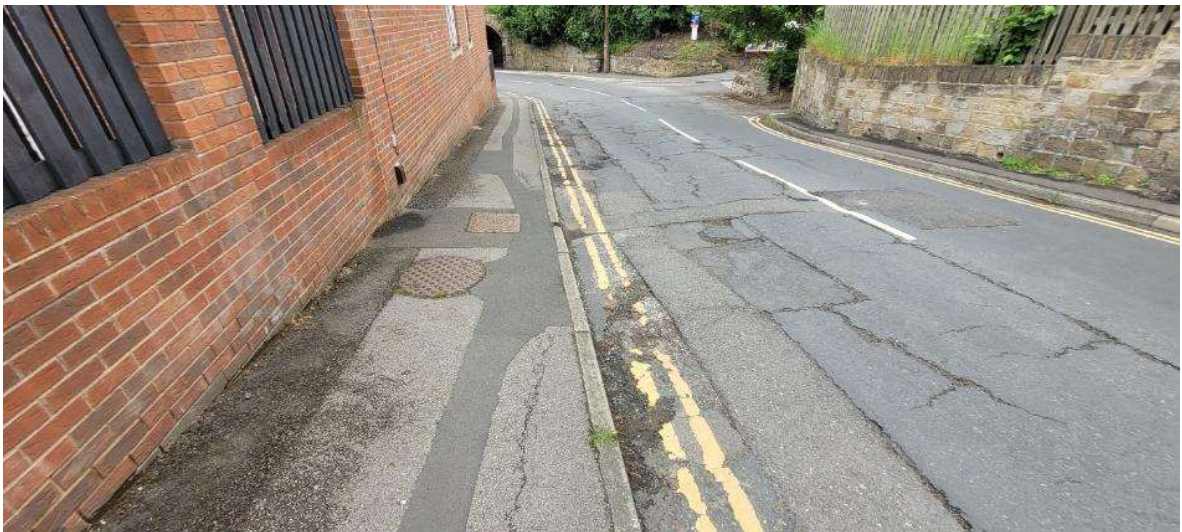
**Photo 44**

Woolley Colliery Road – Looking South

Visible cracking in surface course material, visible utility scars in carriageway and footway.

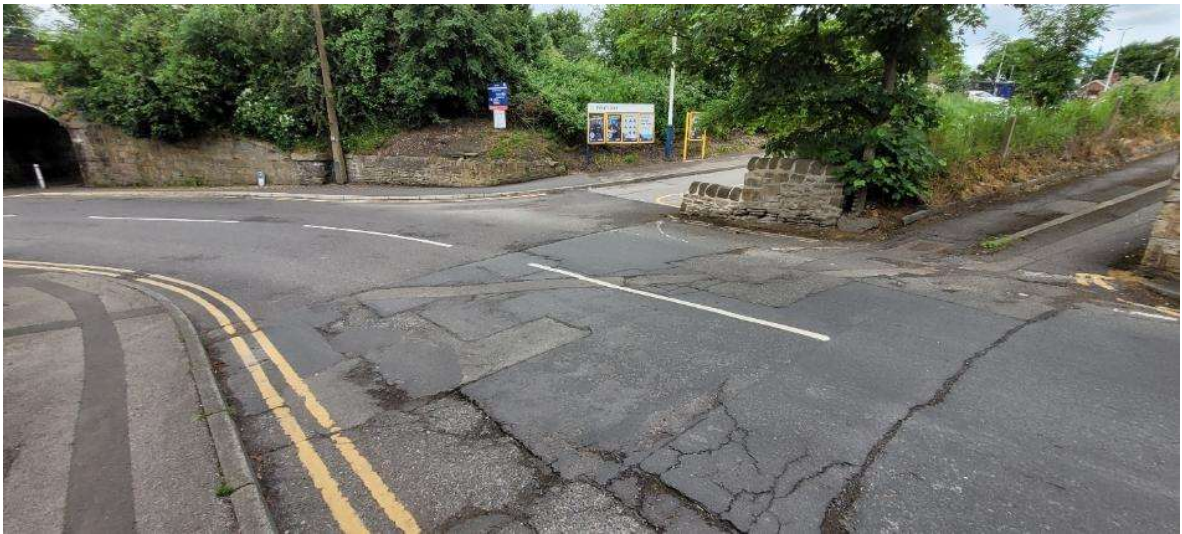
**Photo 45**

Woolley Colliery Road – Looking South

Visible cracking in surface course material, visible utility scars in carriageway and footway.

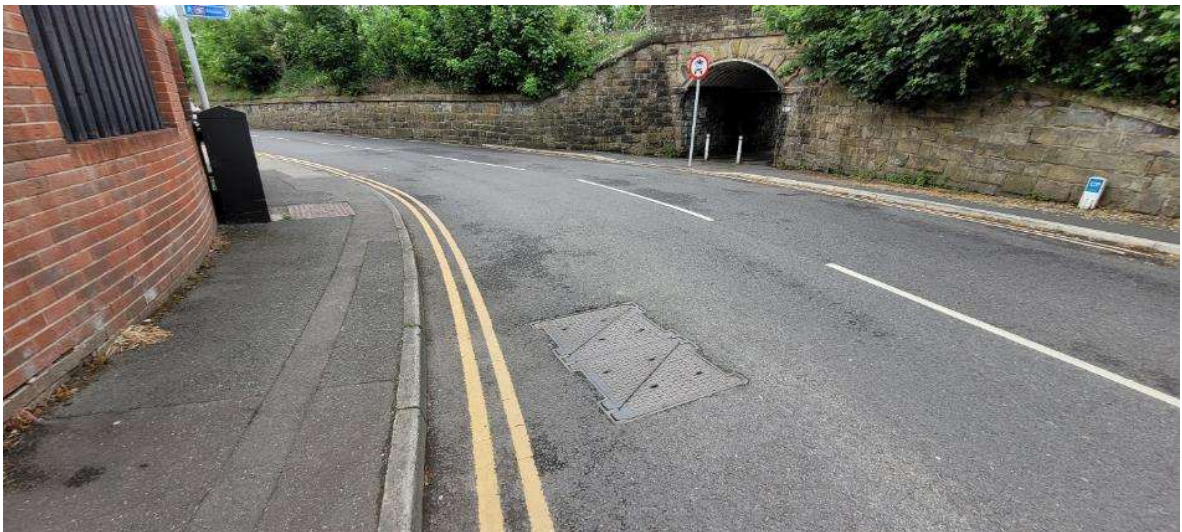
**Photo 46**

Woolley Colliery Road / Station Road – Looking South

Visible utility scar in footway.

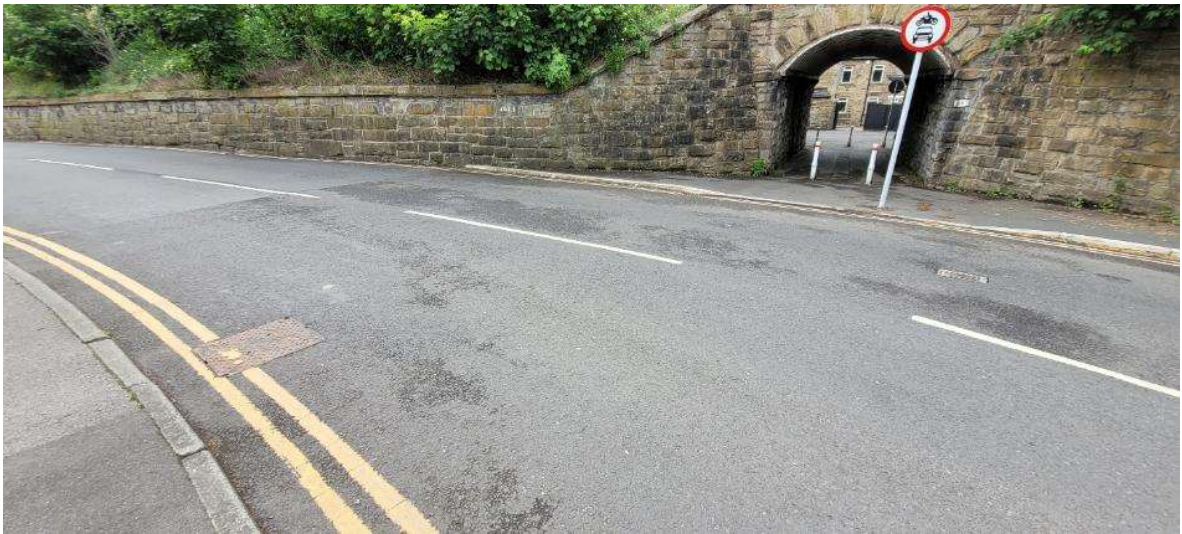
**Photo 47**

Station Road – Looking South

Stop Tap appears low in the recently resurfaced carriageway.

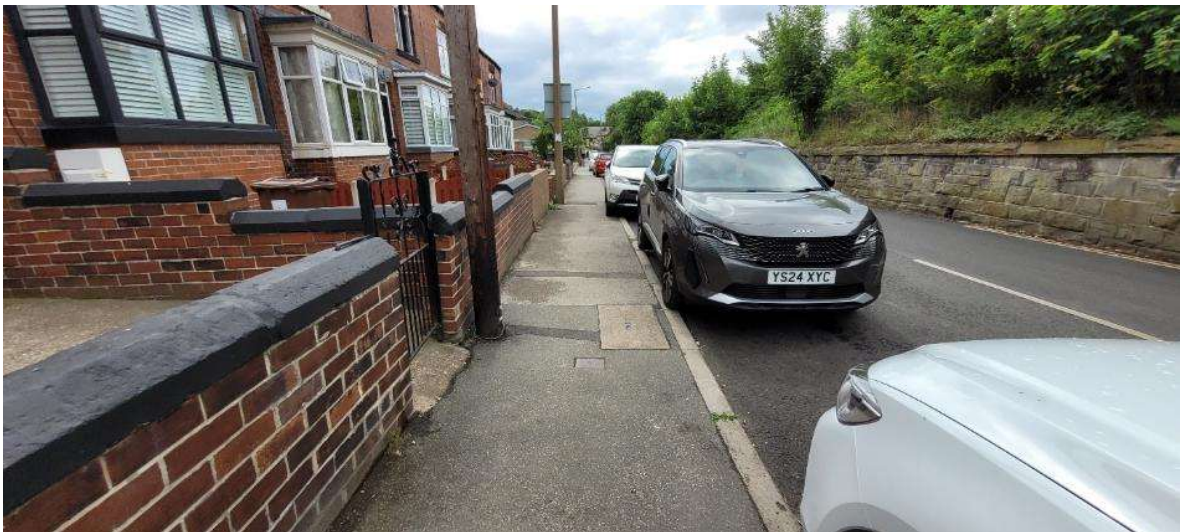
**Photo 48**

Station Road – Looking East

Visible utility scar in footway.

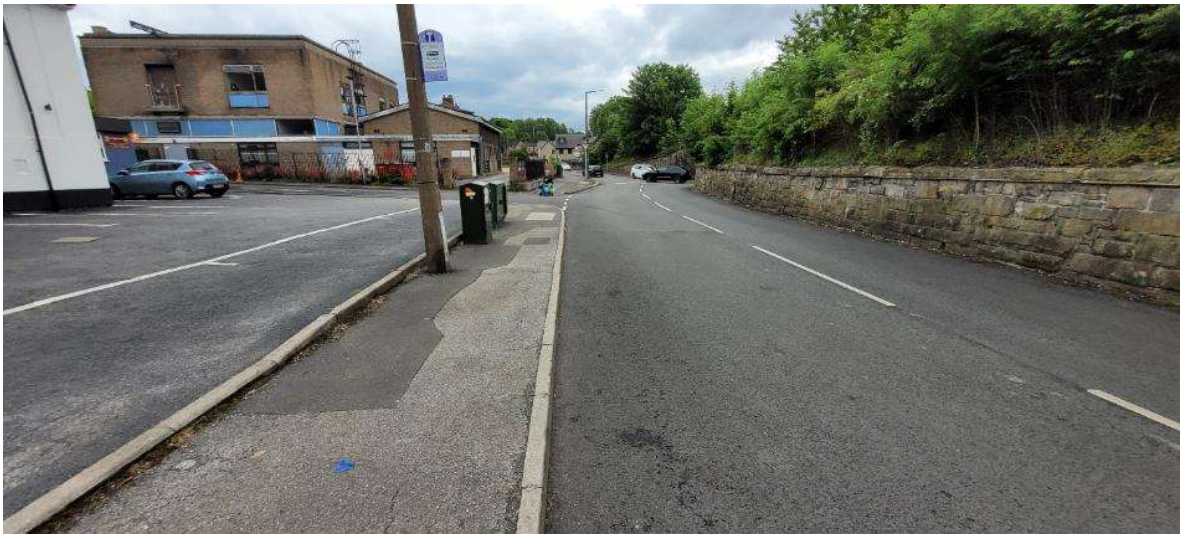
**Photo 49**

Station Road – Looking East

Visible utility scar in footway.

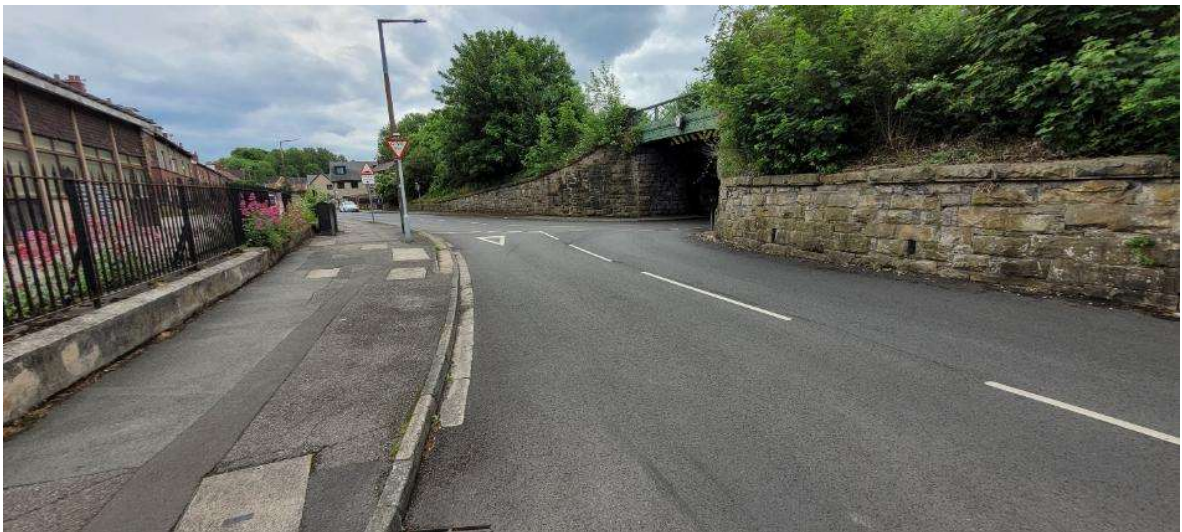
**Photo 50**

Station Road – Looking East towards Church Street

Visible utility scar in footway.

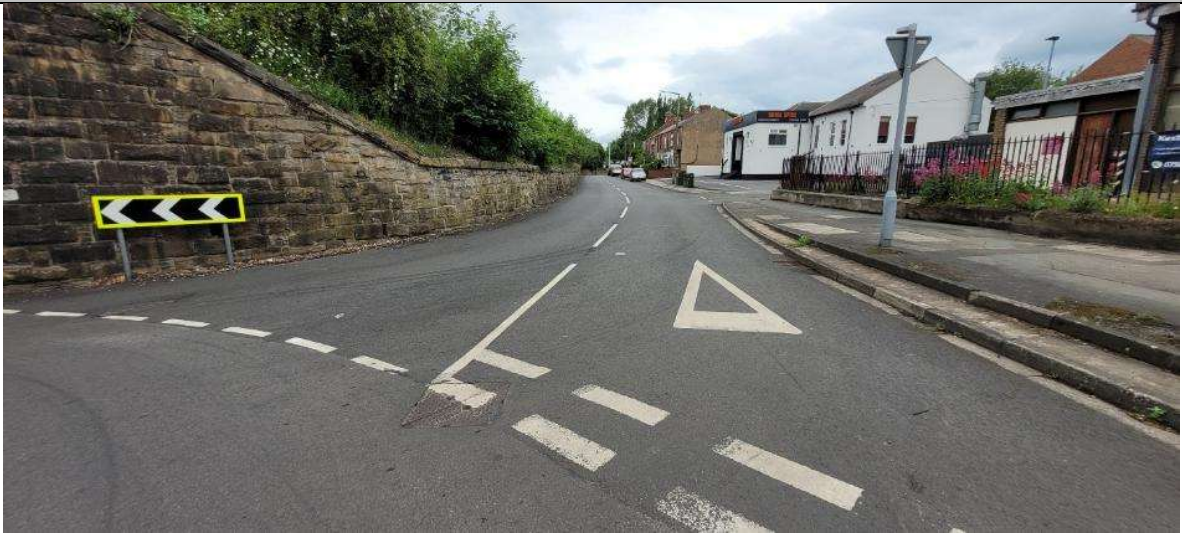
**Photo 51**

Church Street looking along Station Road

Visible utility scar in footway.
