Structural Solutions Ltd

Ref: NYP/16/104

REF: Land to Plot 2 `Delf Garth', High Street, Dodworth – Boundary Wall Remedial Works

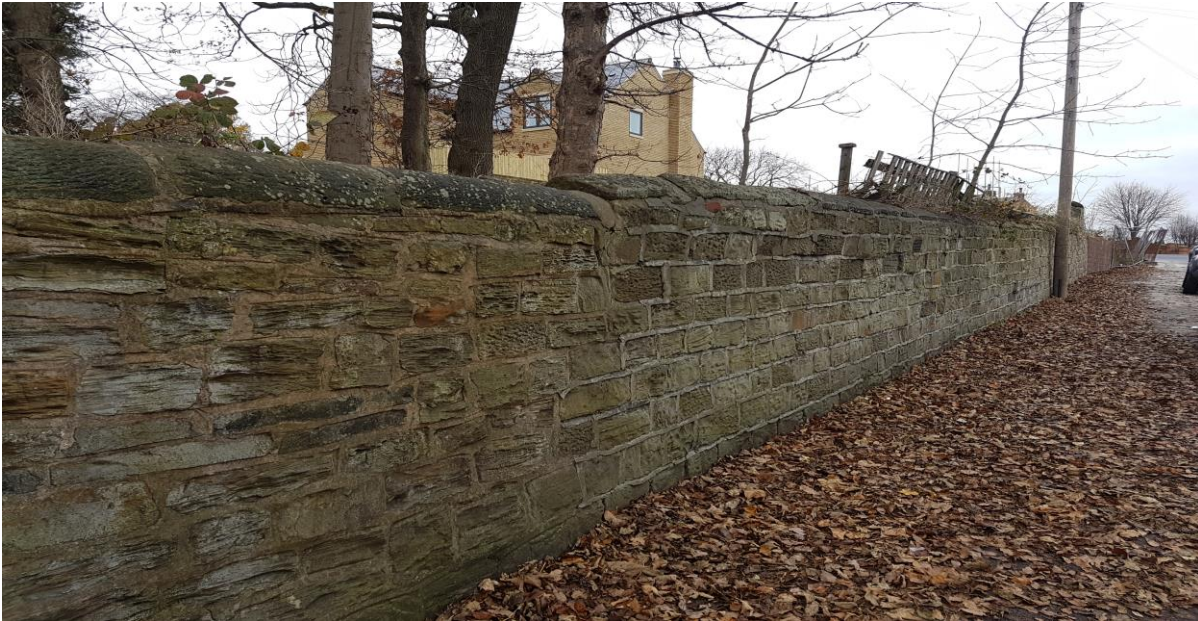
Photo 1

From our observations, the boundary retaining wall is of solid coursed stone construction, approx. 450 thk, which extends 30m from the bottom corner boundary back up the hill before the construction changes to a 9" solid brick built wall. The existing stone wall is approx. 1.8m in height, of 8 courses and a copping / header stone. Refer to Photo 1.

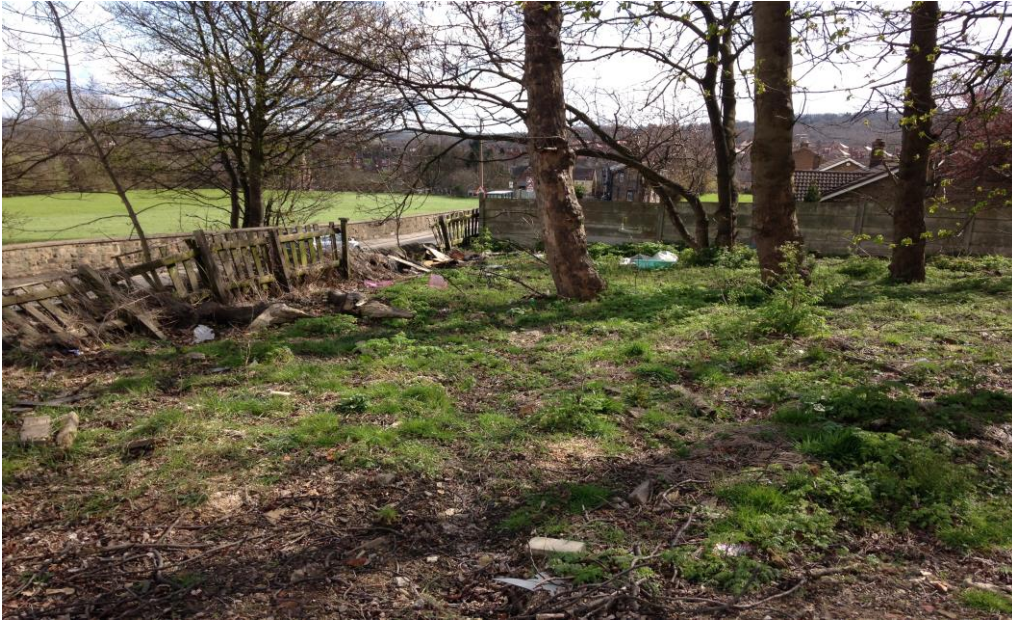
Photo 3

It is our opinion that it will be necessary to undertake rebuilding works to the existing stone boundary wall. The lower section of the boundary wall, from the existing telegraph pole to the corner of the site, approx. 20m in length, has suffered distortion. The stone construction appears to be bulging, and sections of the coursed stone are cracked on the bed joints. Refer to Photo 2. We suggest that the structural issues viewed are a direct result of the influence of existing trees, which are in very close proximity to the boundary wall, refer to Photo 3.

The arboricultural report states that it is likely the root growth of trees T1 & T2, as well as extended roots of T3, T4 & T5, are causing structural damage to the existing stone boundary wall. The report concludes that these 5 trees are not viable, or of value, to retain and could be removed.

We would suggest that although the wall has been damaged, due to pressures from tree root growth, it does appear that the wall is rotating about the foundation. From our inspection of the wall, the 2 courses of stone above pavement level appear to be structurally sound with no distortion. This would suggest that tree roots have pushed the upper section of the stonework outwards.

We would suggest that if the trees are removed this will remove surcharge pressure off the back of the upper section of the wall. In this regard, appropriate remedial works would be to take down rebuild and realign the upper section of the wall. To be able to undertake rebuilding remedial works to the wall, and to maintain the structural integrity following repairs it will be necessary to remove trees T1 – T5, as noted in AWA's report.

4. Removal of the top 7 courses of the wall, including the header stones, can be undertaken. This could be carried out in sections or in its entirety.
5. Re build the wall, using existing stonework if possible, allowing for movement joints in the coursed stone at 10m max intervals and/or at steps in the wall line depending on the wall span between previous joints.
