High Street, Great Houghton – Dilapidation Survey

Carried out 03.12.2025

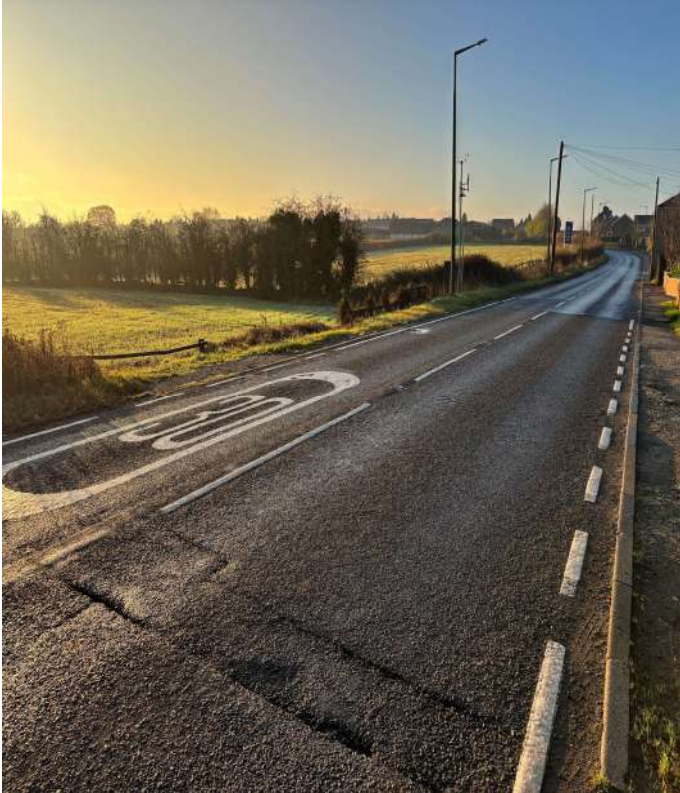
1 – Patch of tarmac from services.

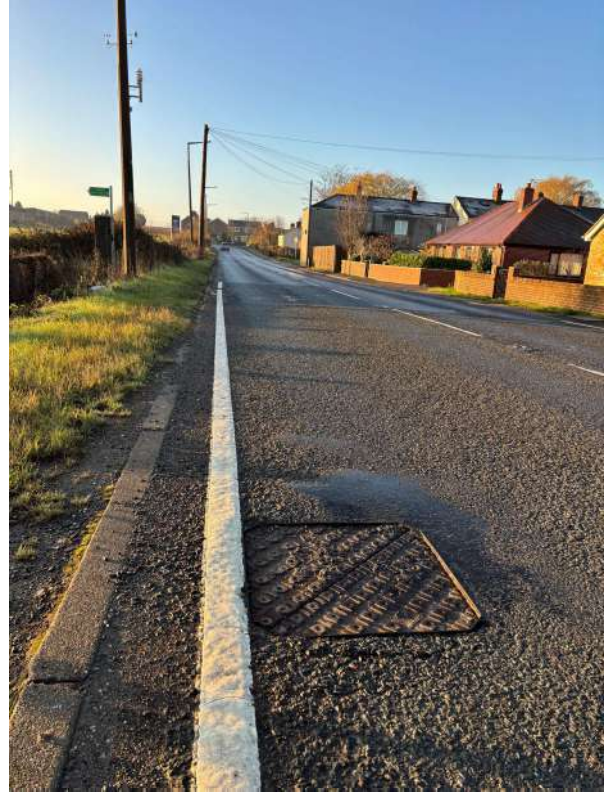
2 – Manhole cover sunken which receives heavy traffic.

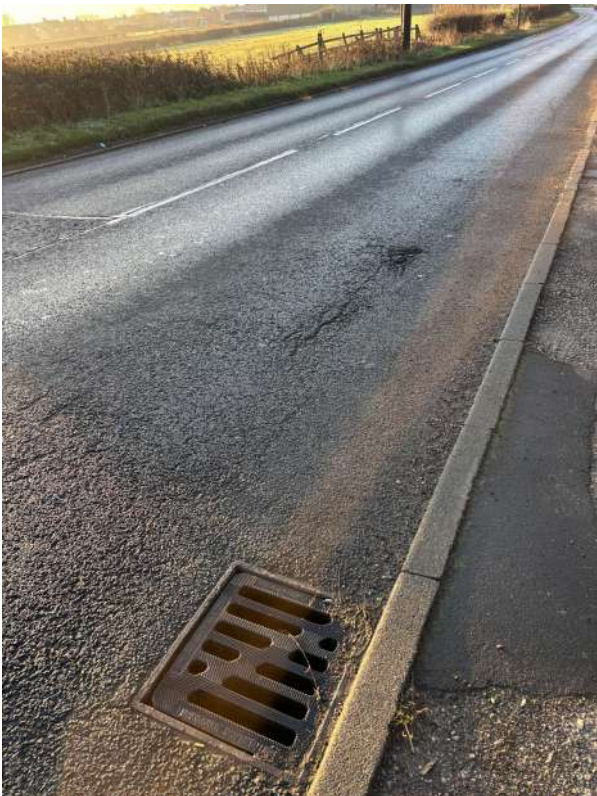
3 – Cracking and depression in carriageway.

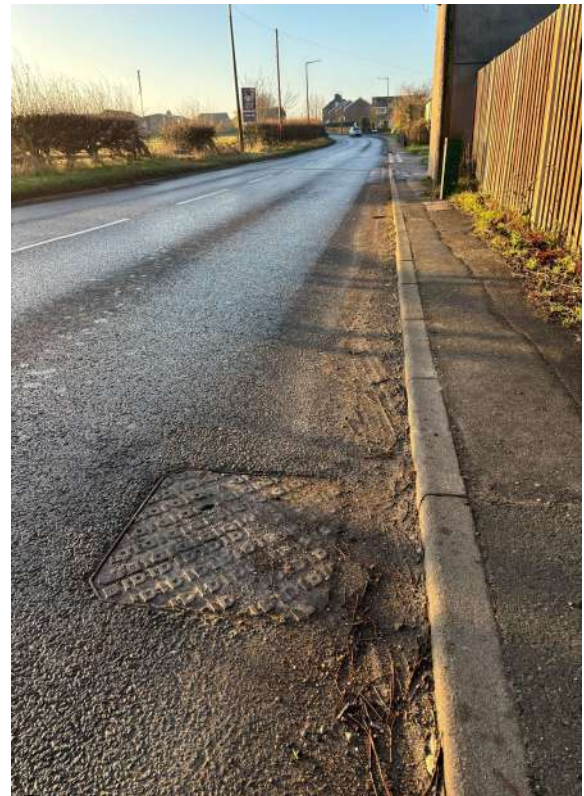
4 – Manhole cover to receive heavy traffic.

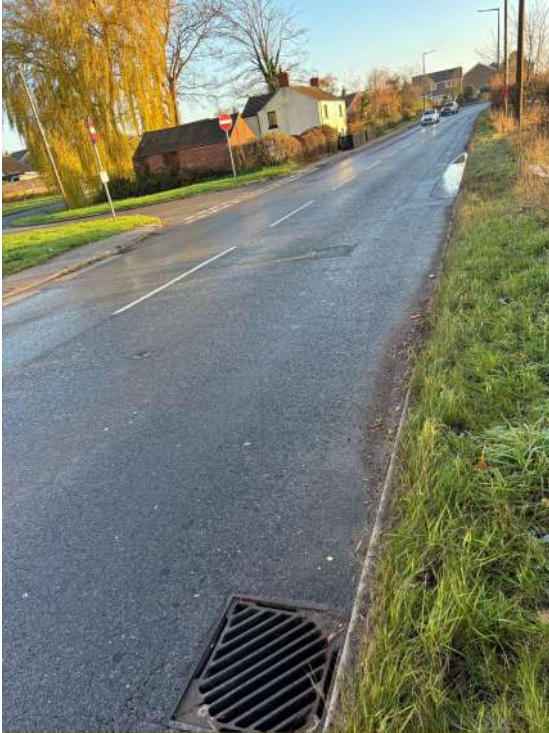
5 – Carriageway generally in good condition.

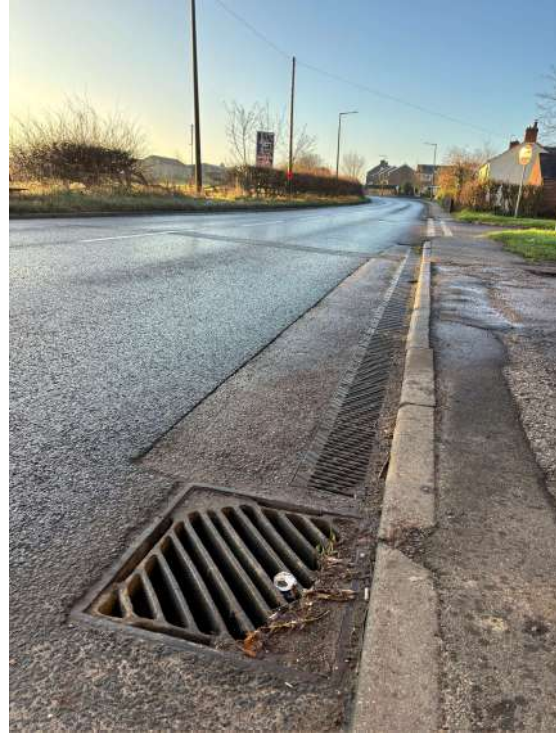
6 – Gully and ACO channel drain likely to suffer heavy HGV traffic.

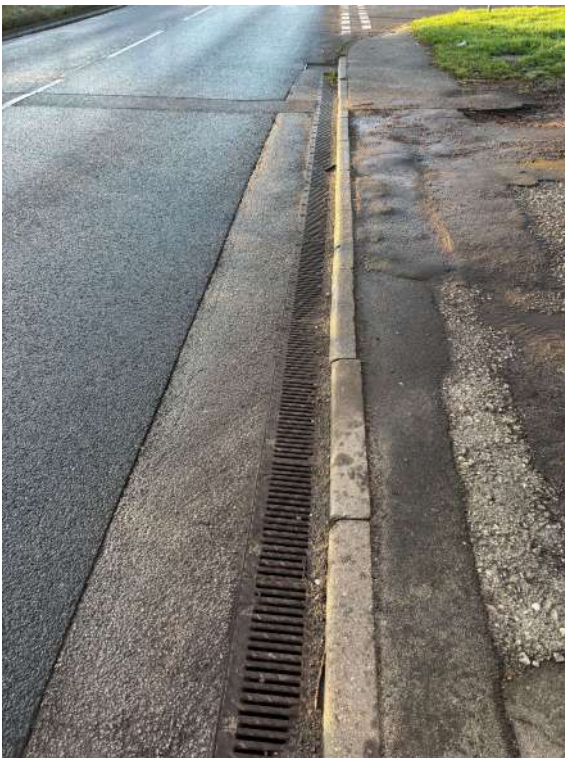
7 – Additional photo of ACO drain.

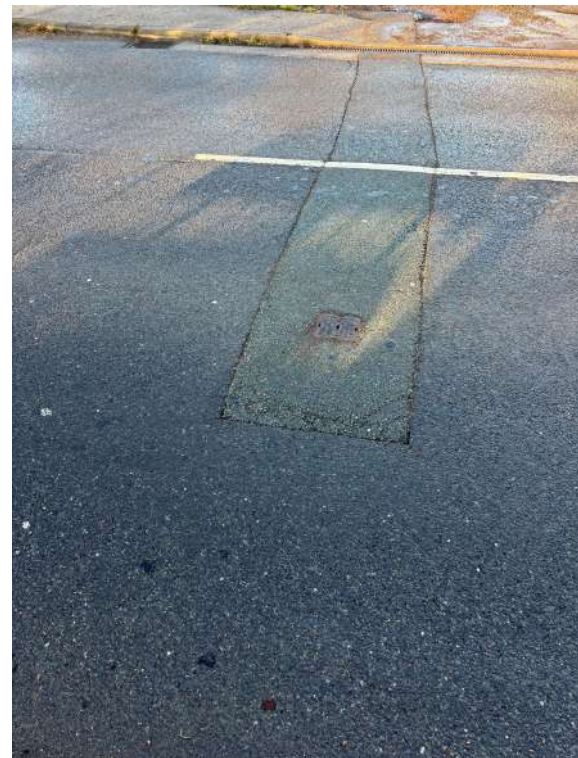
8 - Water meter lid & patch of tarmac to receive heavy traffic.

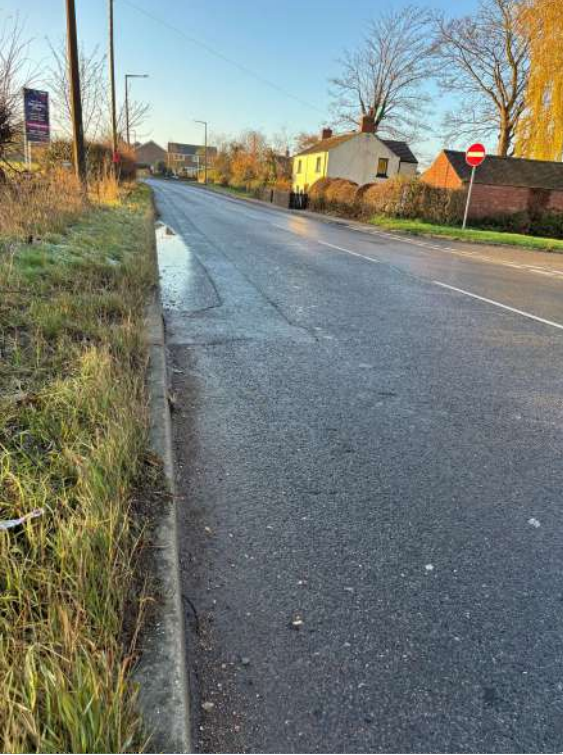
9 – Area of ponding along kerbline heading into village.

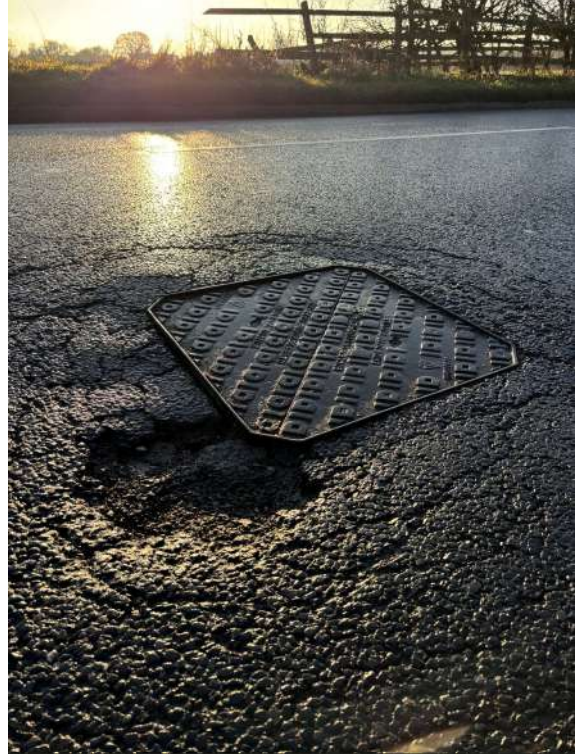
10 – Manhole lid in wheel line, in poor condition, lid rocking.

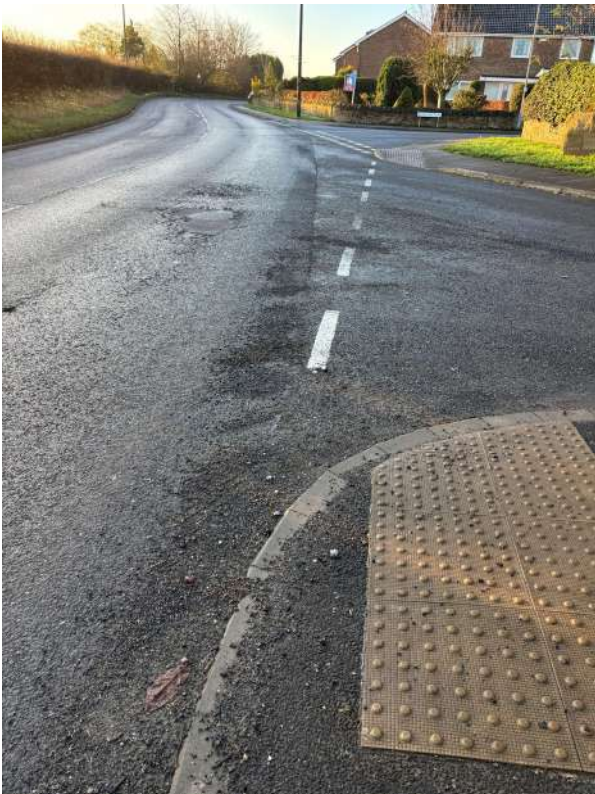
11 – Access to Bus Stop, Tarmac in poor condition.

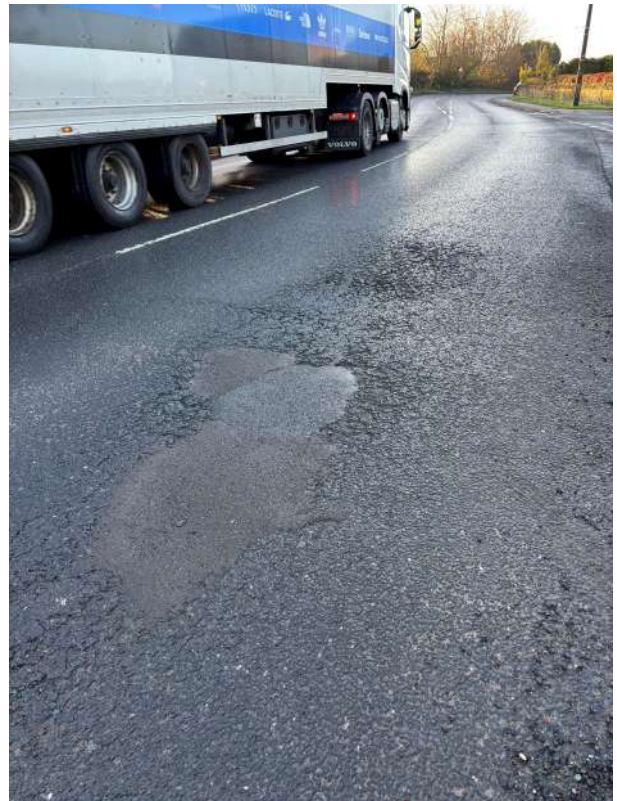
12 – Patchwork tarmac and crocodile cracking within highway.

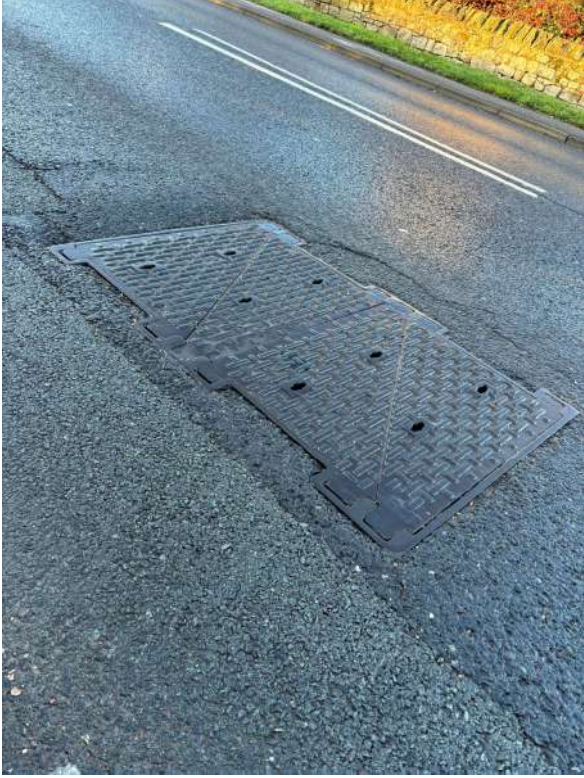
13 – Manhole Cover to receive heavy traffic.

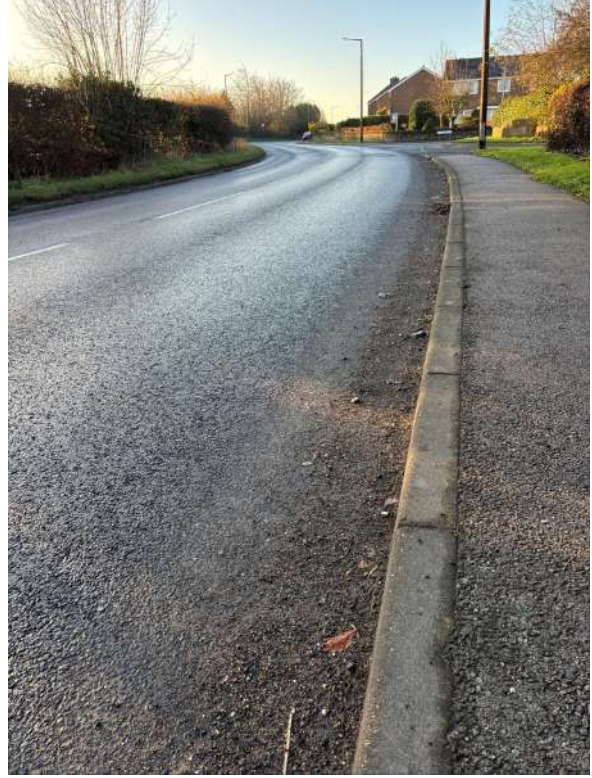
14 – Highstreet, Kerbline and road in good condition.

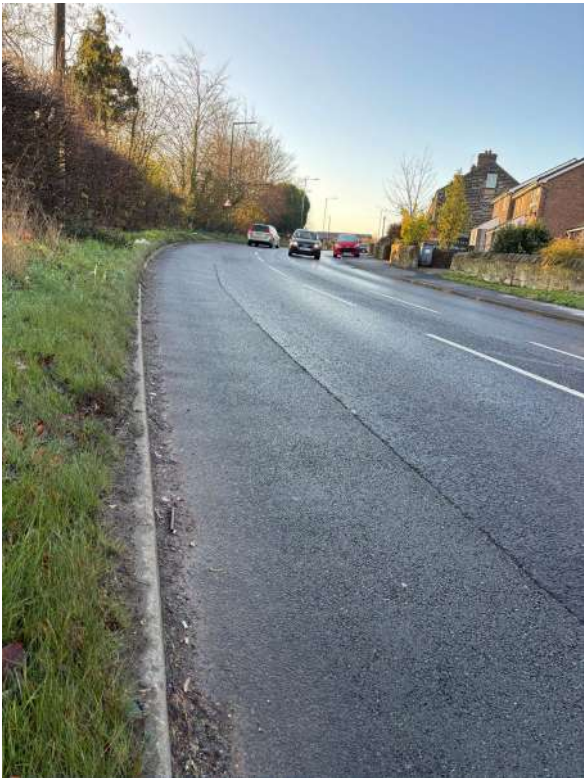
15 – High Street, Highway in good condition.

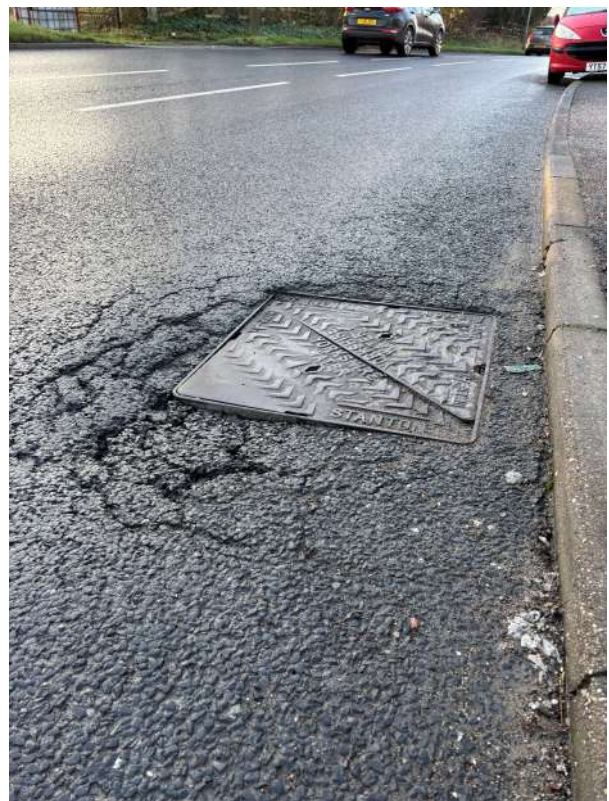
16 – Manhole cover in poor condition to receive heavy traffic.

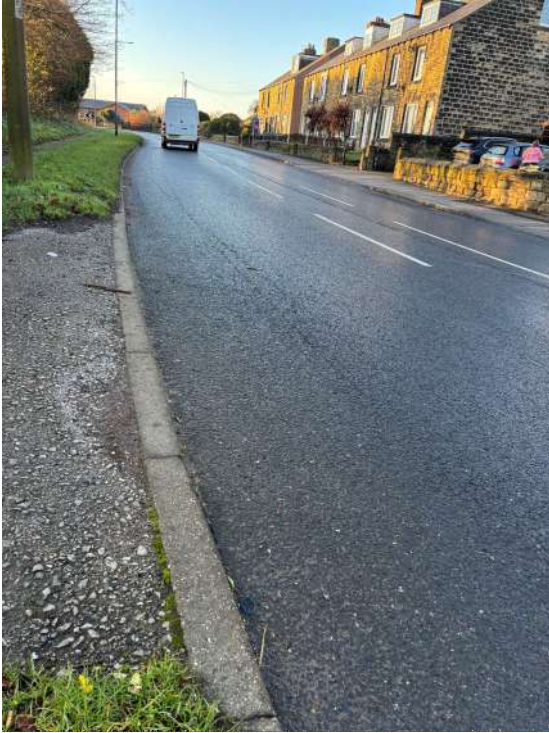
17 – High Street kerbline and carriageway in good condition.

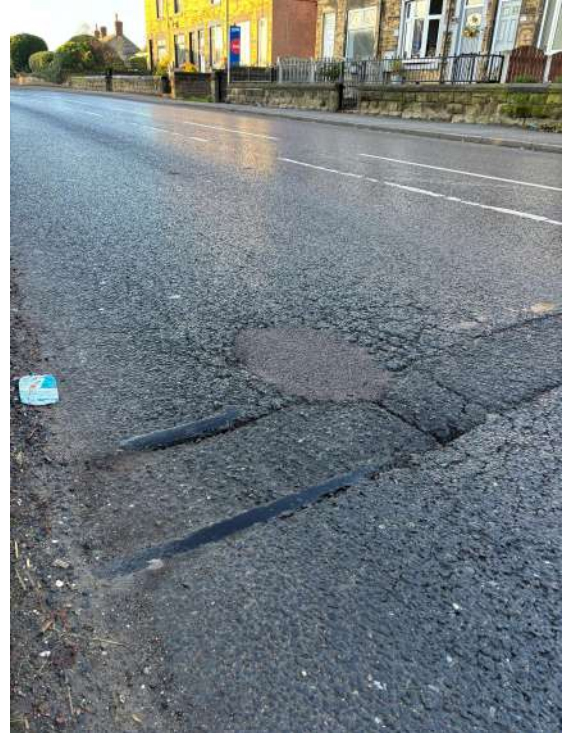
18 – Area of patchwork tarmac, rutting and cracking present.

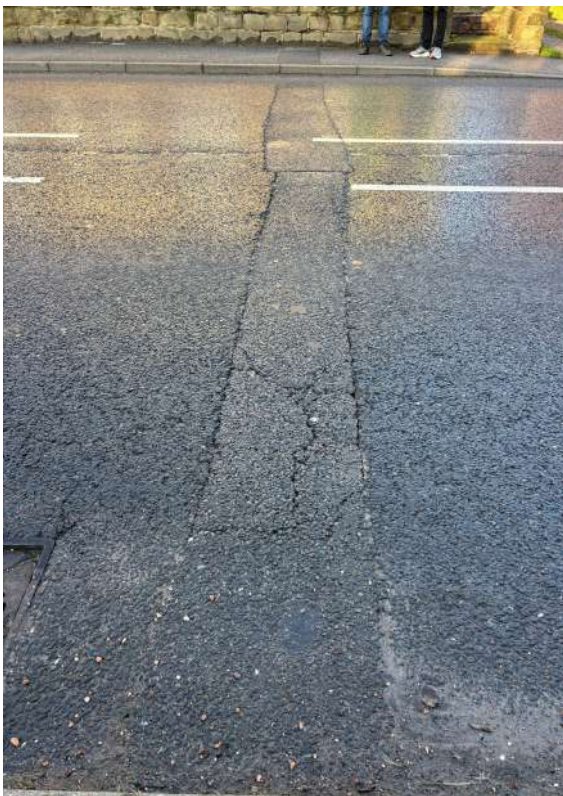
19 – Patchwork tarmac cracking and rutting.

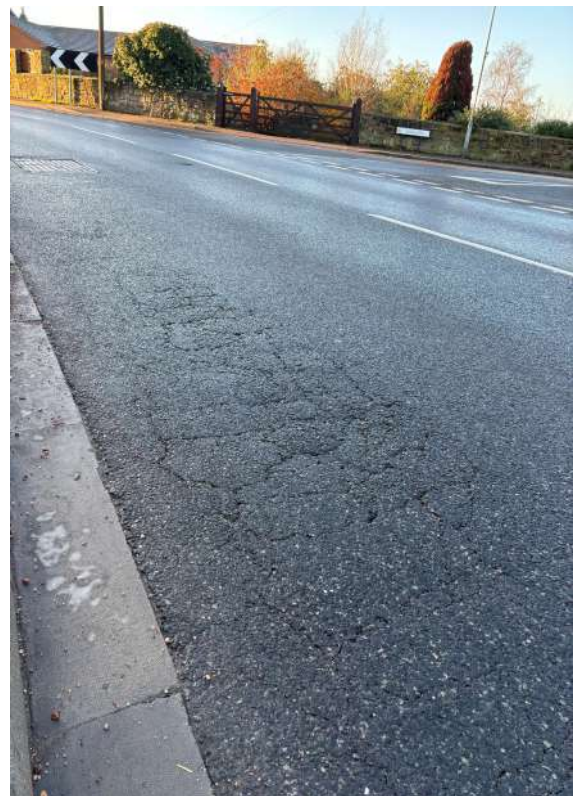
20 – Cracking in carriageway in junction outside entrance to park lane.

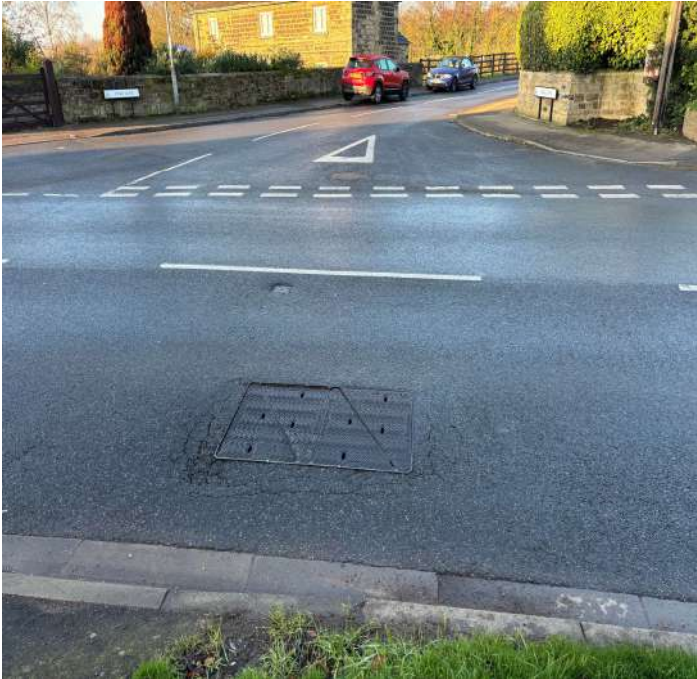
21 – Manhole which will receive heavy traffic have sunk and cracked.

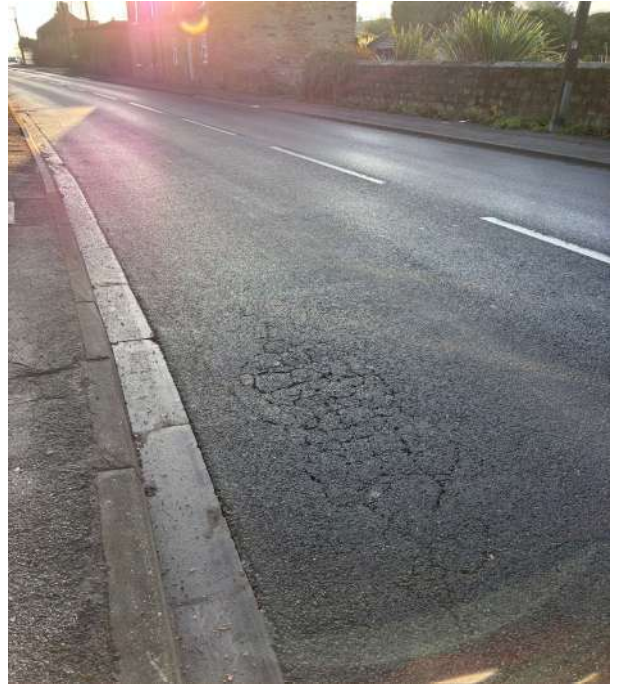
22 – Area of cracking and rutting when turning into village on the bend.

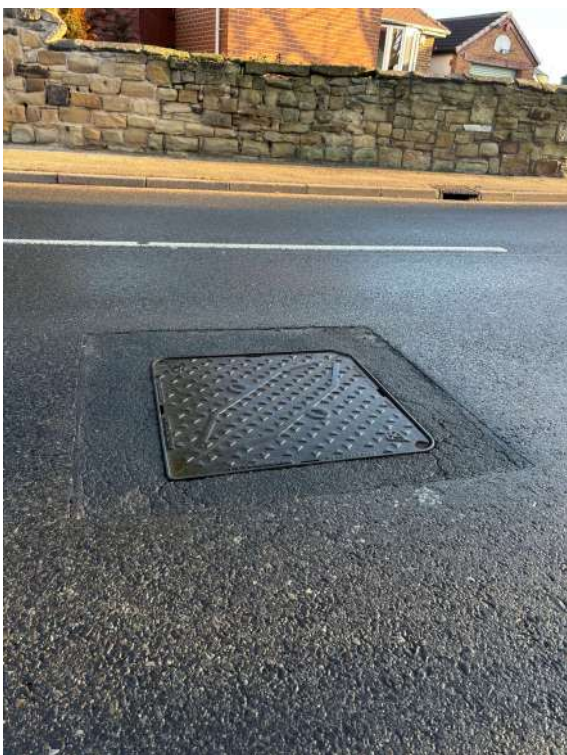
23 – Manhole in recently been patched and in good condition.

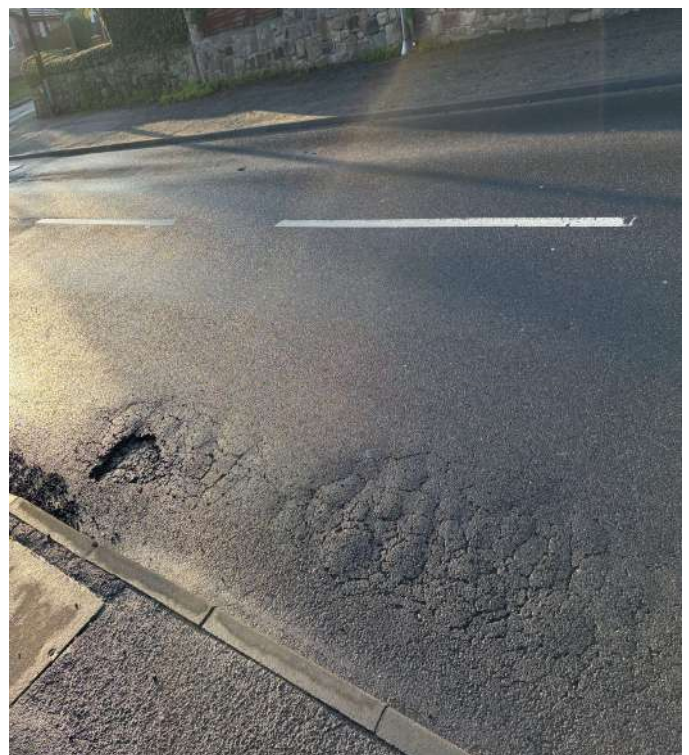
24 – Cracking and pothole to be subject of heavy traffic.

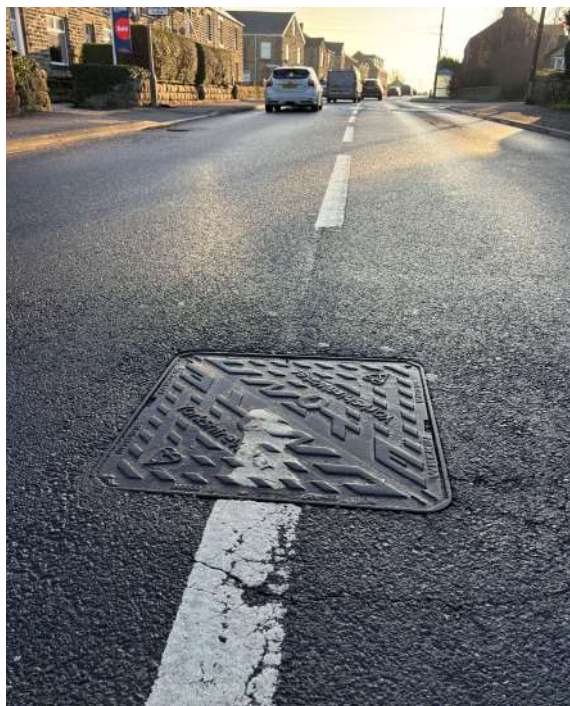
25 – Manhole which will receive heavy traffic in good condition.

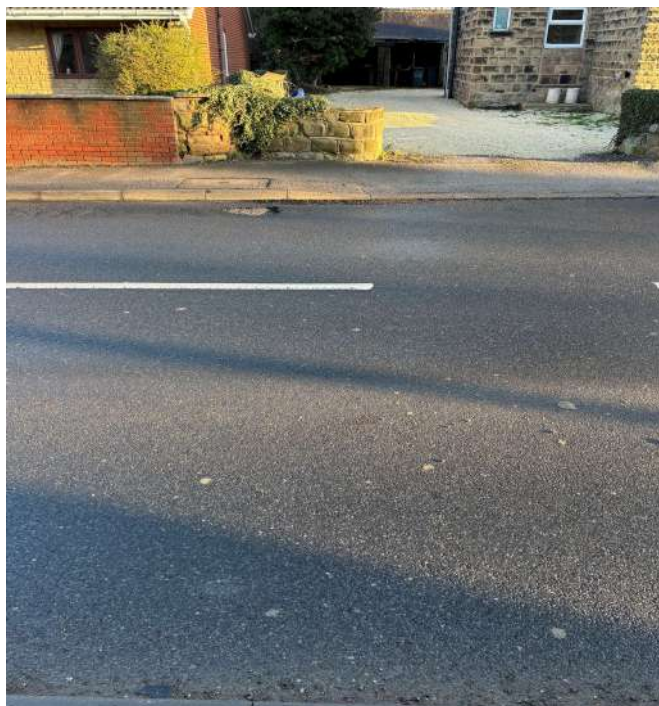
26 – Highway in good condition.

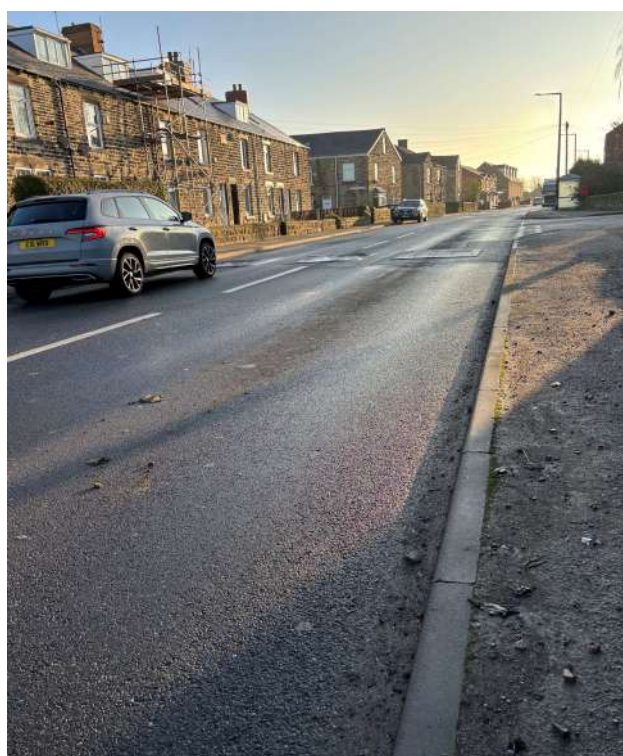
27 – Highway in good condition.

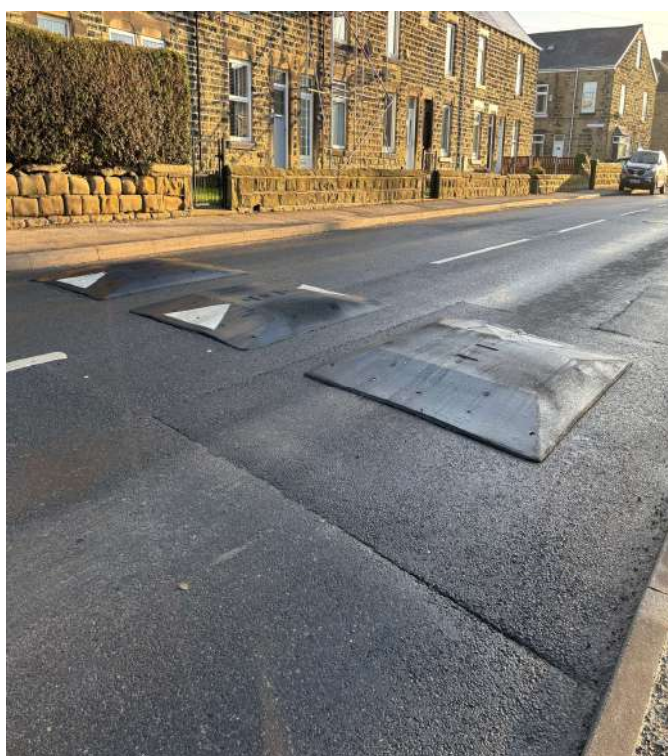
28 – Extents of highway, traffic calming measures (speed ramps).
