**PLOT 4B & 5, ASHROYD BUSINESS PARK, HOYLAND**

**G F TOMLINSON BUILDING LTD**

**PRE-START HIGHWAY CONDITION INSPECTION**

**JUNE 2019**

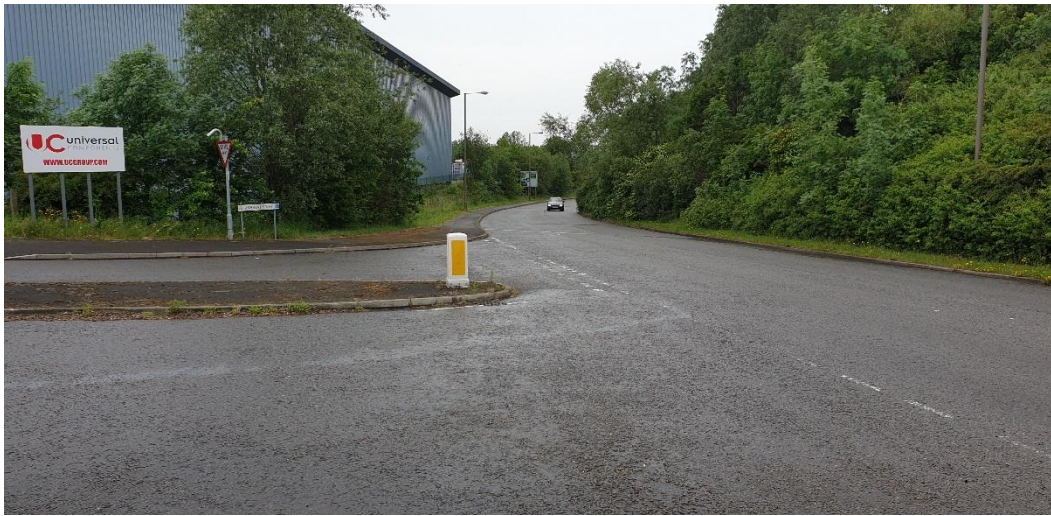
*Figure 1 - View South across Junction with Ryecroft Bank.*

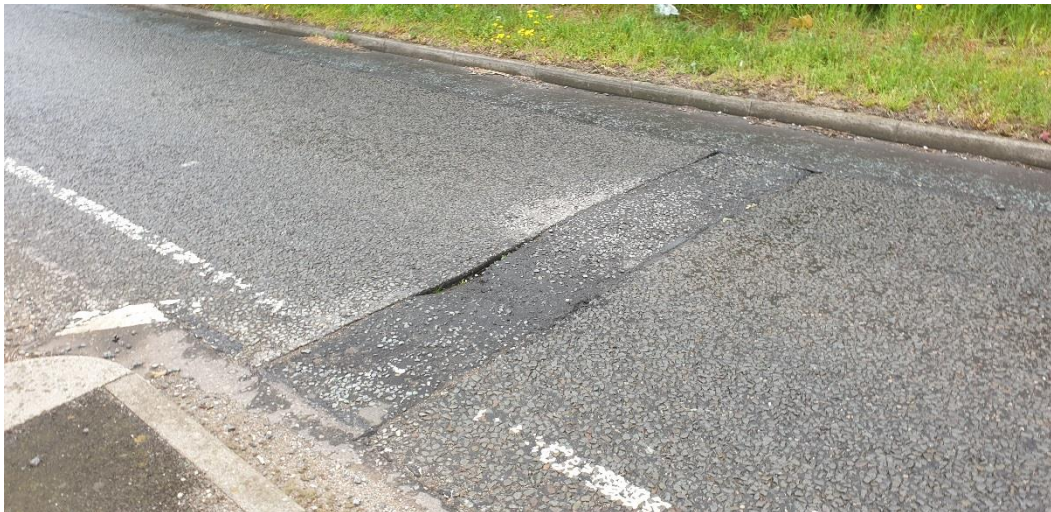
*Figure 2 - Failed reinstatement on Ryecroft Bank to the north of junction with Ashroyds Way.*

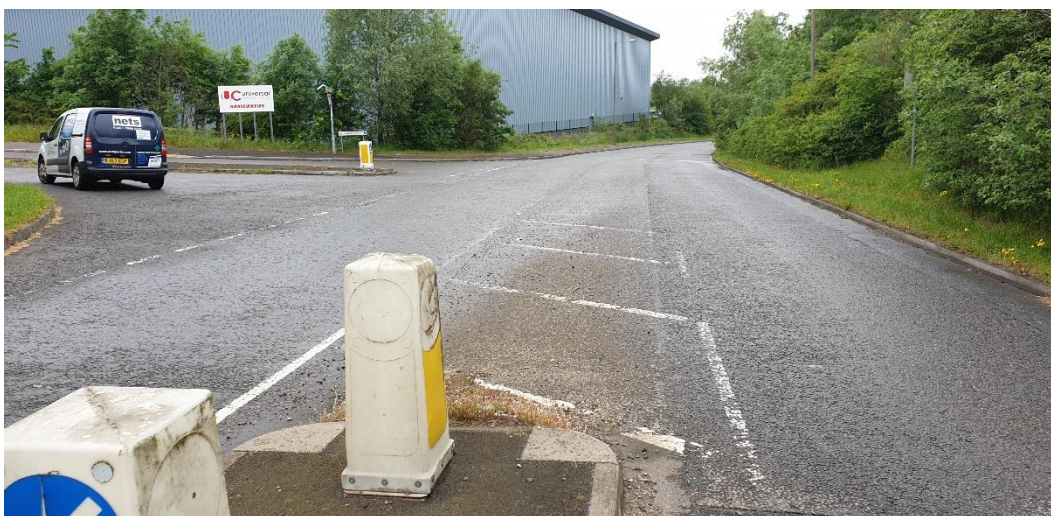
*Figure 3 - View South on Ryecroft Bank from pedestrian island to the north of junction*

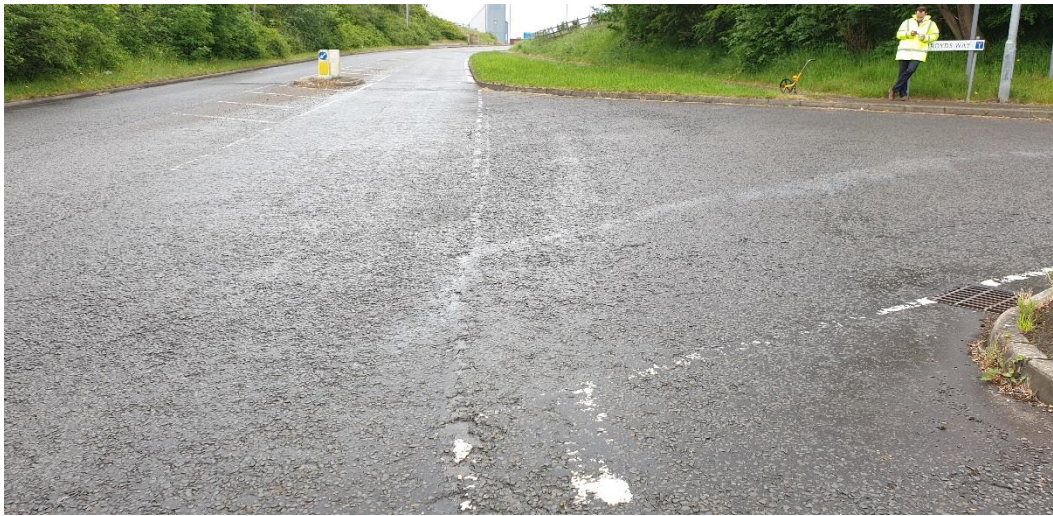
Figure 4 - View north of westbound lane into Ashroyds Way. Some minor chipping loss in the surface course. All junction lining is worn out.

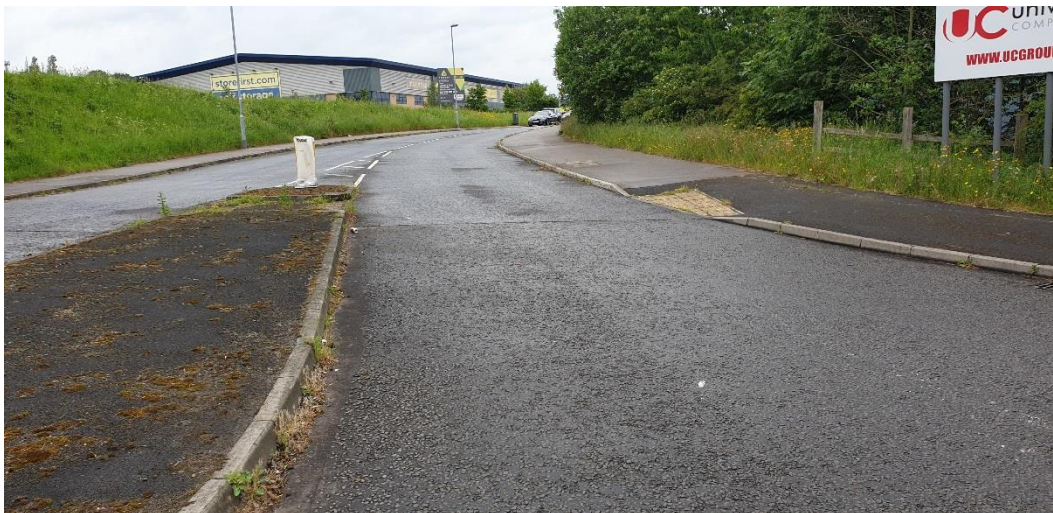
Figure 5 - View west of outbound lane. Some minor chipping loss in surface course.

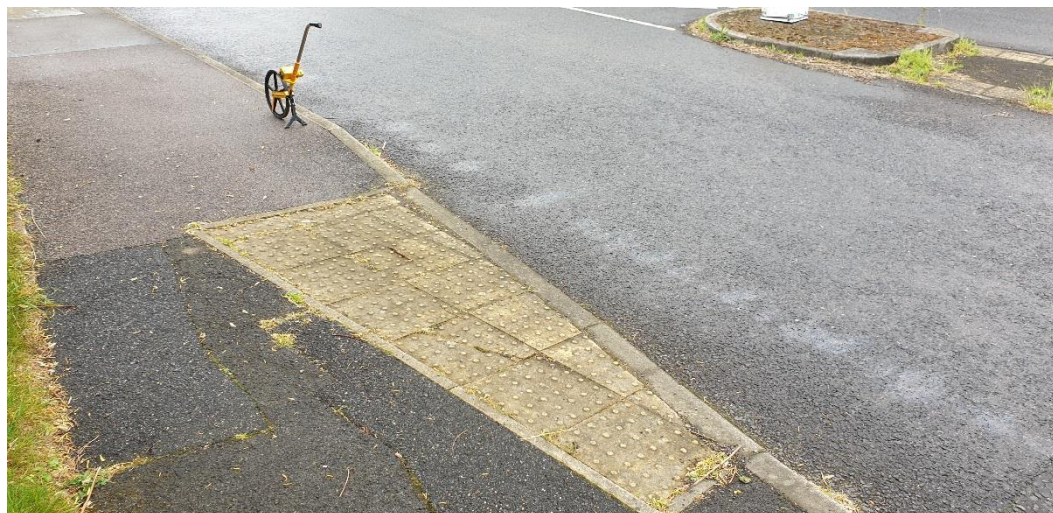
Figure 6 - Tactile crossing at entrance to site. Pavers cracked but not rocking.

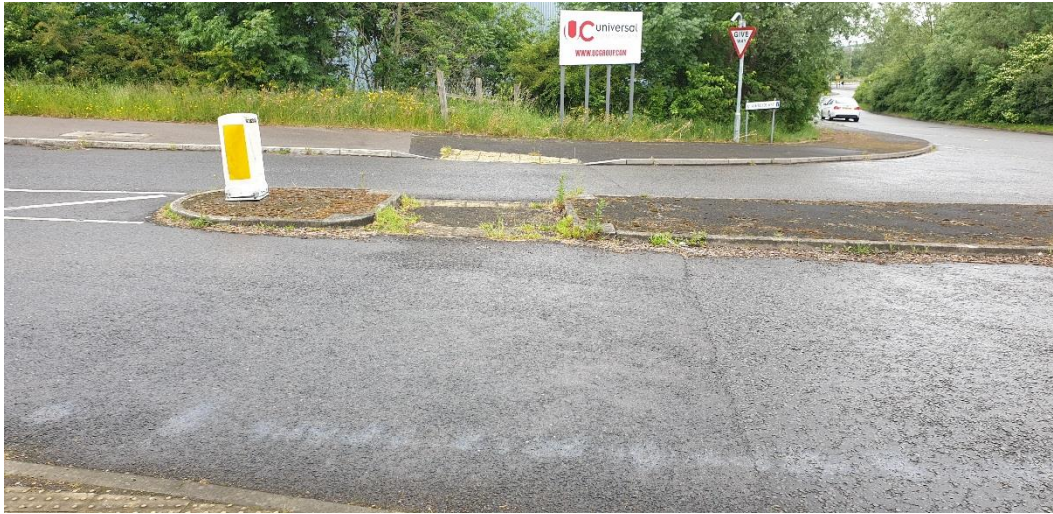
Figure 7 - View across pedestrian crossing. Heavy vegetation in channels and against kerbs.

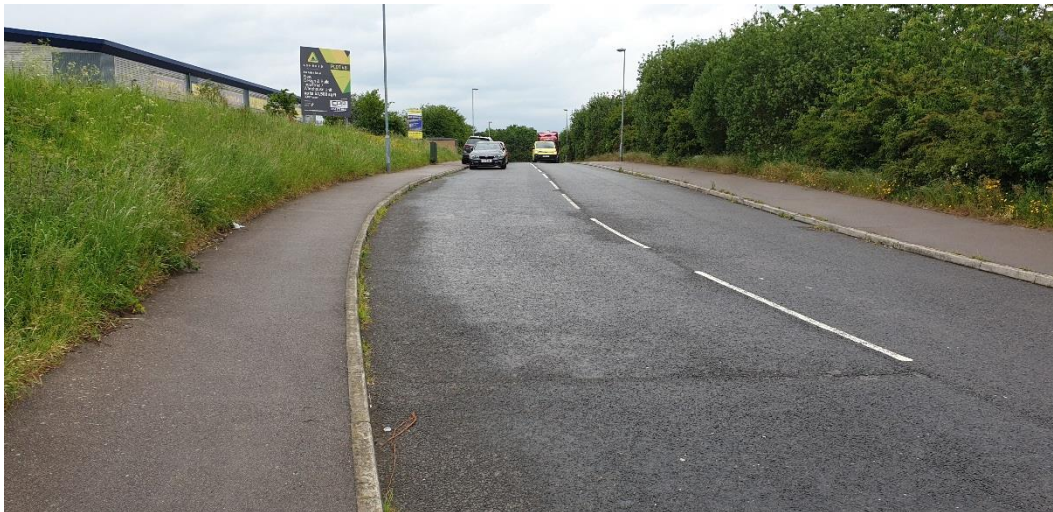
Figure 8 - Southern footway on Ashroyd Way looking west.

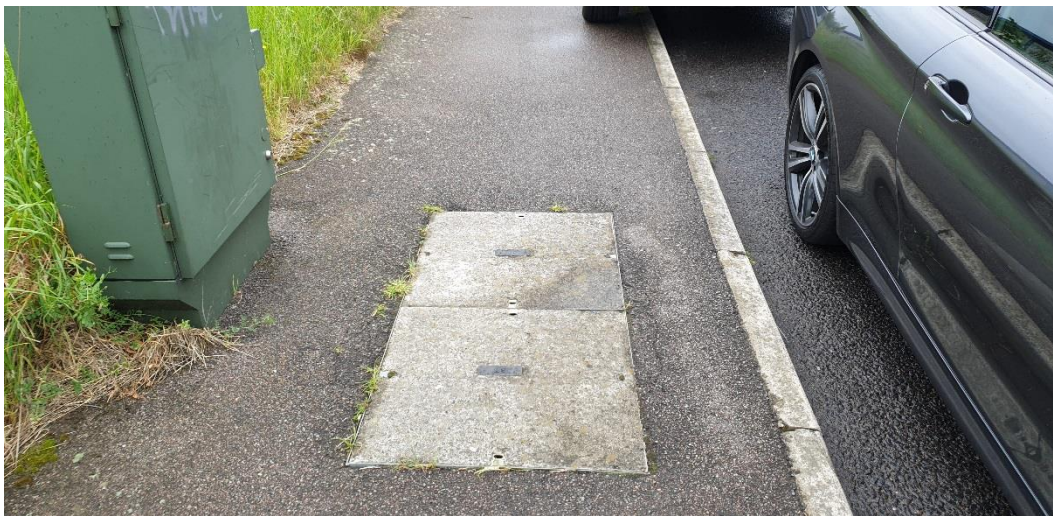
Figure 9 - BT chamber in southern footway.

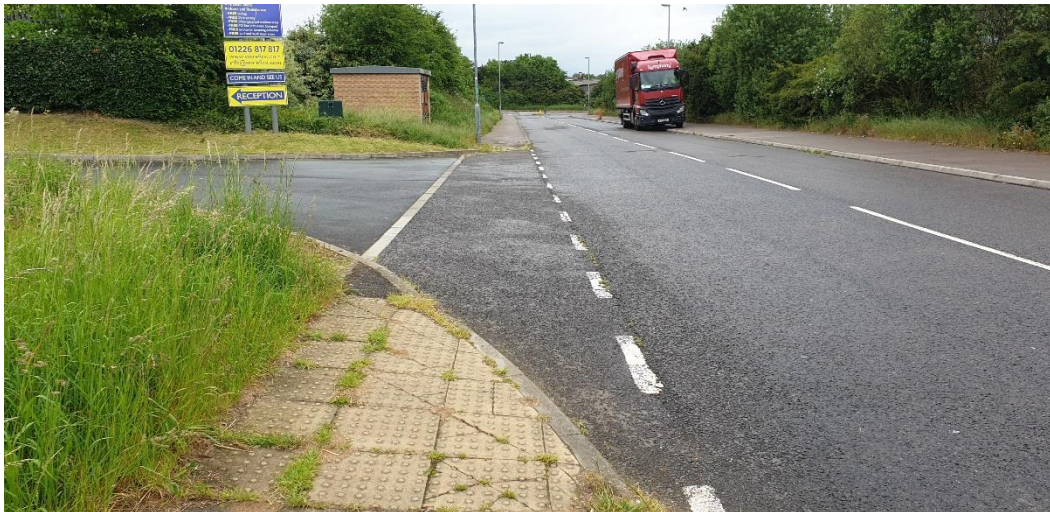
Figure 10 - View across entrance to Self-Store site/ Plot 4B entrance. Vegetation in tactile pavers.

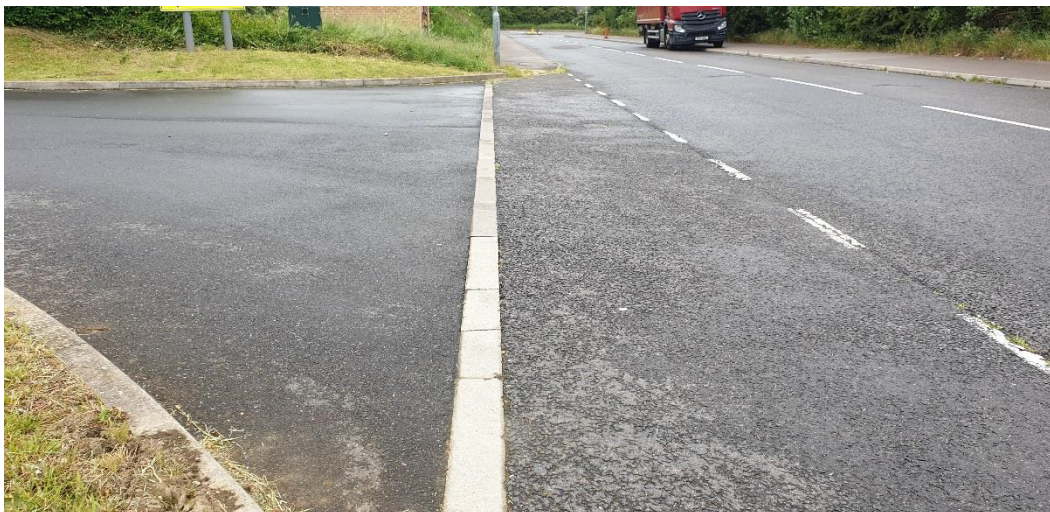
Figure 11 - Existing demarcation channels at rear of Highway boundary. Some channel blocks are loose and rocking.

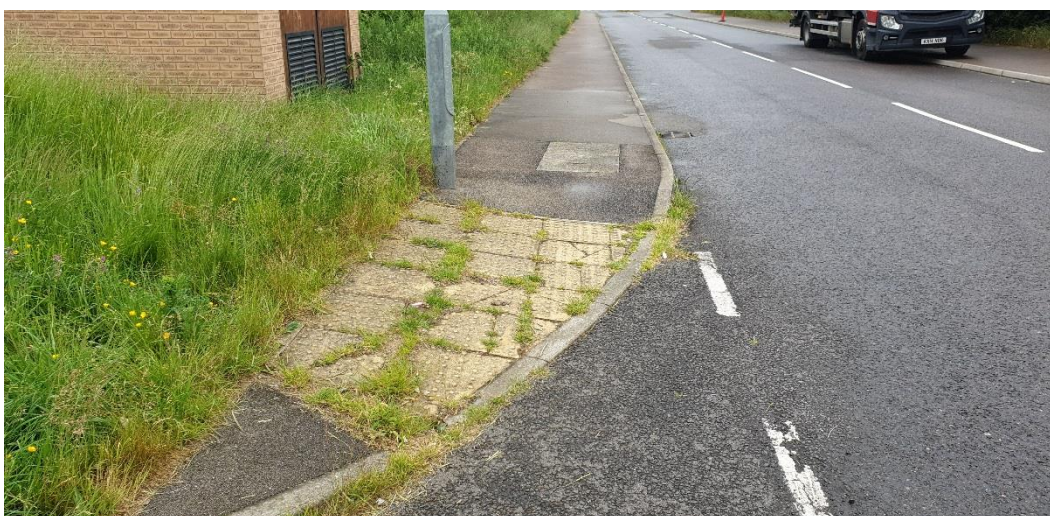
Figure 12 - Western side of entrance. Heavy vegetation in between tactile pavers.

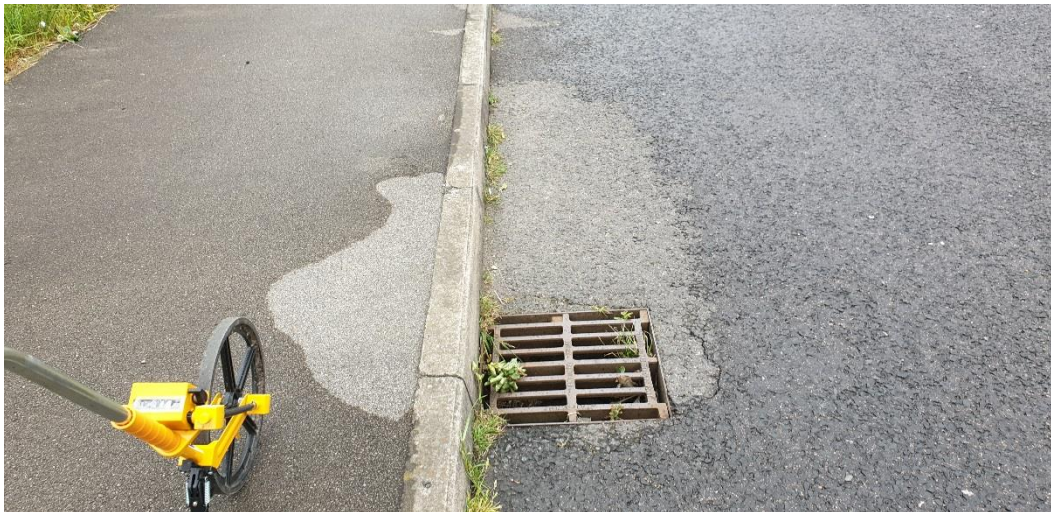
*Figure 13 - Some minor cracking in surface course around gully.*

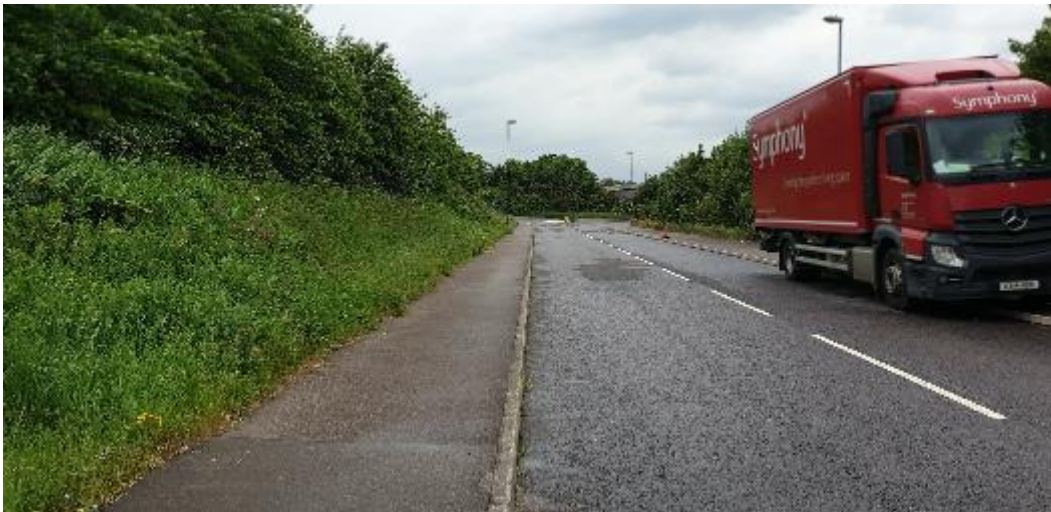
*Figure 14 - View west of southern footway.*

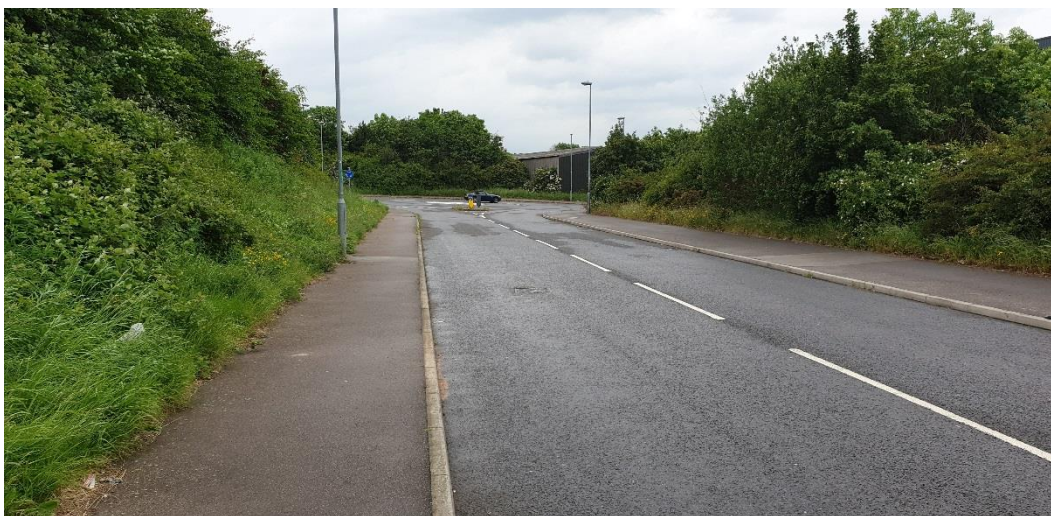
*Figure 15 - View west on approach to mini roundabout.*

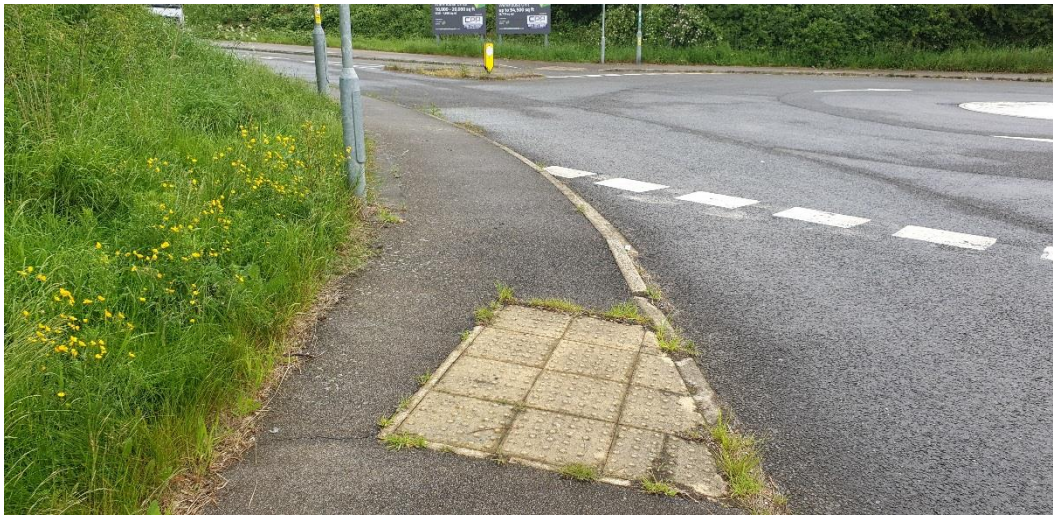
*Figure 16 - Tactile paving on southern footway on east leg of mini roundabout.*

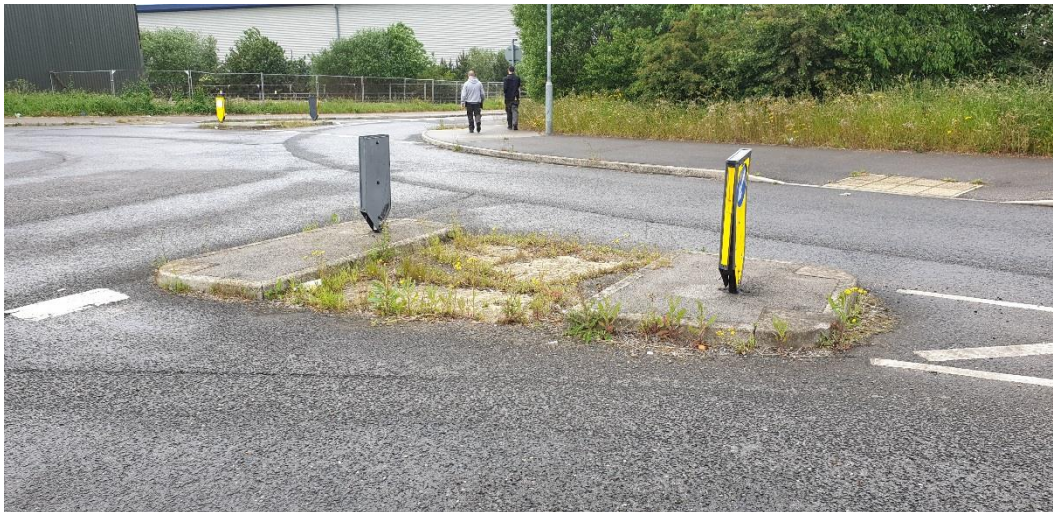
*Figure 17 - View across pedestrian crossing point on eastern leg of mini roundabout. Very heavy vegetation on tactile paving in island.*

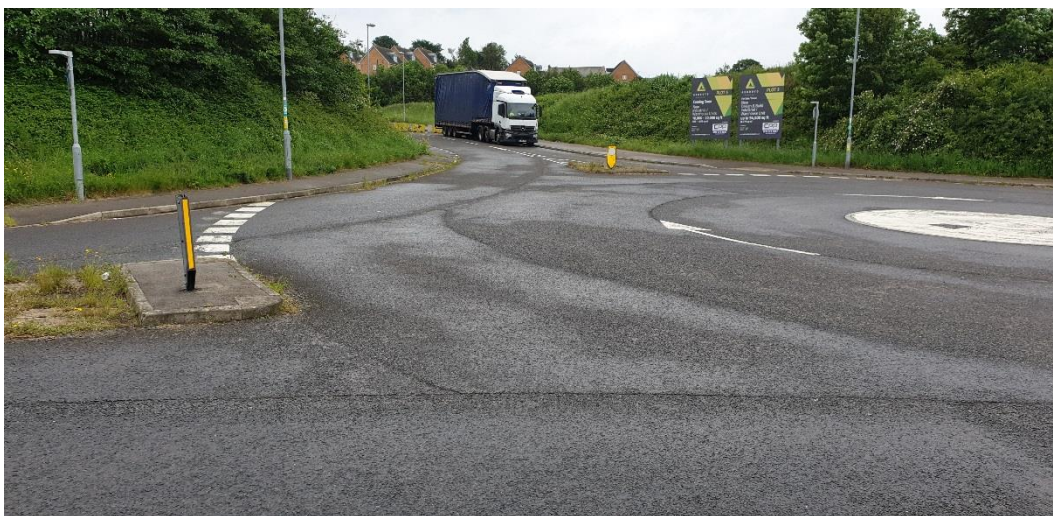
*Figure 18 - View from northern side of eastern leg to the southern leg (Access to Plot 5)*

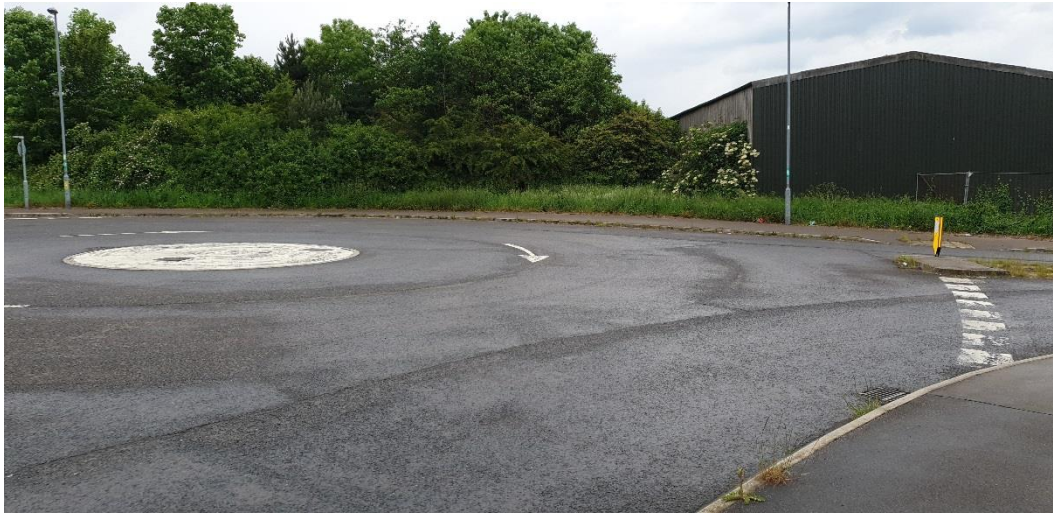
*Figure 19 - View from eastern leg to northern leg.*

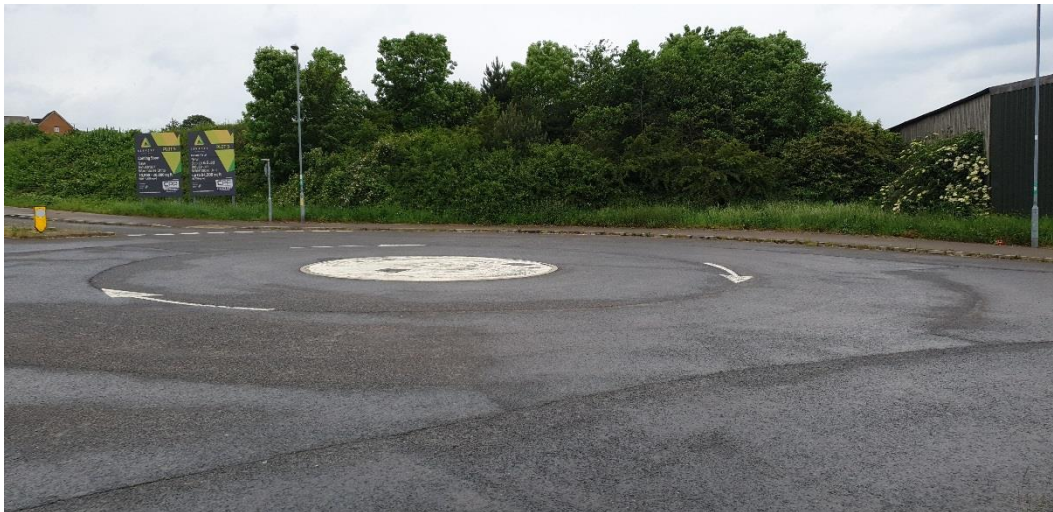
*Figure 20 - View of surfacing across mini roundabout.*

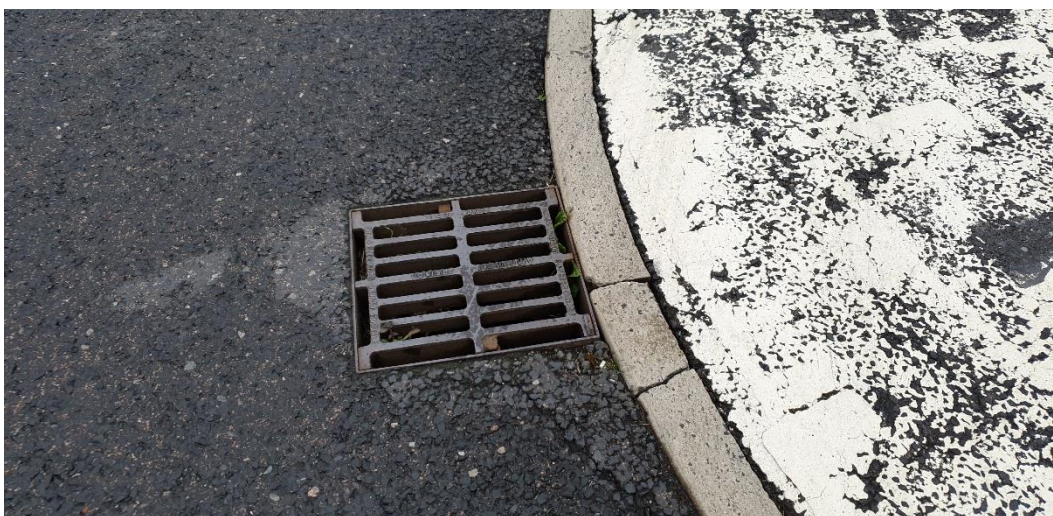
*Figure 21 - Loose kerbing adjacent gully on island.*

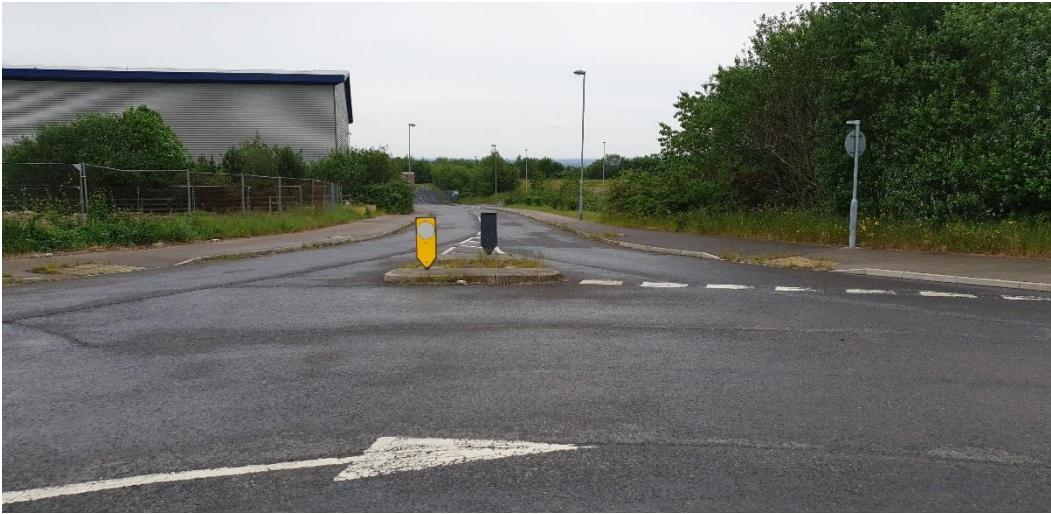
*Figure 22 - View from island to the northern leg.*

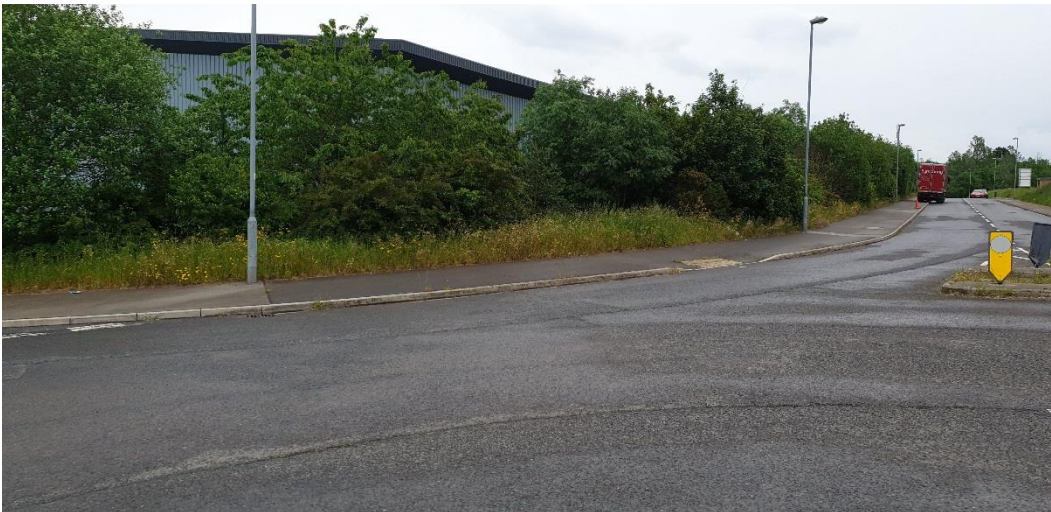
*Figure 23 - View from island to north-east of roundabout.*

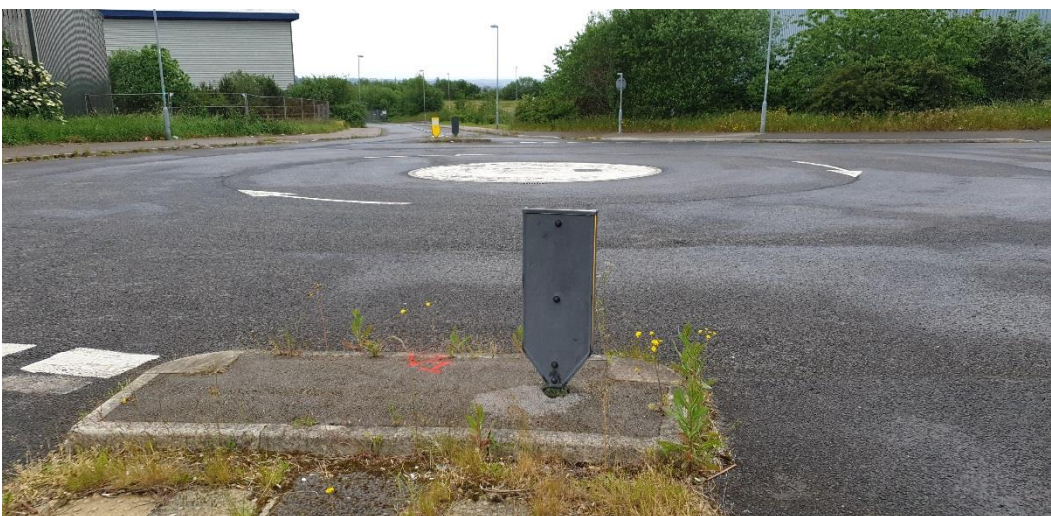
*Figure 24 - View from pedestrian island on southern leg. Heavy vegetation in kerb lines/tactile paving.*

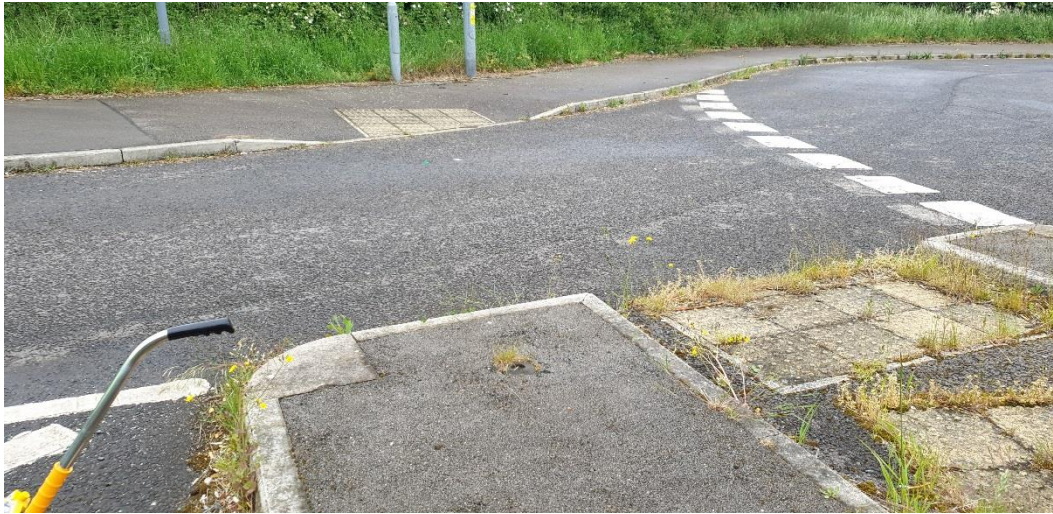
Figure 25 - Missing reflective bollard on southern side of island on southern leg.

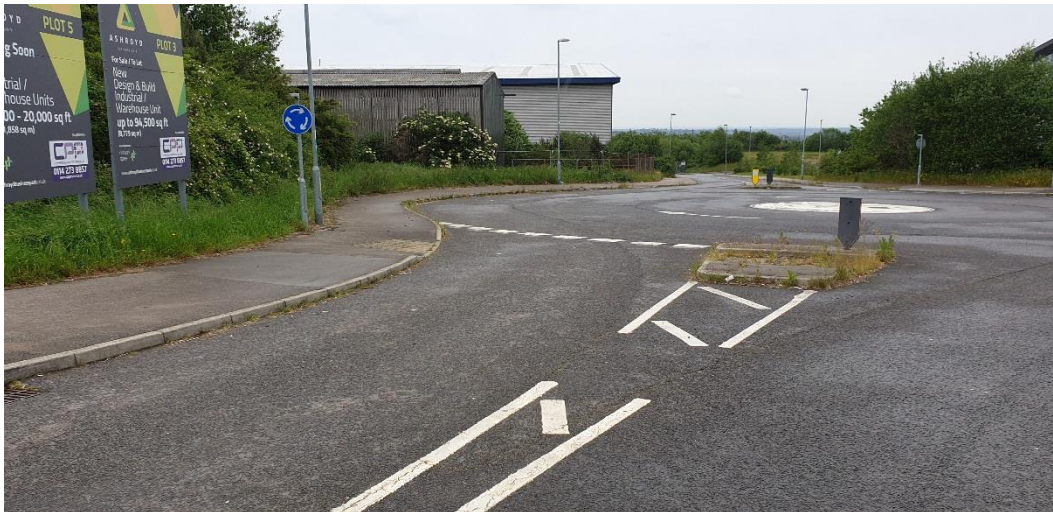
Figure 26 - Approach to roundabout on southern leg.

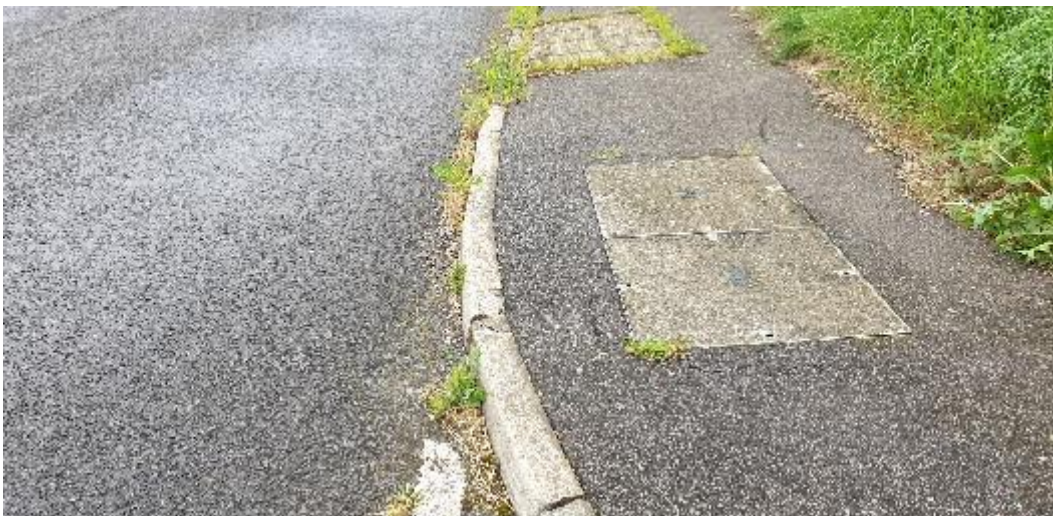
Figure 27 - Chipped kerbs on western side of southern leg off mini roundabout adjacent BT box.

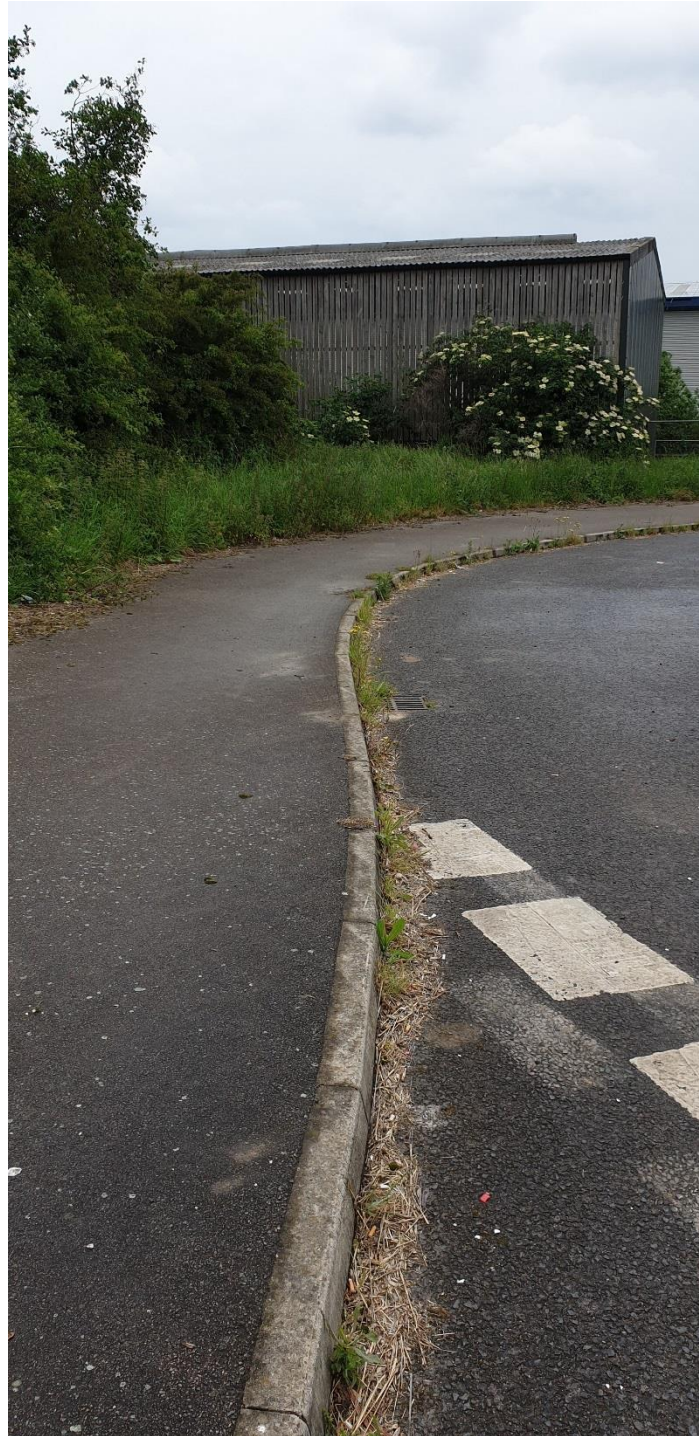
*Figure 28 - Kerb line on western side of roundabout looking north from southern leg.*

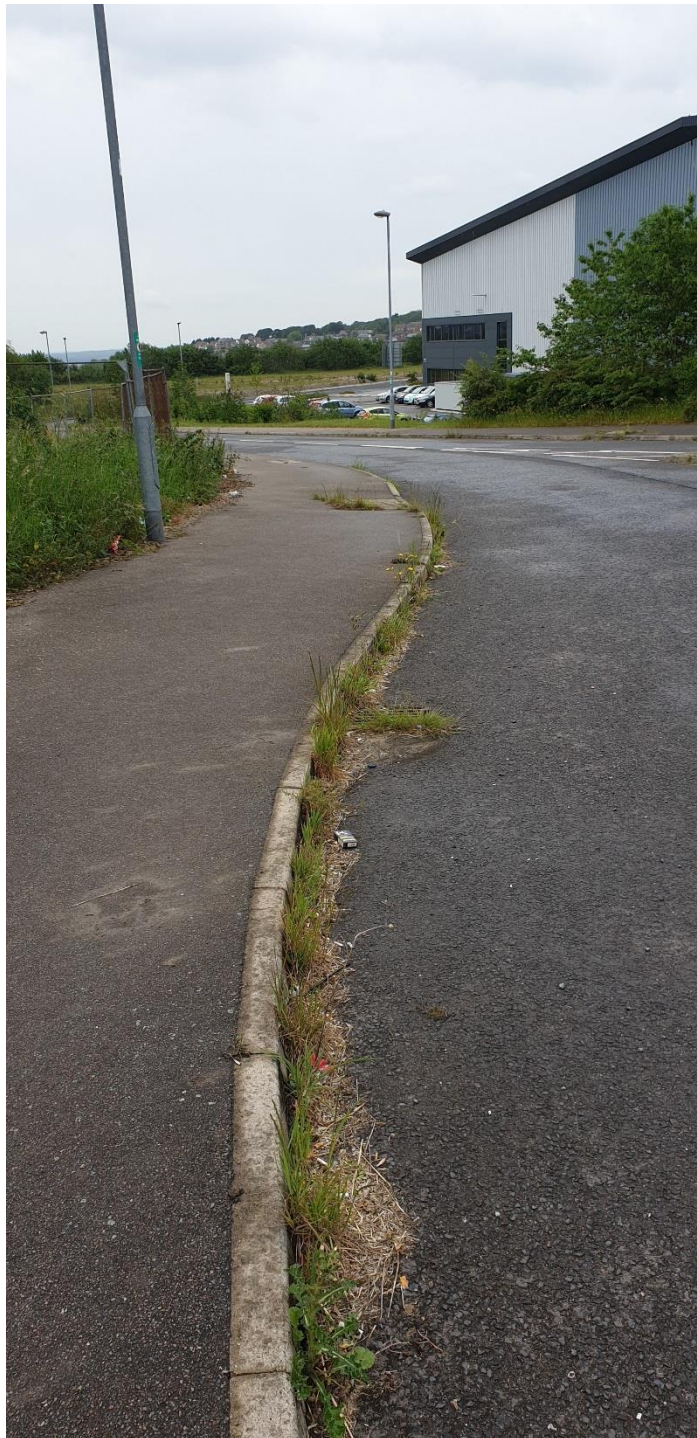
*Figure 29 - Kerb line on western side of roundabout looking toward the northern leg.*

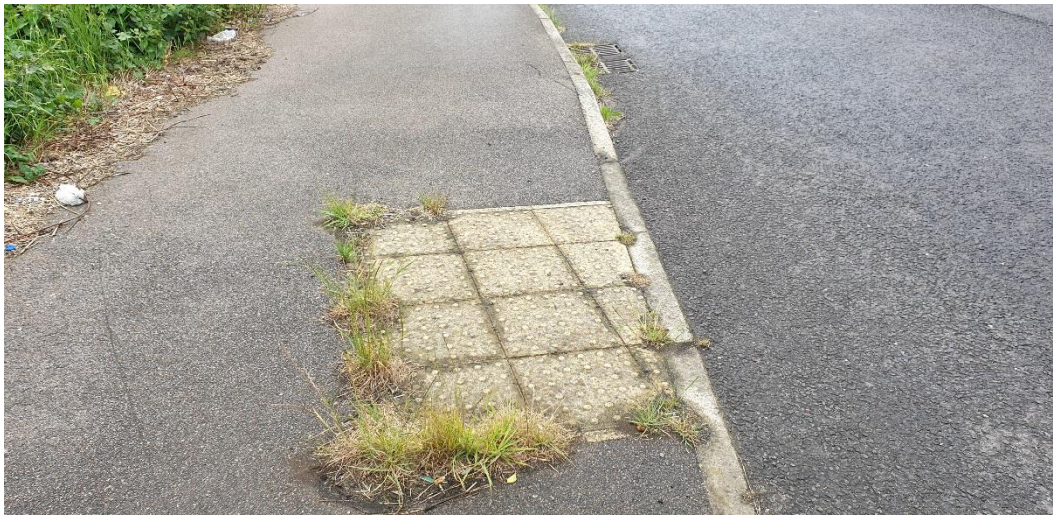
*Figure 30 - West side of northern leg - tactile pavers.*

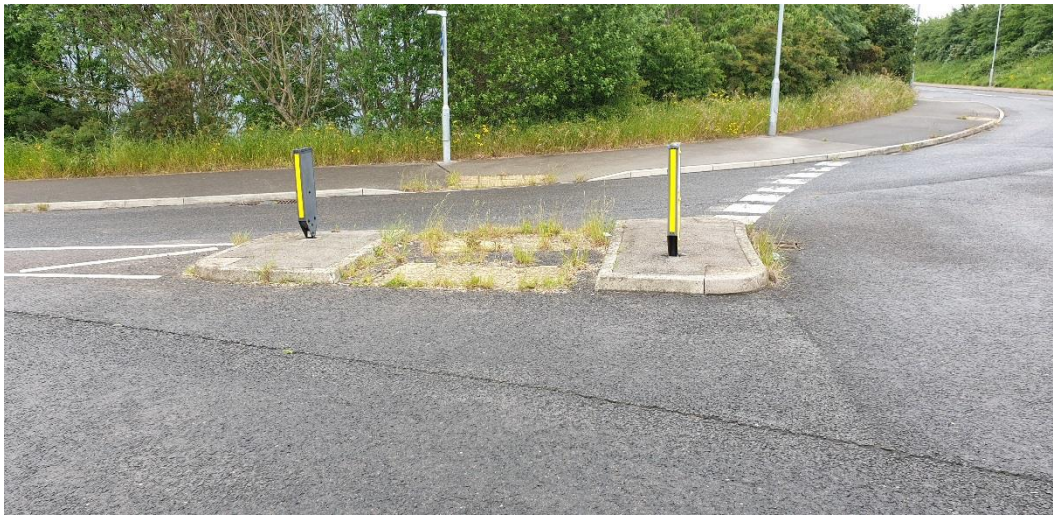
*Figure 31 - Island on northern leg. Overgrown with weeds and vegetation etc.*

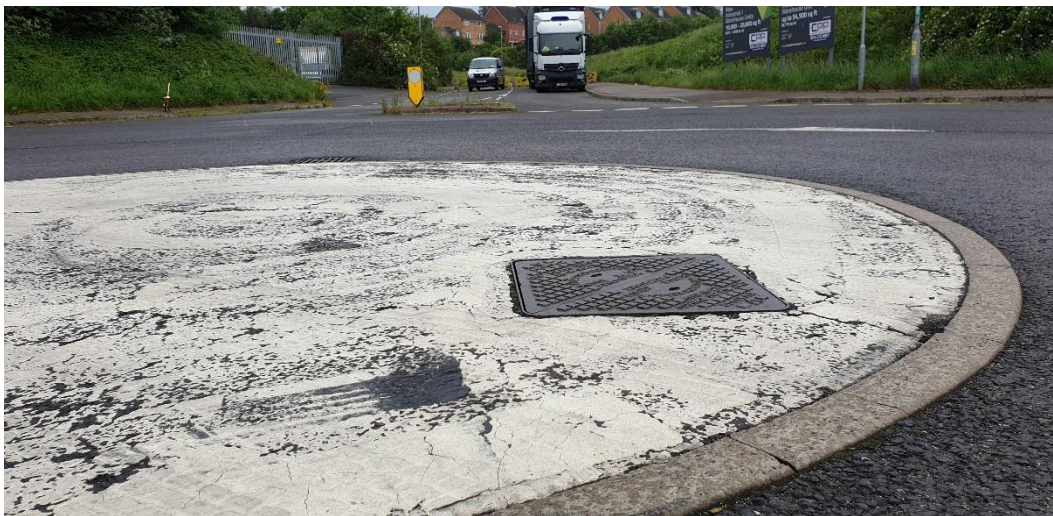
*Figure 32 - Depression in mini-roundabout island from vehicle overrun into the northern leg. Slight breaking up of surfacing around manhole cover.*

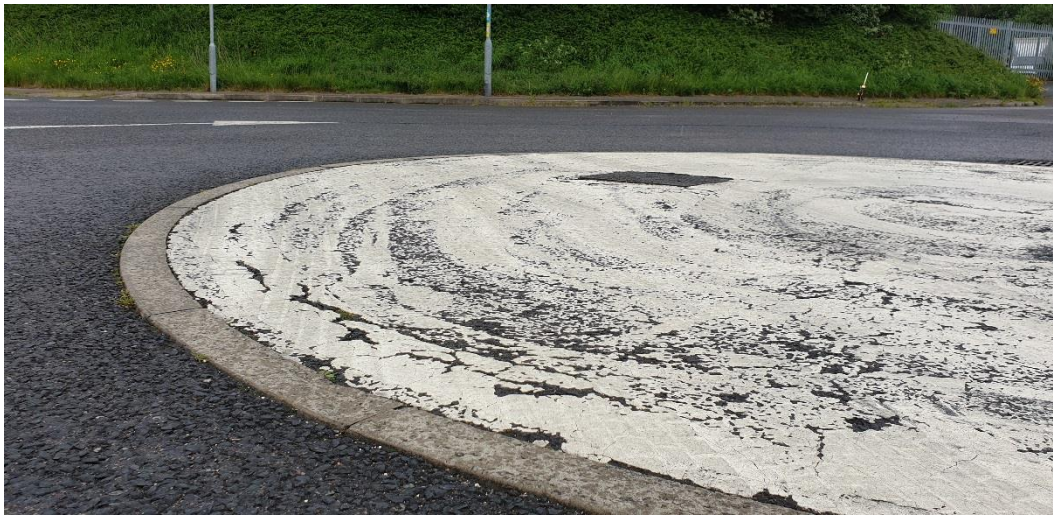
*Figure 33 - Depression in mini-roundabout surfacing.*

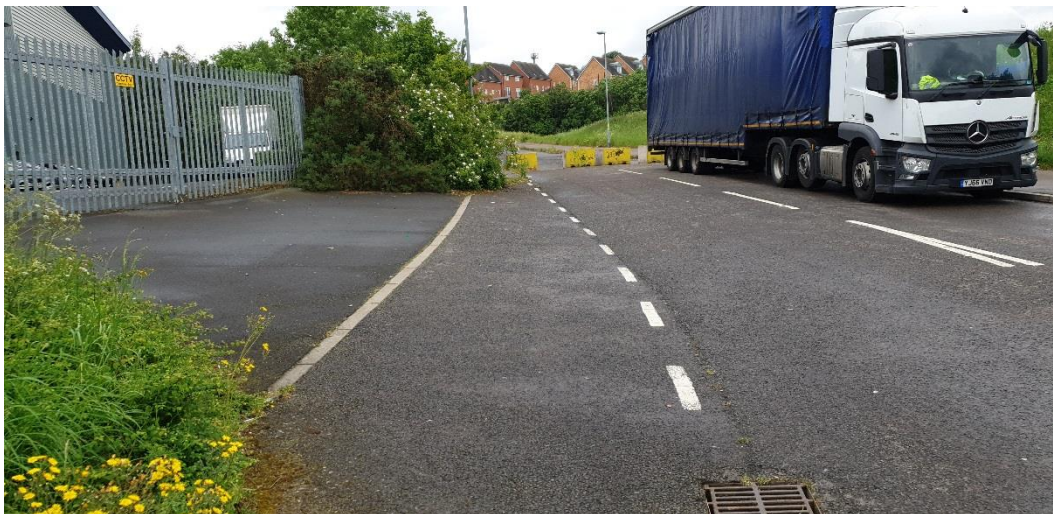
*Figure 34 - Looking south on eastern side footway. Second access into Self Store unit.*

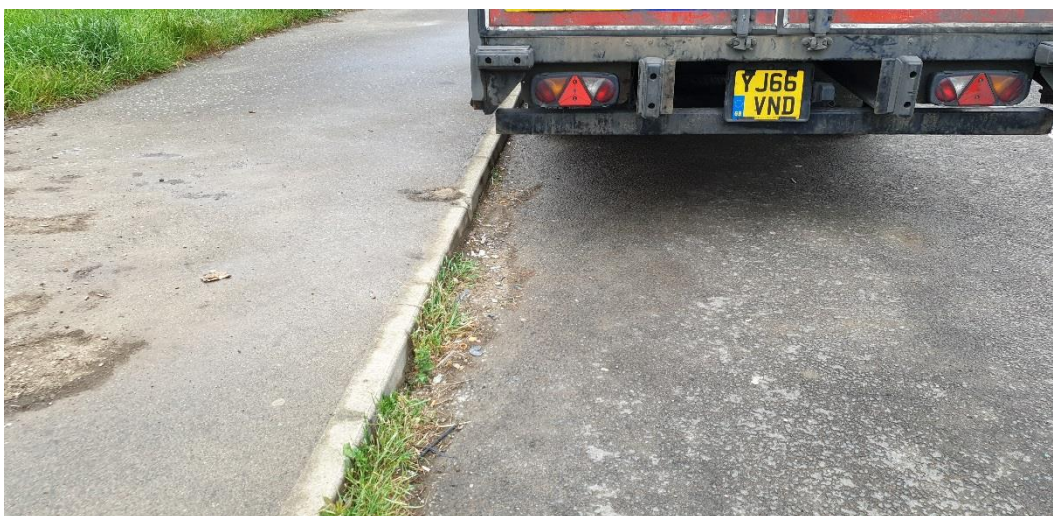
*Figure 35 - Western channel of southern leg.*

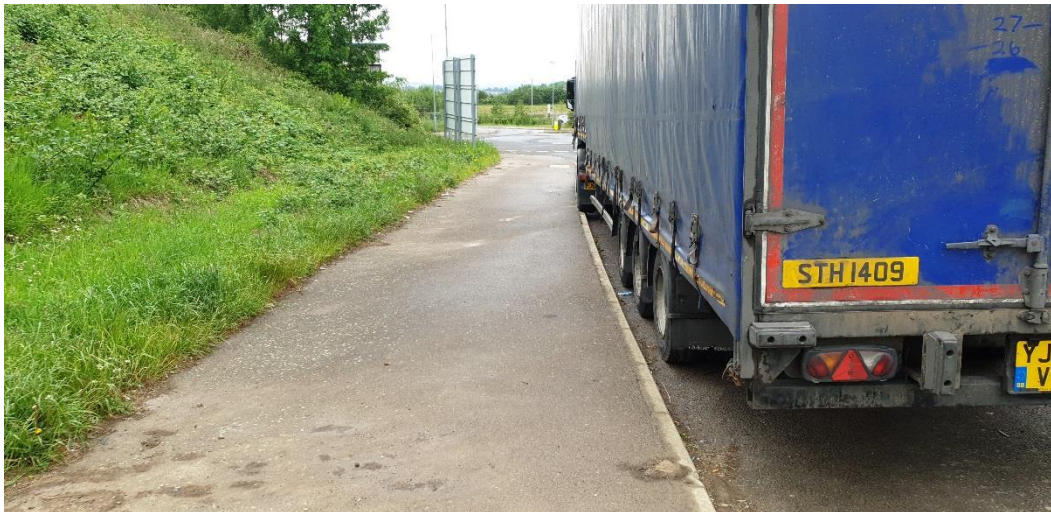
*Figure 36 - Western footway looking north toward roundabout.*

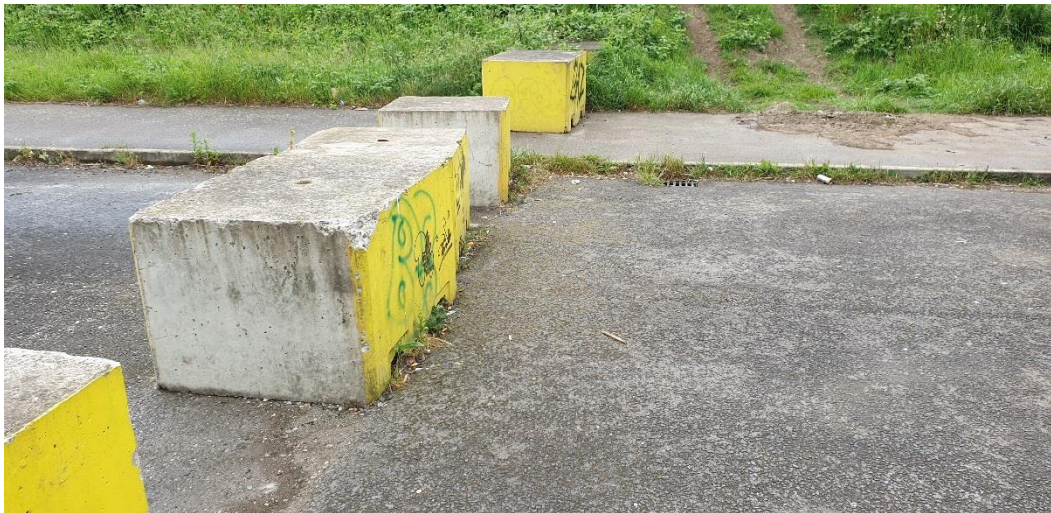
*Figure 37 - Concrete blocks prevent access onto unmade section of road which is not yet adopted.*

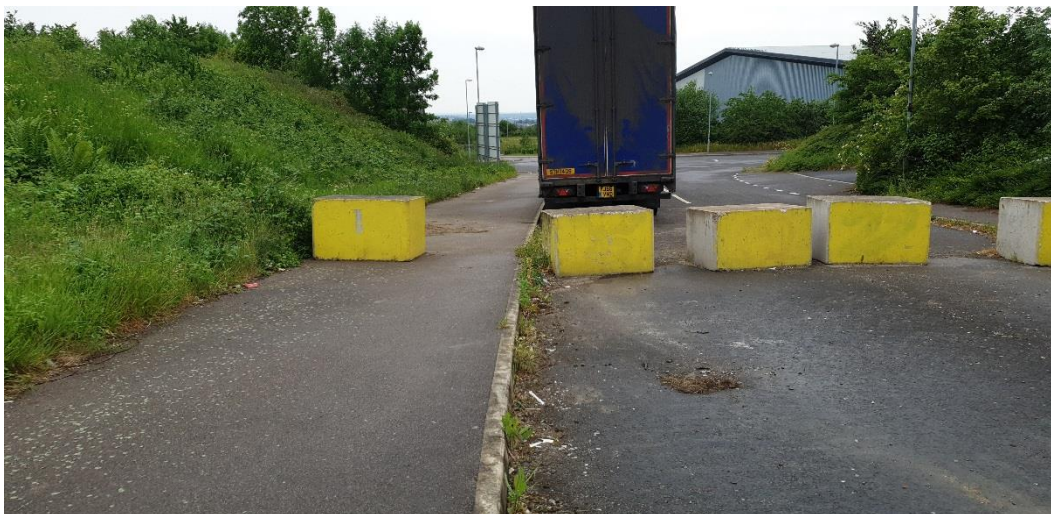
*Figure 38 - Looking north through concrete blocks. Carriageway south of the blocks is not finished with surface course.*

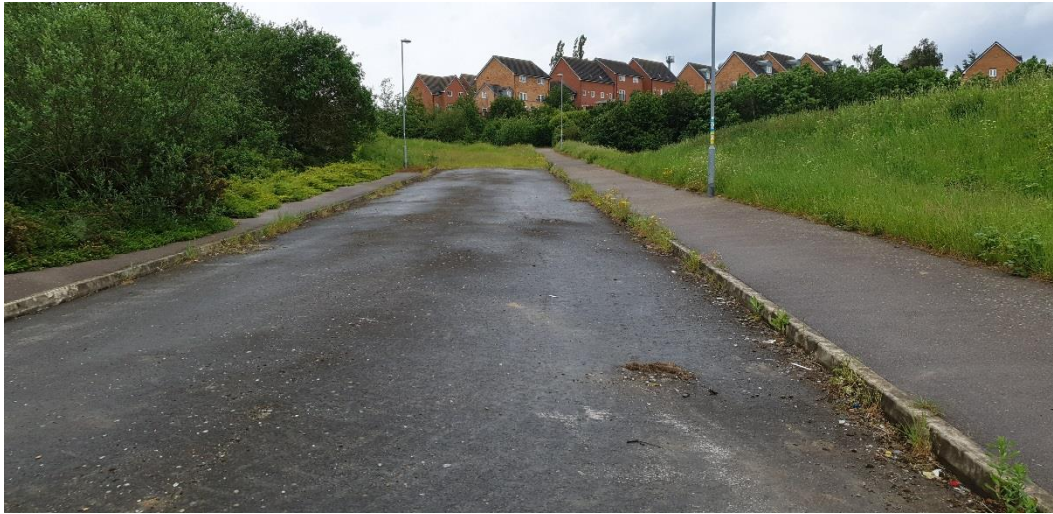
*Figure 39 - View south beyond concrete blocks. Footway on western side is complete and surfaced. Carriageway is incomplete.*
