**PLOT 4B & 5, ASHROYD BUSINESS PARK, HOYLAND**

**G F TOMLINSON BUILDING LTD**

**PRE-START HIGHWAY CONDITION INSPECTION**

**JUNE 2019**

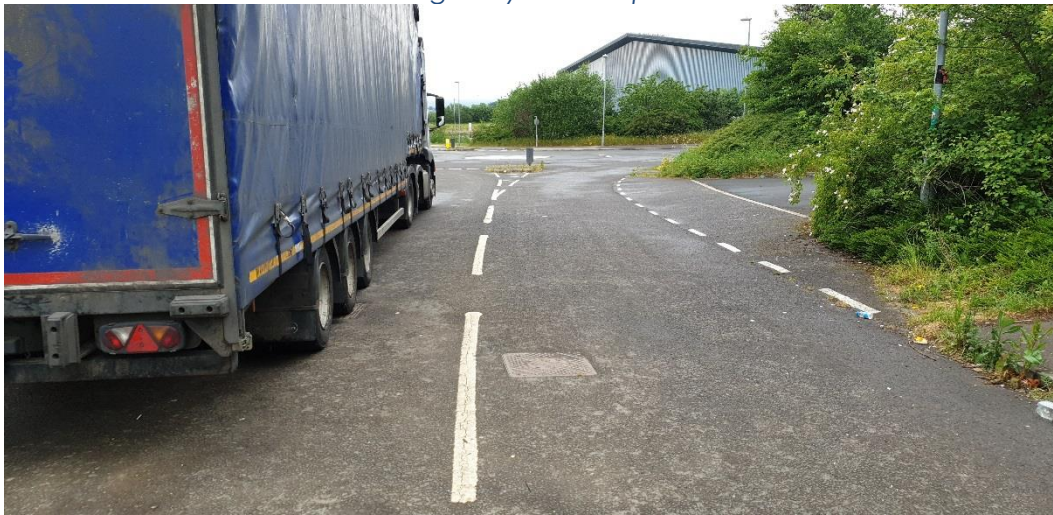
*Figure 40 - Looking south - eastern side tactiles heavily overgrown, vegetation over footway.*

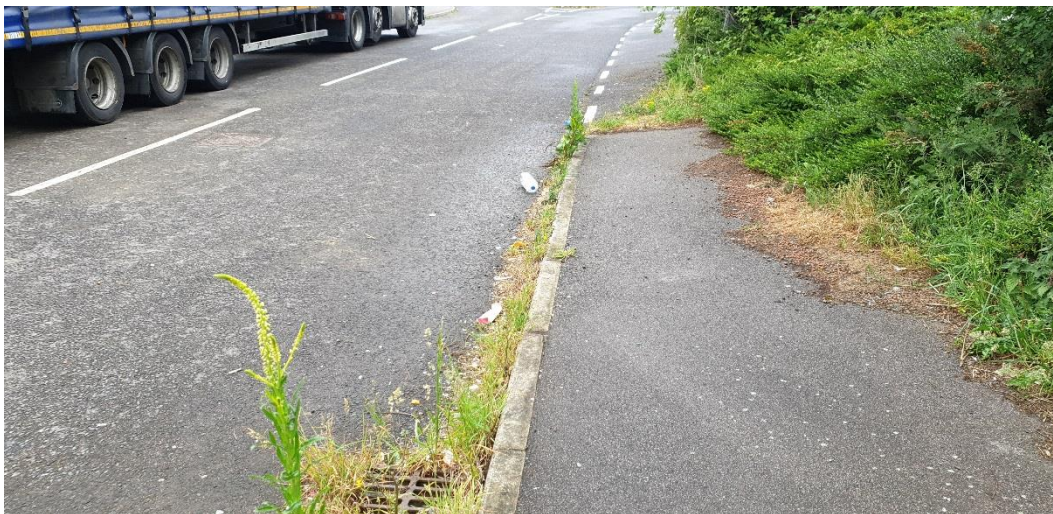
*Figure 41 - Growth in channel linem encroaching back of footway and over tactiles.*

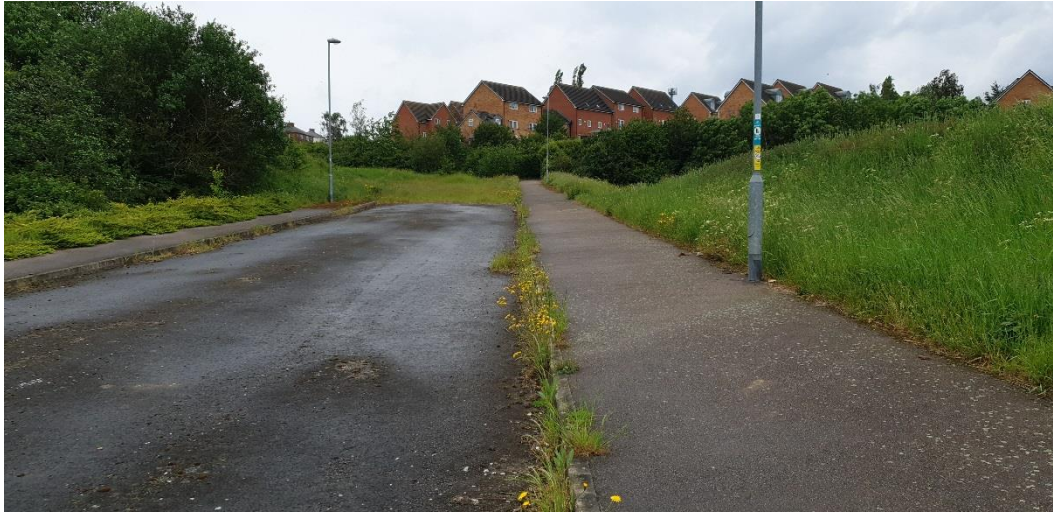
*Figure 42 - Western channel looking south.*

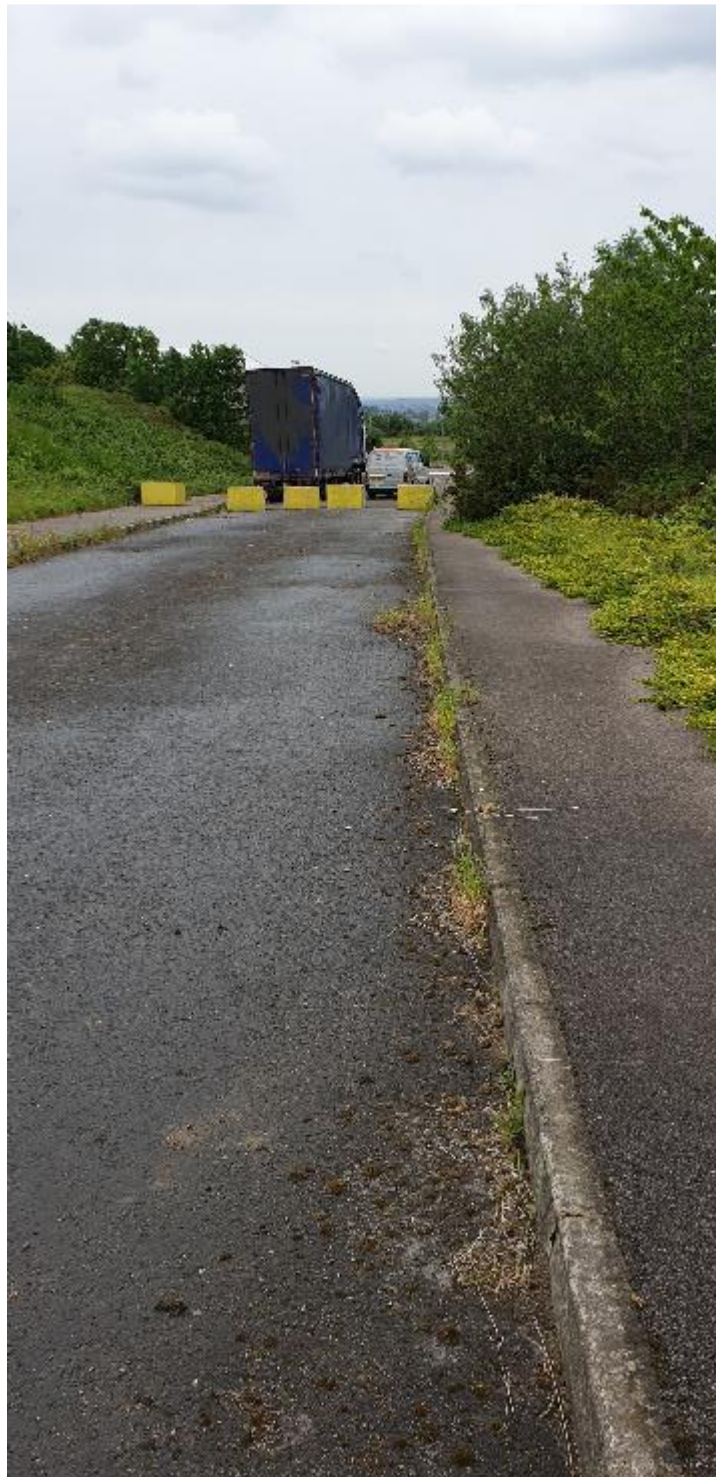
*Figure 43 - Eastern channel looking north.*

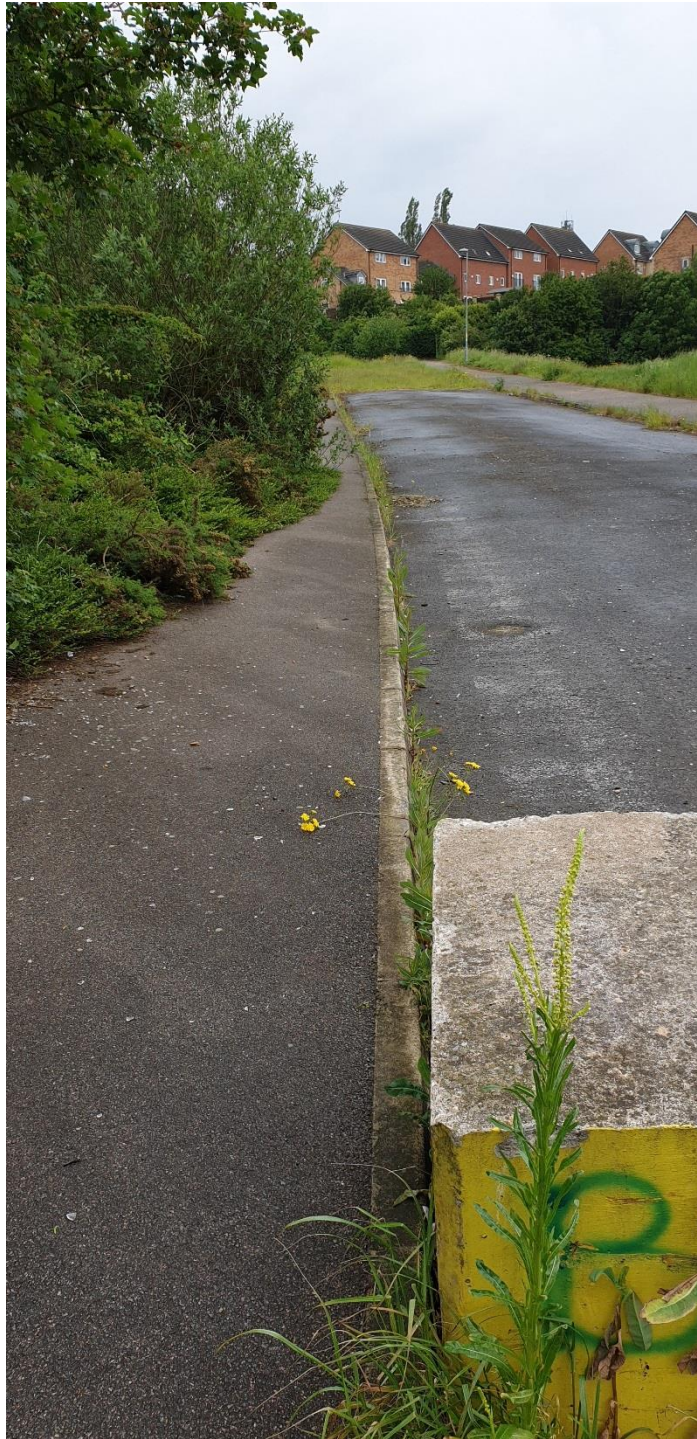
*Figure 44 - Eastern channel looking south from concrete blocks. Vegetation encroaching over footway.*

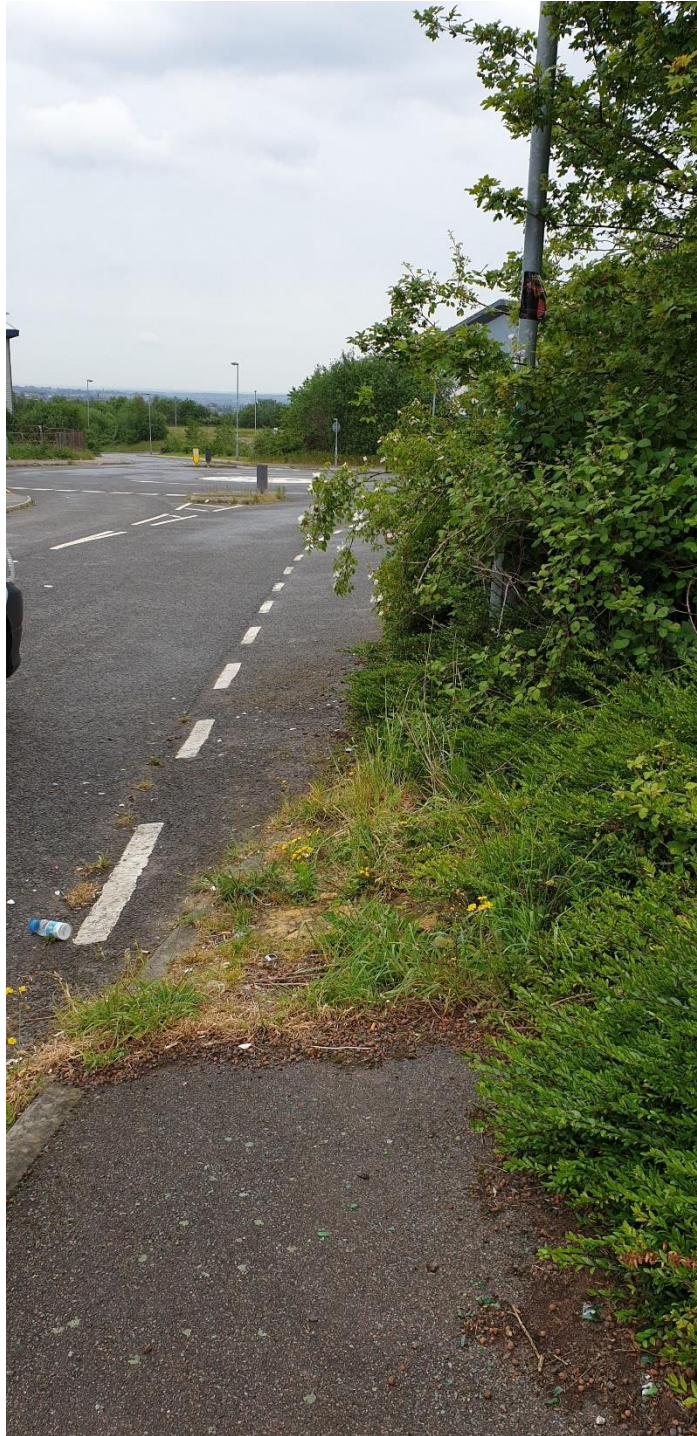
*Figure 45 - Tactile crossing across access. Vegetation encroaching.*

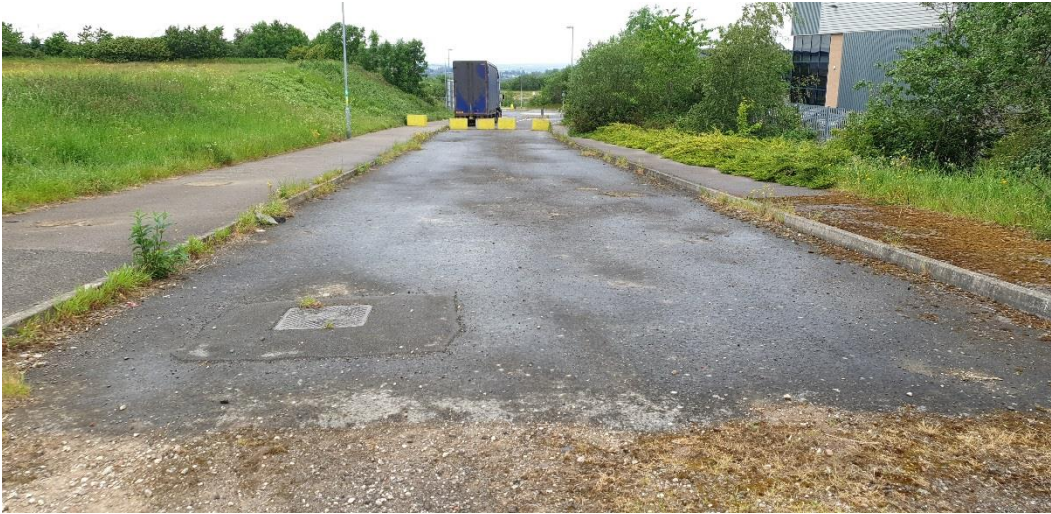
*Figure 46 - View north from end of macadam binder course.*

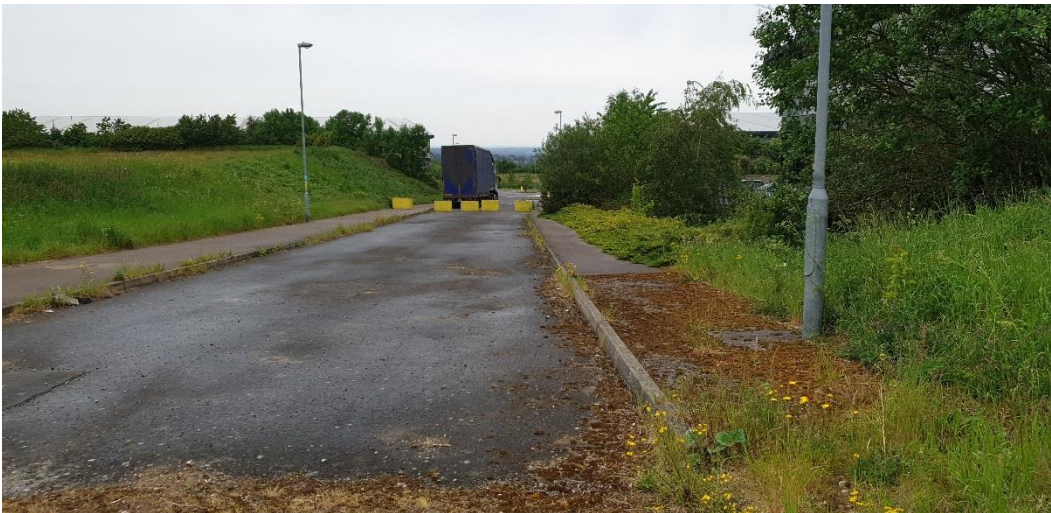
*Figure 47 - Footway on eastern side heavily covered in moss.*

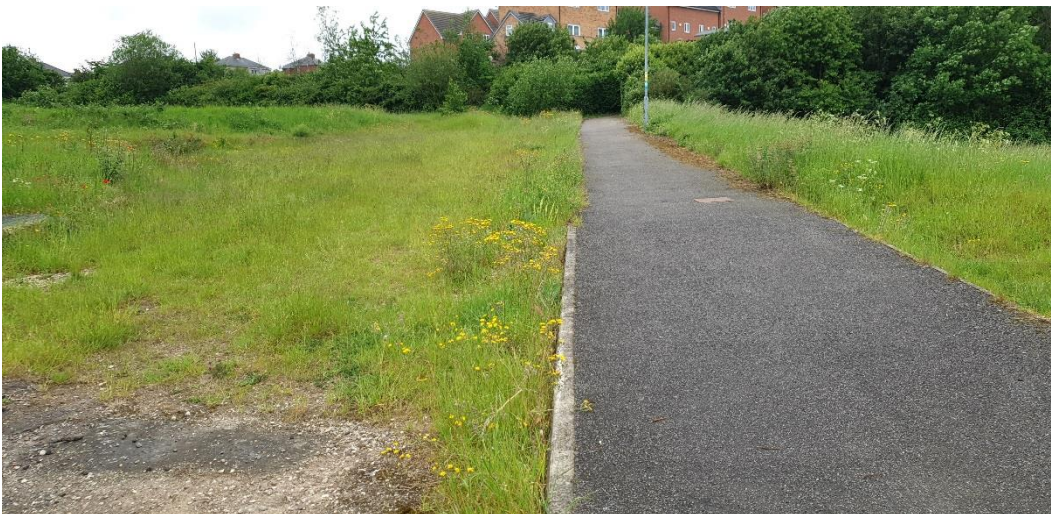
*Figure 48 - Footway continuing south toward end of site boundary. Footway in good condition. Carriageway incomplete.*

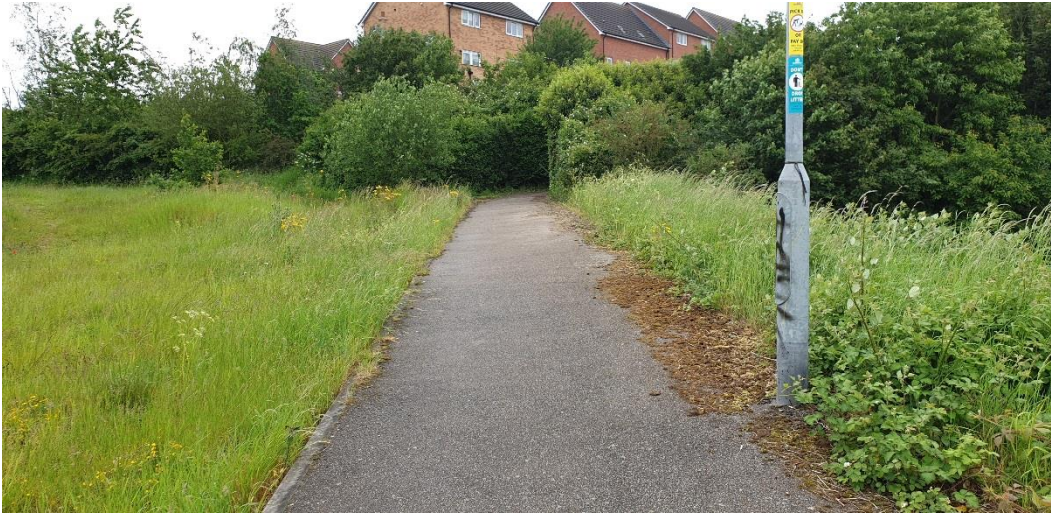
Figure 49 - Footway in good condition toward link through to beyond site boundary.

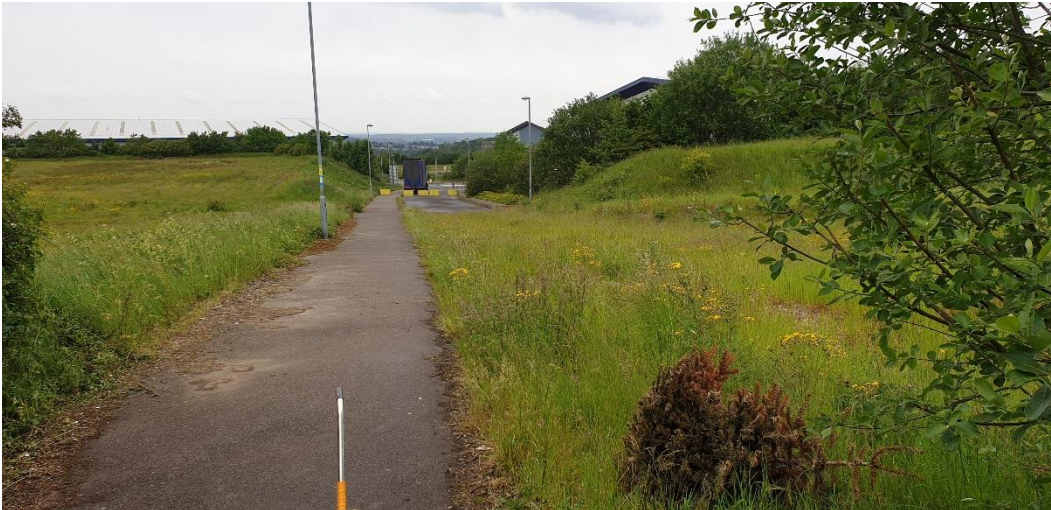
Figure 50 - View north from footway on site boundary.

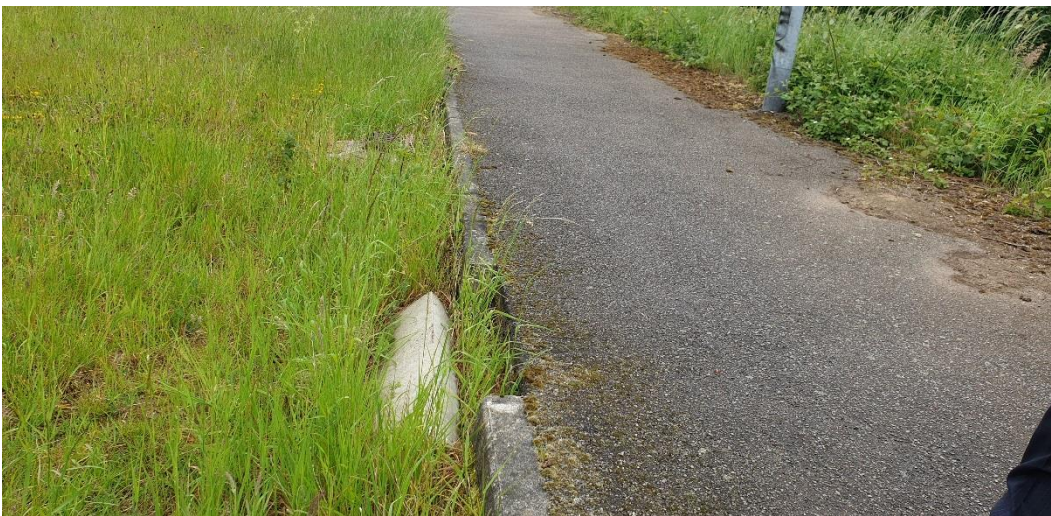
Figure 51 - One kerb has dislodged. To be replaced in S38 works.
