# Soakaway and Foul Drainage Testing Report

**Woodbine Cottage, Doncaster Road, Billingley**

Issued: September 2019

Delta-Simons Project No. 19-1049.01

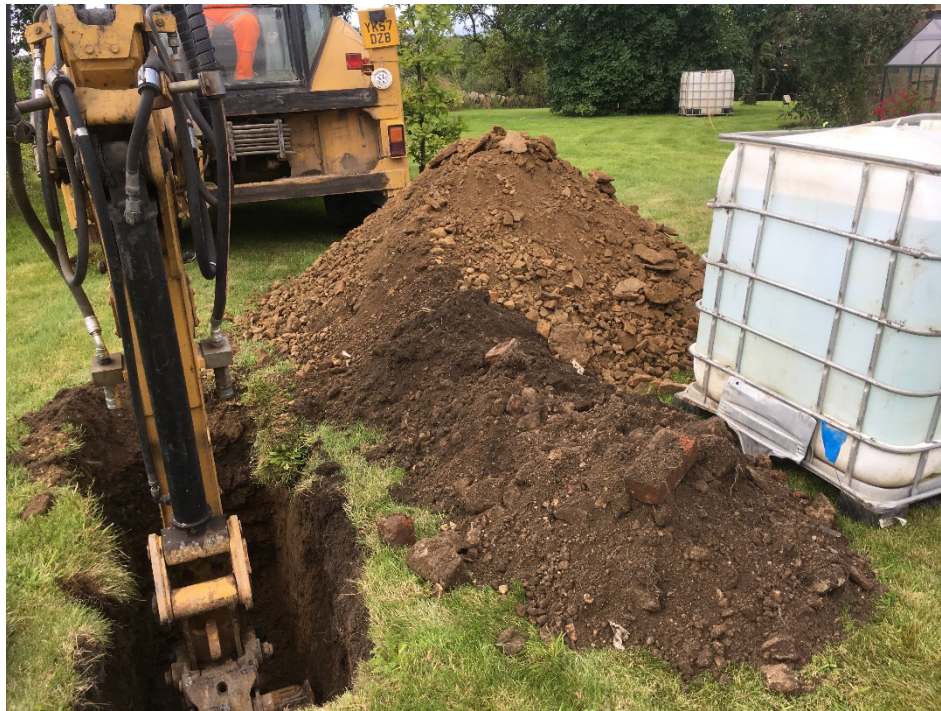
**Photograph 1 – Excavation of SA101 to 2.3 m bgl. Facing approximately south.**

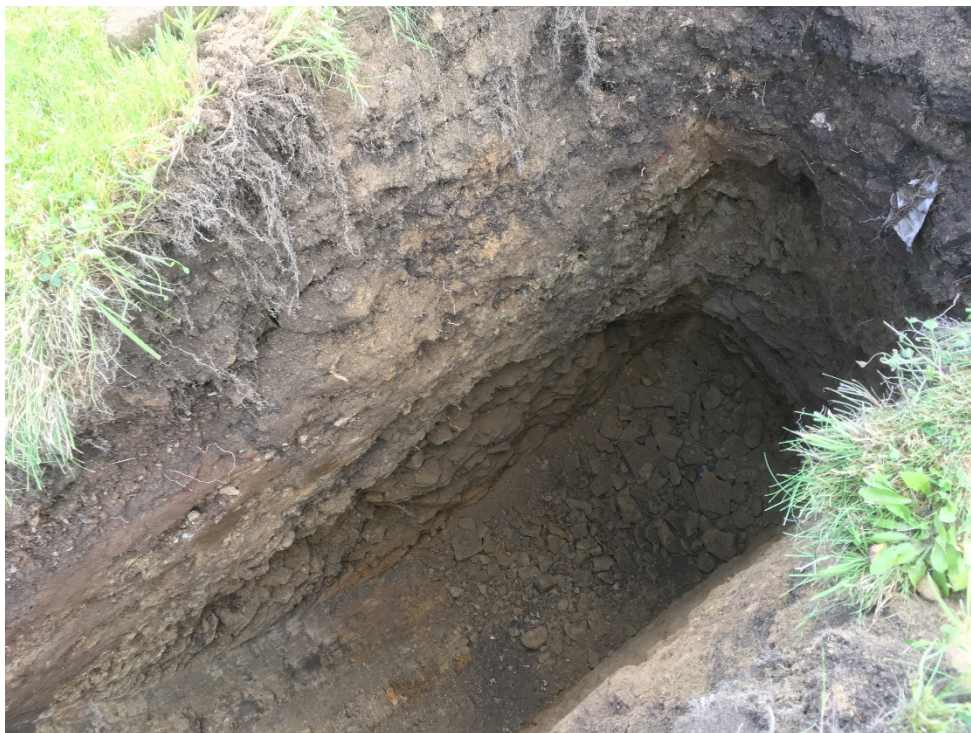
**Photograph 2 – View at the base of SA101 (2.3 m bgl). Made Ground is present up to 0.65 m bgl, with weathered sandstone bedrock being encountered at 1.5 m bgl. Facing approximately south-east.**

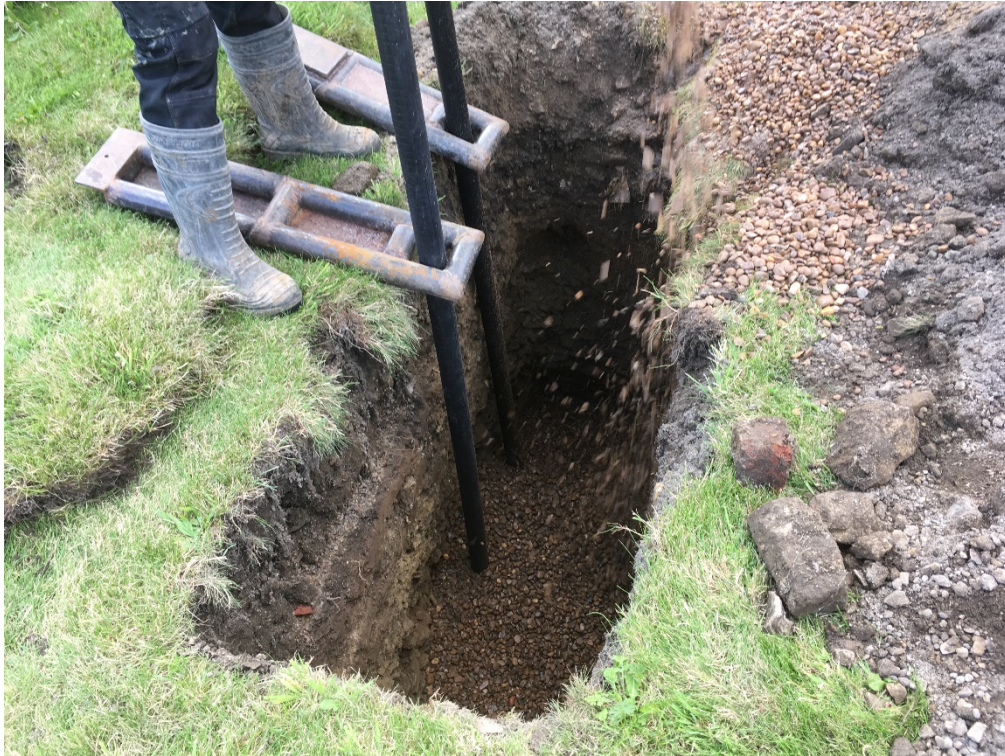
**Photograph 3 – Soakaway installation in SA101. Pipework and gravel are being placed, with the gravel pack filling the trial pit from 2.3 to 1.5 m bgl.**

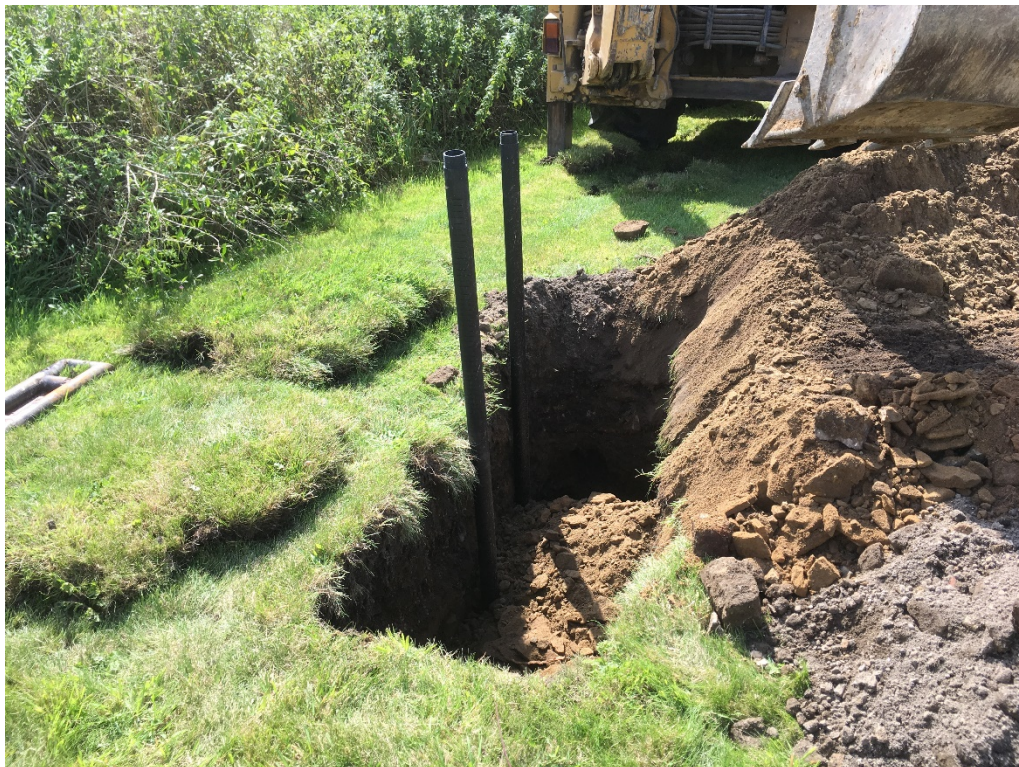
**Photograph 4 – Backfilling of SA101 with arisings from 1.5 m bgl to ground level. Facing approximately south-east.**

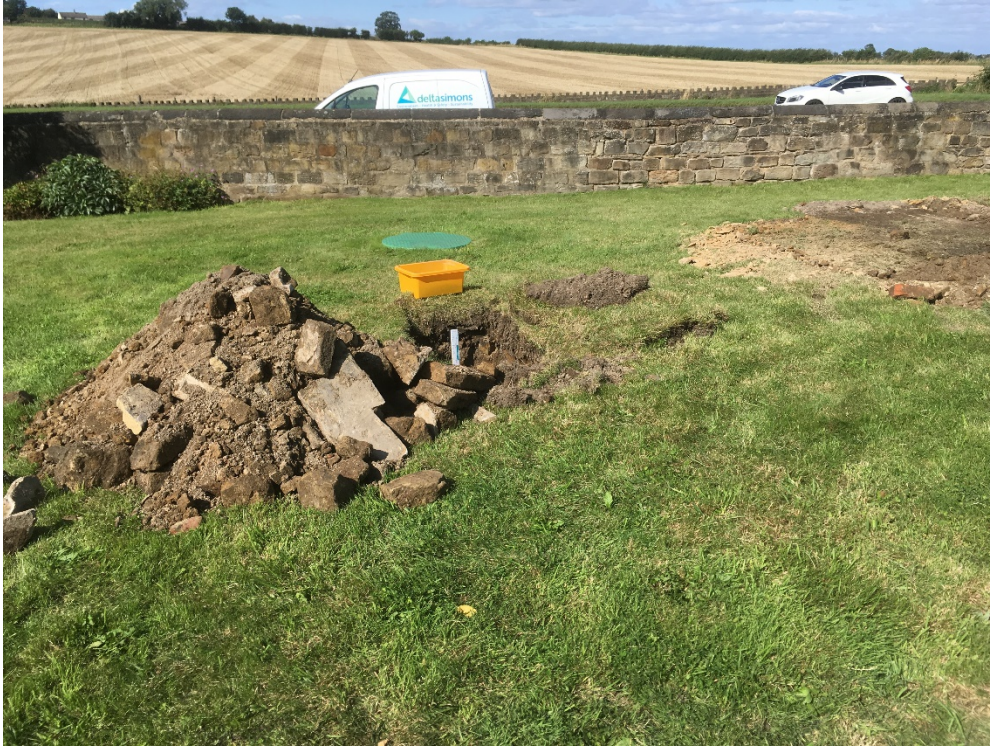
**Photograph 5 – Position of FD101 (left of image) in relation to SA101 (top right of image). Demolition rubble excavated from FD101 can be seen stockpiled to the left of the hole. Facing approximately north.**

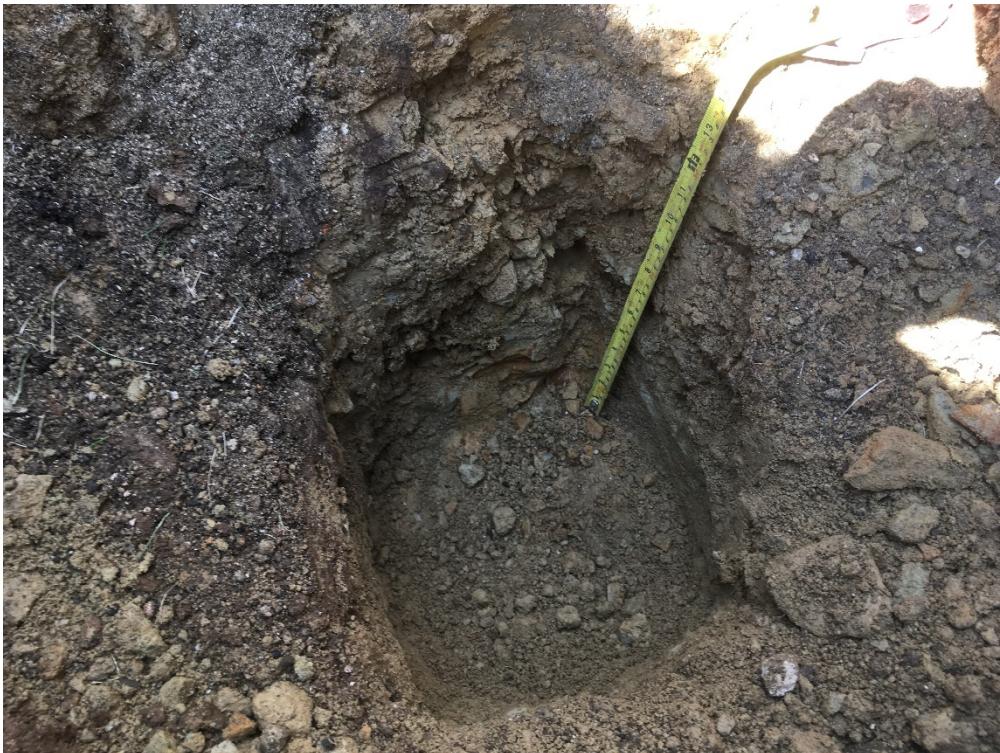
**Photograph 6 – View of the 0.3 x 0.3 x 0.3 m hand pit excavated at the base of the FD101 trial pit, from 0.8 to 1.1 m bgl.**

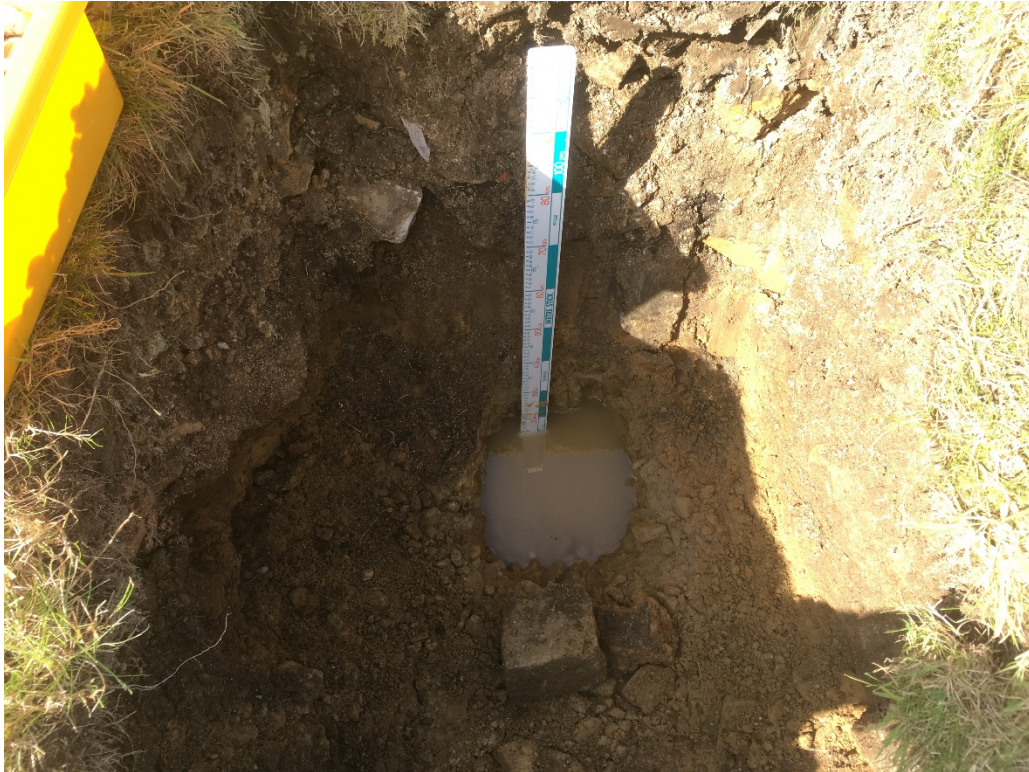
| Percolation Test Location I.D. | Test Depth Range (m bgl) | Response Zone Thickness (m) | Percolation Value [ $V_p$ ] (sec/mm) | Geology |
|---|---|---|---|---|
| FD101 | 0.8 – 1.1 | 0.3 | 27.8 | Clayey gravelly fine to medium SAND. |

**Photograph 7 – View of percolation testing being conducted in the base of FD101, from 0.8 to 1.1 m bgl. Facing approximately north.**
