# Annual Tree Health & Woodland Inspection.

# Annual Tree Health & Woodland Inspection

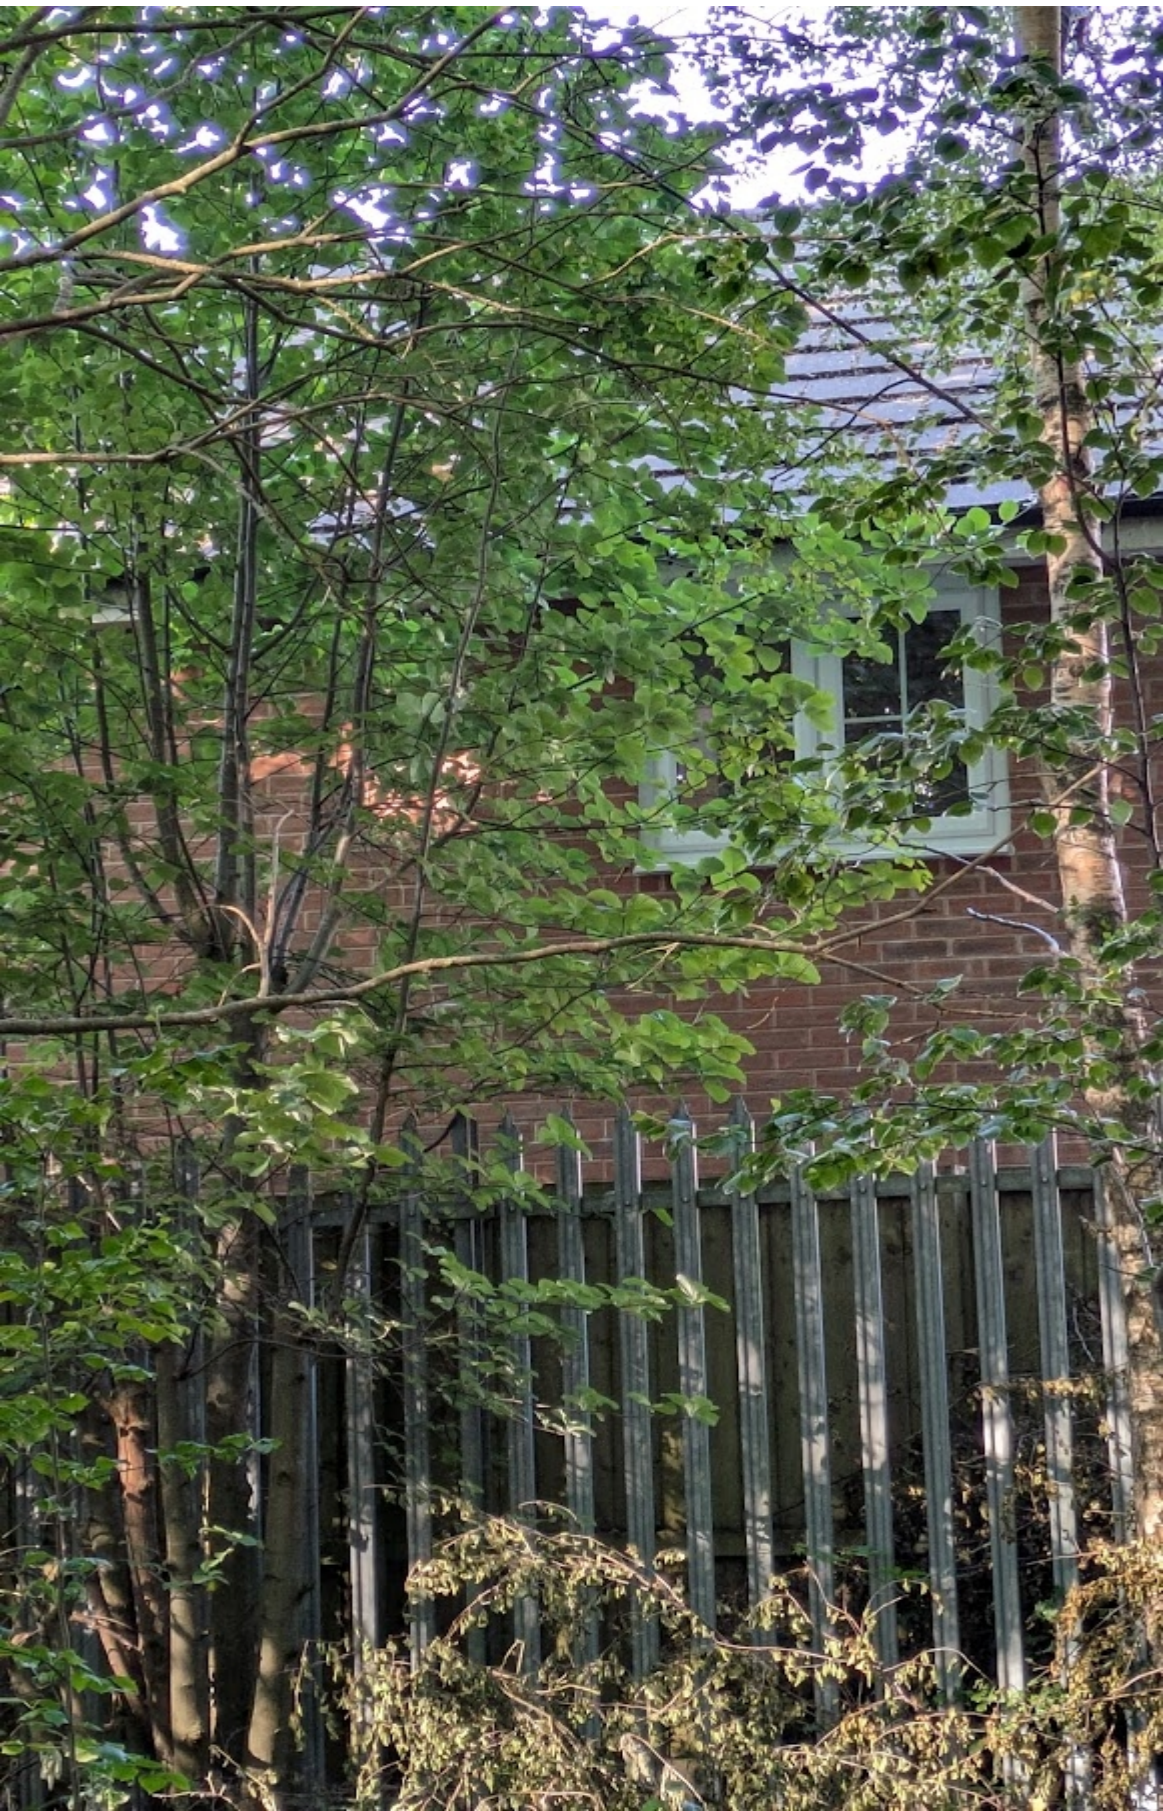
The vegetation to the westerly side of the site has heavy encroachment in to the industrial estate and the gardens, it is prescribed that all overhang is cut back the low vegetation to the fence line, and any heavy leaning tree to be pruned back to the fence line, this can be done in two stages if too costly.

Area to remove excessive low overhang vegetation to the fence line,

Prescribed work: It is prescribed that all overhang is cut back the low vegetation to the fence line, and any heavy leaning tree to be pruned back to the fence line, this can be done in two stages if too costly.

TPO application will need to be submitted prior to the commencement of the prescribed work

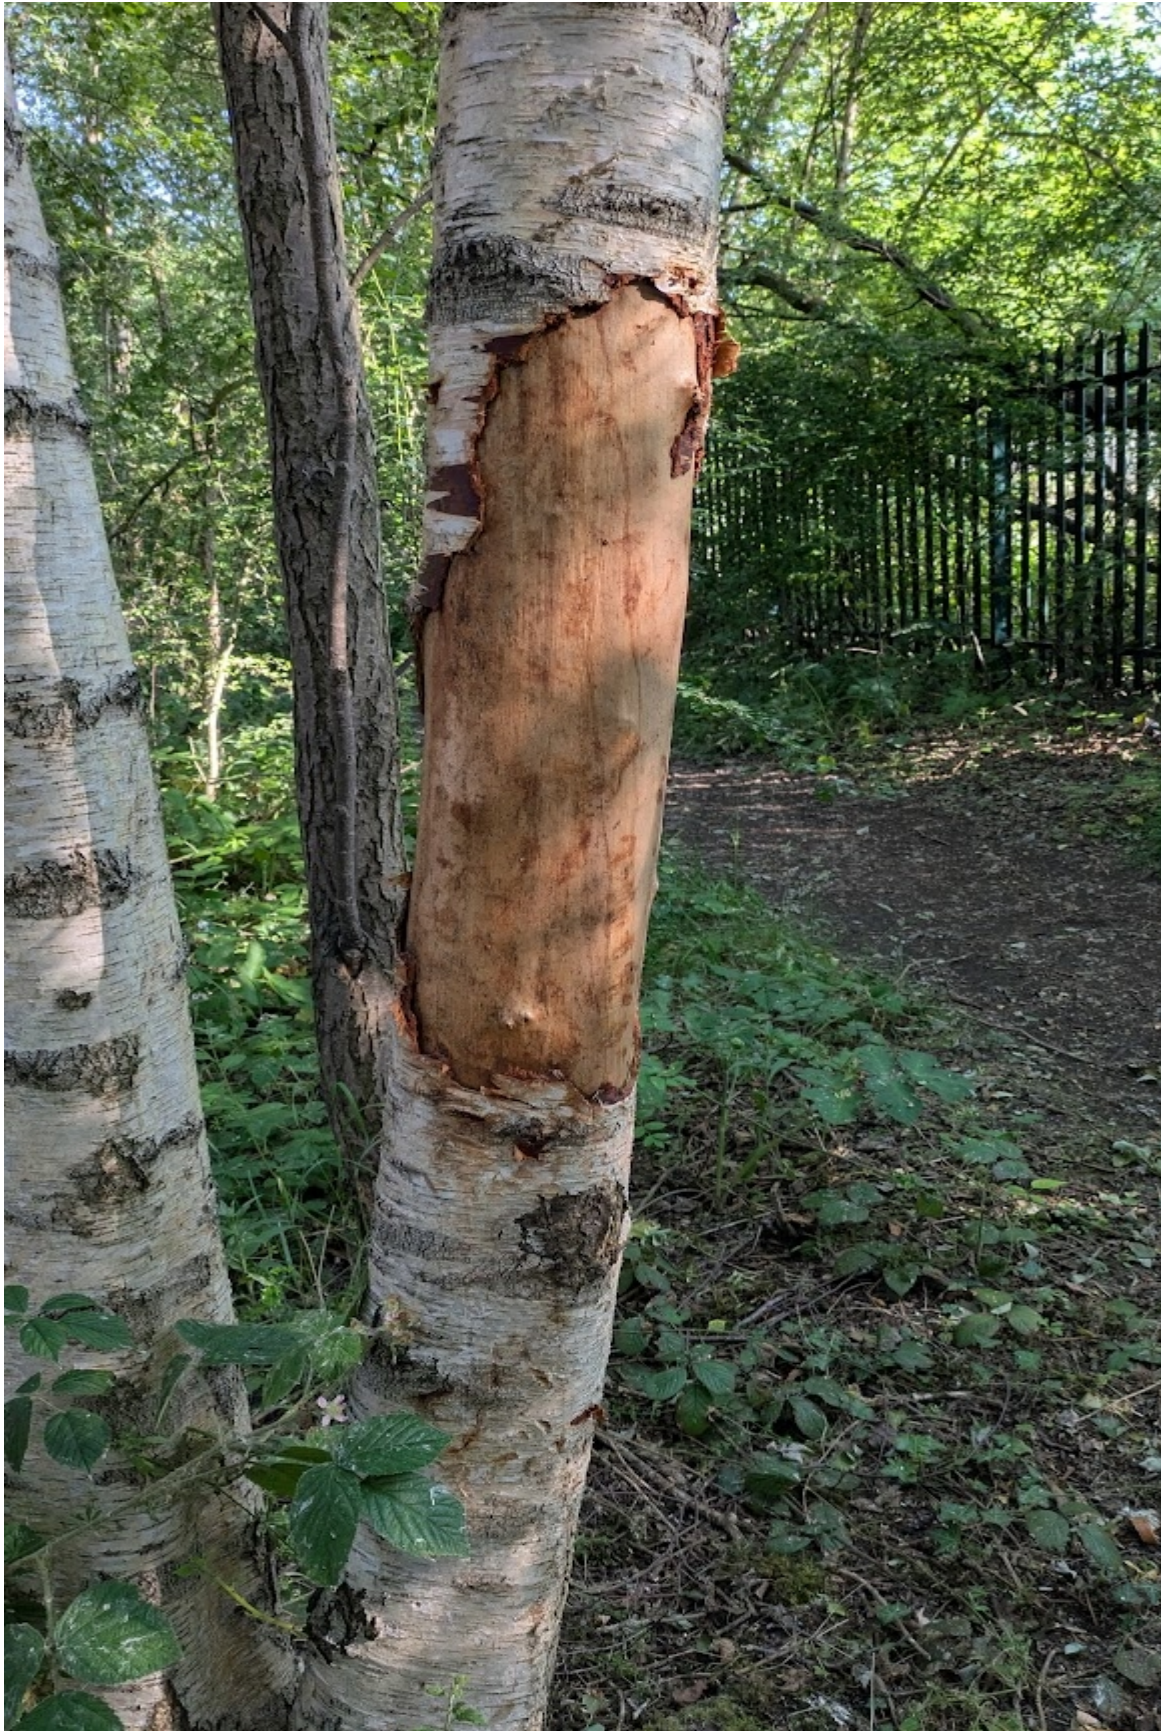
Some vandalism has also occurred, removal of bark from trees.

Vandalism to a tree. Missing bark.
