# **ARBORICULTURAL REPORT**

## **& Impact Assessment**

***34 Westgate,  
Monk Bretton,  
Barnsley  
S71 2DJ***

Reference: AWA6490

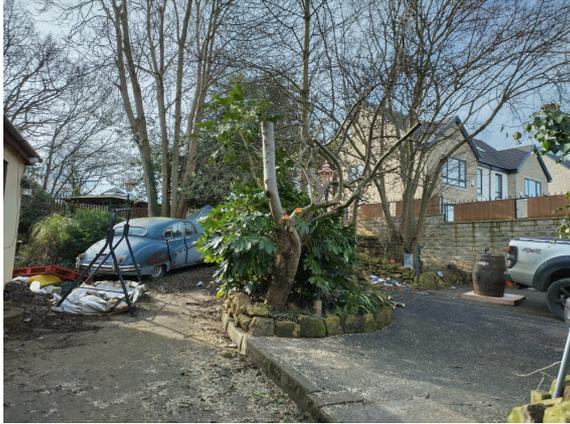
Photo 1: T3-T10 looking south west

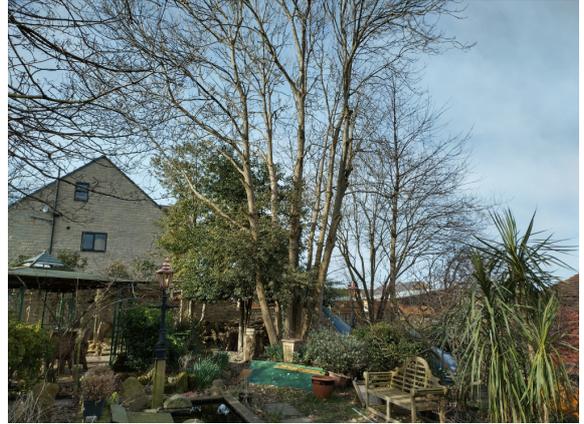
Photo 2: T5-T10 looking west

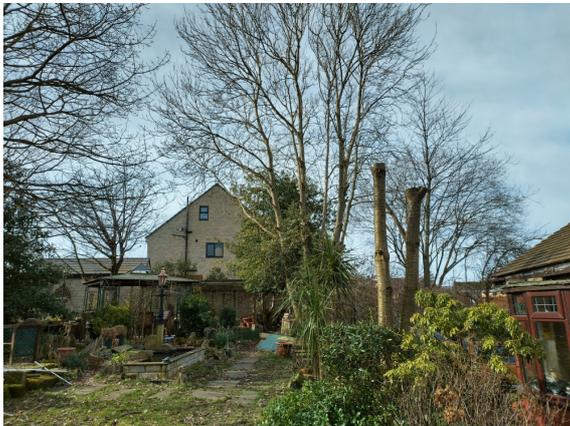
Photo 3: T5-T11 and T14 looking west

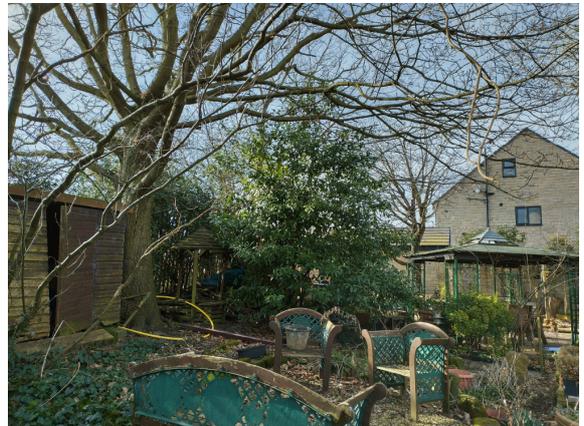
Photo 4: T11-T13 looking south west

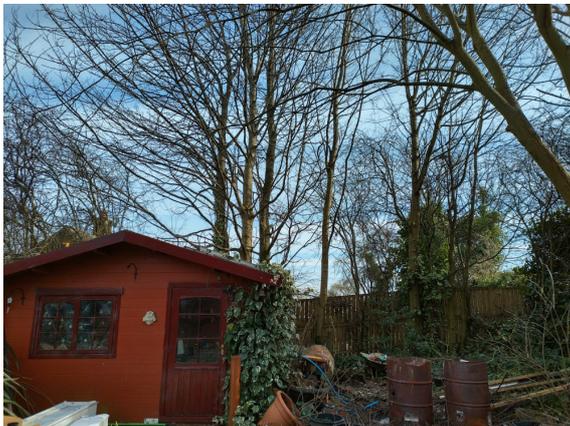
- 3.2.8 Trees T20, T21, T22, T23 and tree group G19 are situated at the eastern boundary of the site. G19 is an understory shrub group providing some screening value whilst Sycamores T20, T21, T22, and T23 are larger semi-mature trees which are prominent throughout the site and local area.

Photo 5: G19 and T20-T23 looking east

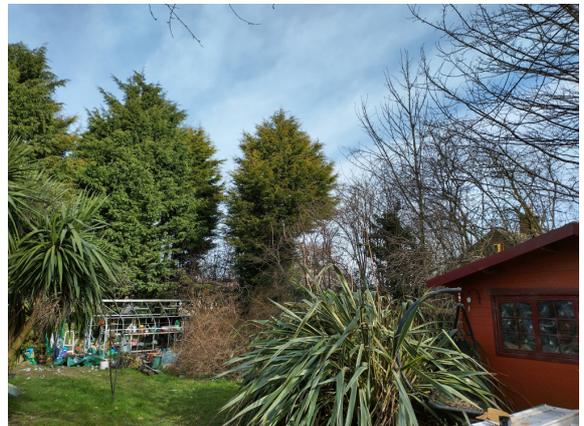
- 3.2.9 Cypresses T24, T25, T26, T27, T28, T29, and T30 are situated at the north eastern corner of the site and provide some screening from the adjacent highway, however they are an unsuitable species for the location and likely to outgrow their context in the longer-term.

Photo 6: G19 and T24-T30 looking north

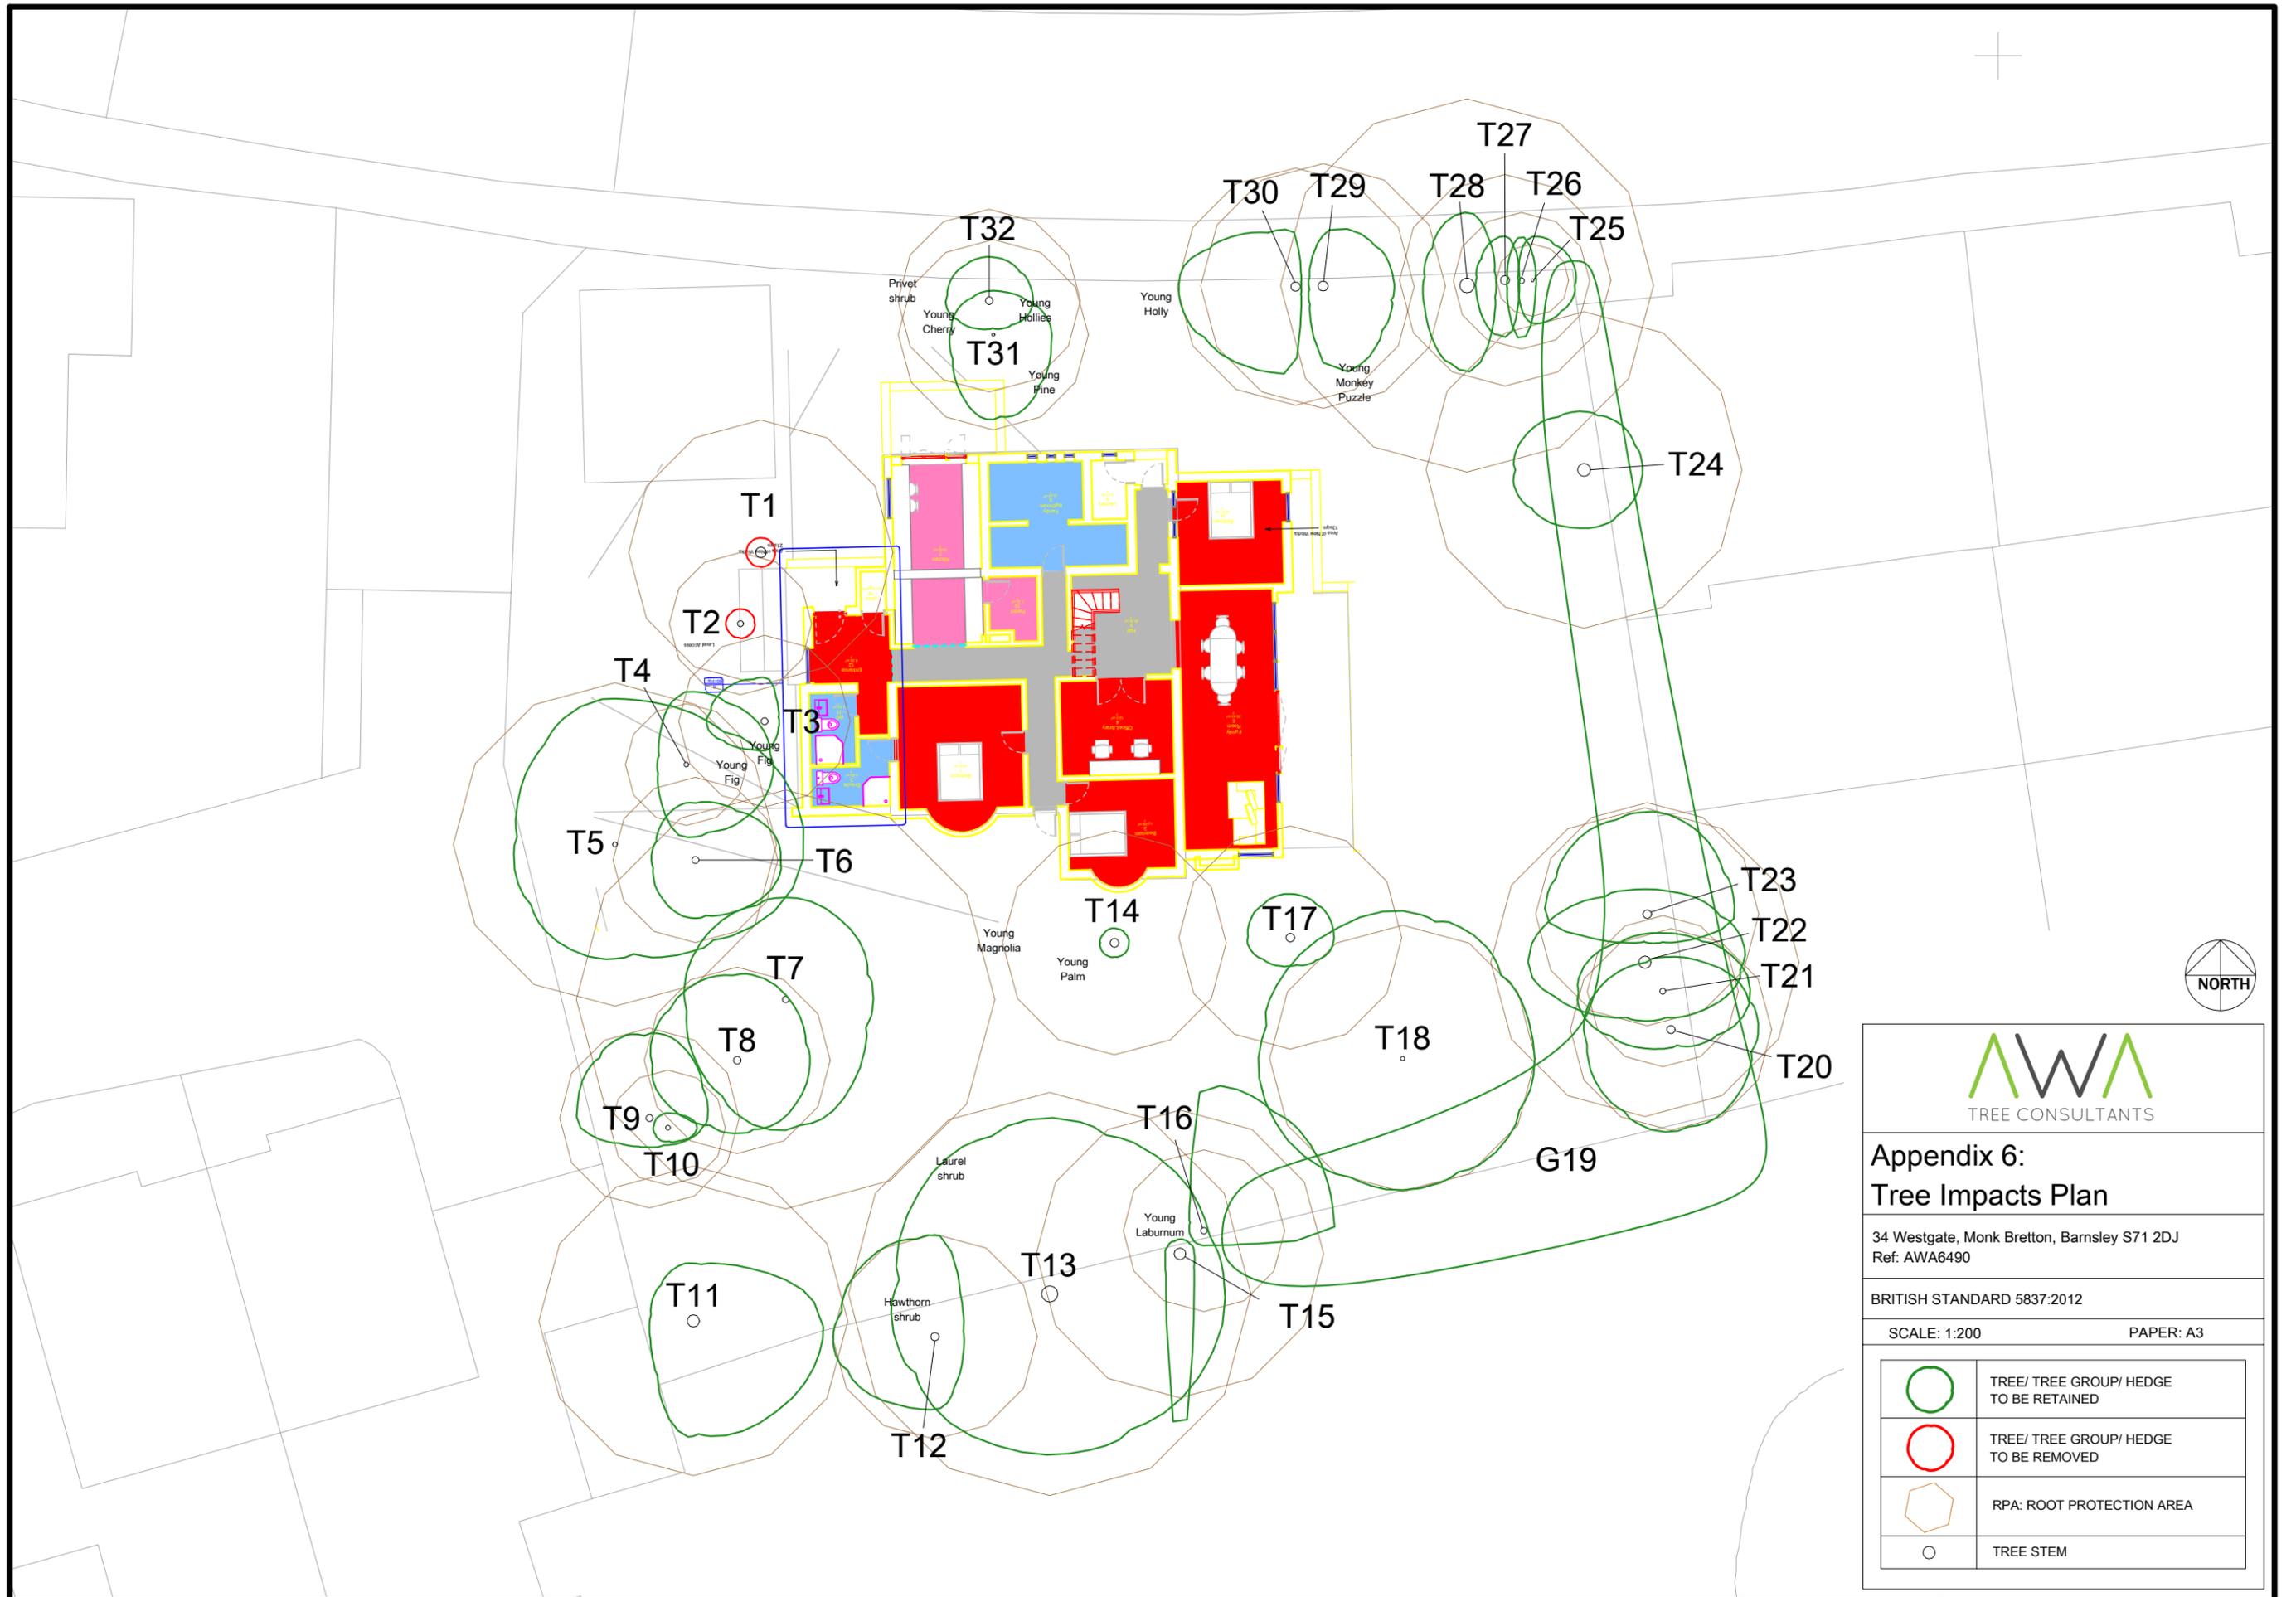
**Appendix 6:  
Tree Impacts Plan**

4.2.1 From assessing the new development proposals, 2 trees will require removal to facilitate the development as they are situated in the footprint of the development or their retention and protection throughout the development is not suitable.

4.2.2 The trees that require removal to facilitate the development are T1 and T2.

4.2.3 Trees T1 and T2 are lower value retention category 'U'. Both have historically been topped, with pruning wounds that limit their value and prospects. Due to the low value of the trees to be removed the removals will have only a negligible negative arboricultural impact.

4.3.2 Potentially damaging activities are proposed in the vicinity of retained trees. The new development encroaches close to and into the edge of the RPA of T3 and T7. Construction within the RPA, can have negative impacts on tree roots. Whilst the proposed extension is within the RPA of T3, it is situated within the footprint of the existing hardstanding driveway. The encroachment into T7's RPA is very minor, and the detailed RPA for this tree is likely to be a slightly exaggerated representation of the tree's actual rooting area. As such, it is unlikely that significant roots will be within these areas and the retained trees should remain largely unaffected by the works, provided care is taken during construction.

4.5.1 The retained trees will require protection by fencing in accordance with BS 5837: 2012, during the development phase.
