**ARBORICULTURAL REPORT**  
**at**  
**16 Green Spring Avenue**  
**Birdwell**  
**Barnsley**  
**South Yorkshire**  
**S70 5RW**

**Client:**  
360Globalnet,  
for LV Insurance

**Claim Number:**  
LIV-SN-23-006594

**JCA Ref:**  
20548/JC

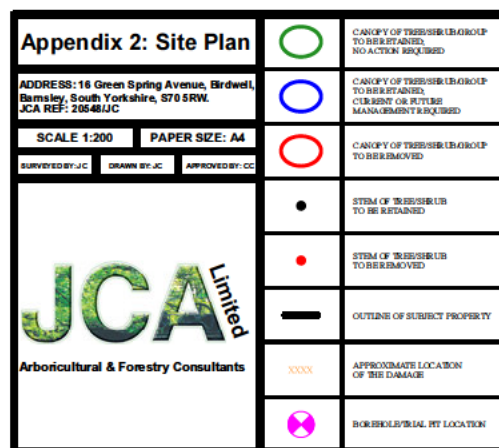
- 5.1 Descriptions of the surveyed vegetation and all recommended work are detailed in the tables at **Appendix 1**.
- 5.2 Please refer to the site plan at **Appendix 2** for the locations of the vegetation surveyed and all the relevant site features.

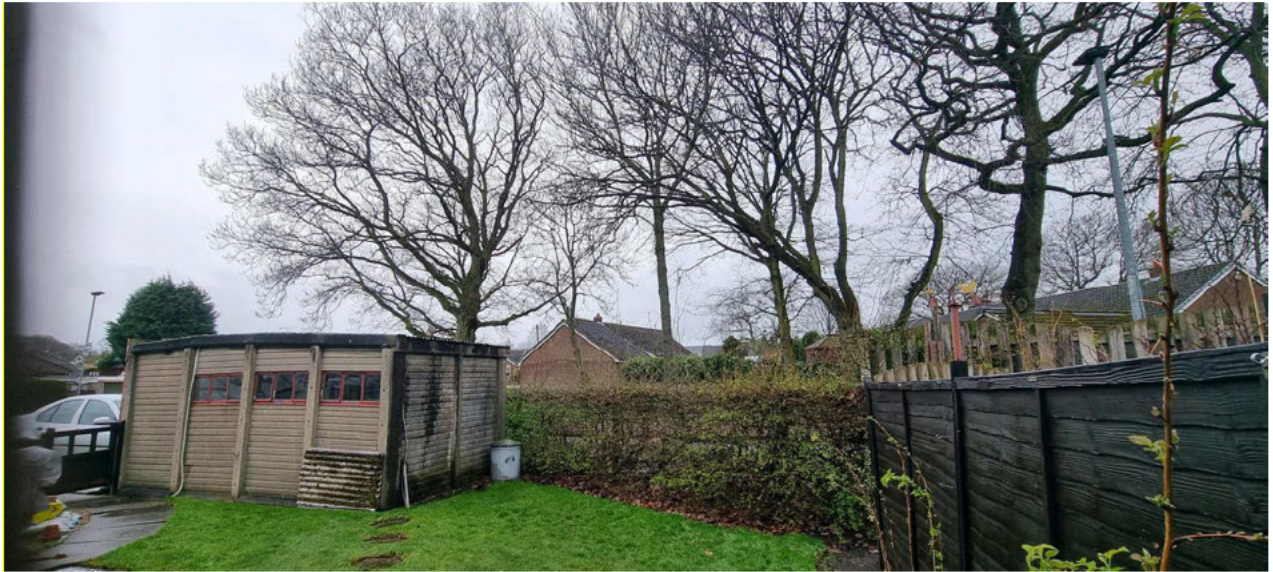
- 6.3 We consider the vegetation identified as **H1 T2, T3, T4 & T5** to all be influencing factors in the damage observed to the garage.
- 6.4 In order to negate the influence of the above items, the only guaranteed vegetation management option available is to remove **T2, T3, T4 & T5** to ground level and treat the stumps to prevent regrowth. **H1** can be reduced and managed accordingly.

| Tree Ref. | Age<br>Common Name<br><i>Botanical Name</i> | Height (m) | Stem Diameter (cm) | Owner / Occupier<br><br>Observations | Condition | Distance to Garage (m) | NHBC Water Demand | Life Expectancy (yrs) | Within Potential Influencing Distance | Root Identification Match | Contributing to Damage | Vegetation Management Option |
|---|---|---|---|---|---|---|---|---|---|---|---|---|
| T 5 | Mature<br>Oak<br><i>Quercus robur</i> | 19 | 85 | Third Party - Local Authority<br><br>This is the most likely culprit. Covered by a TPO and forming a high amenity group. | GOOD | 9.7 | HIGH | 40+ | Yes | Yes | Likely | Only vegetation management option available is to remove the tree to ground level and treat the stump to prevent regrowth. Alternative solutions may therefore need to be considered. |

Photograph 1: Trees **T2** to **T5** from right to left. **H1** is just to the right of the garage.

| Item | Species | Recommended Actions | Location/Ownership | Planning Restriction |
|---|---|---|---|---|
| <b>H1</b> | Hawthorn | Reduce to 0.7m and allow to regrow to 1m, repeating each year. | Policy Holder | None |
| <b>T2</b> | Oak | Only vegetation management option available is to remove the tree to ground level and treat the stump to prevent regrowth. Alternative solutions may therefore need to be considered. | Third Party - Local Authority | TPO |
| <b>T3</b> | Oak | Only vegetation management option available is to remove the tree to ground level and treat the stump to prevent regrowth. Alternative solutions may therefore need to be considered. | Third Party - Local Authority | TPO |
| <b>T4</b> | Ash | Only vegetation management option available is to remove the tree to ground level and treat the stump to prevent regrowth. Alternative solutions may therefore need to be considered. | Third Party - Local Authority | TPO |
| <b>T5</b> | Oak | Only vegetation management option available is to remove the tree to ground level and treat the stump to prevent regrowth. Alternative solutions may therefore need to be considered. | Third Party - Local Authority | TPO |
