DRAINAGE INVESTIGATION REPORT

CLIENT HOOBER HOMES LTD.

SITE Land off West Street
Worsbrough

DATE 27/09/2023 JOB No. 8425

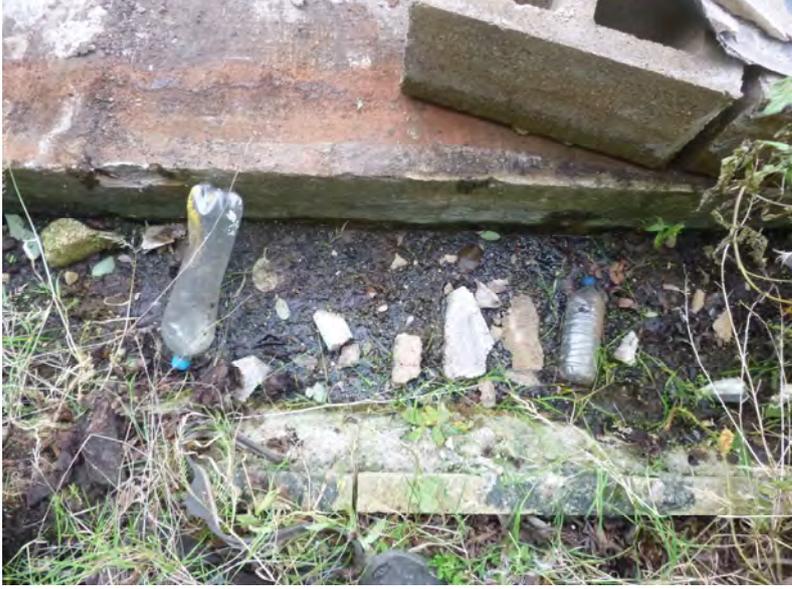
REMARKS	300MM WIDE CHANNEL RUNNING LENGTH OF CONCRETE SLAB.

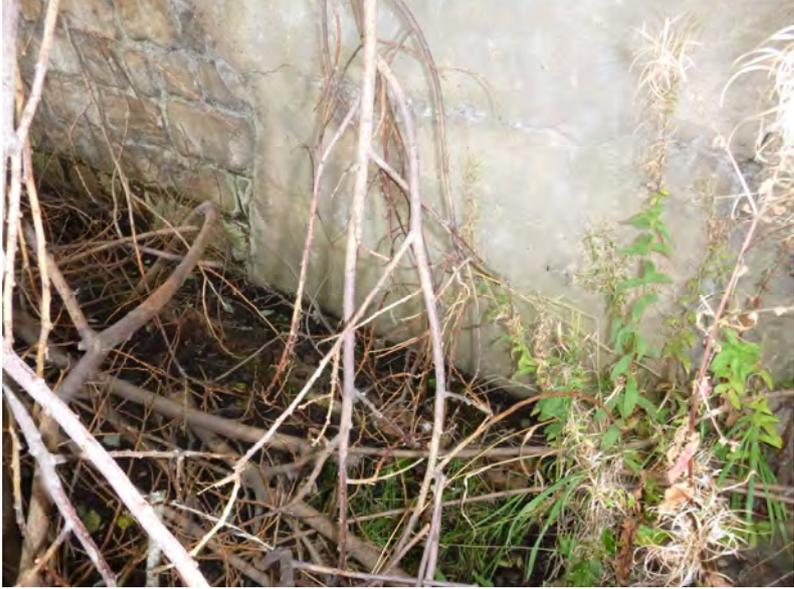
GP5

REMARKS	STANDING WATER ADJACENT TO CONCRETE SLAB
GP6

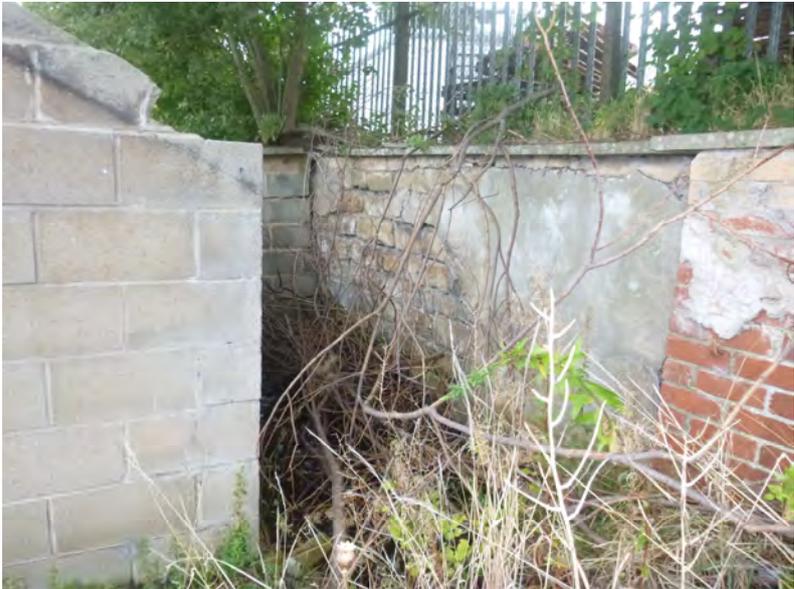
REMARKS	STANDING WATER ADJACENT TO CONCRETE SLAB

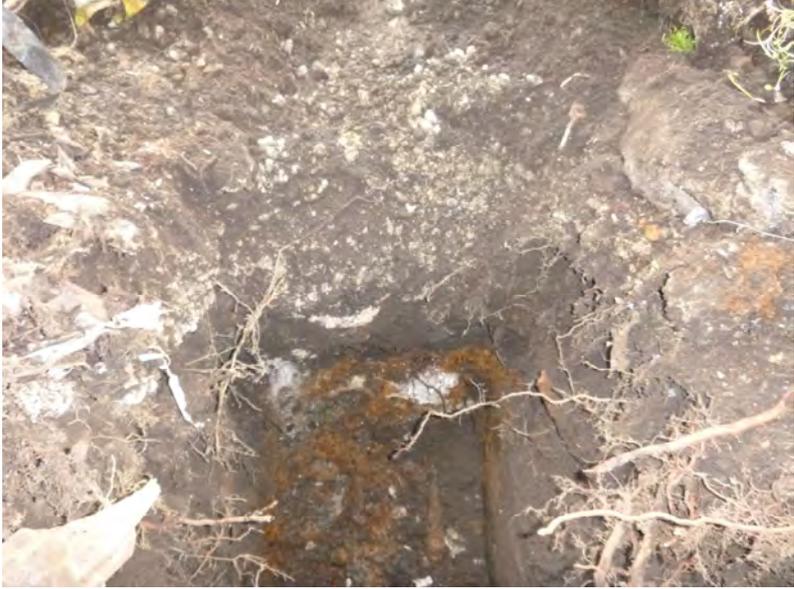
GP7

REMARKS	OUTFALL PRIOR TO DIGGING OUT
GP8

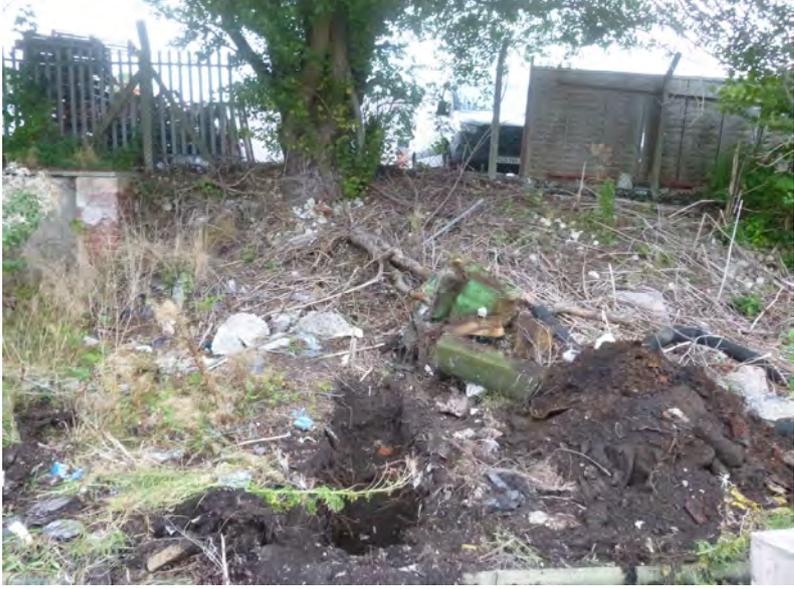
REMARKS	OUTFALL LOCATION PRIOR TO DIGGING OUT

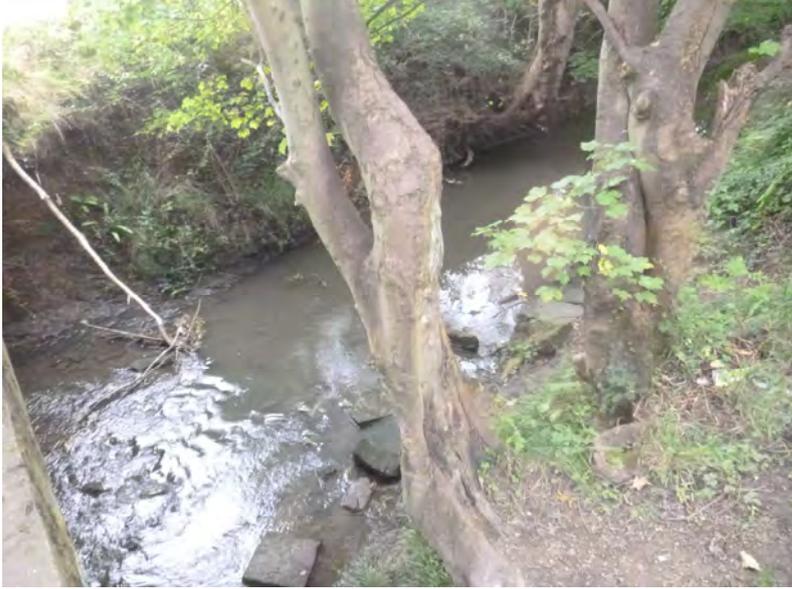
GP9

REMARKS	RIVER DOVE U/S OF FOUL PIPE BRIDGE
GP10

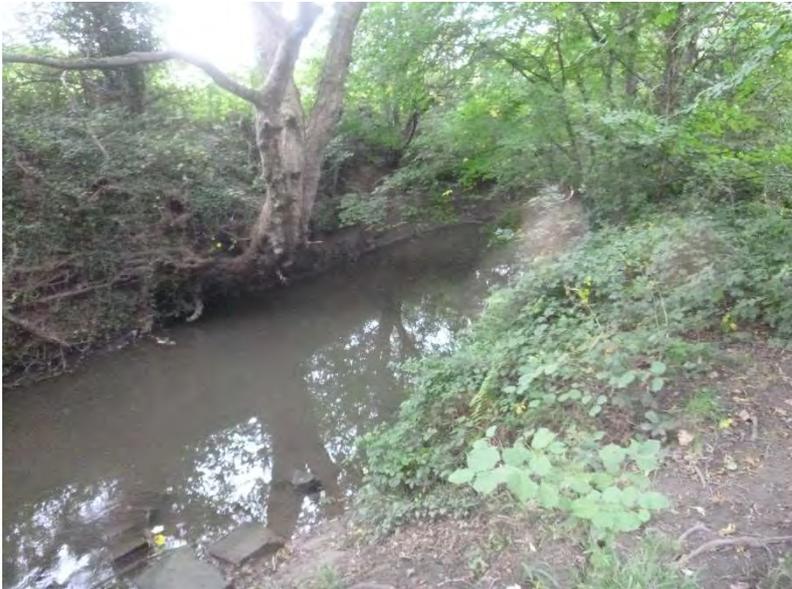
REMARKS	RIVER DOVE U/S OF FOUL PIPE BRIDGE

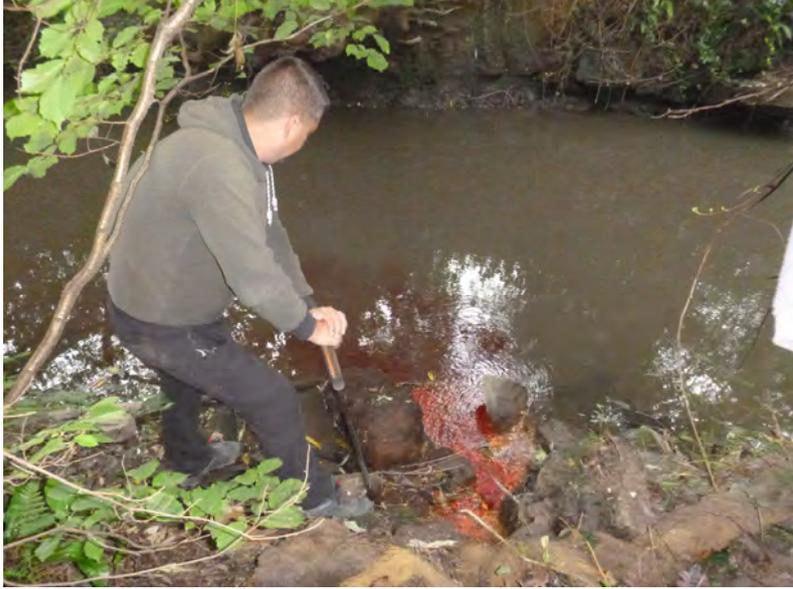
GP11

REMARKS	OUTFALL TO RIVER DOVE D/S OF EDS3, POSITIVE DYE TEST.
GP12

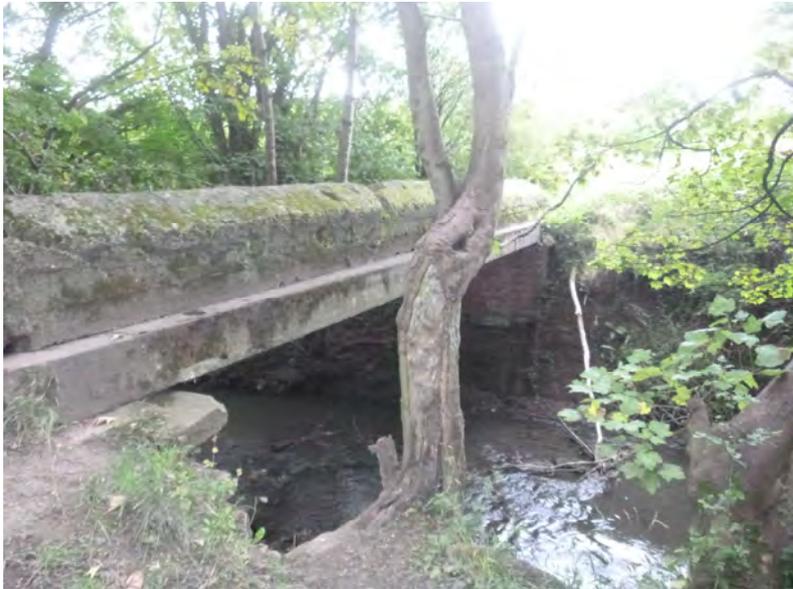
REMARKS	FOUL PIPE BRIDGE OVER RIVER DOVE

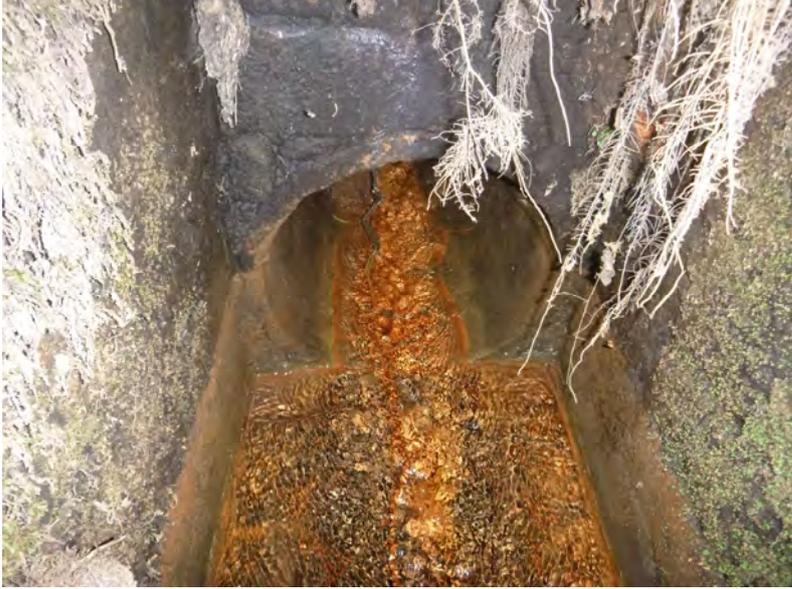
GP13

REMARKS	OUTFALL
GP14

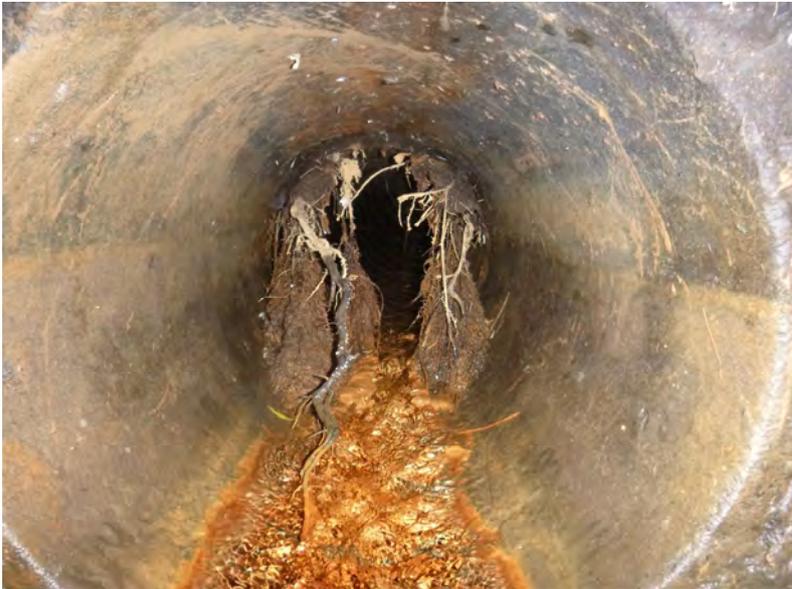
REMARKS	VIEW U/S OF OUTFALL

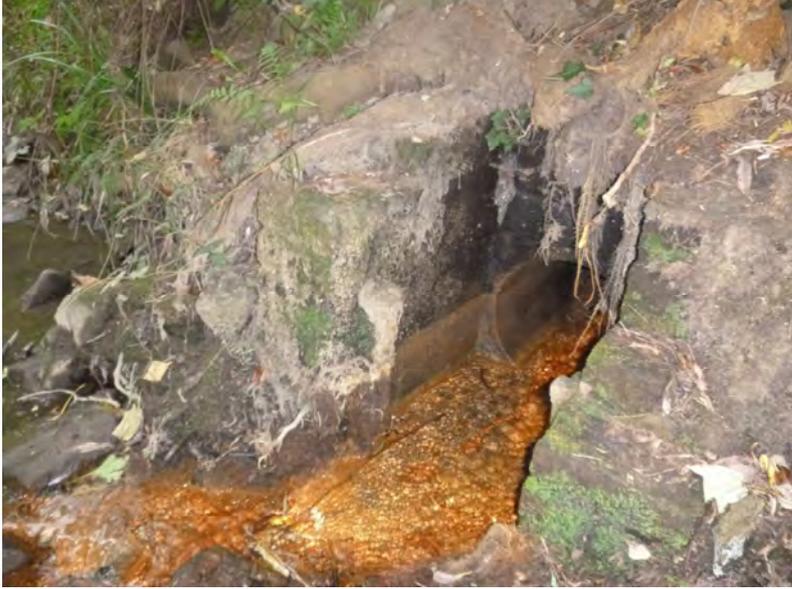
GP15

REMARKS	OUTFALL
GP16

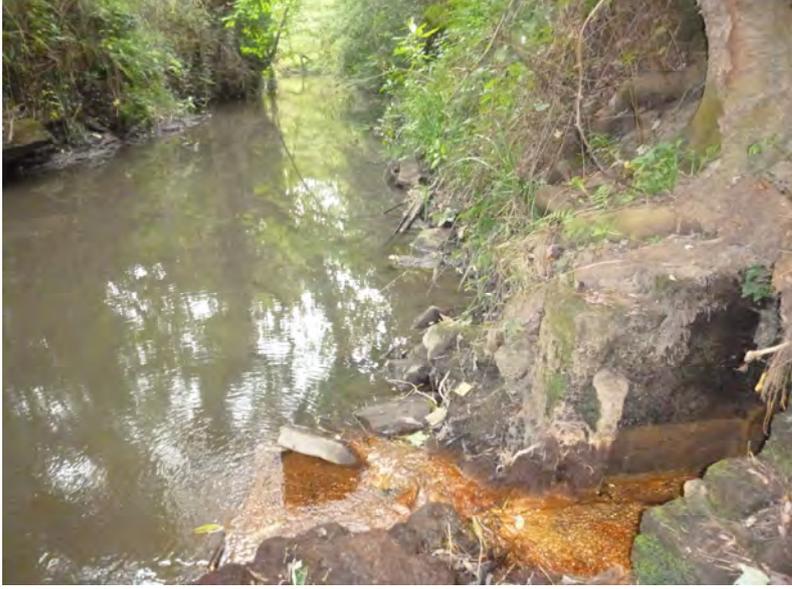
REMARKS	OUTFALL LOCATION

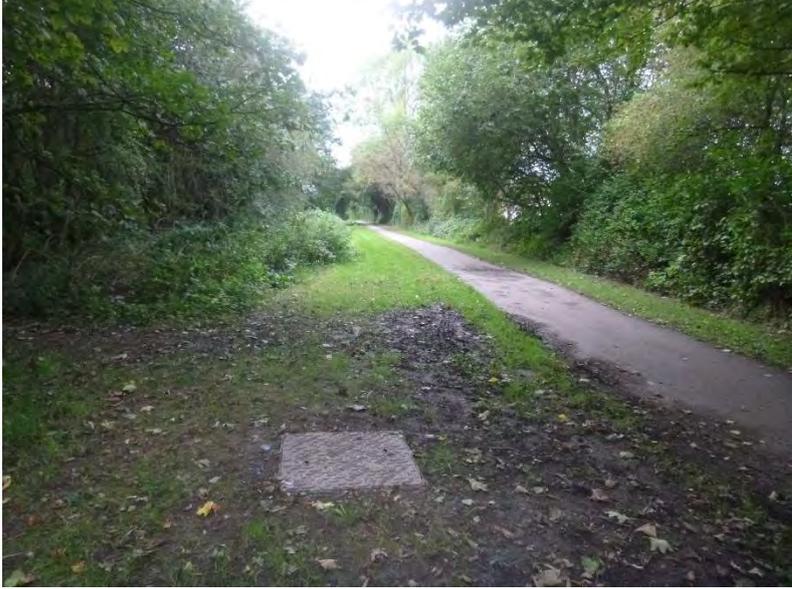
GP17

REMARKS	FMH1
GP18

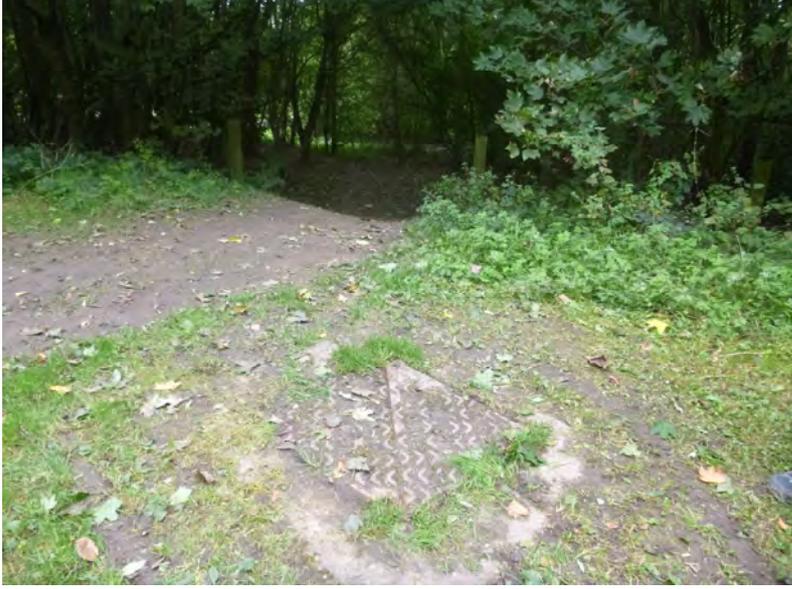
REMARKS	FMH2

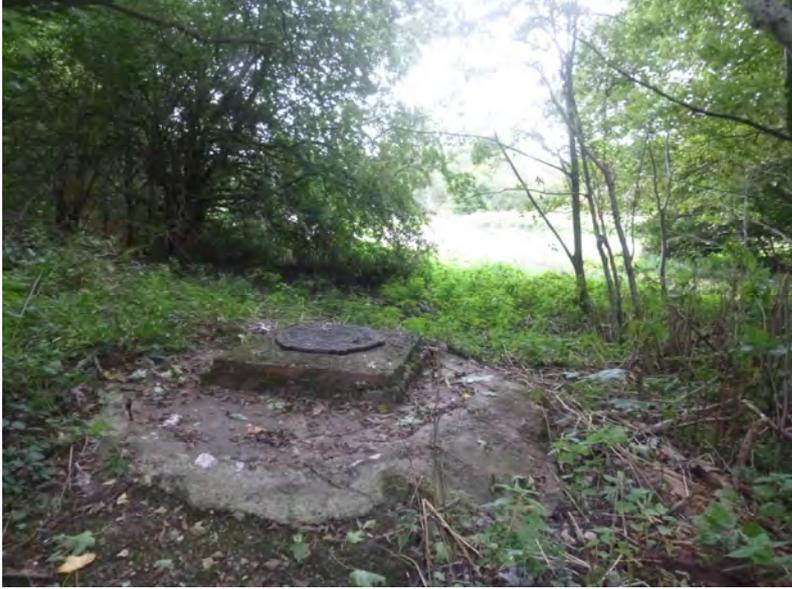
GP19

REMARKS	FMH3
GP20

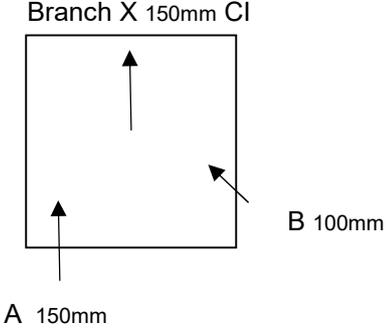
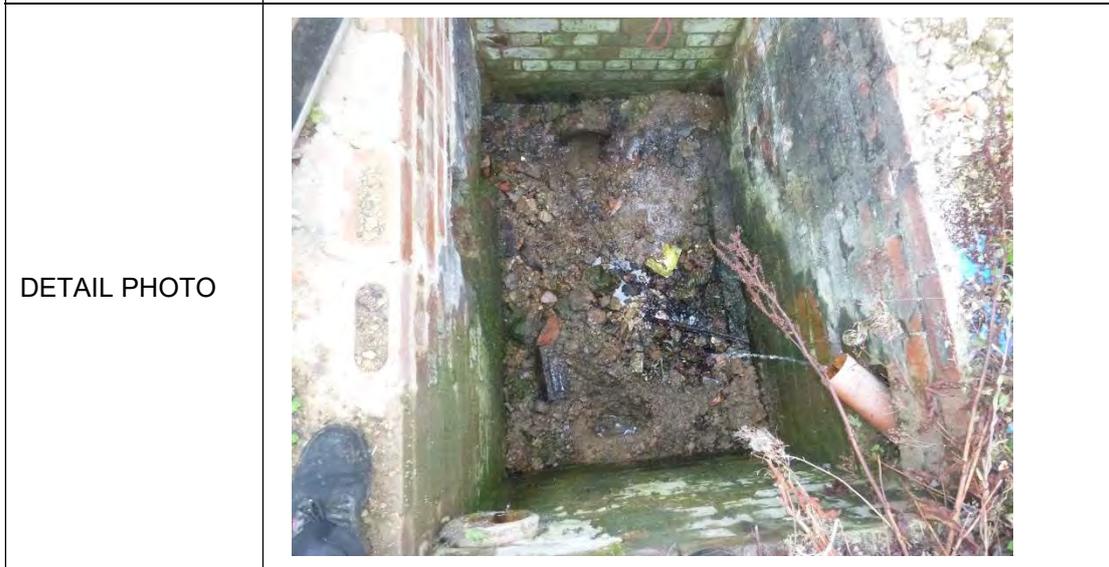
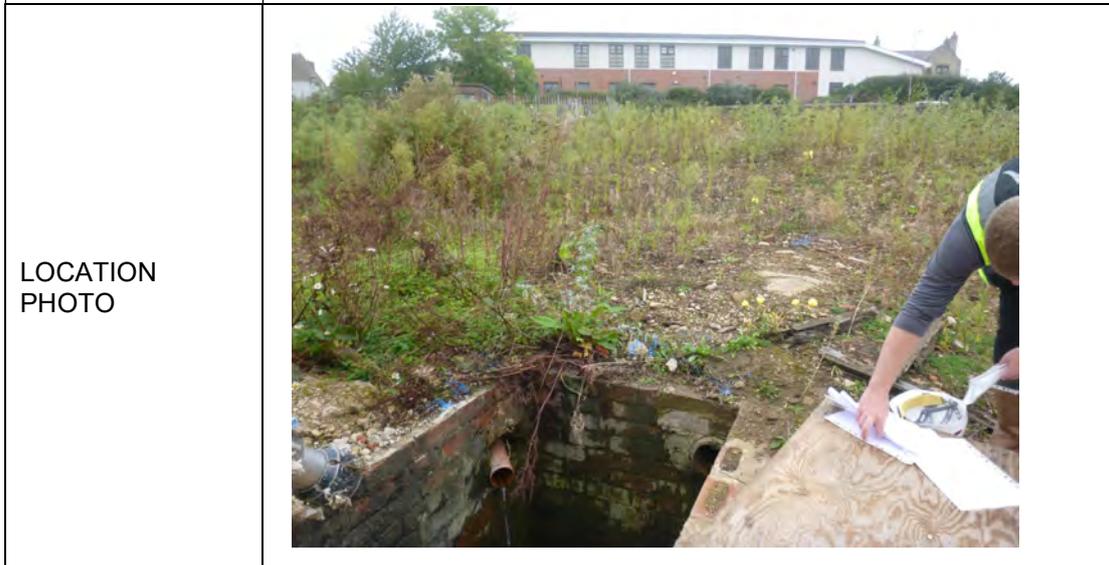
NODE REF	EDS1

REMARKS (Photos etc)
 BR A 0.74M TO INVERT
 BR B 0.5M TO INVERT

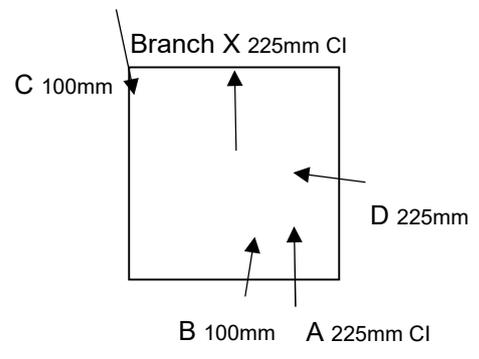
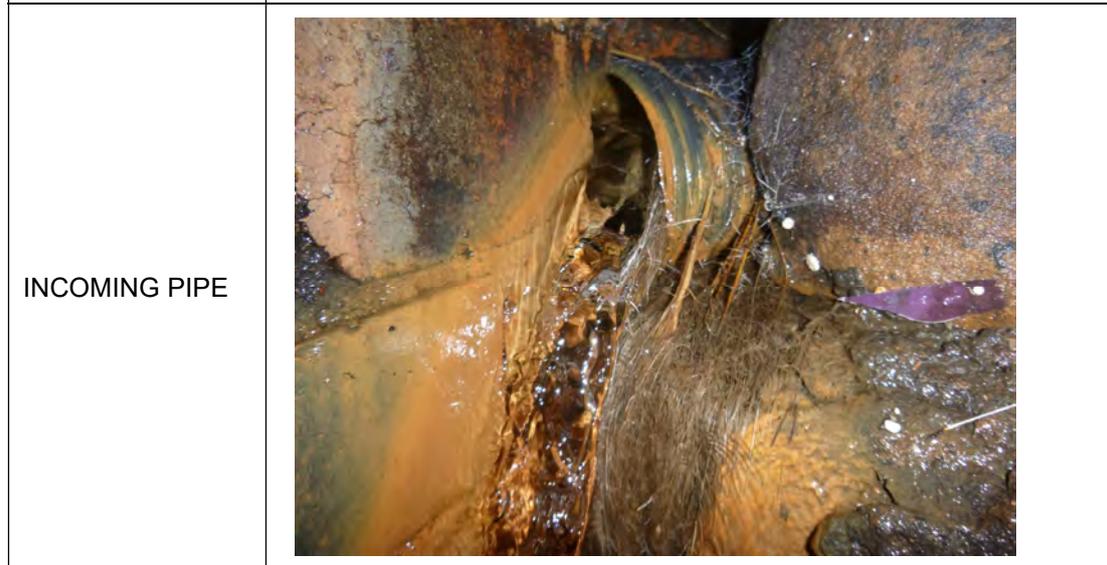
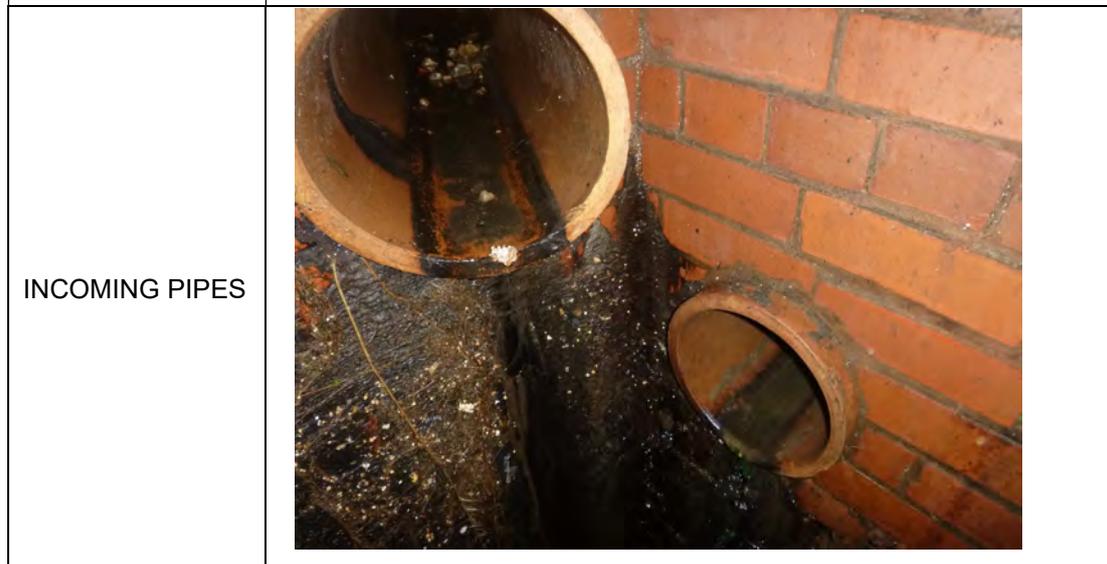
NODE REF	EDS3

CHAMBER ABOVE GROUND LEVEL, 3.35M TO BASE.
BR C THROUGH HOLE IN MH WALL (DETAIL PHOTO) RIBBED PIPE WITH RESTRICTION INTO CHAMBER

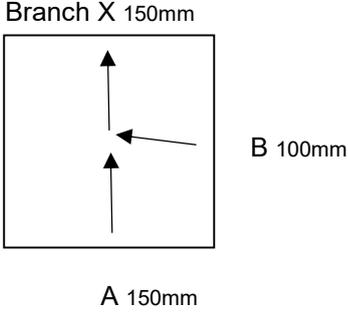
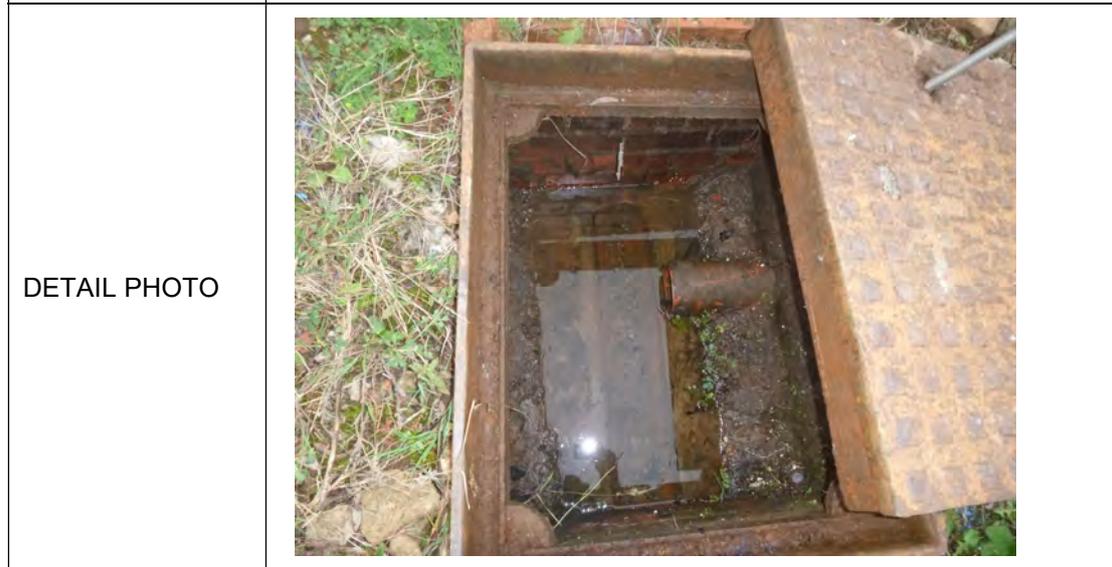
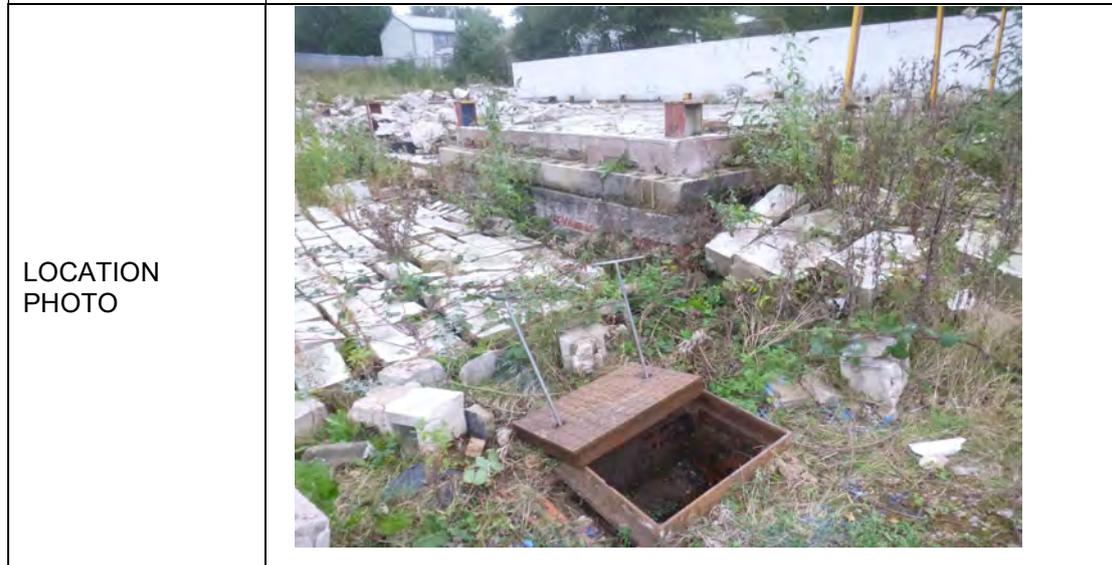
NODE REF	EDS4

REMARKS
(Photos etc) SLOWLY FLOWING WATER IN CHAMBER, WATER SAMPLE TAKEN FROM EDS4 29/9/23 08:30.
