# ARBORICULTURAL REPORT & Impact Assessment to BS 5837:2012 at:

***Keresforth Road,  
Dodworth,  
Barnsley***

Prepared for: *Keepmoat*

Reference: *AWA6688*

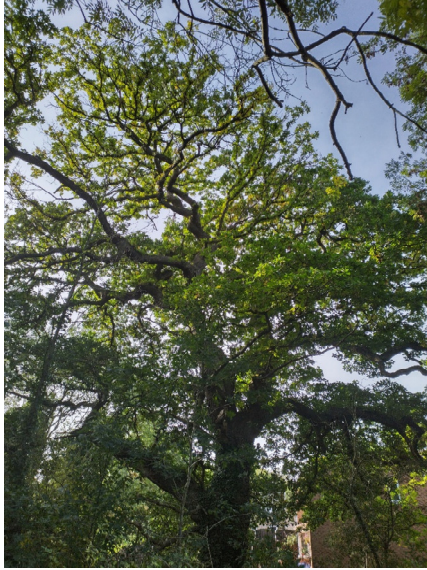
Photo 1: T5 from east

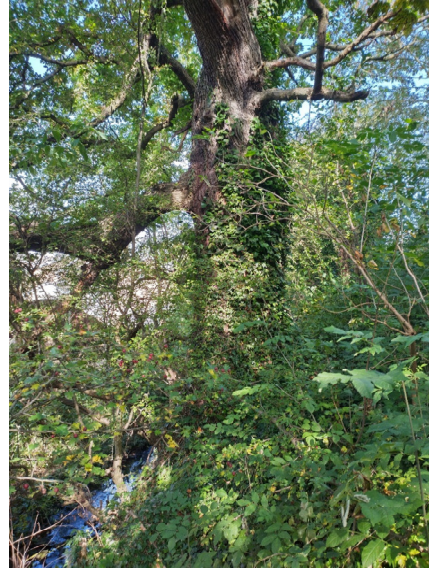
Photo 2: T5 from south

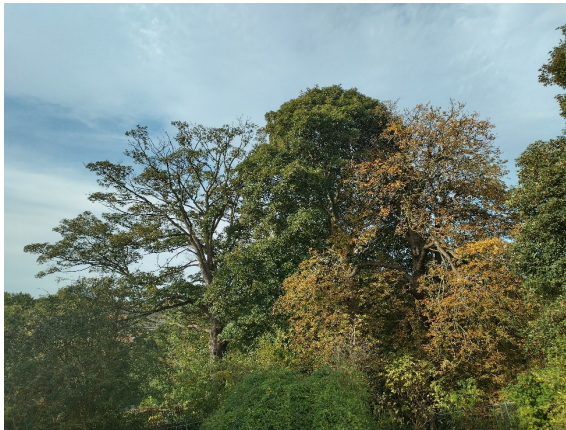
Photo 3: T23, T24 and T31 from east

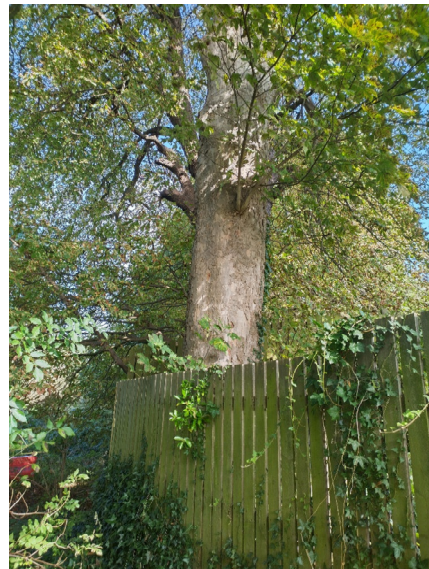
Photo 4: T24 from south west

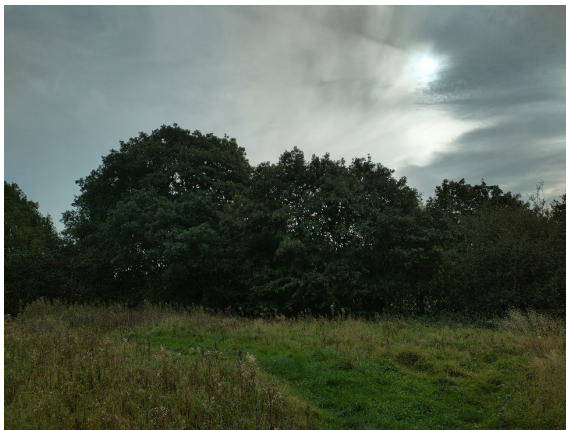
Photo 5: G47 and T52 from north

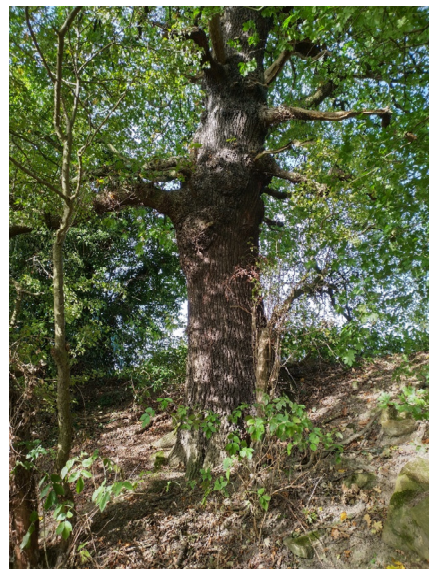
Photo 6: T52 from south east

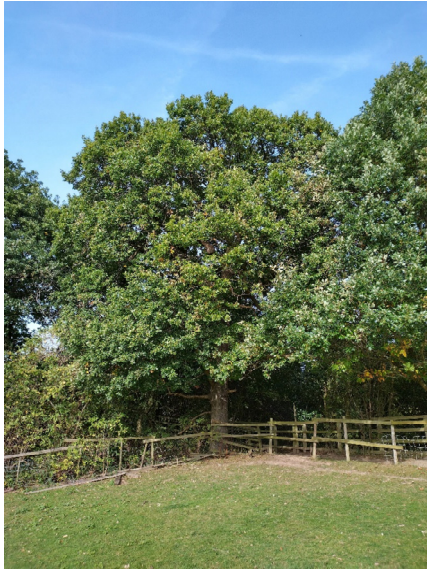
Photo 7: T55 from south west

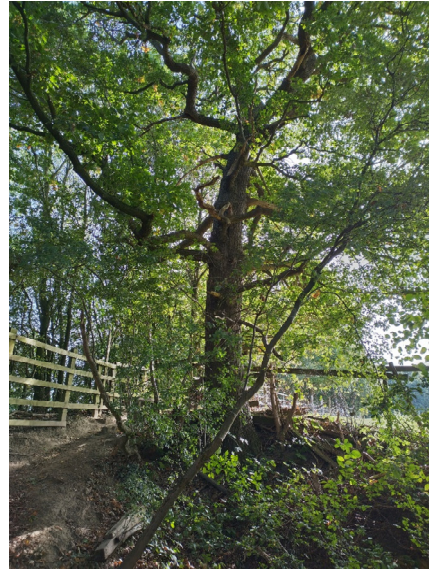
Photo 8: T55 from north west

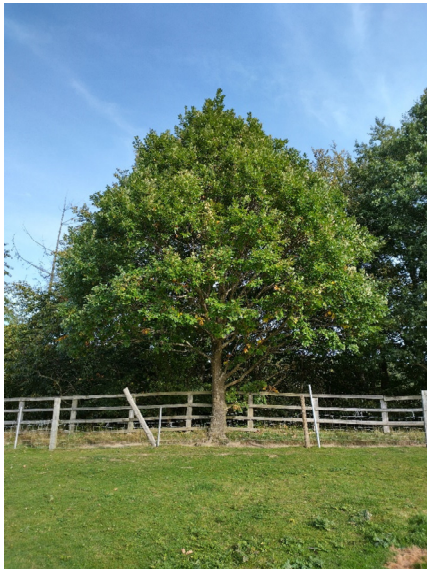
Photo 9: T61 from west

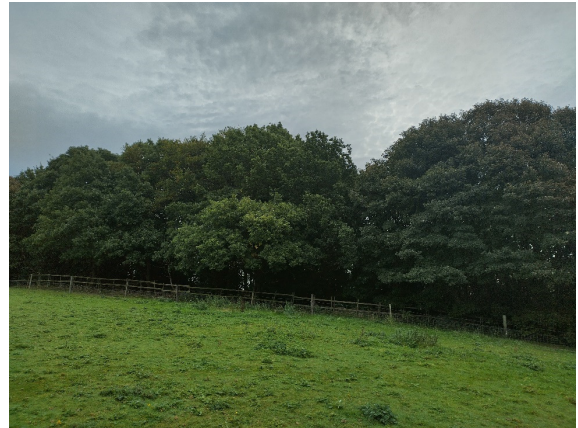
Photo 10: G69 from north west

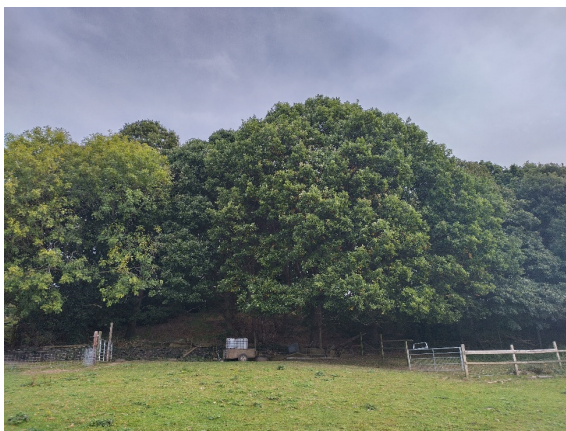
Photo 11: G69 from south west

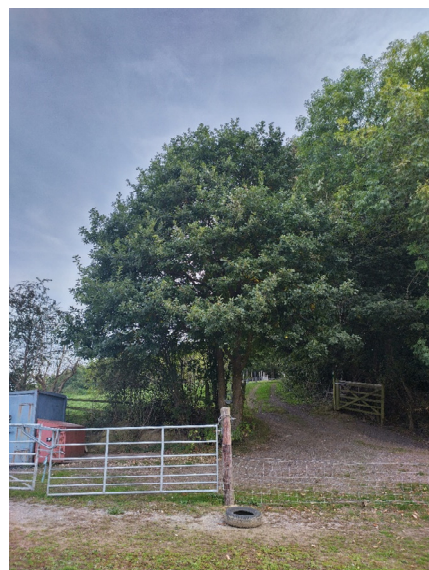
Photo 12: T80 from south west

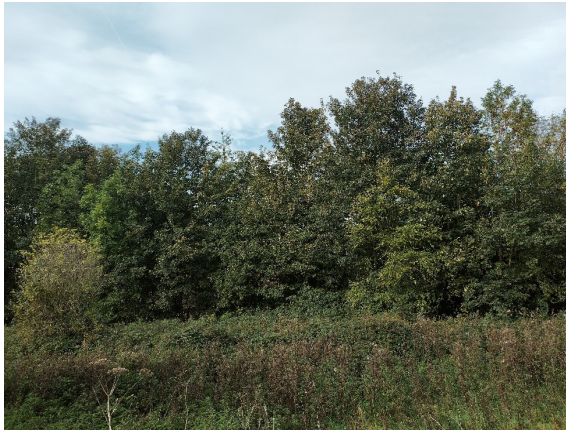
Photo 13: G81 from east

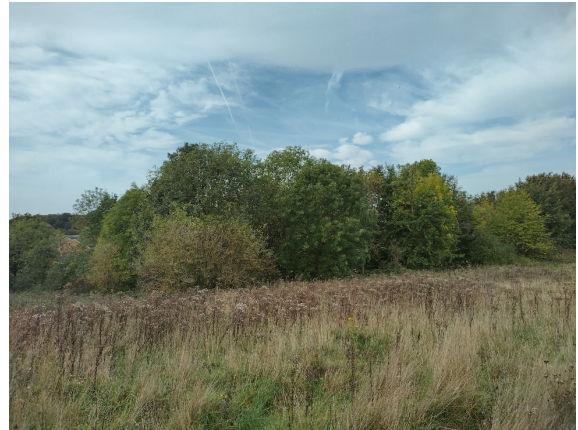
Photo 14: G83 from east

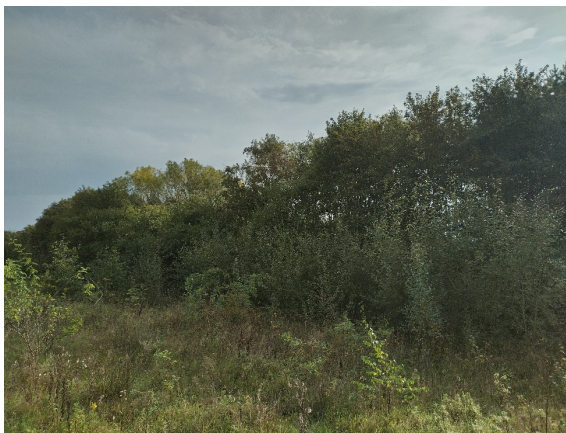
Photo 15: G85 from north east

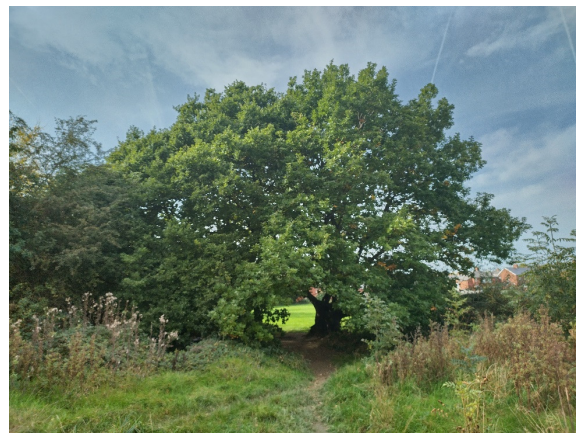
Photo 16: T86 and T87 from east

T86	Oak	<i>Quercus robur</i>	Early-mature	13	4	270, 390, 270, 370	No	1	6	9	9.5	7	Soil compaction. Exposed roots	Multiple stemmed at base. Slight lean. Stubs. Bark damage. Rubbing stems. Fused stems	Minor deadwood. Minor snapouts	Squat form. Forms feature with T87. Extensive compaction at base to north east. Fused stems to south western aspect. Large low horizontal southern limb. Likely historically managed as part of field boundary.	Good	Good	>40 yrs	Moderate	B	No works required
T87	Oak	<i>Quercus robur</i>	Early-mature	13	5	310, 330, 280, 330, 230	No	1.5	8	8	2	6.5	Soil compaction. Exposed roots	Multiple stemmed at base. Slight lean north east. Stubs. Bark damage. Epicormic growths. Fused stems	Minor deadwood. Minor snapouts. Epicormic growths. Hazard beam	Squat form. Extensive compaction at base to south west. Forms feature with T86. Likely historically managed as part of field boundary. Fused stems at western aspect.	Good	Good	>40 yrs	Moderate	B	No works required

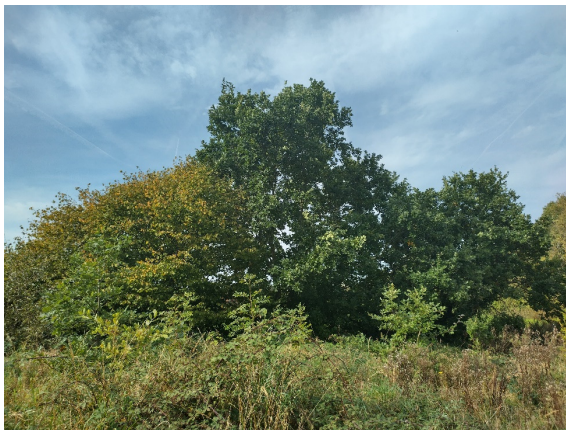
Photo 17: T89 and G90 from south east

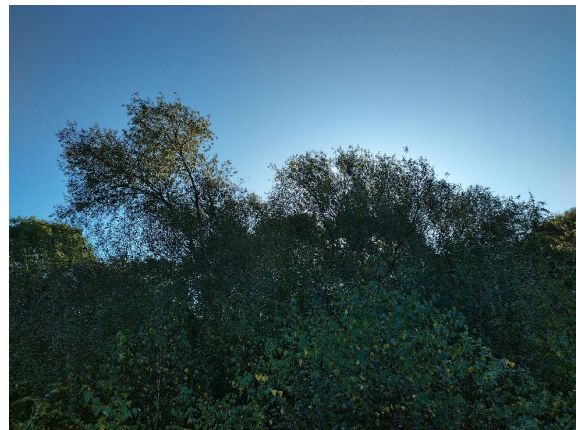
Photo 18: G96 from north west
