Ref: AWA1482
21st December 2015

Arboricultural Report

27 DARTON STREET, BARNLSLEY, S70 3PN

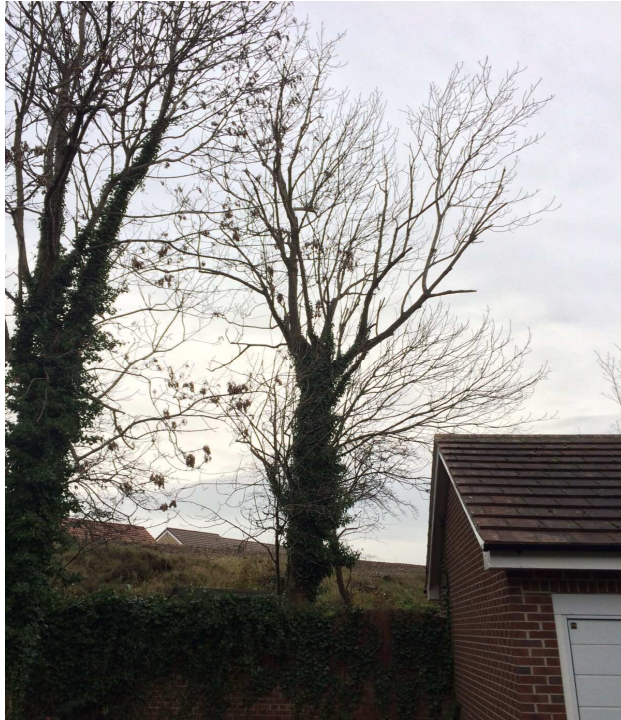
Occasional dieback and moderate deadwood was noted in the crown, the canopy shows signs of decline with smaller branches appearing to have snapped and multiple branches with buds missing. The decline of the canopy as whole is made clearer by the vigour and good health of the adjacent ash trees (see picture 1).

Photograph 1: Early mature Ash tree

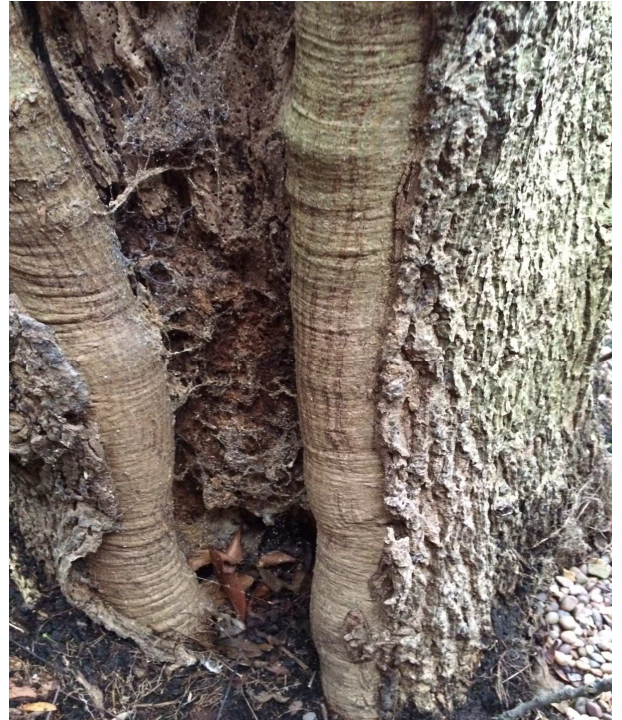
The stem base has a significant area of decay to the south (see picture 2). The decayed area was noted up to around 1m and was around 150cm wide at the stem base – with two pronounced 'ribs' of solid reaction wood each side of the area of decay. An examination of the decayed area with a hand held metal probe revealed soft completely decayed wood extending into the stem. It is very likely a zone of decay extends from this open cavity further into the main stem at the base; with dysfunctional wood (wood that has dried out and cannot retain its normal function properly) into around a quarter of the stem base area. The north eastern side of the stem has two separate areas of decay, one close the base and a second around 2m from ground level (see picture 3), it is likely the open cavities join to forms a column of decay. There is a possibility of further areas of decay up the stem but due to large amounts of ivy it was not possible to complete a detailed inspection.

Photograph 2: Column of decay

Crown reduce by up to 30%: Removing a maximum of 2 m in height and a maximum radial crown spread of 2m, back to suitable points; resulting in a final tree height of around 14m (as detailed in the tree work images). Remove all epicormics from the main stem and sever the ivy.

The crown reduction will alleviate biomechanical stress by reducing both the leverage and the sail area of the tree. The recommended pruning intervention in the form of a general crown reduction is needed in order to reduce the probability of mechanical failure, as a result of the weaknesses from the stems central decay.

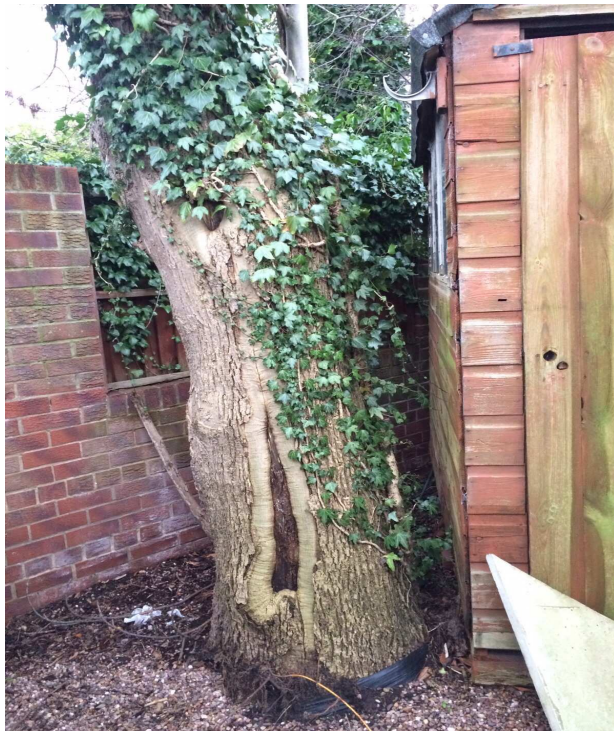
Photograph 3: Second column of decay

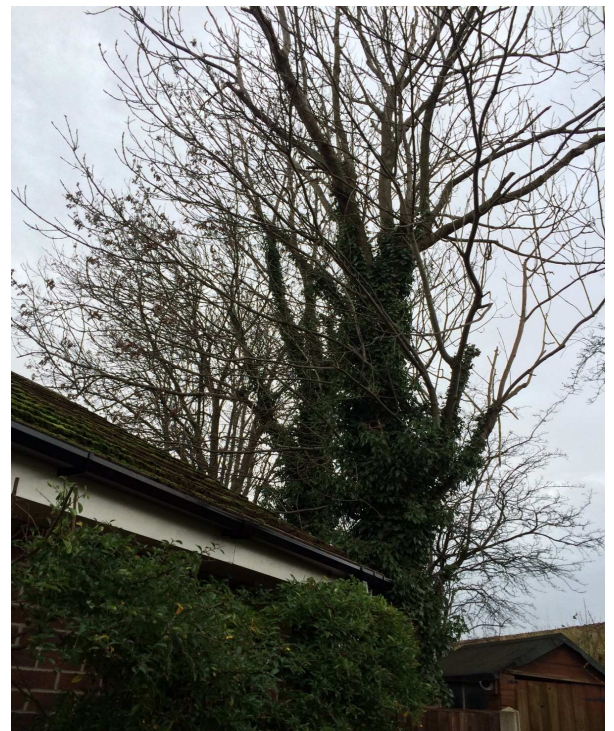
The tree is single stemmed from ground level and vertical. The stem has moderate sized epicormic growth up the main stem. Dense ivy covered much of the tree stem. Although this is unlikely to significantly impact on the future condition of the tree, it can hinder a full detailed assessment of the condition of the tree stem. As such, it is advised that the ivy is severed at the base and allowed to fall from the tree.

Photograph 4: Ivy on stem

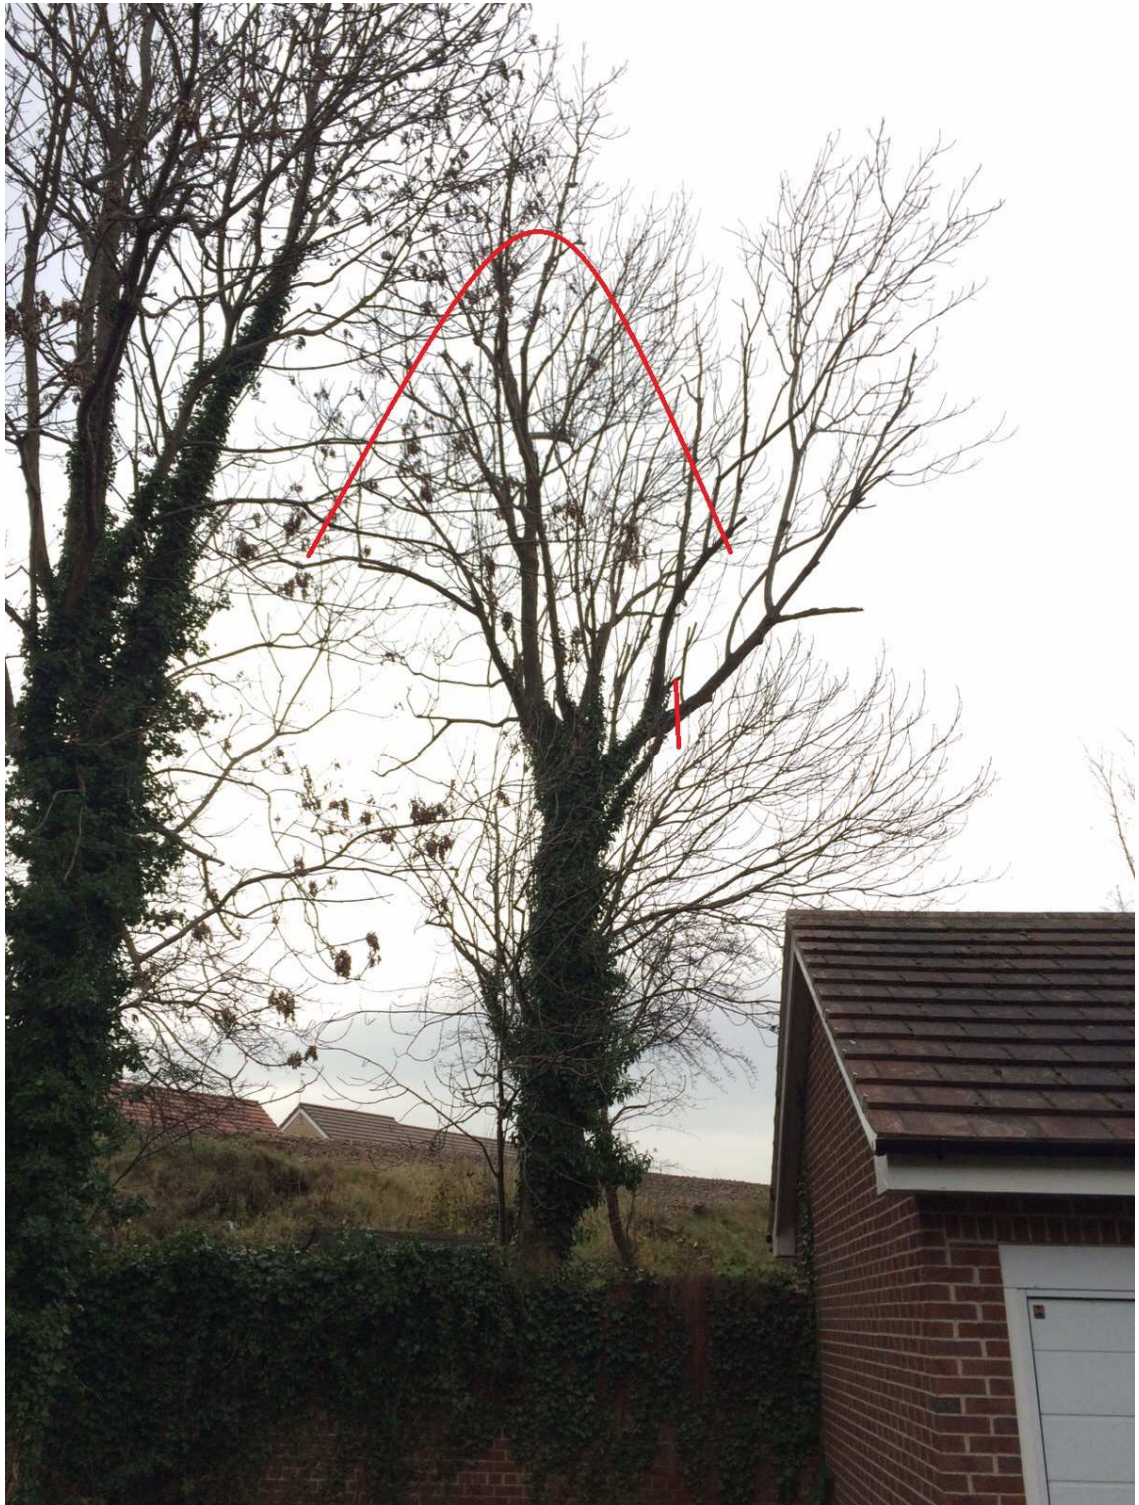
Photograph5: Proposed extent of pruning works

By reducing the crown as specified this will allow ample room to enable the proposed garage development, whilst retaining the trees form and amenity value. (See picture 5).
