Wombwell Wetlands and Doveside Tree Report

Final

December 2017

The Garganey Trust
11 Springfields
BARNSLEY
South Yorkshire
S75 1JS

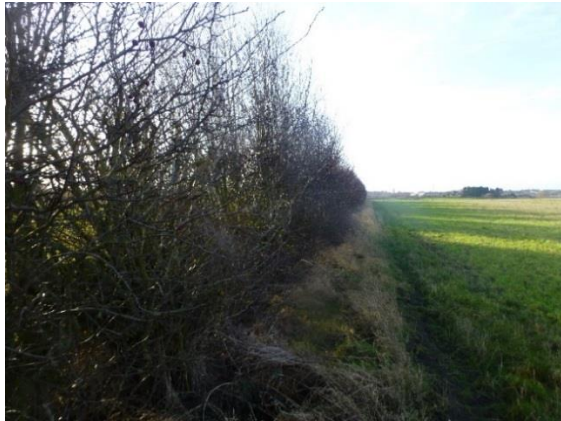
This area is a mature, single-species hedge comprised of Hawthorn with improved grassland south of hedge, and arable land to the north of the hedge. The hedge is reasonably intact with occasional gaps along its length. The understorey is mainly ruderal species with grasses, Nettle, and Cleavers

present. There are a number of active rabbit holes present occasionally in the base of the hedge. The hedge has been managed in the past by laying, and is now managed through annual flailing.

Photograph 1 Area 1 North Side

The hedgerows in Area 1 will be removed to facilitate the habitat improvements proposed within this area.

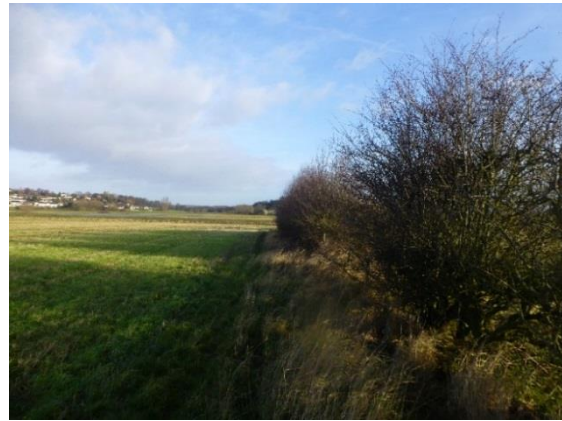
Photograph 2 Area 1 South Side

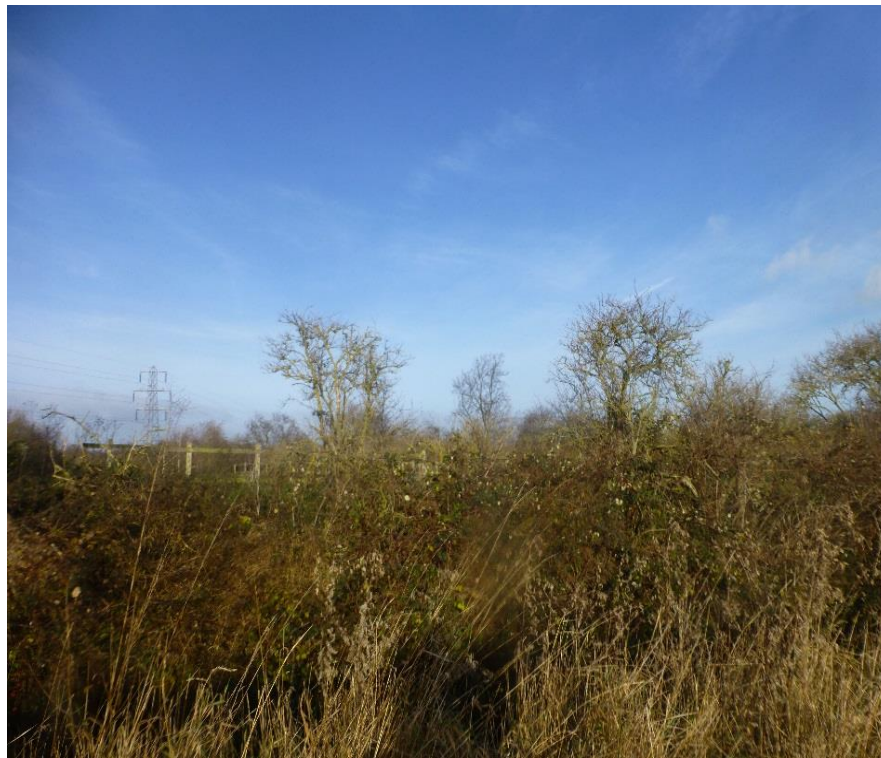
Access to this area of the site is restricted by the security fencing around the water treatment works. In the vicinity of the works, three mature Elder trees are situated on the top of the bank. These appear to be mature specimens growing amongst rough grassland with brambles.

Photograph 3 Area 2 Elders on the top of the bank

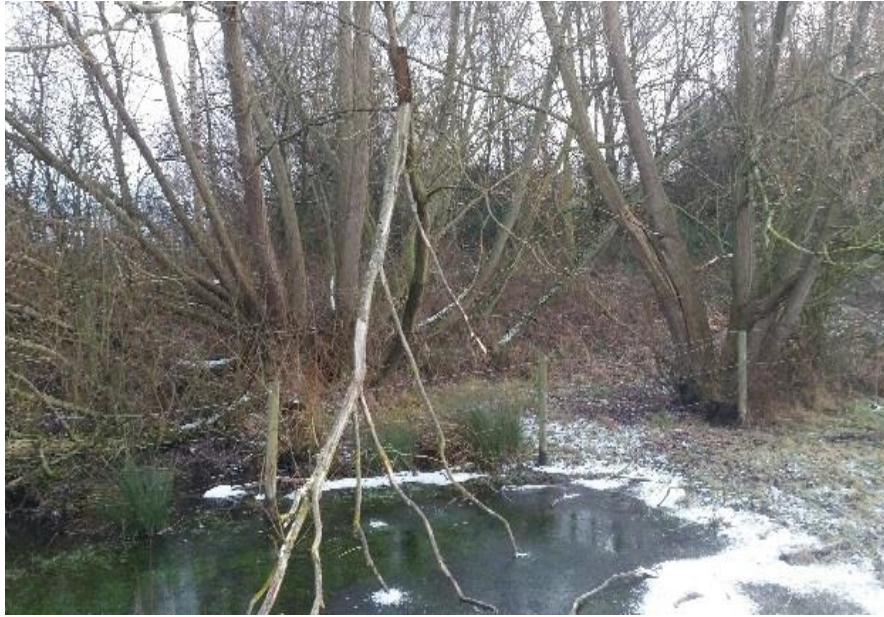
Located at the northwest corner of the site (west of the recreation ground), there is an over-mature Ash growing amongst a line of mature Ivy-covered Hawthorn. These trees form a grown out hedgerow, and this hedge line continues south across the site to Area 4. The trees in this Area 3 are a mixture of planted young mature Silver Birch, Field Maple, and occasional Ash on the embankment of the ex-landfill site, with over-mature Crack Willow at the base of the bank. These trees have been coppiced in the past resulting in multi-stemmed trees. In some of these, the stems have sheared from the coppice stool and re rooted resulting in large spreading trees. These trees have a considerable amount of deadwood present within their crowns, and some rot at the base of the trunks within the coppice stool.

Photograph 4 Area 3 over mature Crack Willow

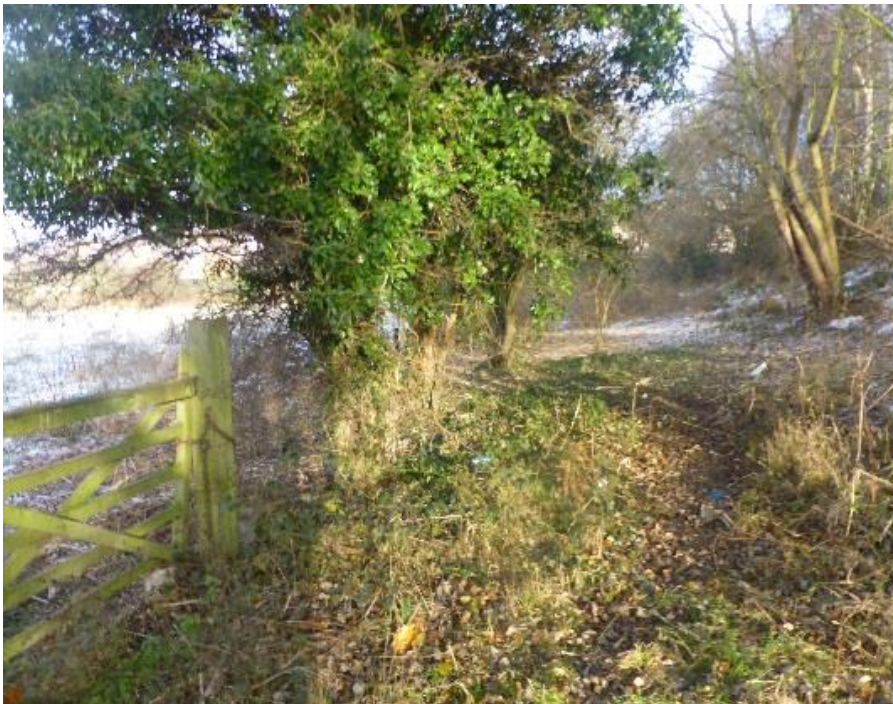
Photograph 5 Hedgerow along the edge of area 3

It is recommended that the RPA for the hedgerow and the Crack Willow are protected in accordance with BS5837 (British Standards Institution, 2012) as outlined in Appendix B. The line of the new drain should be moved slightly towards the west to avoid the roots of these trees. This deviation may require the removal of a small number of the trees in the planted section of Area 4. These trees are relatively young, and should be replaced with some understorey species to form a shrubby edge to the woodland, increasing the species diversity and ecological value, and reducing the amount of wind blowing through the base of the woodland.

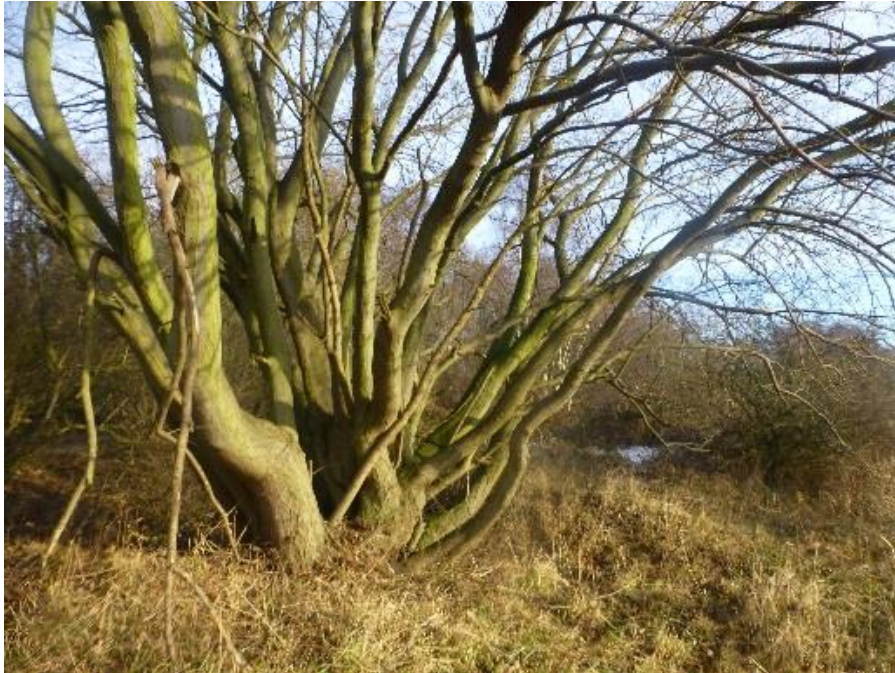
This area is in the location of the proposed new drain outfall. The area has a large coppiced Crack Willow on the river bank on the west side of the new drain cut. The east side has a mix of young mature Pedunculate Oak, Ash, and Hawthorn planted in three rows on the river bank. These trees are still at the original 3m planting spacing. There are several Hazel present growing along the end of the grass paddock. These trees have been coppiced several times and predate the planted trees, and are considered to be of a similar age to the Crack Willows.

Photograph 6 Coppiced Crack Willow, East of area 4

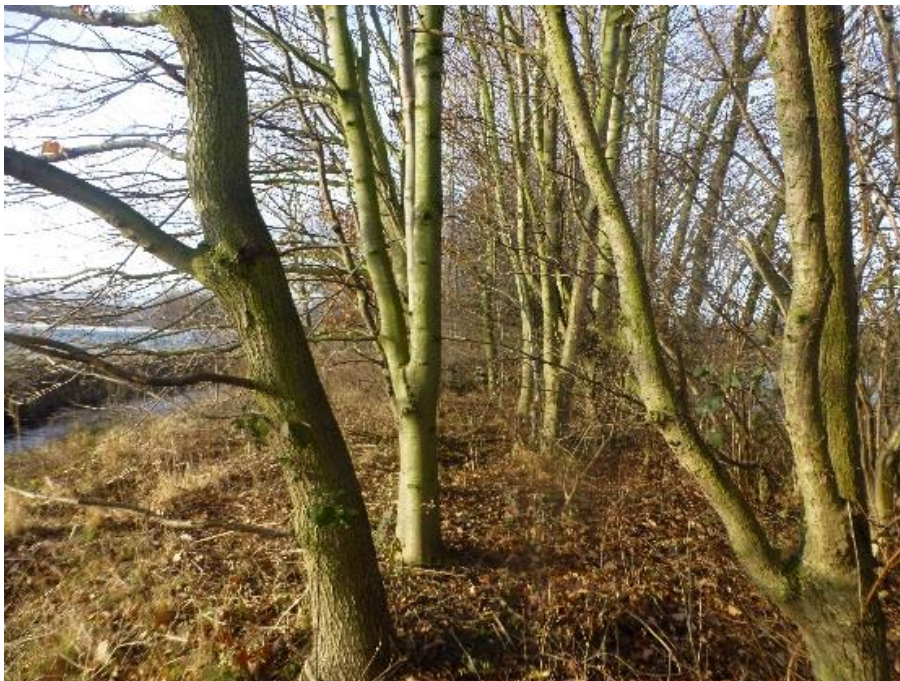
Photograph 7 Area 3 Planted Pedunculate Oak and Ash on river bank

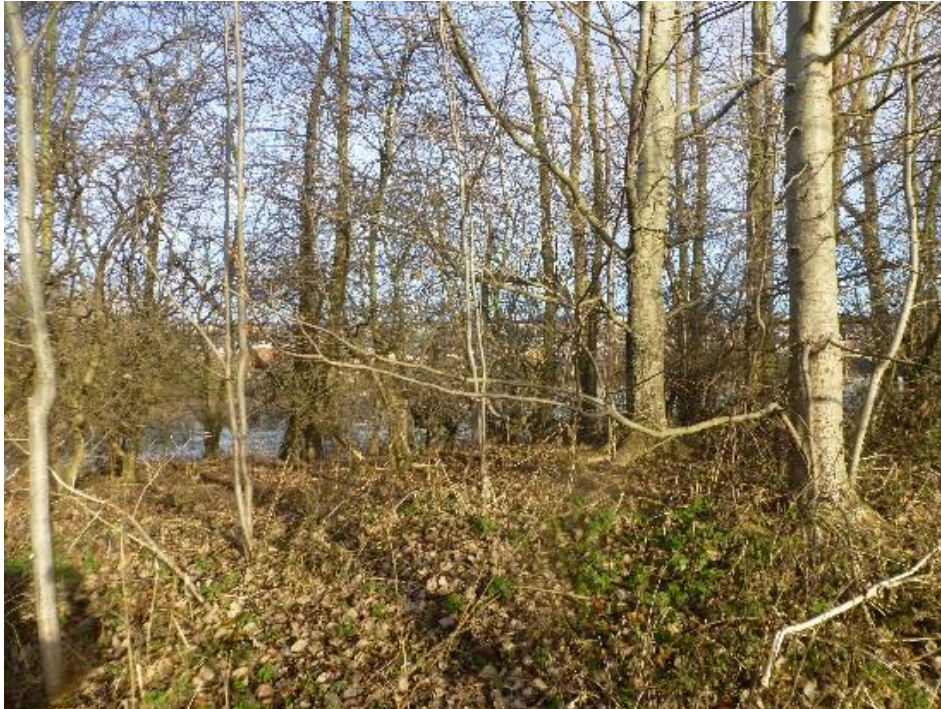
Situated in the centre of the site on the west edge (at the opposite end of the plantation to Area 4), there is a mix of Common Alder, Crack Willow, Hawthorn, with some Black Poplar which are planted in rows and have suckered, giving the woodland a more natural appearance. On the river bank south of the plantation is a large over-mature Crack Willow with a double stem; one of which has failed and re-rooted, leaving an exposed rot pocket at the base of the stem. West of the Crack Willow is a mature Hawthorn growing on the crest of the river bank.

Photograph 8 Area 5 Planted Poplar and Common Alder

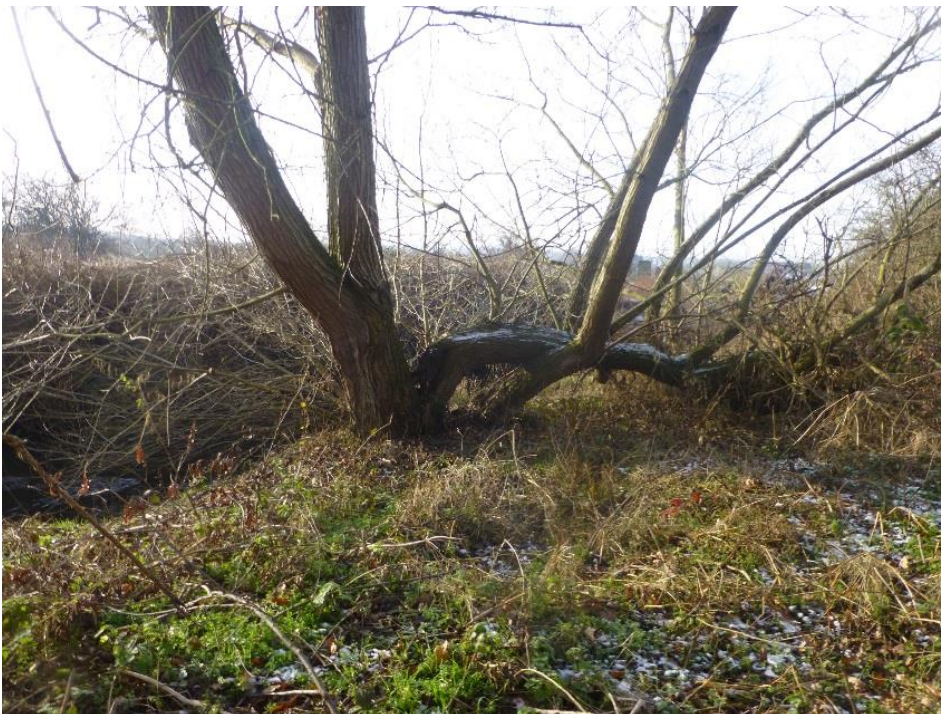
Photograph 9 Area 5 Natural Crack Willow and Hawthorn on the riverbank

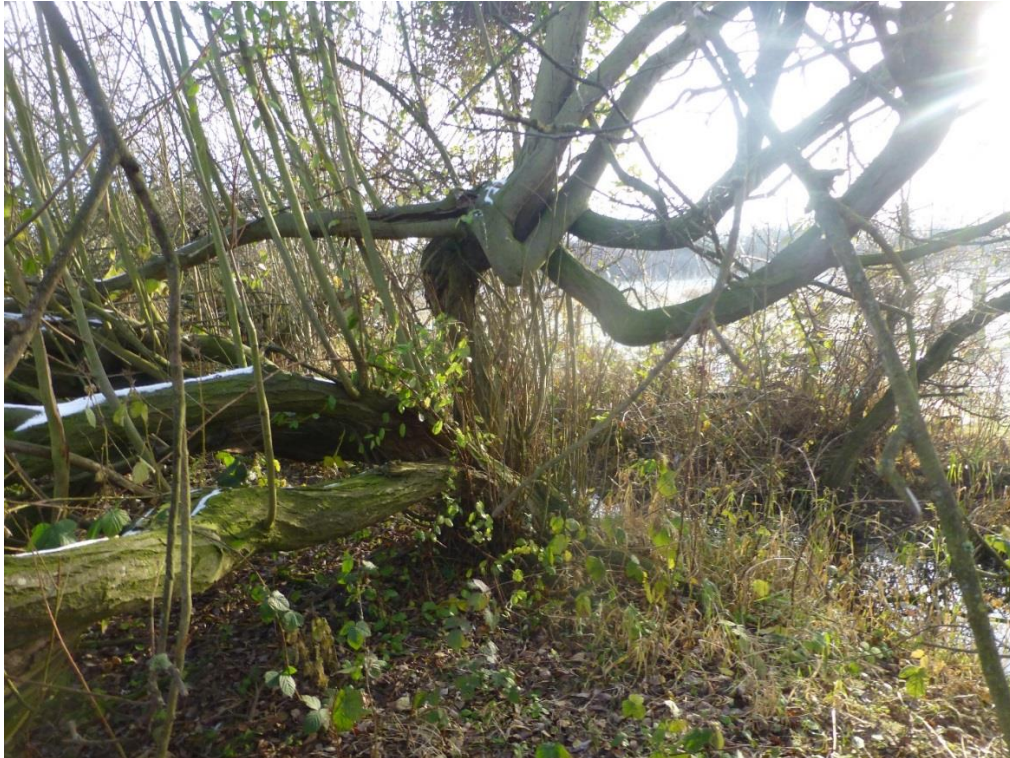
This area is located in the centre of the site, on the north side of an existing drain. The area has a large, collapsed Crack Willow. This tree has re-rooted and produced a mass of new growth making a dense, low, bushing canopy. The tree appears to have been laid to produce nesting habitat. To the west of the Crack Willow is a Grey willow that appears to have received similar treatment. Growing amongst the willow stems is an evergreen Honeysuckle, that is well established and is growing well.

Photograph 10 Area 6 Laid Crack Willow

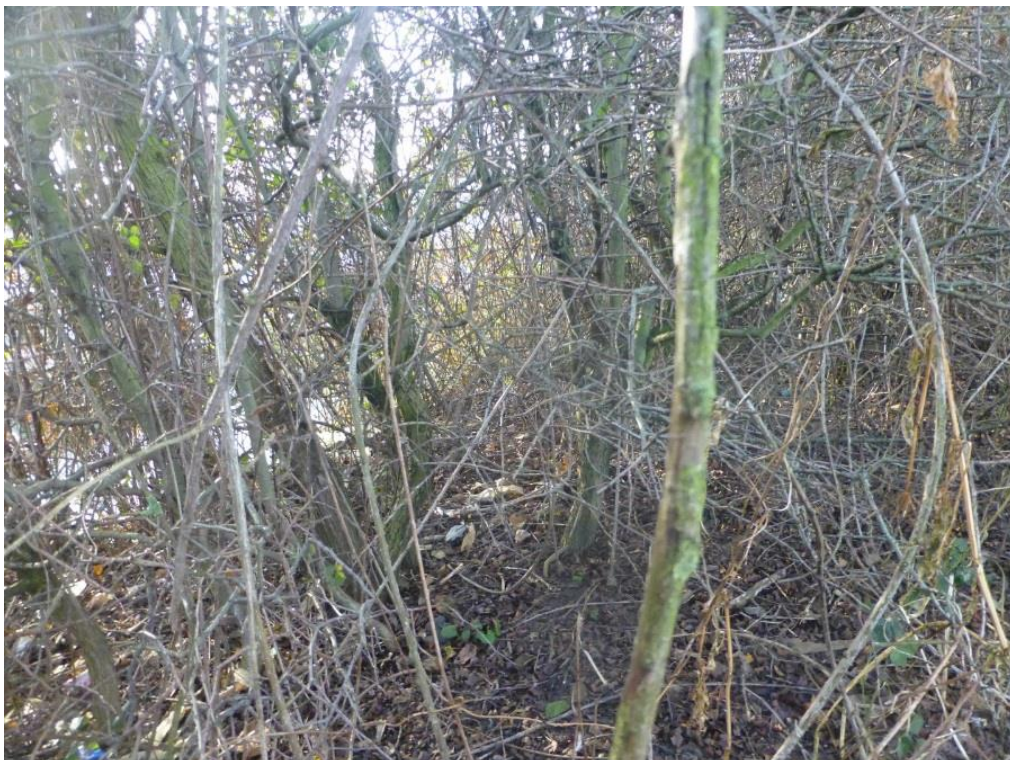
Located at the southwest corner of the site this is a length of Hawthorn hedge that has been planted on the top of the river bank. Planted as a double staggered row, some of the original plants have died, but the remaining hedge is thick and bushy, having only received light pruning in the past. The plants are at 250mm to 400mm spacings. The hedgerow is in good condition and growing well. On the south side of the hedge, on the river bank, there is an area of Japanese Knotweed.

Photograph 11 Area 7 Planted Hawthorn hedge

The section of hedgerow within Area 7 will be removed to facilitate the excavation of the new drain to allow access for machinery and equipment to site. A section wider than the actual channel will be removed to provide an area for machinery to operate. The trees on the edge of the work area will require their roots to protected according to the RPA's calculated and outlined in Appendix A in accordance with BS5837 (British Standards Institution, 2012).
