**LAND OFF  
HOYLE MILL ROAD, BARNSELEY**

**PHASE I/II GEO-ENVIRONMENTAL  
INVESTIGATION  
FOR  
BARRATT SHEFFIELD**

S5/028a  
September 2005

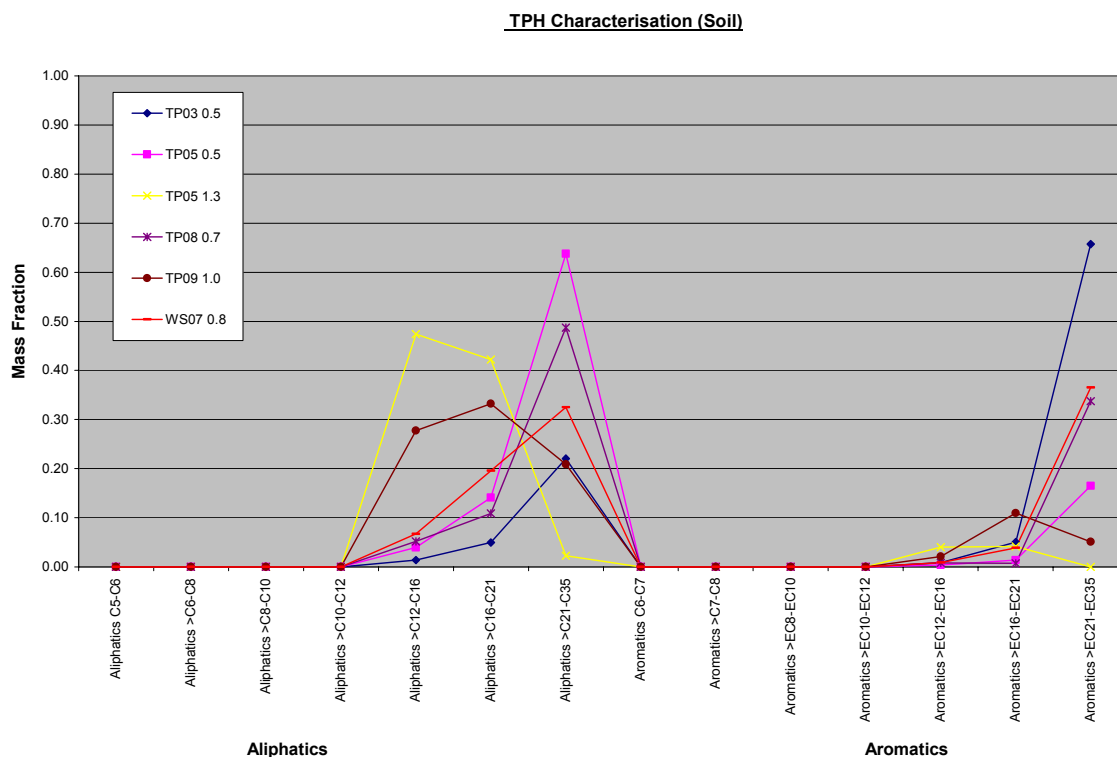
Total Petroleum Hydrocarbon analysis, comprising the fractionation of hydrocarbons in accordance with the Total Petroleum Hydrocarbon Criteria Working Group (TPHCWG), was carried out on six of the soil samples (refer to Appendix V for individual test results). Elevated TPH concentrations were primarily identified within the made ground materials which underlie the northern and eastern car parking areas at shallow depth, at the investigation locations given on the chart below. Speciated TPH analysis indicates that the TPH comprises a mixture of both aliphatic and aromatic hydrocarbons. Contamination is anticipated to most probably be associated with the localised spillage/leakage of fuels (i.e. diesel) from heavy goods vehicles/buses that have been parked on the site over many years. The data indicates that the hydrocarbons are most probably weathered, with heavier molecular weight organics (between C12 and C35) remaining in the host soils. However, the carbon band C21-C35 is the dominant fraction for both aromatics and aliphatics. PAH identified in the soils is also most probably associated with fuel contamination.
