BS5837:2012 -Trees in relation to design, demolition and construction. Tree Constraints report in relation to trees Belle Green Court Care Home, Cudworth, Barnsley.

Prepared by: East Midlands Tree Surveys Ltd.

Date: 22/12/23

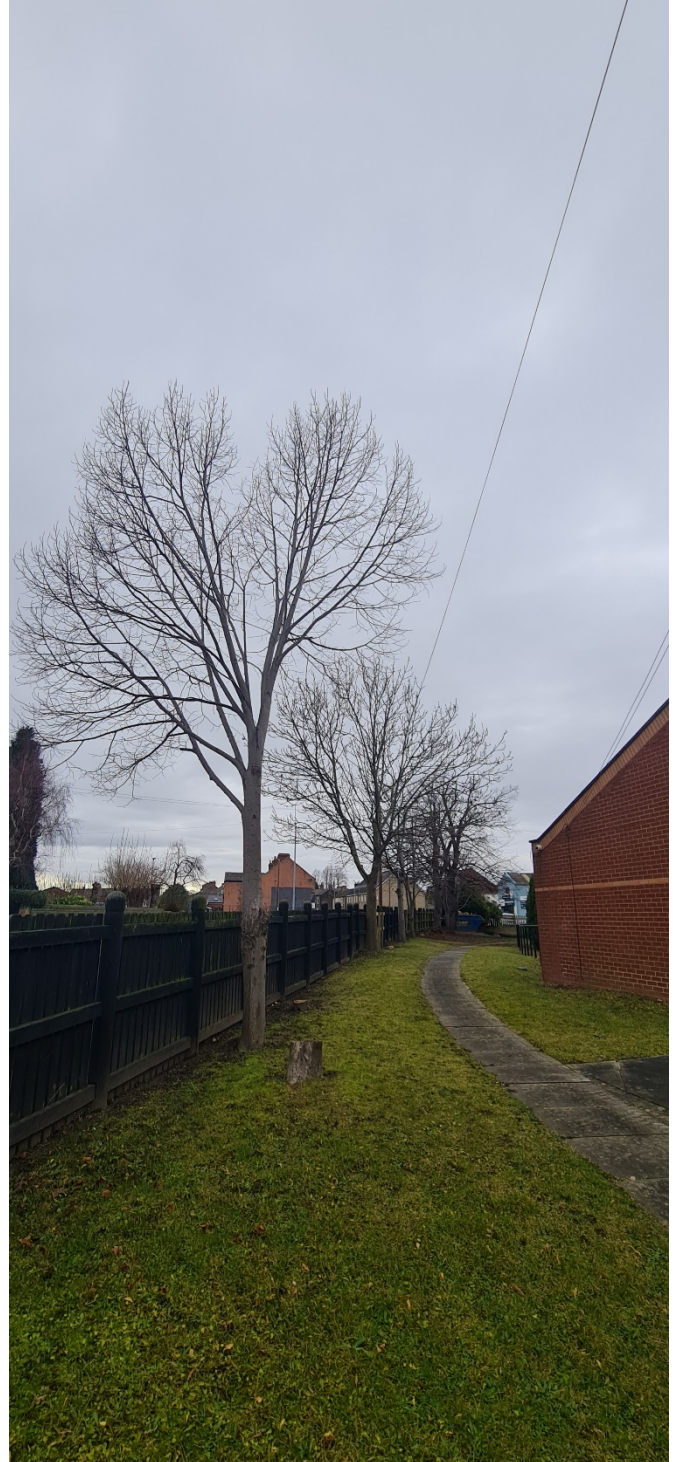
T2-T9

Due to the high target, it is recommended that the Limes are risk assessed during the summer months based on the levels of crown die back to determine their overall condition.

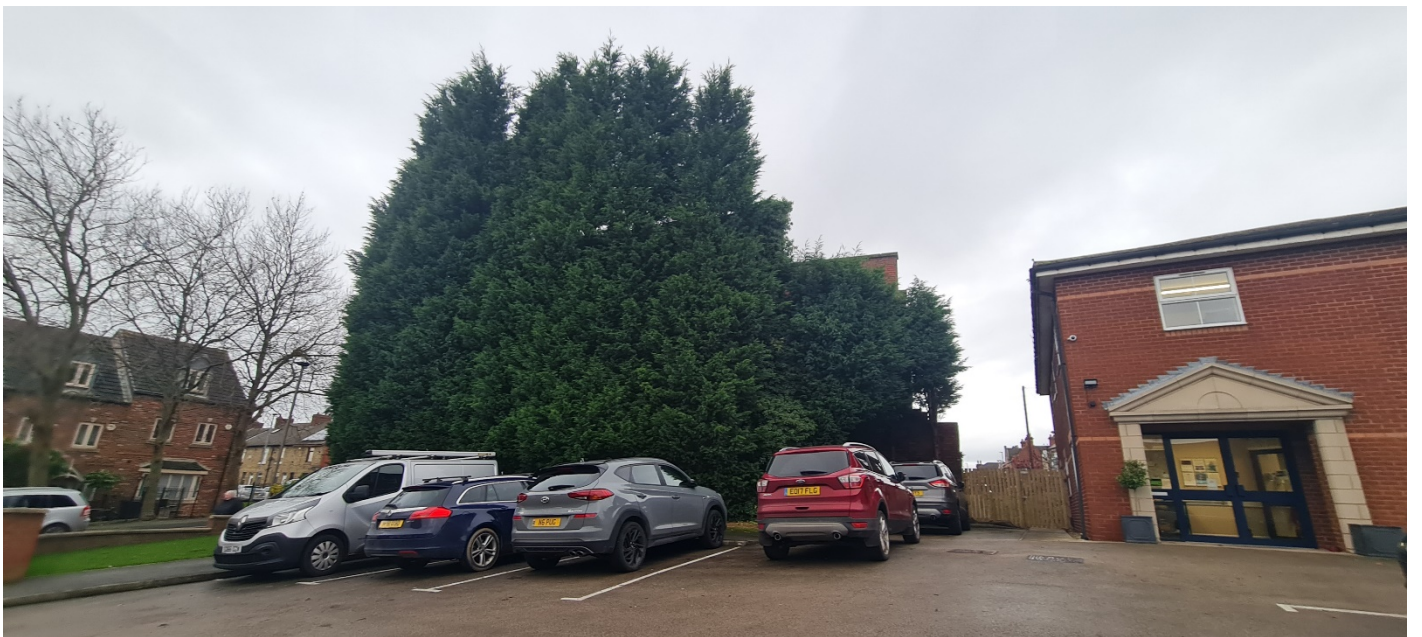
G3 Cypress should also be removed, they are unsustainable in that location, growing so close to the adjacent building with the tops touching the upper brick work, equally, there is damage the adjacent retaining wall (See photos).
