# Arboricultural Consultancy for Direct Line Insurance

| <b>Insured</b> | Dr John Harban | <b>Address</b> | The Gables, Carlton Road, Carlton, Barnsley, S71 3JD | | |

## 2. Property and Damage Description

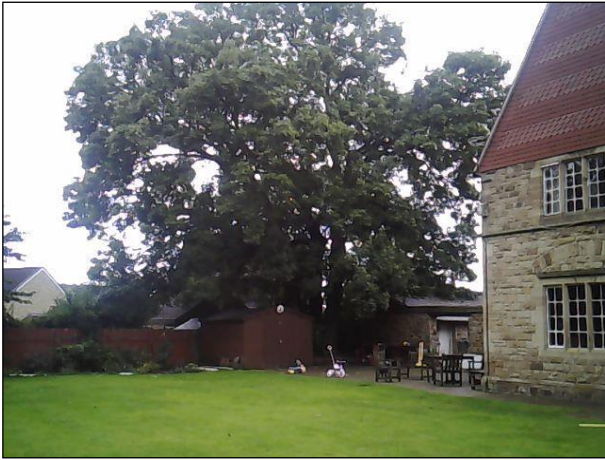
T7 - Ash

We are mindful of the presence of T7 (Ash) which is another significant specimen, but set to the rear of the insured property; given the information provided as to area of damage and also taking level monitoring results into account, it remains our opinion that of the two trees, T3 (Ash) is, on balance of probability, the likely source of the root material found.

We note fresh Level Monitoring is in place however readings are not yet available; in the event this continues to show a cyclical pattern of movement (in the absence of TG1) and confirms that the single storey section of the property is also moving, then this will confirm the role of T7 in the claim. Our advice may be subject to review.

| Tree No. | Species | Age Cat | Approx. Height (m) | Distance to Building (m) | Ownership | Action | Requirement |
|---|---|---|---|---|---|---|---|
| T7 | Ash | 2 | 16 | 2.4 | C - Insured | Action to avoid future risk | Remove. |

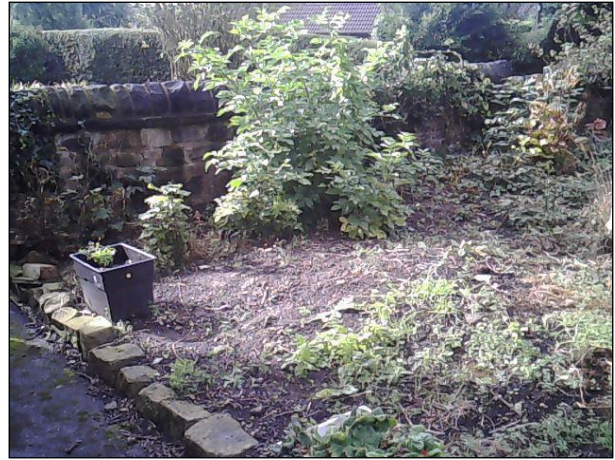
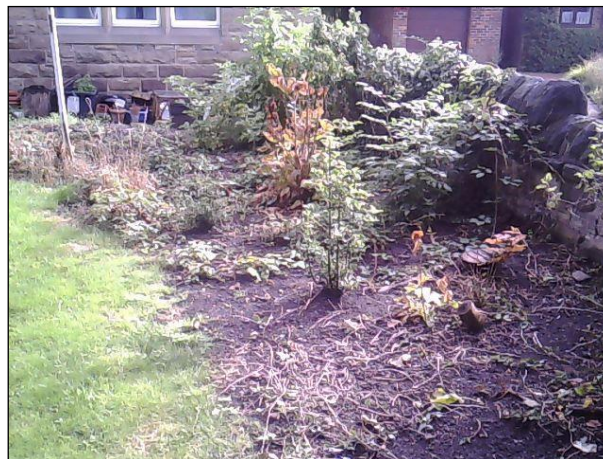
STG1 - Mixed species group

Prior to attending site, TG1 of the above report had been removed (now identified as STG1).

Given that the *Acer spp* roots were recovered to a depth of 2.1m it is our opinion that these roots will derive from T2 and not the now removed Sycamore within STG1.

| Tree No. | Species | Age Cat | Approx. Height (m) | Distance to Building (m) | Ownership | Action | Requirement |
|---|---|---|---|---|---|---|---|
| STG1 | Mixed species group (Sycamore, Holly, Ash) | 1 | 1.6 | 1.7 | C - Insured | Action to avoid future risk | Manage stumps to inhibit regrowth. |

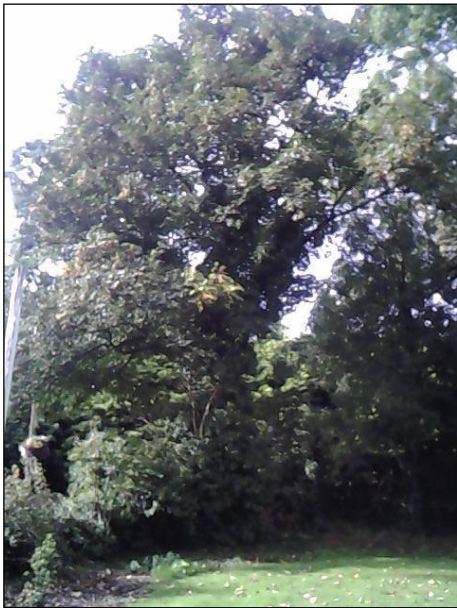
T2 - Sycamore

The most likely origin of the roots is T3 (Ash) and T2 (Sycamore), respectively.

T2 (Sycamore) cannot be discounted as contributing to the overall level of soil drying proximate to the area of damage and is therefore also considered to retain a contributory influence, albeit in a limited / secondary capacity when compared to T3.

| Tree No. | Species | Age Cat | Approx. Height (m) | Distance to Building (m) | Ownership | Action | Requirement |
|---|---|---|---|---|---|---|---|
| T2 | Sycamore | 1 | 11 | 14.6 | C - Insured | Remove | Remove and treat stump to inhibit regrowth. |

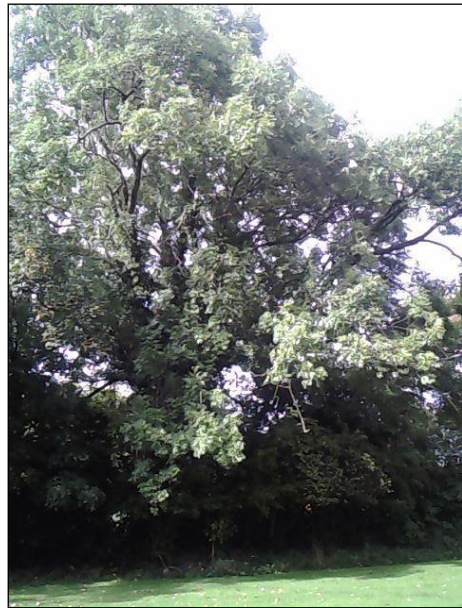
T3 - Ash

Roots recovered from TP/BH1 (2015) to a depth 2000mm have been identified as *Fraxinus* only, with the likely source being T3 (Ash).

Such circumstances confirm the potential for T3 to be influencing soil volumes and thereby contributing to the damage observed.

In assessing the potential drying influence of the vegetation on site, T3 is clearly the dominant feature within the front garden of the insured property and accordingly we have identified it as the principal cause of the subsidence.

| Tree No. | Species | Age Cat | Approx. Height (m) | Distance to Building (m) | Ownership | Action | Requirement |
|---|---|---|---|---|---|---|---|
| T3 | Ash | 1 | 19 | 19.2 | C - Insured | Remove | Remove. |

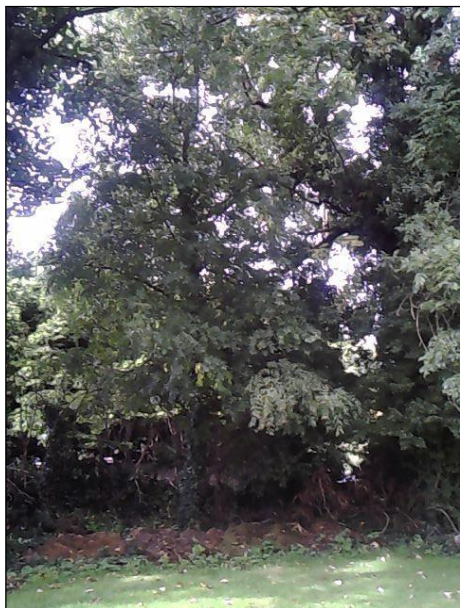
T1 - Ash

| Tree No. | Species | Age Cat | Approx. Height (m) | Distance to Building (m) | Ownership | Action | Requirement |
|---|---|---|---|---|---|---|---|
| T1 | Ash | 1 | 10.7 | 17.4 | C - Insured | Action to avoid future risk | Do not allow to exceed 14m max height by way of regular pruning. |

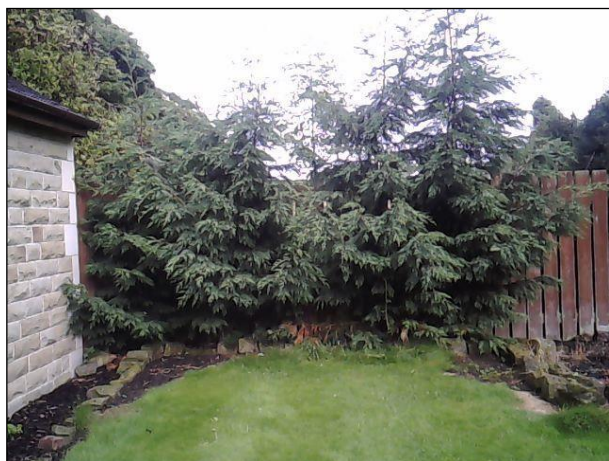
TG1 - Cypress (Leyland)

| Tree No. | Species | Age Cat | Approx. Height (m) | Distance to Building (m) | Ownership | Action | Requirement |
|---|---|---|---|---|---|---|---|
| TG1 | Cypress (Leyland) | 1 | 3.5 | 1 | C - Insured | Action to avoid future risk | Do not allow to exceed current dimensions by way of regular pruning. |

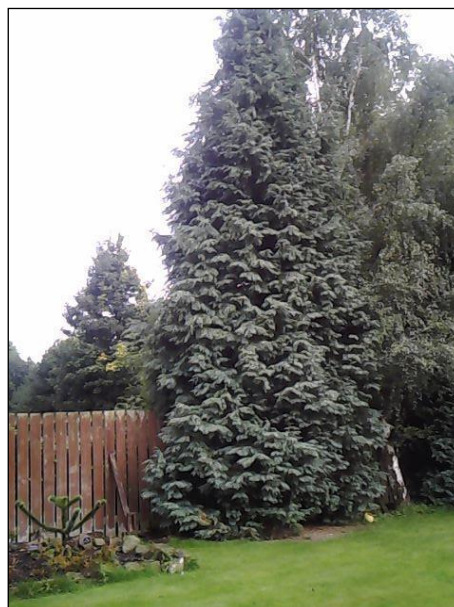
T8 - Cypress (Lawson)

| Tree No. | Species | Age Cat | Approx. Height (m) | Distance to Building (m) | Ownership | Action | Requirement |
|---|---|---|---|---|---|---|---|
| T8 | Cypress (Lawson) | 1 | 8.5 | 10 | C - Insured | Action to avoid future risk | Do not allow to exceed current dimensions by way of regular pruning. |

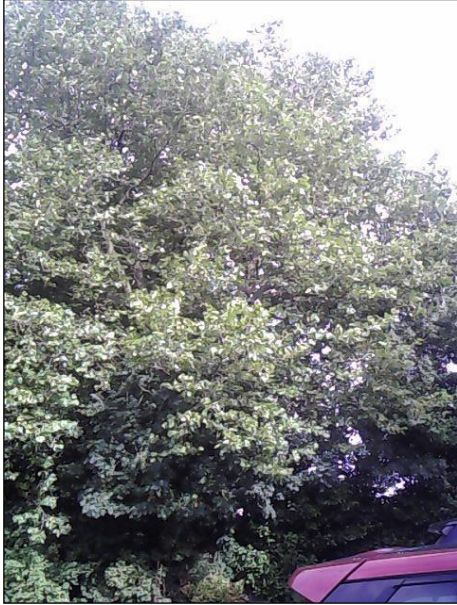
T4 - Plane (London)

| Tree No. | Species | Age Cat | Approx. Height (m) | Distance to Building (m) | Ownership | Action | Requirement |
|---|---|---|---|---|---|---|---|
| T4 | Plane (London) | 3 | 15 | 8 | C - Insured | Action to avoid future risk | Do not allow to exceed current dimensions by way of regular pruning. |

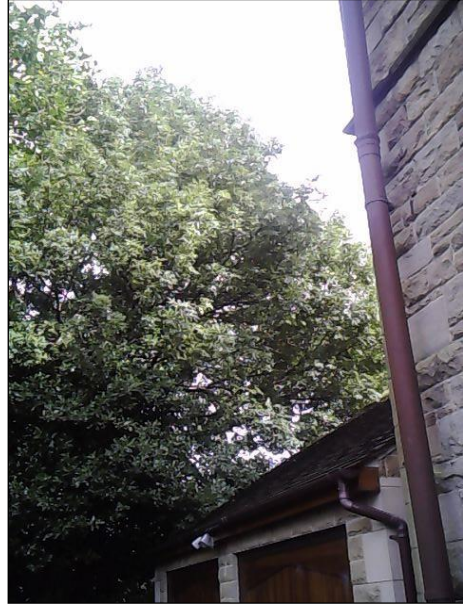
T5 - Ash

| Tree No. | Species | Age Cat | Approx. Height (m) | Distance to Building (m) | Ownership | Action | Requirement |
|---|---|---|---|---|---|---|---|
| T5 | Ash | 2 | 10.5 | 1.9 | E - Boundary Veg (ownership to be confirmed) | Action to avoid future risk | Remove. |

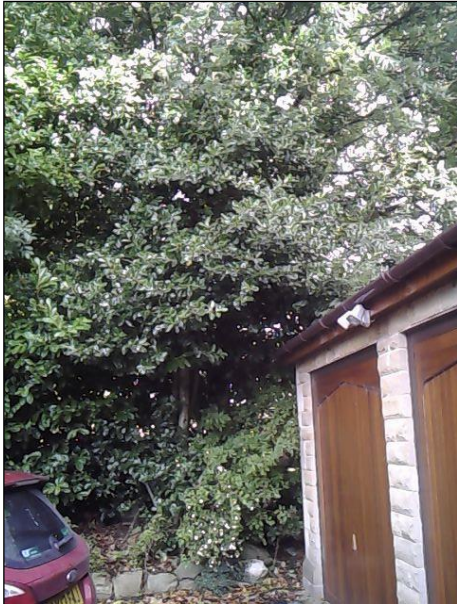
T6 - Holly

| Tree No. | Species | Age Cat | Approx. Height (m) | Distance to Building (m) | Ownership | Action | Requirement |
|---|---|---|---|---|---|---|---|
| T6 | Holly | 1 | 5.4 | 1.5 | C - Insured | Action to avoid future risk | Do not allow to exceed current dimensions by way of regular pruning. |
