**MOOR ROYD BARN.**

**BAT SURVEY.**

**Ref No:- 150640.**

**Date: 6<sup>th</sup> July 2015.**

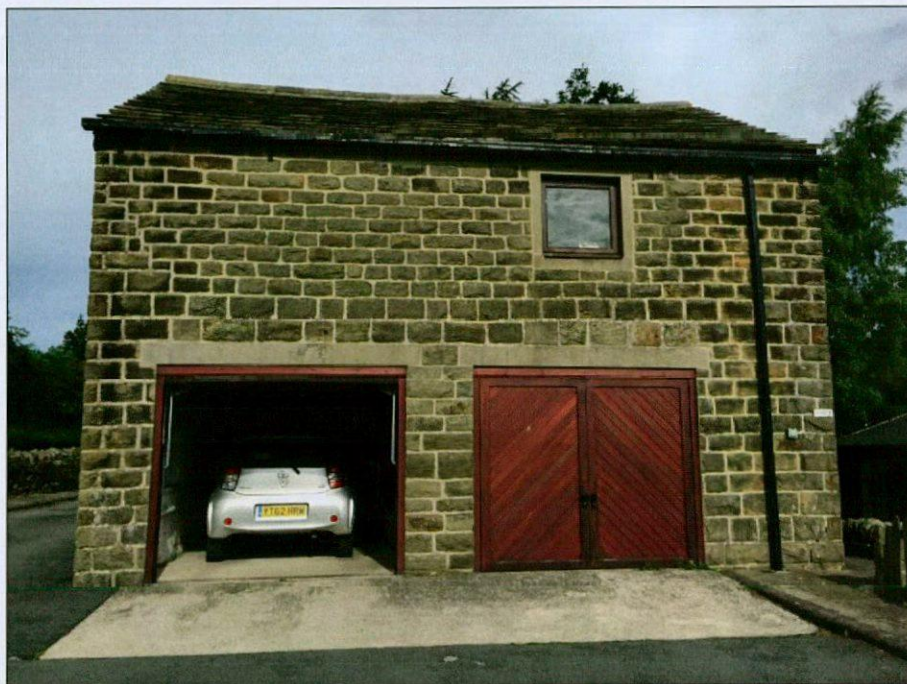
3.2.8. Photograph showing the eastern side of the building.

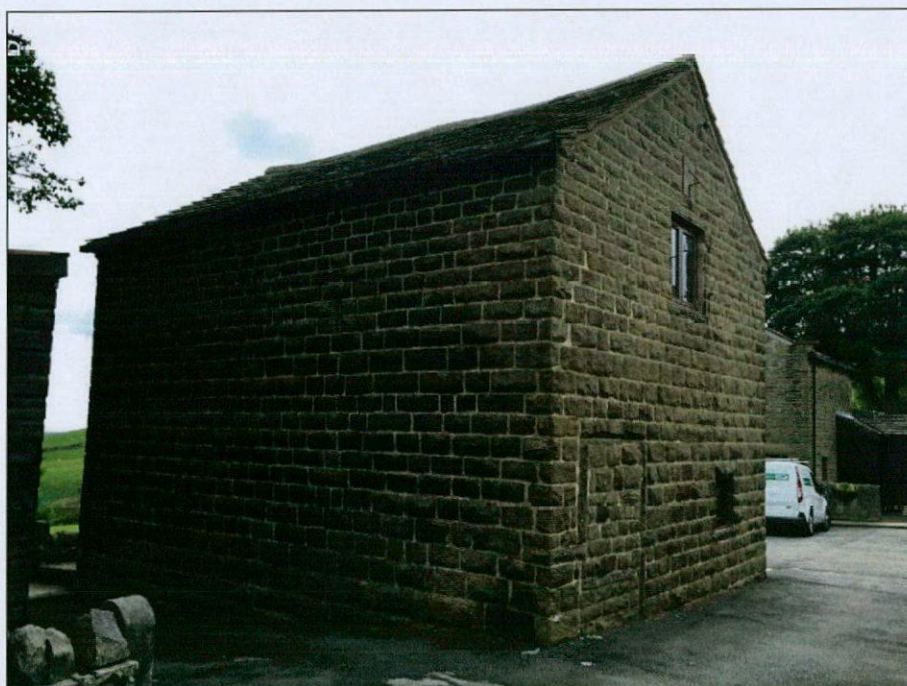
3.2.9. Photograph looking at the northwest corner of the building.
