# Annual Tree Health & Woodland Inspection

Tree protection,  
TPO 22 -W1

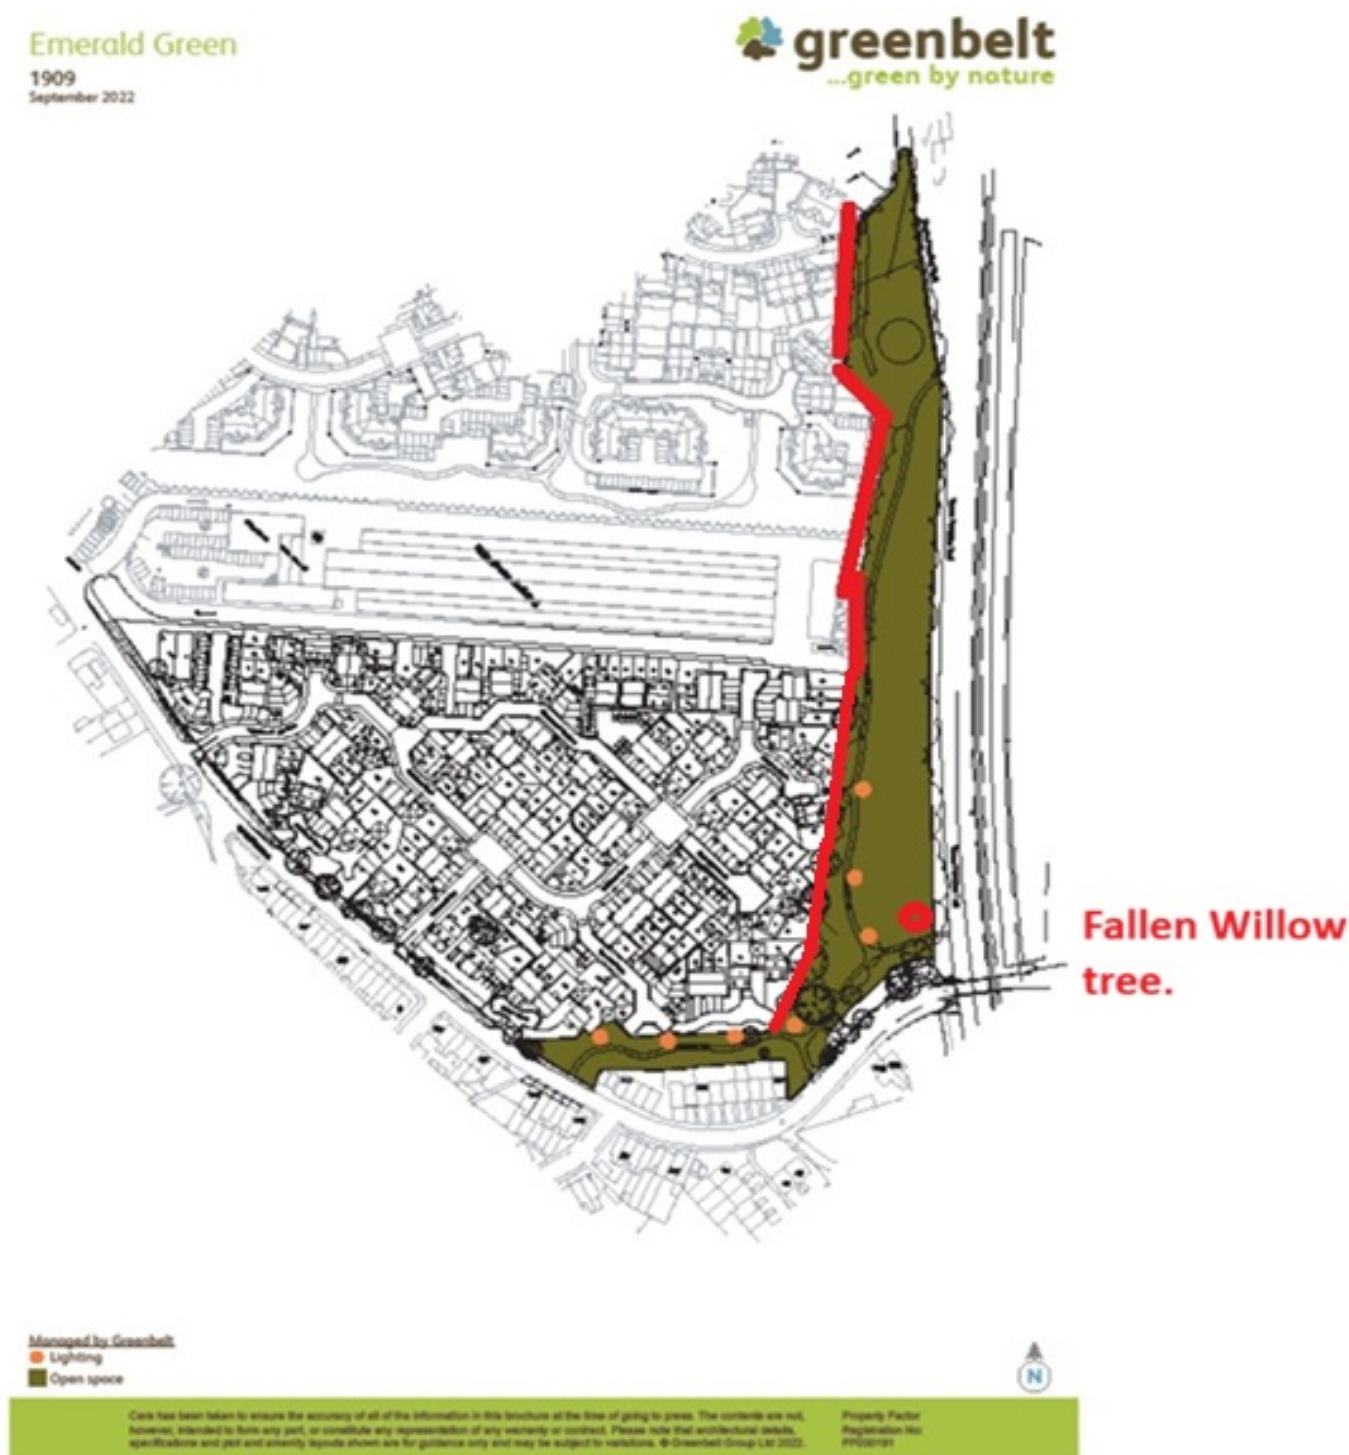
A root-plate heaved willow is resting on the fence near the footpath, this requires to be made safe and the small arisings chipped, the larger wood can be stacked to form habitat piles, it has a colonisation of *stereum hirsutum*, (see attached photograph). To be made safe within 3 months.

Prescriptions. Remove fallen tree, 3 months.
