Tree Survey; **Proposed factory extension,  
Oxspring Wire Mills, Penistone,  
Sheffield, S36 8YW.**

Client; **Peter Robinson Esq. Director.**

Date of Survey; **February 10<sup>th</sup> 2011.**

File reference **Oxspring Wire 01**

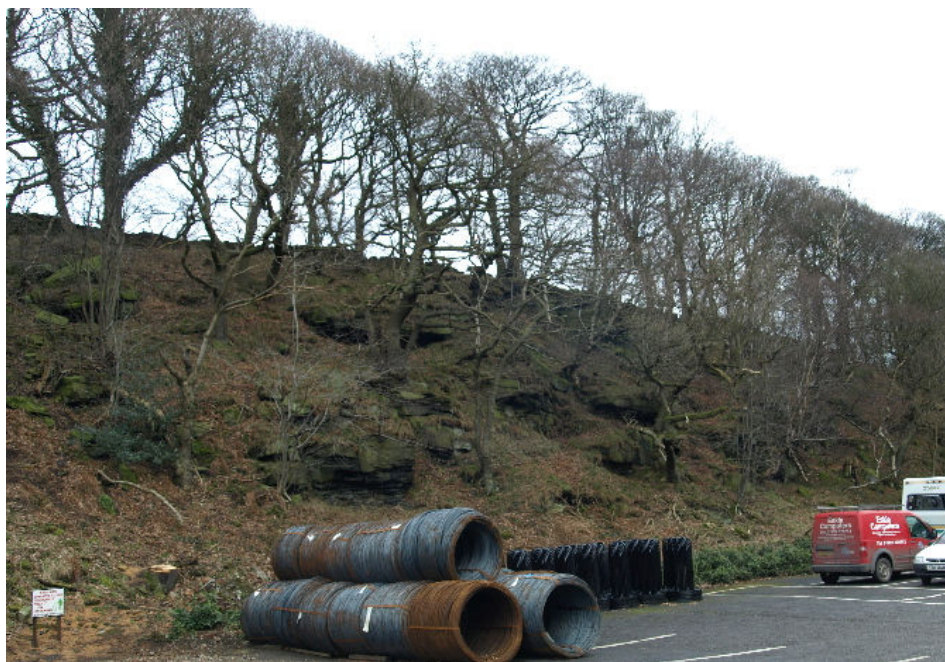
Photograph 1.

Photograph 1 is taken looking roughly east from the centre of the car park. The new building will sit on the car park and finish roughly where the coils of steel currently are stored. The trees on the embankment appear to have been left alone for many years. The transmission lines were behind me when I took this photograph and photo 2 shows a view of the trees beneath the

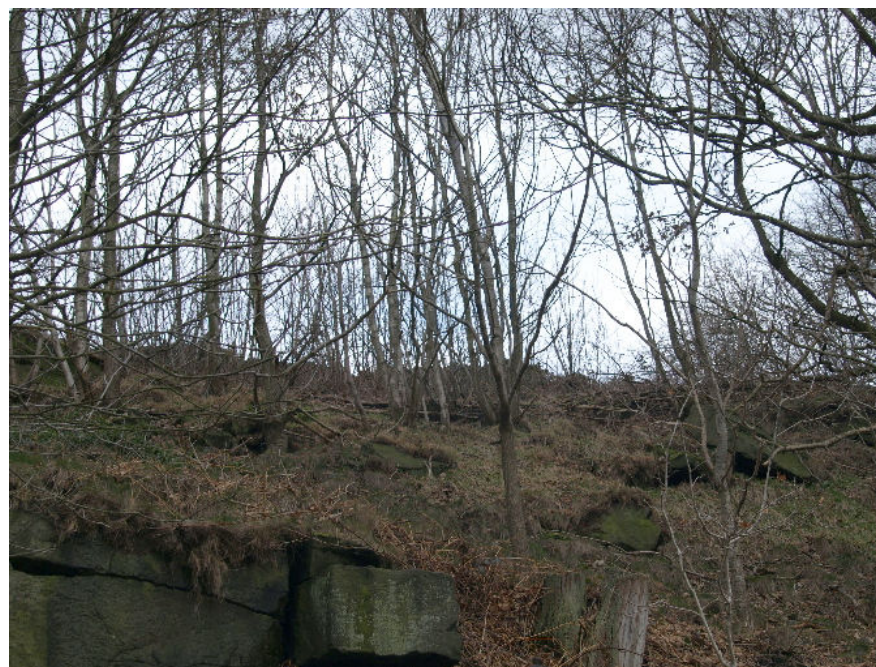
Photograph 2.

transmission lines. The trees here are much smaller due to their being coppice growth, that is when the transmission people cut down the trees beneath the lines they were simply allowed to grow back again. While this sounds somewhat haphazard, in actual fact this sort of management is extremely environmentally beneficial. The rejuvenated growth that results from coppice management is usually more dense and provides good cover for small birds and mammals and the rejuvenated trees may very well produce more flowers and fruit with increased benefits to the food chain. Not only that but the increased light levels will help to prevent the ground flora from being suppressed. There are also benefits from increased carbon sequestration; it's generally accepted that young or coppiced trees putting on increment rapidly must sequester more atmospheric carbon than elderly moribund trees.

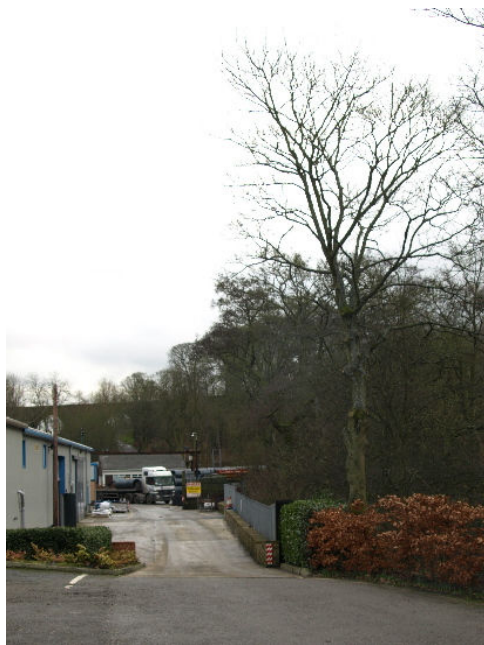
Photograph 3.

Tree No.	Species.	Ht	TD	Age class	Category	Comments.	RPA
1.	Sycamore	11	420	M	C1	Appears somewhat moribund, that is lacking vitality. Very close to access route, hence lower branches have been removed excessively.	80

Photograph 3 to the left shows tree 1. The access route will be unaffected by this project although it is plain that tree 1 has had a lot of branches removed, presumably so they didn't catch goods vehicles.

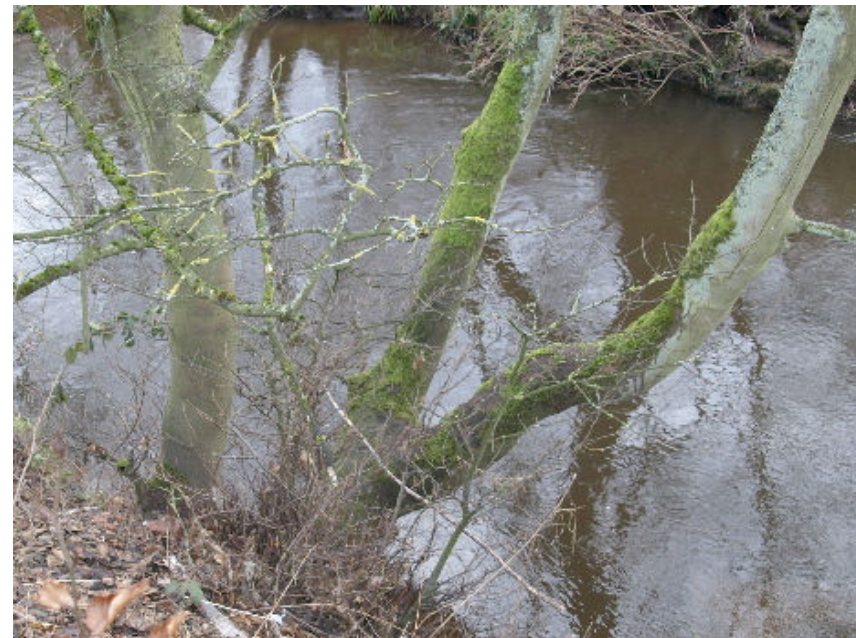
Photograph 4.

2.	Sycamore	11	500af	M	C1	At water's edge, 3 stems.	79
3.	Sycamore	11	370	M	C1	Also moribund, possibly due to soil level being raised over the roots.	62

Photograph 4 shows tree 2 at the water's edge. This is the sort of tree that might cause flooding problems.

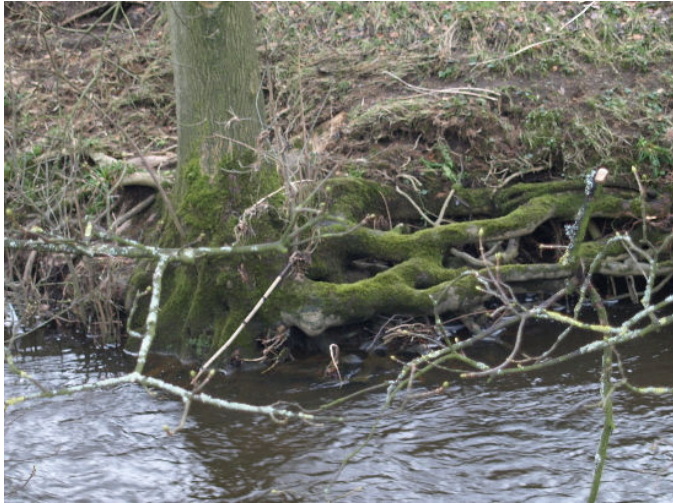
Photograph 5.

Photograph 5 shows a tree at the opposite side of the River Don to the site, I took it because it illustrates how roots develop but may have soil washed away. While this tree is probably not unstable, the 2007 inundations toppled many trees like this, which then became the cause of the problems when they were washed downstream and caused blockages.

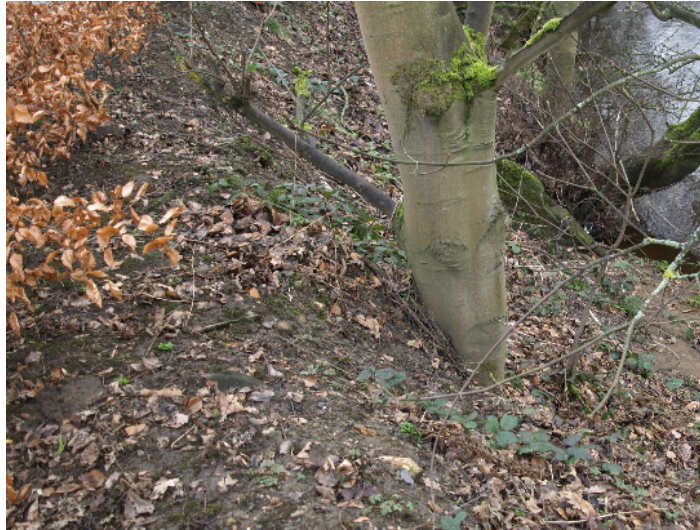
Photograph 6.

Photograph 6 shows the base of tree 3 with the soil level having been raised at one side. The car park and driveway is to the left in this photograph. I presume that the soil level must have been raised when the drive was constructed. Trees are badly affected by changes in soil level over their root system, this has probably led to this tree's lack of vigour.

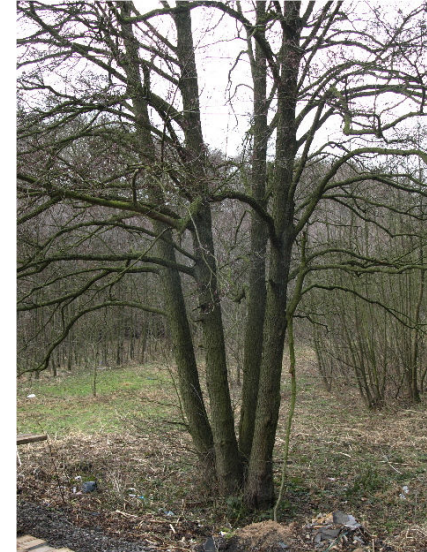
Photograph 7.

Tree No.	Species.	Ht	TD	Age class	Category	Comments.	RPA
17.	Alder	15	700	M	B2	4 similar sized stems, possibly coppice growth, a pleasing specimen. TD calculated.	222

Photograph 7 shows tree 17, which I think is a fine specimen. This tree at the far end (NW) of the site grows at a lower level than the site although the spoil used to raise the level of the yard is spreading towards the tree. I'm not sure if it is growing in made-up ground or if this is merely the original ground level; I presume the River Don used to meander here. Note the Alder saplings in the background forming quite a dense thicket. Alders have evolved to tolerate flooding and can become established on quite poor soils.

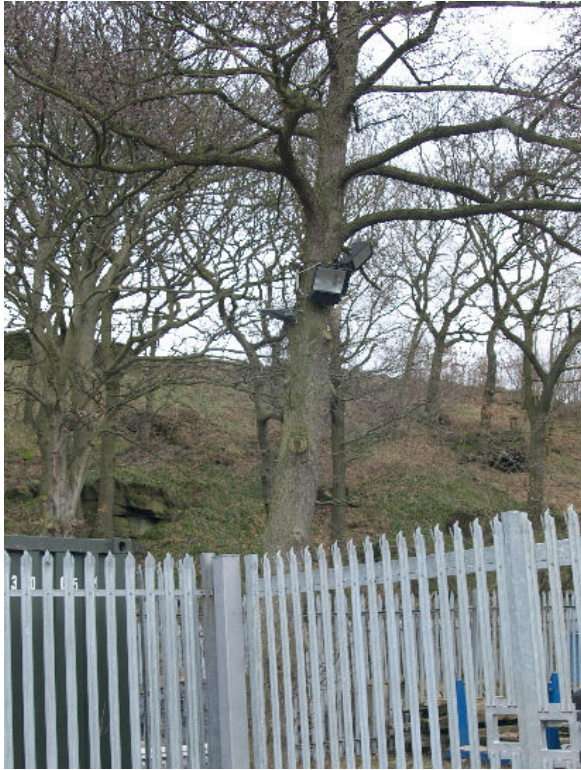
Photograph 8.

21.	Alder	17	510	M	C1	Festooned with flood lights and wires. Some decay, probably best removed.	118
22.	Ash	18	730	OM	C1	Has suffered some damage, some fungal infection and is festooned with cables. Appears to have had excavations at the base, probably best removed.	241

Photograph 8 shows tree 21 which has been used as a convenient lamp post. While the project is not actually reaching this far it would probably be sensible to take these lights and cables down and then remove the tree. The disturbance around its roots is likely to hasten its demise and having the tree fall down would be bad enough without it dragging live cables across the yard as well. Photograph 9 shows tree 22, this has suffered some damage and there appear to have been excavations very close to its trunk. Photograph 10 shows tree 24 festooned with wires. It appears as if something has been fastened around the stem which has led to the deformity. This might break. I suggest tree 24 is removed along with trees 21, 22, and 23.
