ARBORICULTURAL REPORT

& Impact Assessment

Land off
Hoyland Common,
Sheffield Road,
Barnsley,
S74 0DQ

Reference: *AWA5530*

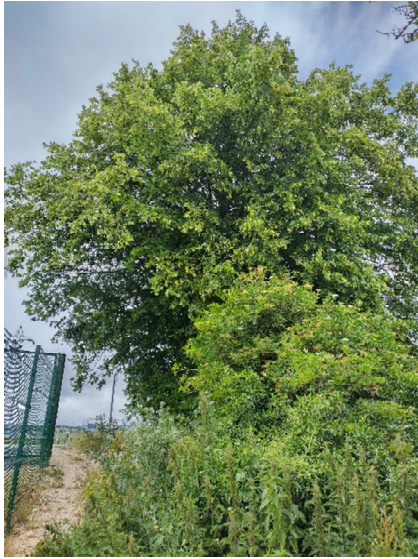
- 3.2.9 Early-mature Lime T1 was also a prominent tree in good condition. Limited access at the base due to the undergrowth meant that inspection of T1 was cursory, however the form and prospects of this tree appeared good and as such it is a retention category 'B' tree.

Photo 1: T1 from east

4.3.2 New hard surfaces are proposed within the RPA of retained tree T1. Construction within the RPA can have negative impacts on tree roots. However, the encroachment is very minor, and the detailed RPA for this tree is likely to be a slightly exaggerated representation of the trees actual rooting area. As such, it is unlikely that significant roots will be within these areas and the retained tree should remain largely unaffected by the works, provided care is taken during construction.

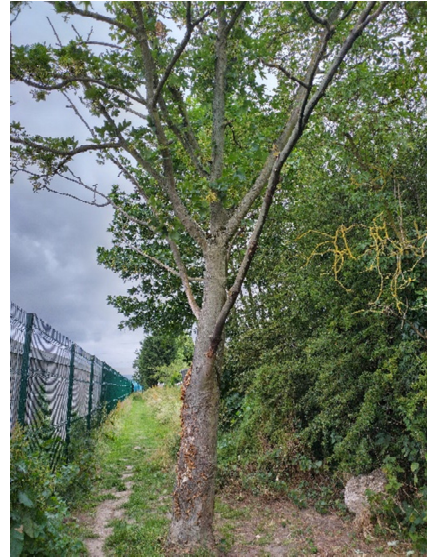
- 3.2.10 T9 is an early-mature Sycamore showing poor physiological health and structural condition, with a large hollow cavity to the south and lots of moderate deadwood within the crown. The long-term prospects of T9 are limited and is of low amenity value.

- 3.2.12 T9 was found to have significant defects which limits its safe and useful life expectancy and is recommended for removal regardless of any new development at the site (as detailed in Appendix 4).

Photo 2: T9 from east

4.2.4 T9 is recommended for removal regardless of the development due to its poor condition.

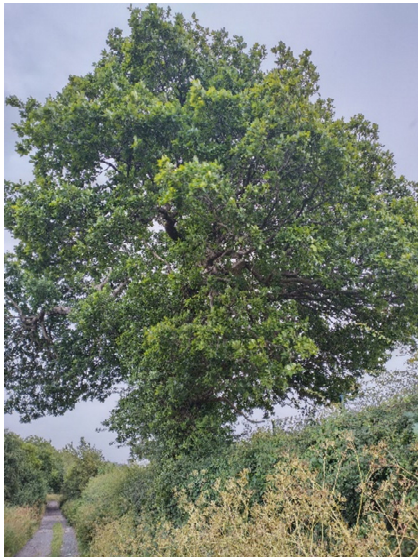
- 3.2.8 The sites most significant tree is T18, a mature Oak tree situated on the eastern boundary of the site. This tree is prominent throughout the entire site and surrounding area and provides a high level of amenity value. Due to its good long-term value and high amenity within the site and surrounding area, this tree is retention category 'A'.

Photo 3: T18 from north

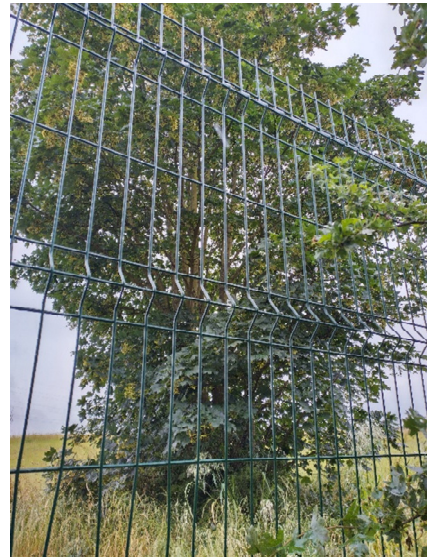
Photo 4: T20 from south east

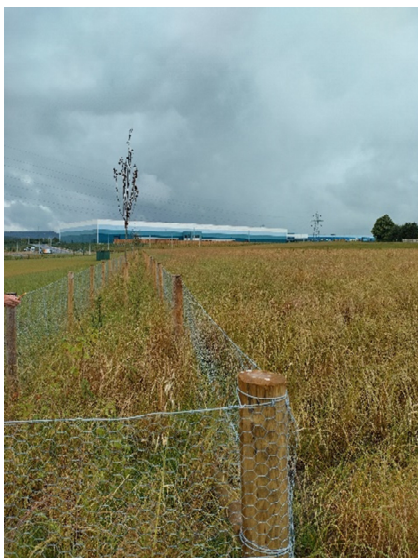
- 3.2.7 New plantings make up G23 and G24 within the site itself, however some of these have failed or are showing signs of stress. The saplings within G23 and G24 fall below the remit of BS5837 but have been included for advice.

Photo 5: G23 from east

4.2.3 G23 is formed of low value, newly planted saplings, some of which have failed or are low vigour. Due to its low value, the removal of G23 will have no arboricultural impact. Where suitable, those saplings with reasonable future prospects could be transplanted to another area of the site and be incorporated into the proposed development.

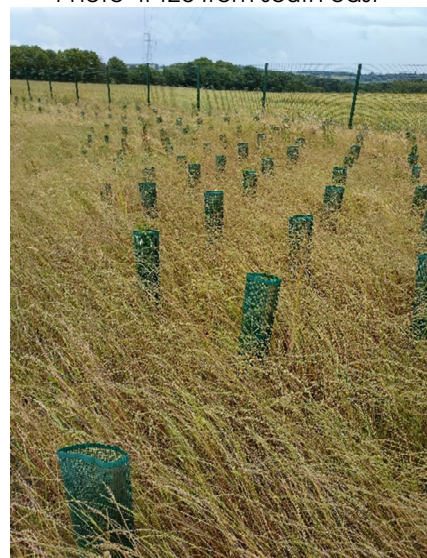
Photo 6: G24 from north west

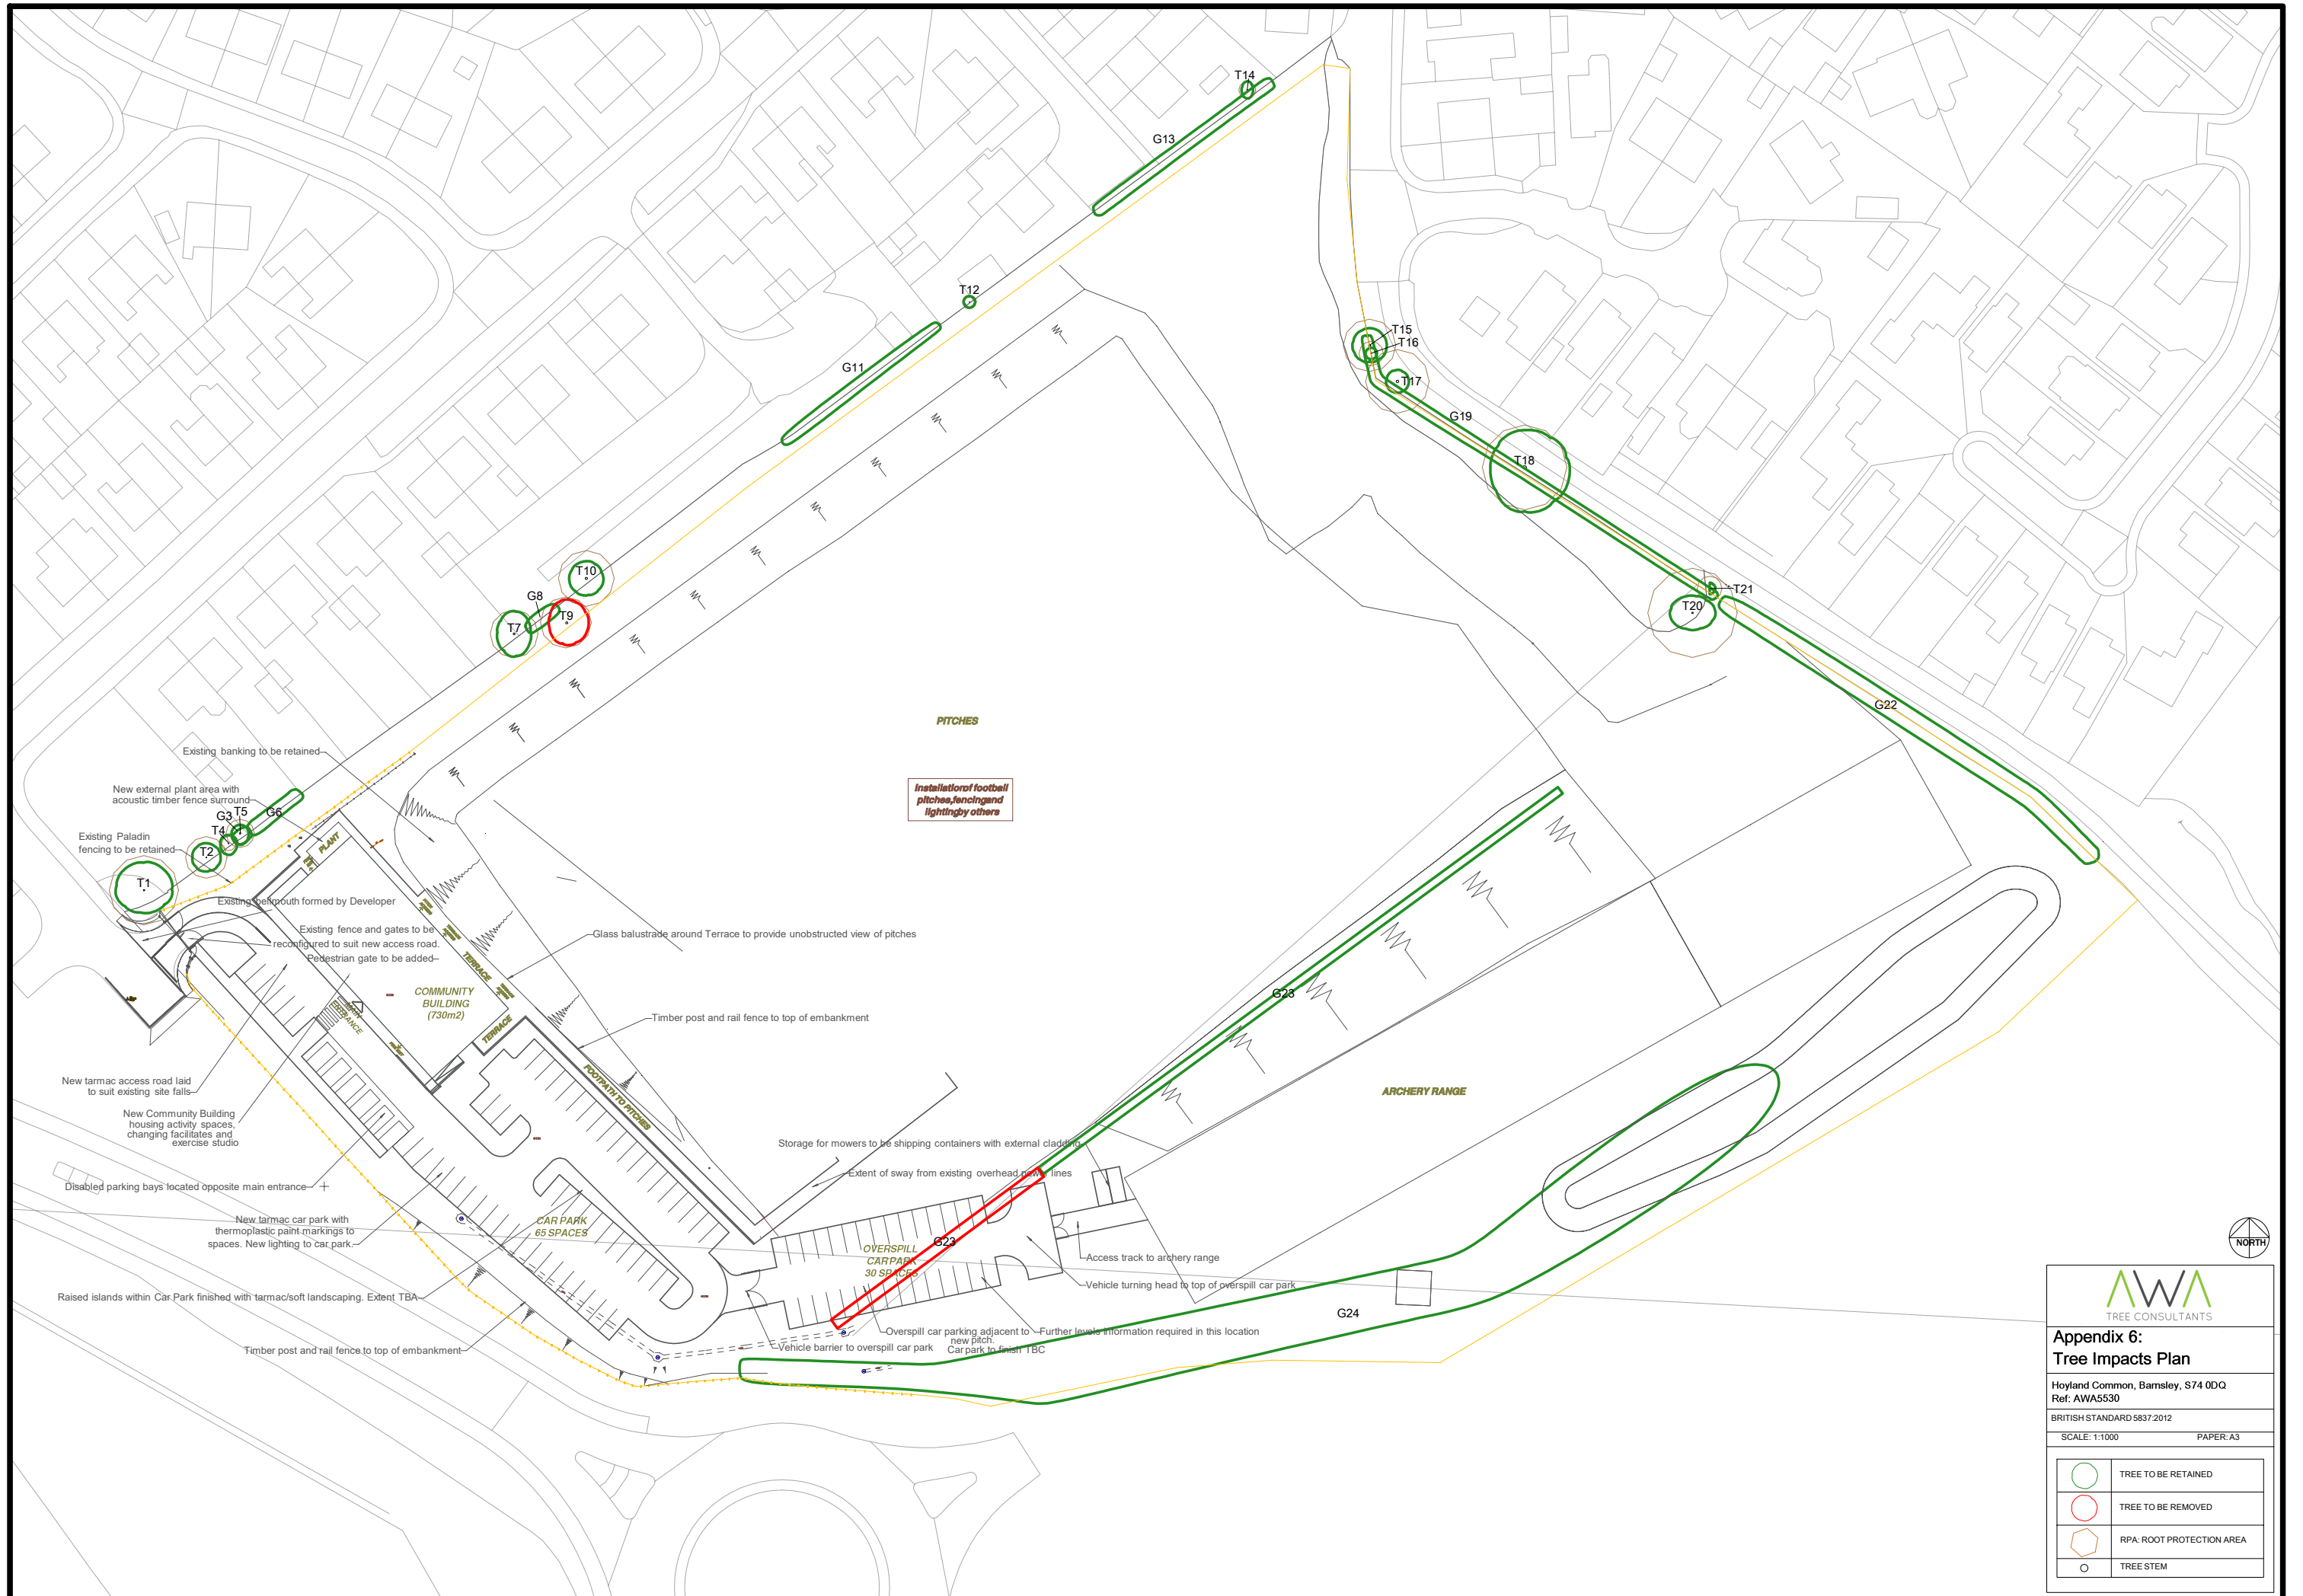
Appendix 6:
Tree Impacts Plan

4.2.1 From assessing the new development proposals, 1 tree group will require partial removal to facilitate the development as it is situated in the footprint of the development or its retention and protection throughout the development is not suitable.

4.2.2 The tree group that requires partial removal to facilitate the development is G23.
