**WORSBROUGH WATER MILL
BARNSELY
STRUCTURAL APPRAISAL REPORT**

**Commissioned by Donald Insall Associates
on behalf of Barnsley Metropolitan Borough Council**

Report 22587-Y-RP-001-R0

23 August 2024

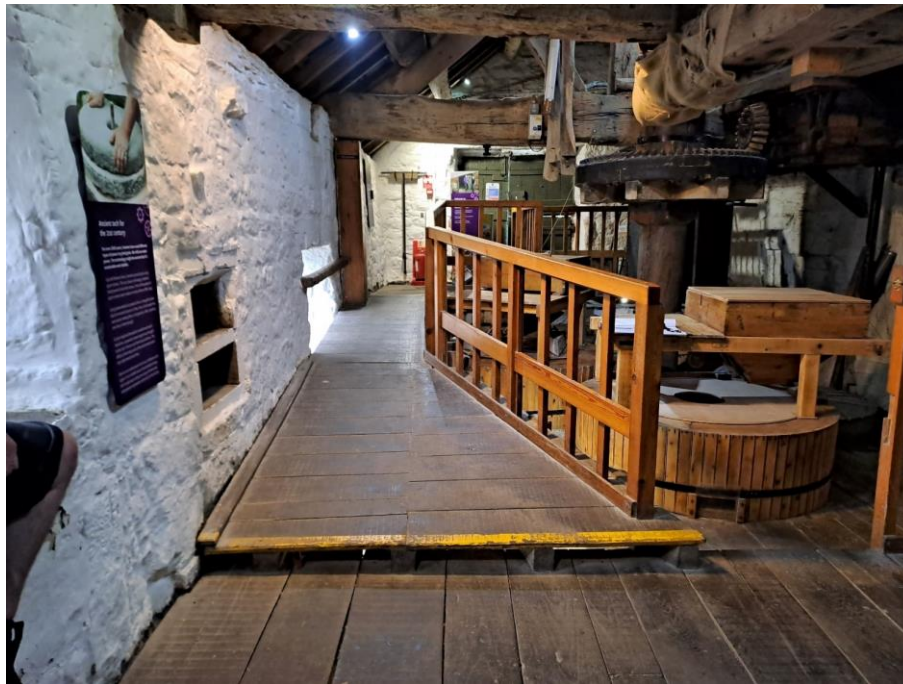
- 1 First-floor level - Milling Room 2. View of the existing ramp from the northwest side. Difference in level between the ramp and the floor. Handrail loose especially in the first 1.5m from the east access.

The existing timber guardrail is loose, particularly in the first 1.5m from the east access. The timber elements of the existing guardrail can most likely be reused for the new guardrail, if suitable for the architectural design, but connections should be strengthened. The proposed guardrail must be designed to comply with horizontal loads proposed in current codes.

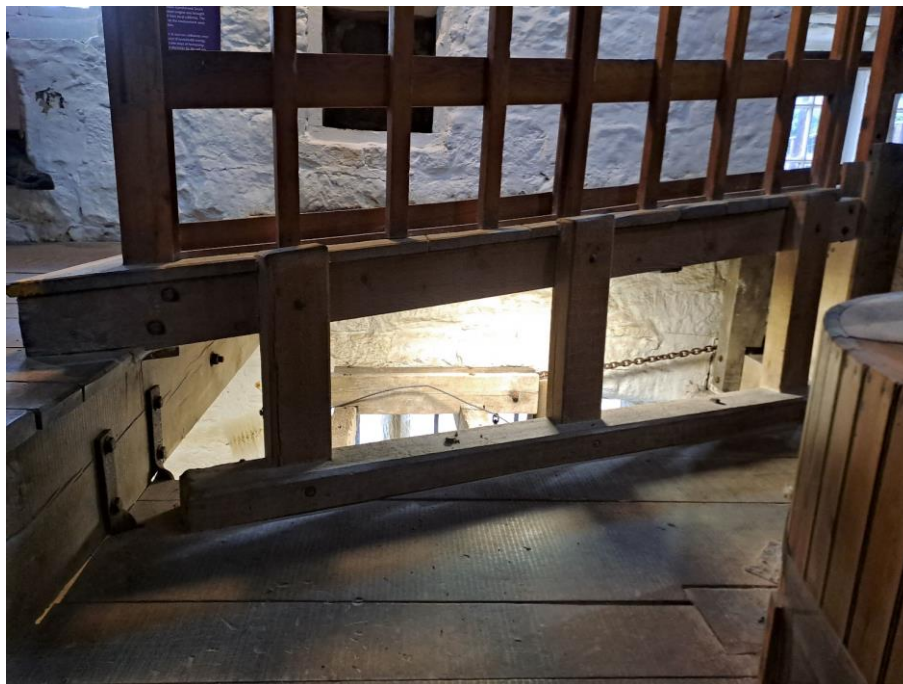
- 2 First-floor level - Milling Room 2. Proposed area of new timber floor. Existing timber elements, generally in good condition.

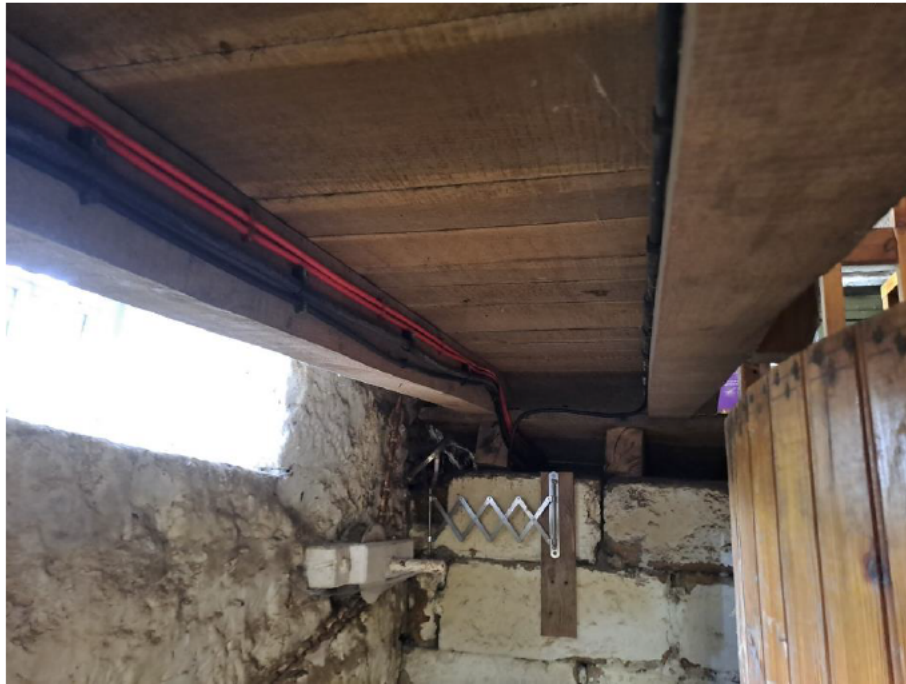
3 First-floor level - Milling Room 2. Underside of existing ramp. Timbers generally in good condition.

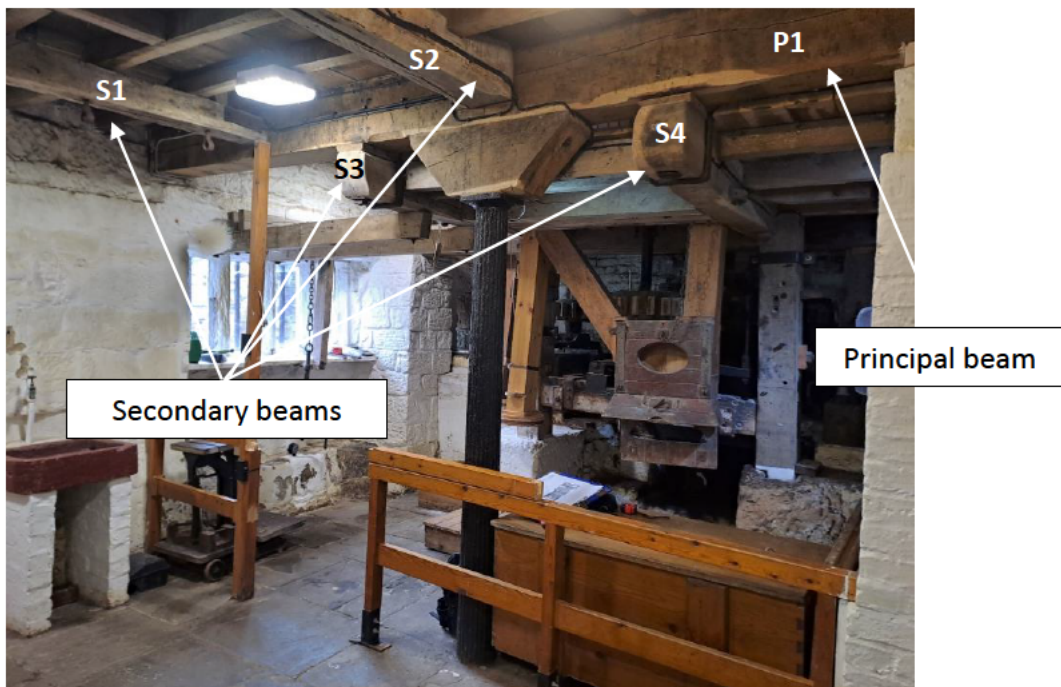
4 Ground-floor level - Milling Room 3. Area under the existing ramp and first floor where the mill stones and stone furniture is located. Timbers generally in good condition. Cast iron column supporting the one of the principal timber beams. Principal timber beam supporting all secondary timber beams.

The principal beams have an approximate section of 240x300mm, and they appear to bear directly on the external masonry walls. Principal beam P1 has an intermediate support formed by a cast iron column, which does not have evident cracks.

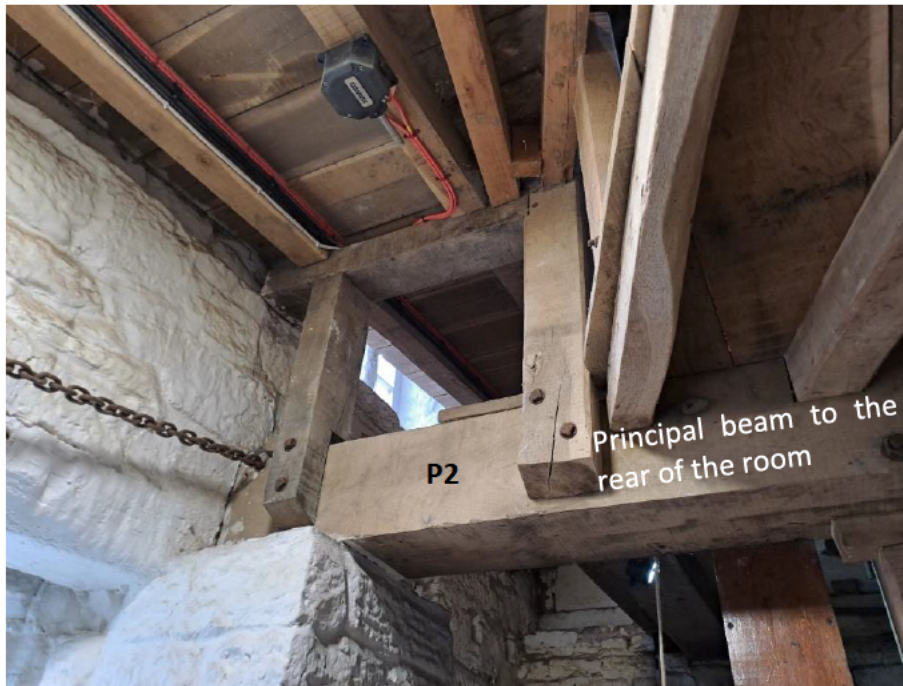
5 Ground-floor level - Milling Room 3. Timber posts supporting the ramp and connected to principal beam at the rear. Timbers generally in good condition. Minor corrosion to fixings. In average 17% relative humidity.

- i. Strengthening of beams S1 & S5 with side-by-side timbers or stainless-steel/steel plates
- ii. Replacement/strengthening of decayed joists.
- iii. Installation of timber joists to new area of floor. The floor to span between existing secondary timber beams and the northeast wall.
- iv. Surface cleaning and application of protective coating to existing metallic straps and fixings.

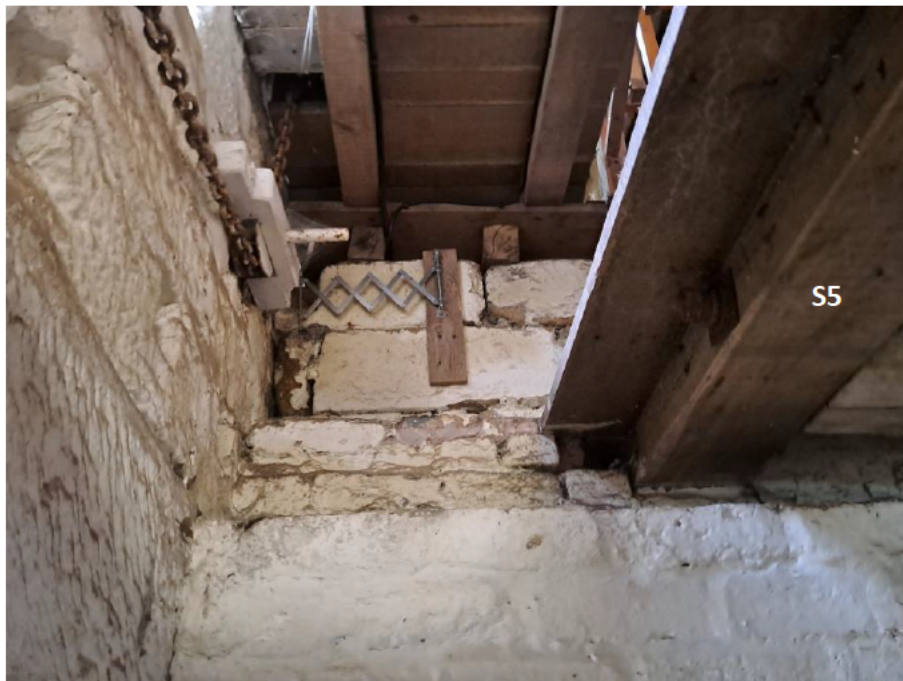
6 Ground-floor level - Milling Room 3. View of upper floor timber support beam S5.

Secondary beams S3 and S4 have an approximate section of 250x250mm, and they transfer the loads to the principal beams through metallic straps and bolts. Secondary beam S5 wasn't measured due to limited access, but it is orientated on its minor axis.

A preliminary assessment based on an estimation of the proposed permanent loads and an imposed load of 300kg/m² shows that most timber beams would comply with current code limits for bending resistance and deflection, except for beam S1 and S5.

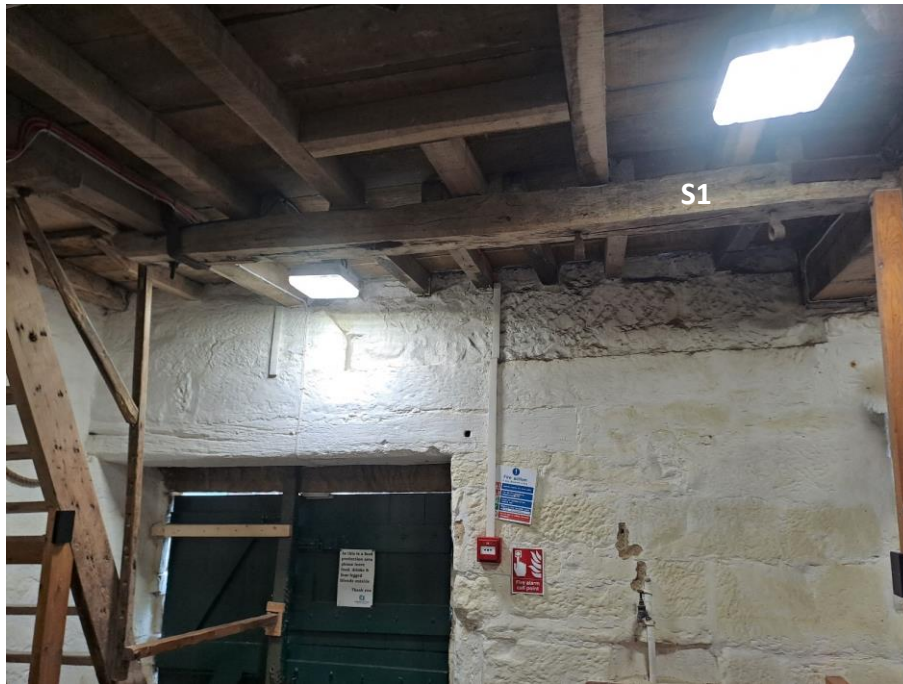
- 7 Ground-floor level, Milling Room 3. Minor deflection to existing secondary timber beam. Minor corrosion to metallic fixings on both ends of the beam. Splits to the underside of the beam. In average 17% relative humidity.

Secondary beam S1 has a minor deflection and is orientated along its minor axis. Its approximate section is 175x150mm. The floor joists in this area to the south of beam S1 are approximately 90x100mm at 460mm centres and to the north are 75x115mm at 420mm centres. A small part of the ramp will extend over these existing joists and beam, which will bring a small increase in permanent load. A number of joists on the north side of the floor has surface decay close to the bearings possibly from damp in the external wall.

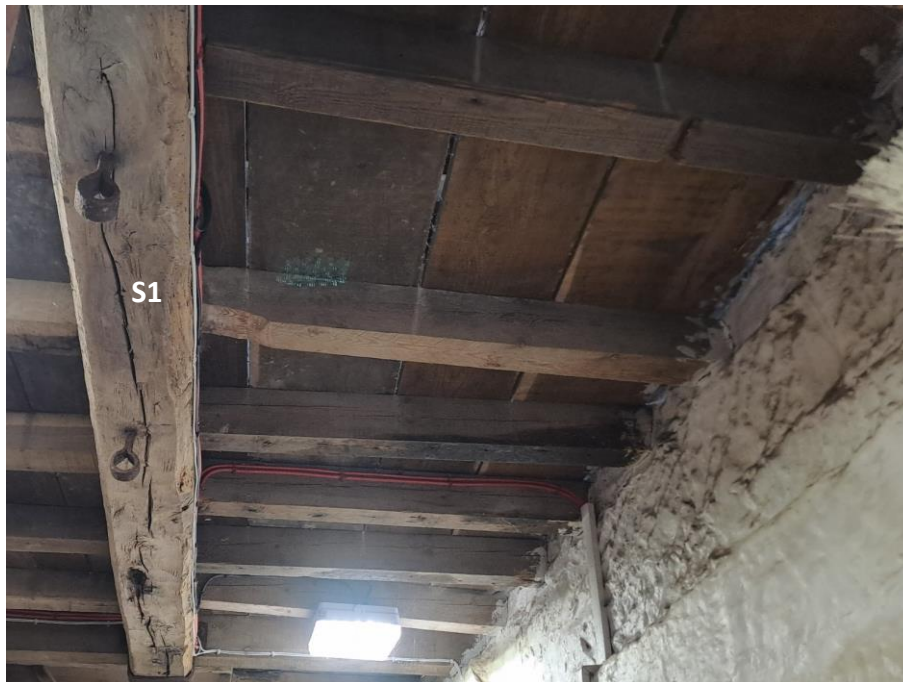
- 8 Ground-floor level, Milling Room 3. Splits to the underside of the beam. Surface decay to bearings of timber joists on the wall. In average 17% relative humidity.

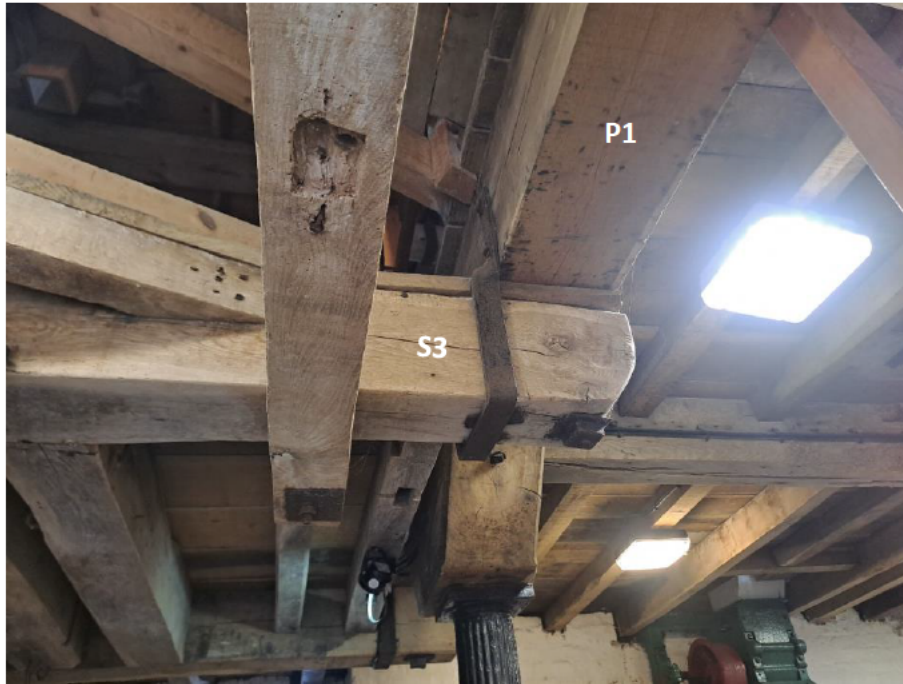
- 9 Ground-floor level, Milling Room 3. Surface corrosion to metallic connection between principal and secondary beam that can receive the new floor joists. Timber elements generally in good condition.

There is a significant number of timber elements to the underside of the first-floor ramp and floor. Photos 4 to 9 show the existing arrangement formed of principal (P) and secondary (S) beams. These beams are connected between themselves with a series of cross beams. In most cases, connections between timber members were achieved with metallic fixings, which evidence surface corrosion.
