## Engineers Report

**Risk Address** 16 Green Spring Avenue  
Birdwell  
Barnsley  
S70 5RW

**360 Reference** LIV-SN-23-006594  
**Claim Reference** 100-50-225844  
**Policyholder** Mr R Flavell

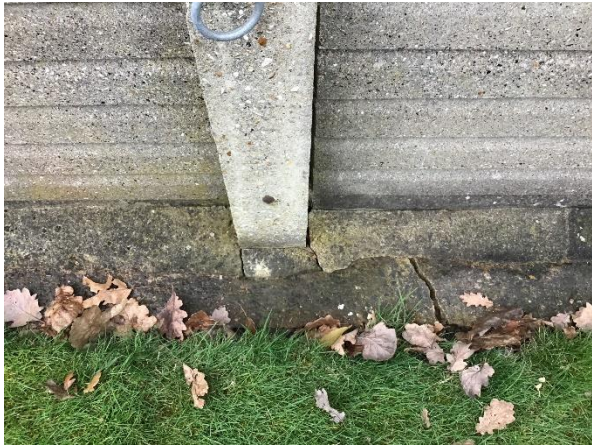
Cracking at the right-hand  
junction of the rear extension

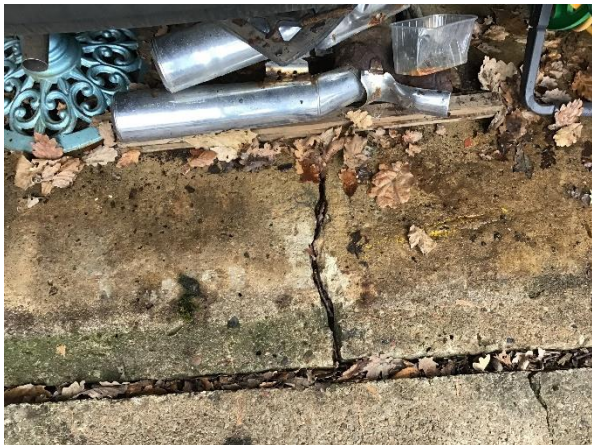
There is a 10-15mm crack to the mid-left-hand section of the garage floor slab, running from side-to-side. This cracking appears to be historic. The extent of this cracking could not be fully determined, due to the contents of the garage internally.

There is a diagonal 5-6mm crack across the rear left-hand section of the floor slab. This cracking appears to be historic.

Historic cracking to garage floor  
slab

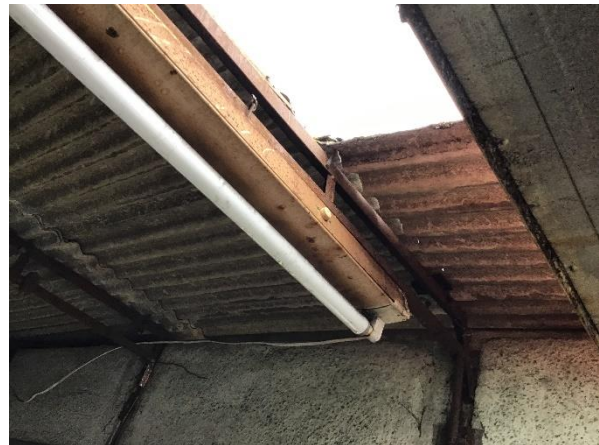
One of the asbestos roof sheets within the middle section of the garage has collapsed.

Missing asbestos roof sheet to  
middle of the garage

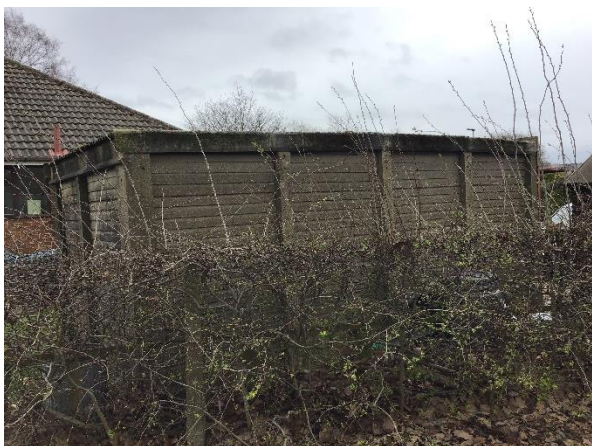
There is a tapering 5-10mm gap between the middle concrete post and the adjoining left-hand concrete panel, noted to the rear elevation of the structure.

General view of the rear  
elevation of the garage

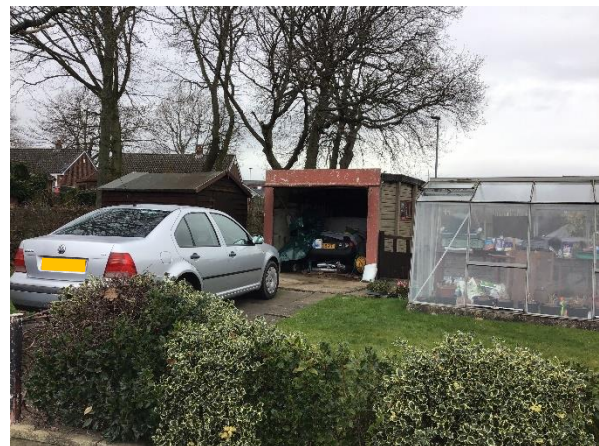
Proximity of vegetation to the  
rear in relation to the garage

In this particular instance, it is believed that the close proximity vegetation, consisting specifically of the Local Authority owned vegetation to the rear of the garage, are likely to be the significant factor in the foundation movement which has occurred to the building.

To abate any further foundation movement from occurring and provide long-term stability for the building, it is recommended that some of the close proximity vegetation is removed. The advice of a professional arboriculturist will be sought, to confirm, in their opinion, which of the vegetation in question requires removing.
