# **ARBORICULTURAL REPORT & Impact Assessment to BS5837:2012 at:**

***Dismantled railway between  
Bar Lane and Lee Lane,  
Barnsley***

Prepared for:  
***Barnsley Metropolitan Borough Council***

Reference: AWA4235

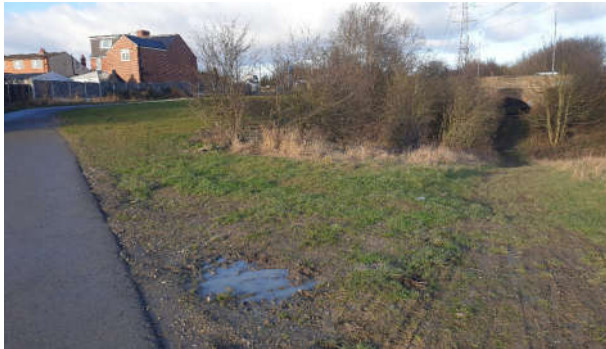
Photo 1: The start of the footpath near Bar Lane. G1 and T3, looking north

| Tree ID | Tree Species | | Maturity | Measurements | | | | Crown (m) | | | | Tree Condition | | | | | | | Value | | Management | |
|---|---|---|---|---|---|---|---|---|---|---|---|---|---|---|---|---|---|---|---|---|---|---|
| T3 | Sycamore | Acer pseudoplatanus | Early-mature | 11 | 6 | 230 avg | Yes | 2 | 4.5 | 4 | 4.5 | 4.5 | No visual defects | Multiple stemmed at base. Vertical. Epicormic growths. Old pruning wounds. Stubs. Partially included bark. Cup-like union collecting dirt/water. Bark damage | Rubbing branches. Old pruning wounds. Cavities. Minor deadwood. Snapped /hanging branches | Included bark at base. Minor vandalism on several stems | Fair | Fair | 10 to 20 yrs | Low | C | Removal required to facilitate development |

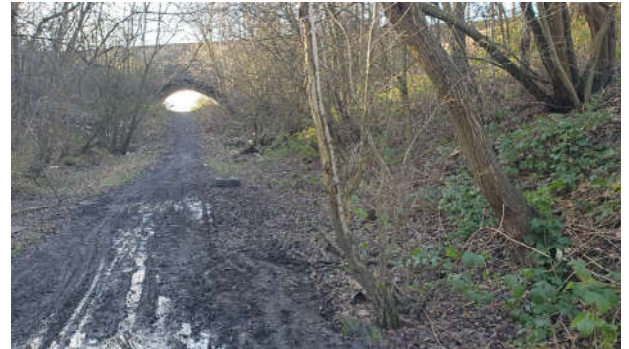
Photo 2: T5 to T17, looking south

| Tree Species | | | | Measurements | | | | Crown (m) | | | | Tree Condition | | | | | | | Value | | Management | |
|---|---|---|---|---|---|---|---|---|---|---|---|---|---|---|---|---|---|---|---|---|---|---|
| T5 | Birch | Betula pendula | Semi-mature | 11 | 1 | 160 | No | 2 | 1 | 2.5 | 3 | 2 | No visual defects | Single stemmed. Slight lean to south. Epicormic growths. Old pruning wounds. Stubs | Old pruning wounds. Cavities. Minor deadwood. Snapped /hanging branches | Slight lean corrects at 2m | Fair | Fair | 20 to 40 yrs | Moderate | C | No works required |

| | Tree Species | | | Measurements | | | | Crown (m) | | | | Tree Condition | | | | | | | | Value | | Management |
|---|---|---|---|---|---|---|---|---|---|---|---|---|---|---|---|---|---|---|---|---|---|---|
| T11 | Poplar | Populus canescens | Semi-mature | 8 | 2 | 200 90 | Yes | 3 | 1 | 1 | 3 | 4 | Exposed roots. Waterlogged | Twin stemmed at 0.5m. Significant lean. Old pruning wounds. Stubs. Bark damage. Cavities. Major decay | All dead / absent. Major deadwood. Snapped /hanging branches | Leans over path | Dead | Dead | n/a | Low | U | Removal recommended regardless of development |

| Tree Species | | | | Measurements | | | | Crown (m) | | | | Tree Condition | | | | | | | Value | | Management | |
|---|---|---|---|---|---|---|---|---|---|---|---|---|---|---|---|---|---|---|---|---|---|---|
| T16 | Birch | Betula pubescens | Young | 8 | 1 | 100 | No | 6 | 2.5 | 3 | 1.5 | 1 | Waterlogged | Single stemmed. Slight lean to east. Old pruning wounds. Stubs. Bark damage. Major cavity. Decay | Small / sparse. Old pruning wounds. Cavities. Minor deadwood. Snapped /hanging branches | Leans over path | Poor | Poor | <10 yrs | Low | U | Removal recommended regardless of development |

| Tree Species | | | | Measurements | | | | Crown (m) | | | | Tree Condition | | | | | | | Value | | Management | |
|---|---|---|---|---|---|---|---|---|---|---|---|---|---|---|---|---|---|---|---|---|---|---|
| T17 | Birch | Betula pubescens | Semi-mature | 12 | 1 | 120 | Yes | 4 | 1.5 | 1 | 1.5 | 2 | Waterlogged | Single stemmed. Slight lean. Epicormic growths. Old pruning wounds. Stubs. Bark damage. Major cavity. Decay | Old pruning wounds. Cavities. Minor deadwood. Snapped /hanging branches | Overhangs path | Poor | Poor | <10 yrs | Low | U | Removal recommended regardless of development |

- 4.2.11 Several trees were found to be in such poor condition or contain significant defects as to be recommended for removal regardless of development. These trees are T2, T11, T16, T17, T19, T25, T26, T27, T41, T42, T46, T47, T55, T57, T59, T60, T66, T70, T71, T74, T87, T90, T92, T93, T94, T100, T105, T110, T112, T135, and T137, identified in shaded red in the Tree Impacts Plan at Appendix 6.

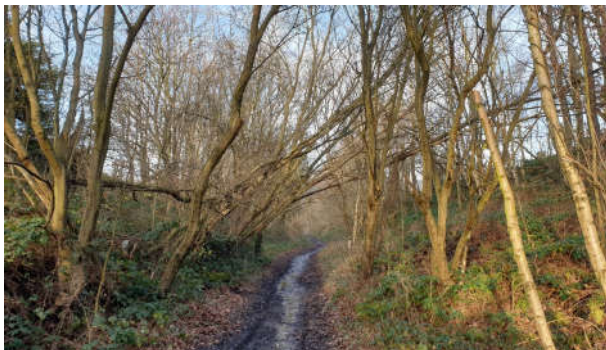
Photo 3: T41, T42, T46 and T47 had significant leans over the footpath and are recommended for removal regardless of development. Looking north

| Tree Species | | | | Measurements | | | | Crown (m) | | | | Tree Condition | | | | | | | Value | | Management | |
|---|---|---|---|---|---|---|---|---|---|---|---|---|---|---|---|---|---|---|---|---|---|---|
| T41 | Birch | Betula pendula | Mature | 9.5 | 1 | 270 | Yes | 3.5 | 1 | 7 | 1 | 0.5 | Limited access around base. Soil erosion. Exposed roots | Single stemmed. Significant lean. Epicormic growths. Old pruning wounds. Stubs. Minor cavities. Minor decay | Old pruning wounds. Cavities. Minor deadwood. Snapped /hanging branches. Unbalanced | Possible root heave/subsidence. Leans over path. Failed branches from adjacent trees leaning on stem | Fair | Poor | <10 yrs | Low | U | Removal recommended regardless of development |
| T42 | Goat Willow | Salix caprea | Mature | 12 | 6 | 220 avg | No | 3 | 4 | 7 | 2 | 1.5 | Limited access around base. Soil heave | Multiple stemmed at base. Significant lean to east. Epicormic growths. Old pruning wounds. Stubs. Bark damage. Tight union. Partially included bark. Cup-like union collecting dirt/water. Major cavities. Major decay | Old pruning wounds. Cavities. Major deadwood. Snapped /hanging branches. Unbalanced. Rubbing branches | Possible root heave/subsidence. Leans over path into stem of adjacent tree | Poor | Poor | <10 yrs | Low | U | Removal recommended regardless of development |

| Tree Species | | | | Measurements | | | | Crown (m) | | | | | Tree Condition | | | | | | | Value | | Management |
|---|---|---|---|---|---|---|---|---|---|---|---|---|---|---|---|---|---|---|---|---|---|---|
| T46 | Goat Willow | Salix caprea | Early-mature | 11 | 3 | 200<br>170<br>150 | No | 6 | 2.5 | 7 | 2.5 | 2 | Limited access around base | Multiple stemmed at base. Slight lean. Epicormic growths. Old pruning wounds. Stubs. Bark damage. Cup-like union collecting dirt/water. Minor cavities. Major decay | Old pruning wounds. Cavities. Moderate deadwood. Snapped /hanging branches. Unbalanced | Eastern stem failed at 3m, leaning into adjacent tree over path. Dead stump at base. Northern stem with significant decay at base | Fair | Poor | <10 yrs | Low | U | Removal recommended regardless of development |

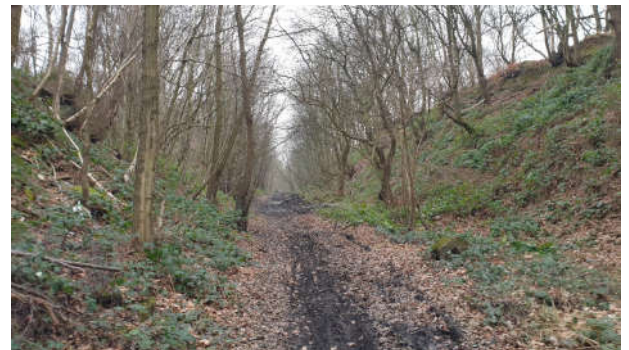
- 3.2.8 G109 and G111 were steep bankside groups mainly consisting of multiple-stemmed Sycamore. Access prevented detailed inspection, but occasional cavities with minor decay and tight unions were visible on numerous stems throughout both groups. Individually these trees were of low value but provided the site with a good degree of screening.

Photo 4: G109 to T117, looking south

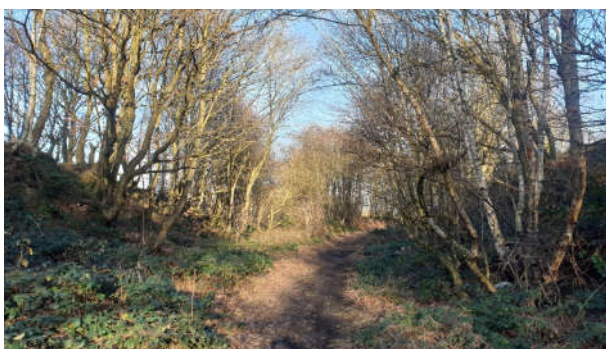
- 3.2.9 The northern half of the footpath runs across the top of some banking, which slopes down either side to the east and west. Trees within this area appeared to be in a better overall condition. T99, T132, T133, T139, T145, T147, T154, T162, T164, T182, and T183 were considered more arboriculturally significant, contributing to the amenity and treescape of the local area and offering good long-term prospects.

Photo 5: T131 to T133 and G138, looking north

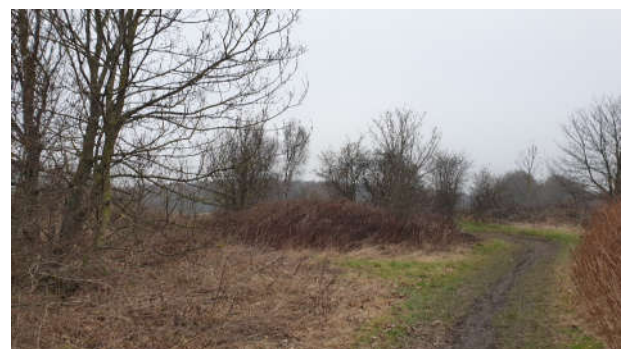
Photo 6: The northern area near Lee Lane contained little of arboricultural interest. G171 and T173, looking north
