**PROPOSED CAR PARK, BARUGH  
GREEN, BARNSELY**

Stage 3 Road Safety Audit

### Retail Development Access

### FINAL Stage 3 Road Safety Audit

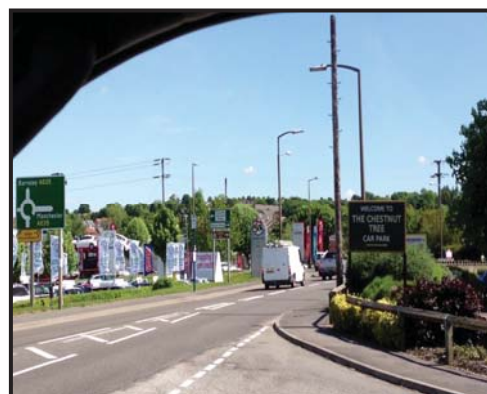
#### A1 PROBLEM

Location: Adjacent to Northwestbound carriageway on approach to Claycliffe Road access/egress.

Summary: Vegetation clearance required to avoid potential collisions.

The existing vegetation adjacent to the access on Claycliffe Road reduces visibility for vehicles exiting the site. If the shrubbery remains in place at its existing height, drivers approaching or leaving the site may not be intervisible, increasing the risk of collisions occurring. This is accentuated for drivers attempting to make a right turn out of the site due to the new road markings at the access being set back to provide sufficient width on Claycliffe Road for the ghost island protecting the right turn lane at the access. There is also a risk that pedestrians crossing the access will be masked from traffic making a left turn into the site, leading to pedestrian collisions.

**Photo 1:** Vegetation reducing visibility at the Claycliffe Road exit

It is recommended that the existing vegetation is replaced with low-level planting to provide clear sight lines for approaching traffic and for vehicles leaving the site.

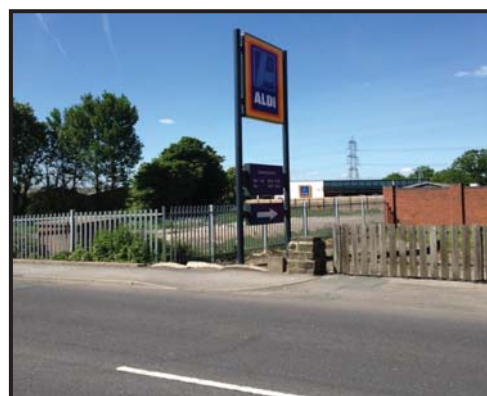
Summary: Misleading arrow sign at the future access/egress on Barugh Green Road.

The Aldi superstore sign located on Barugh Green Road has an arrow pointing in the direction of the site. Vehicles travelling on Barugh Green Road may mistake this as directing them into the newly constructed access/egress; However, there is no access to

**Photo 2:** Misleading arrow sign on Barugh Green Road

the superstore site from Barugh Green Road, nor is access envisaged once the site is developed.

Remove the arrow from the existing Aldi Superstore sign on Barugh Green Road.

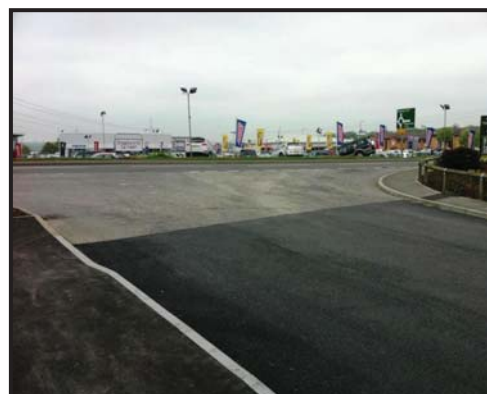
Location: Claycliffe Road access/egress.

Summary: Inadequate pedestrian crossing facility.

A dropped kerb on the west side footway, with no tactiles, has been installed. However, pedestrians using this dropped kerb as a crossing point are then forced to step up onto the east side footway as no corresponding dropped kerbing has been provided. This could cause pedestrians to trip and fall, possibly into the path of oncoming vehicles. Also, if a tactile crossing facility is not provided, visually impaired pedestrians may not realise they are at the edge of the footway and they may unwittingly, enter the carriageway increasing the risk of collisions between themselves and vehicles entering or exiting the site.

**Photo 3:** Crossing point at the Claycliffe Road access/egress

Install a dropped kerb with tactile paving on the southwest side of the Claycliffe Road access/egress, and tactile paving slabs on the northwest side. Ensure that there are flush kerbs between the tactile slabs and the carriageway on both sides of the road, to avoid any trip hazard.

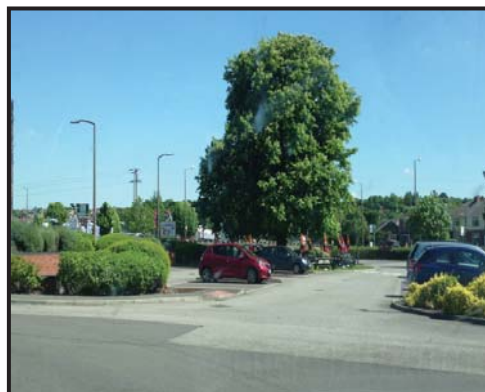
Location: Internal site layout.

Summary: Insufficient road markings.

No road markings have been installed within the internal extents of the site that clearly defines the priority of vehicles. It was noted during the site visit that vehicles exiting The Chestnut Tree public house car park were pulling out in front of oncoming vehicles. The audit team feel it would be beneficial to install give way markings at the access/egress of The Chestnut Tree public house. This would enable a form of priority to be clearly defined within the internal site, reducing the hesitation and confusion, which could lead to collisions.

**Photo 4:** The Chestnut Tree public house access/egress

Install give way markings at the access/egress to The Chestnut Tree public house.
