**ARBORICULTURAL REPORT**  
**to BS 5837:2012**  
**at**  
**65 Market Street**  
**Hoyland**  
**Barnsley**  
**South Yorkshire**  
**S74 0ET**

**Client:**  
Mr Trevor Brown

**JCA Ref:**  
11296/AJB

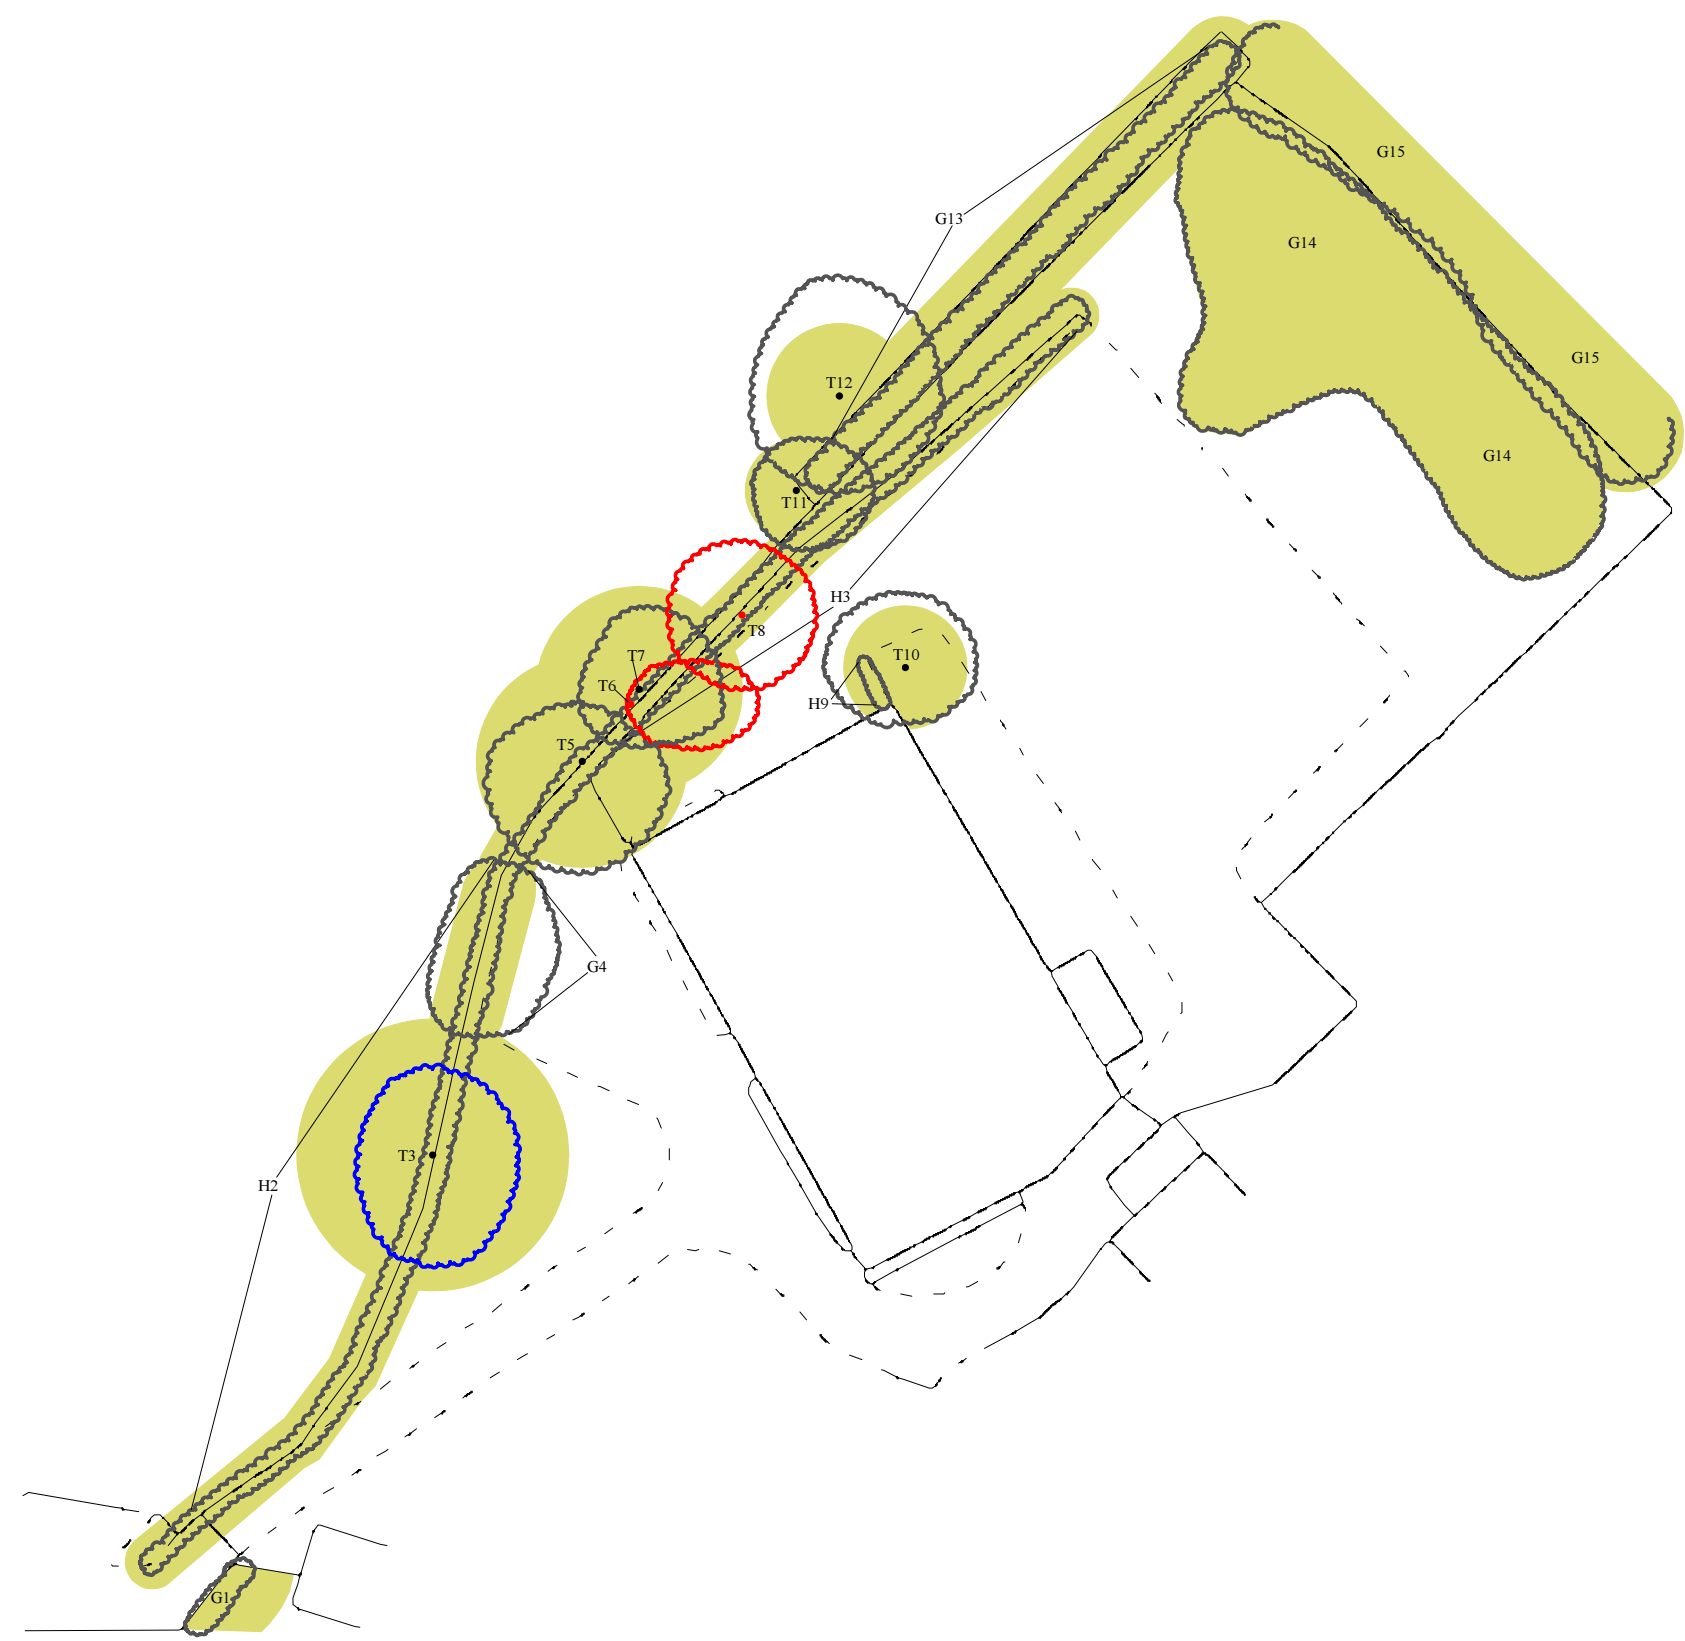
- 5.1.2 **T6** and **T8** were identified as retention category 'U'. These trees have defects and require removal for arboricultural reasons regardless of any on site development, as detailed in **Appendix 1**.

- 6.1 The trees surveyed were generally found to be in good or fair condition.
- 6.2 **T3** is protected by a Tree Preservation Order.
- 6.3 **T6** and **T8** have been recommended for removal for arboricultural reasons. These are discussed in **Section 5.1.2** and detailed at **Appendix 1**.
