**Report** Market Street, Hoyland  
**Client** Linton Properties  
**Project No.** 10086  
**Status** DRAFT  
**Date** 15<sup>th</sup> April 2010

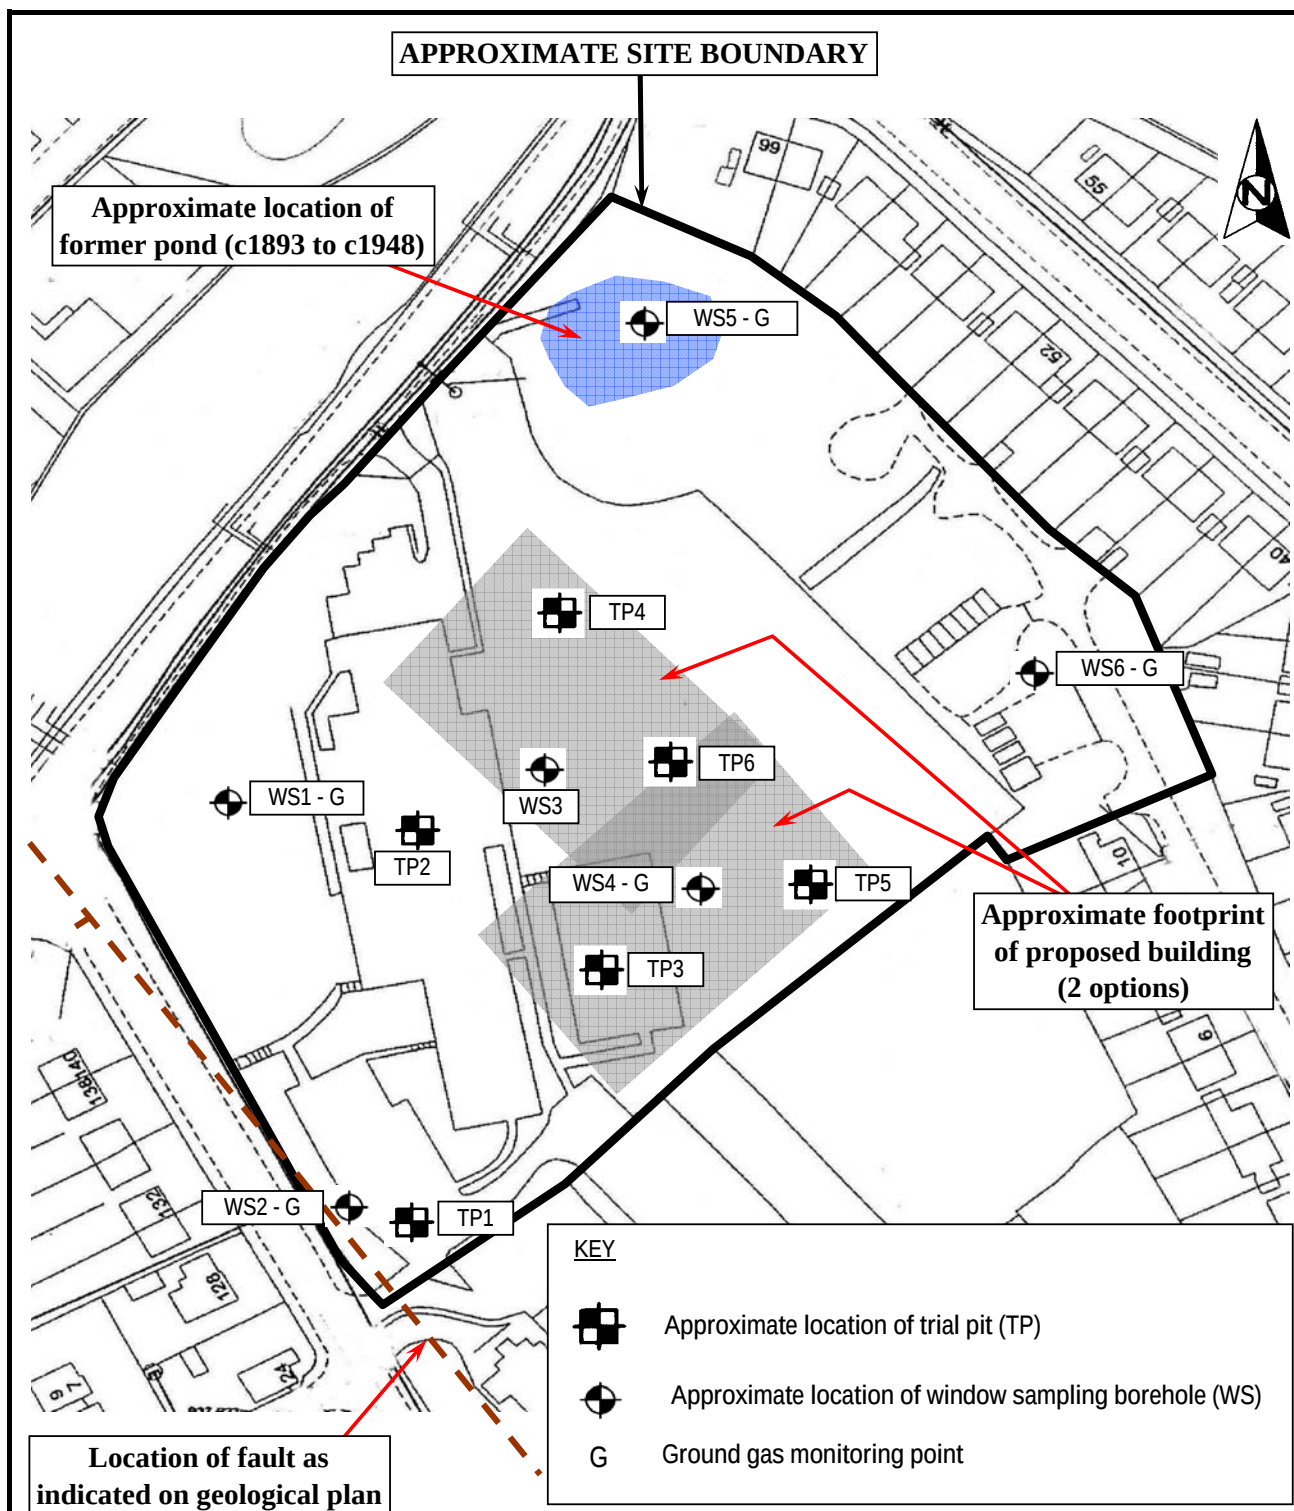
| | | Figure No. | 10086/01 | |

- a) Sub-contracted sub-surface utility scan of exploratory hole locations to attempt to avoid buried services during intrusive works.
- b) Advancement of six trial pits (TP1-TP6) and six window sampling boreholes (WS1-WS6).
- c) Installation of 5No. ground gas monitoring points.

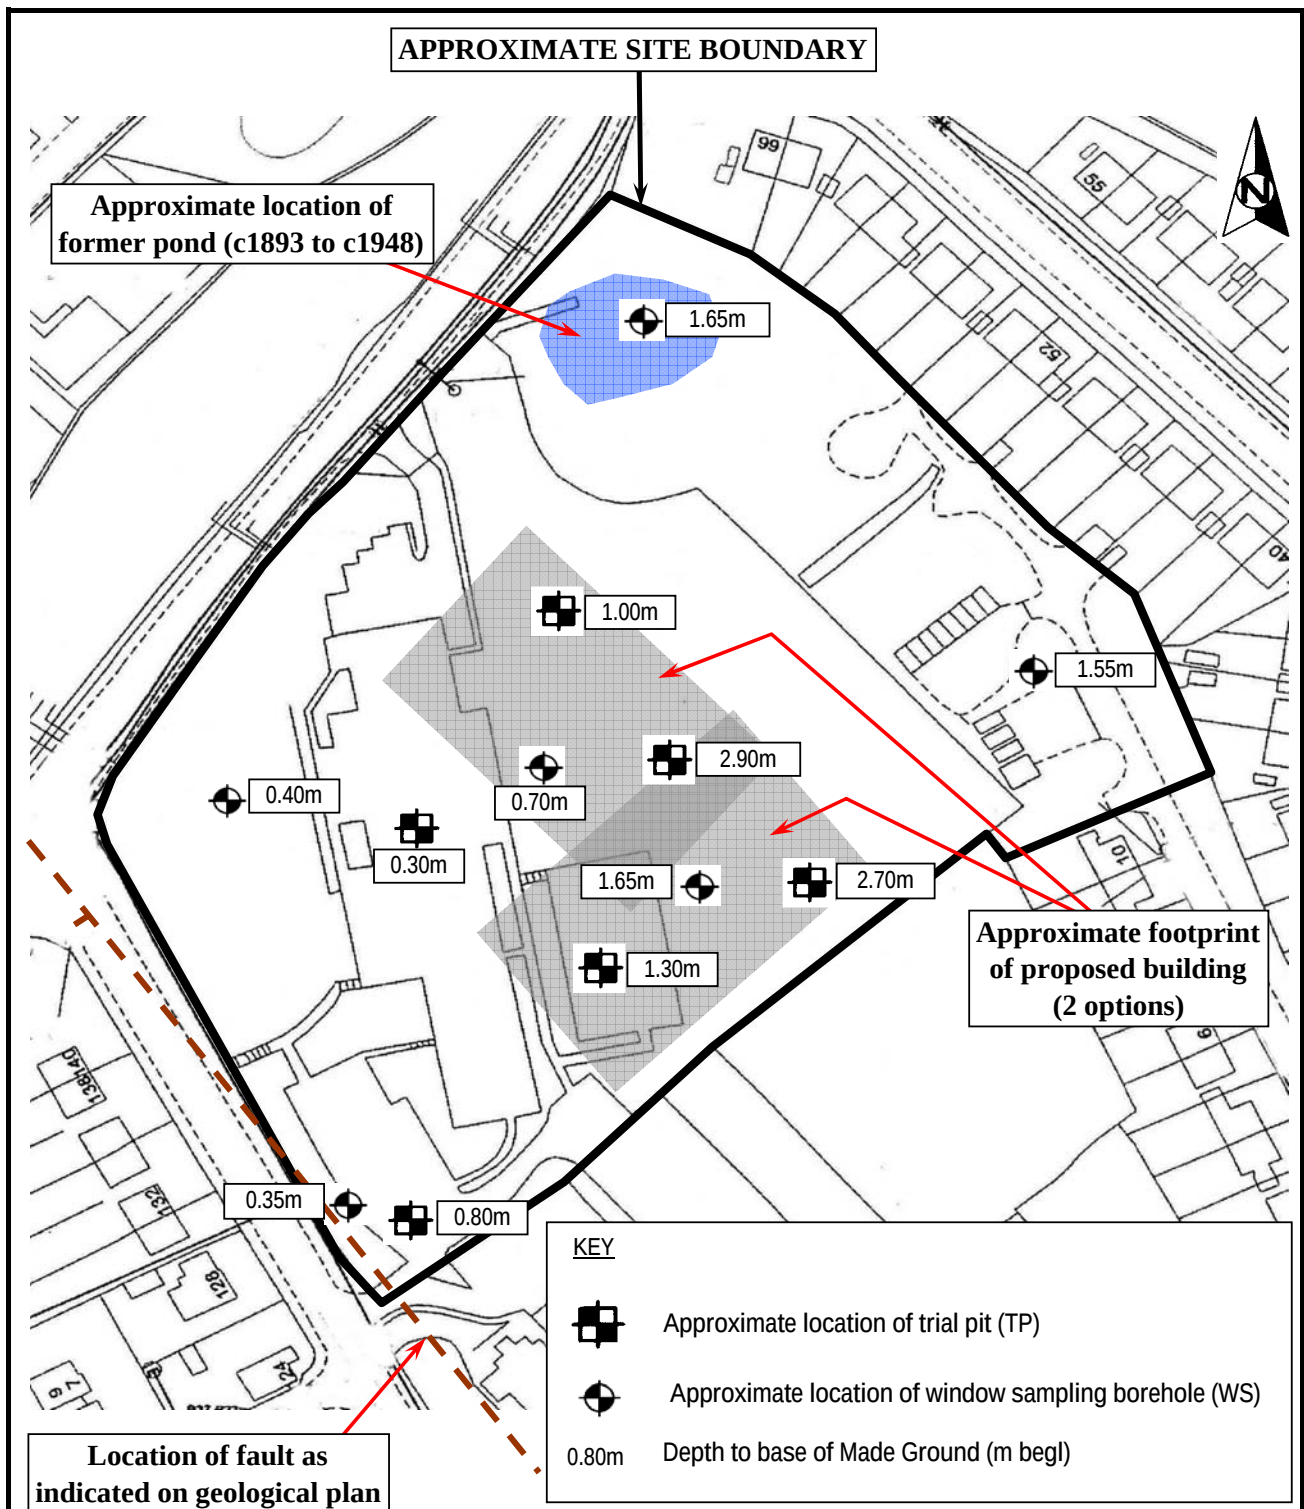
| | | Figure No. | 10086/02 |

Beneath the surface materials, general Made Ground was encountered to variable depths of between 0.30m and 2.90m begl. Made Ground was encountered at depths of up to 2.90m begl beneath the approximate footprint of the proposed building.

A plan showing the depth to the base of the Made Ground at each exploratory hole located is attached (Figure No. 10086/02).

However, the initial 'look-see' intrusive works have revealed the presence of between 0.70m and 2.90m of Made Ground (below existing ground level) beneath the approximate footprint of the proposed building.

The presence of significant depths of Made Ground and the likely requirement to undertake site regrading works prior to development may preclude the use of shallow foundations and it may become necessary to adopt deeper foundations (i.e. piles or ground improvement, for example).
